More than eleven years of temperature and displacements recorded on and in a limestone cliff: Dataset

This data set gives more than 11 years of temperature and displacements recorded on and in a limestone cliff. An extensive presentation of the monitoring devices and interpretation of data is proposed in Gasc-Barbier et al. (2021) [1]. The hazard-monitored zone is a perched cave in a limestone cliff where a part of its roof had collapsed. On its roof, an unstable beam reminds. A horizontal interlayer thinning from East to West, hanging to the roof of the cave at the west and east-clamped in the rock mass, delimits this remaining beam. Opened fractures can be observed all around the beam. In order to assess the remaining hazard, four fissurometers (F1 to F4) and a thermal probe were installed on the roof of the cave and two borehole extensometers (D1 and D2) were drilled perpendicular to the face of the cliff, above the cave, to understand the global behaviour of the rock mass. Measurements have been made between sockets embedded in the rock mass by means of INVAR wire measurements. Four bases made of two sockets each have been installed inside the cavity and five were put on the f

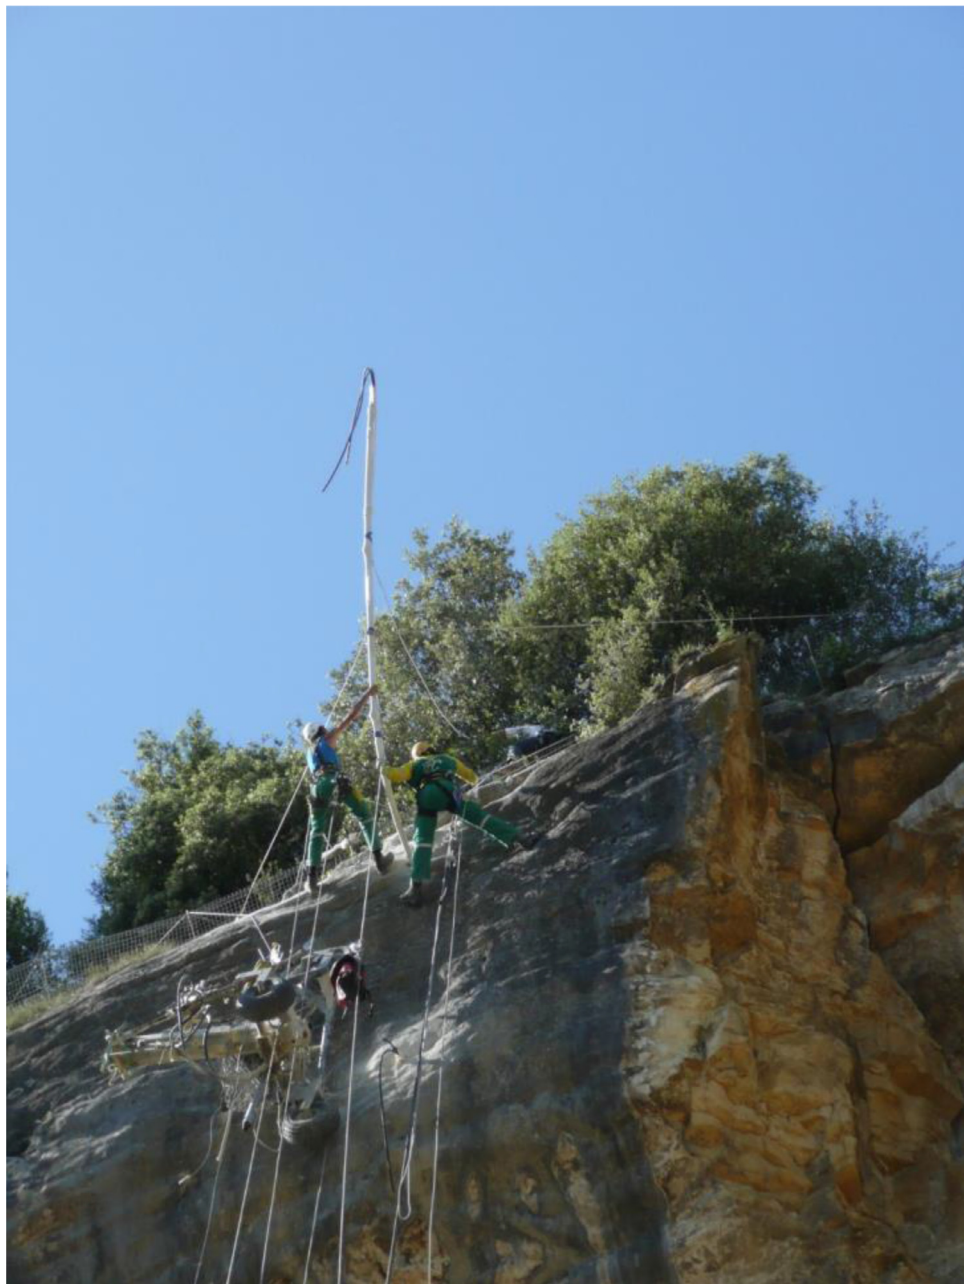
Fig. 1. Installation of borehole extensometer in pre-drilled borehole.

The borehole extensometers (D1 & D2) are RockTest / Télémac distoformTM anchored in the rock mass at the end of the borehole at a depth of 8 m from the cliff wall. Both were prepared by the manufacturer with three displacement-measuring points at depths of 2 m, 4 m and 6 m (see attached leaflet) from the cliff wall and temperature measuring points at 2 m and 6 m depth. The supplier gives a measuring range of 100 mm, a resolution lower than 0.01 mm. Given

the length of the rods used (8 m), the precision is about 0.05 mm. The operating temperature must remain between 0° and 50°C. The devices were placed acrobatically (Fig. 1), perpendicular to the rock face, about 4 m and 7.5 m above the roof of the cave cavity. Before that, boreholes were also drilled acrobatically. DATA-extenso.xlsx gives in the same table all data recorded with both borehole extensometers, 1 measurement point per hour. Columns are “time; displacements (mm) in D1 at 6, 4 and 2m depth, then in D2 at 6, 4 and 2m depth, temperature (°C) in D1 at 6 and 2m depth, then in D2 at 6 and 2m depth”.
