## More than eleven years of temperature and displacements recorded on and in a limestone cliff: Dataset

Didier Virely, Muriel Gasc-Barbier, Véronique Merrien-Soukatchoff

# More than eleven years of temperature and displacements recorded on and in a limestone cliff: Dataset

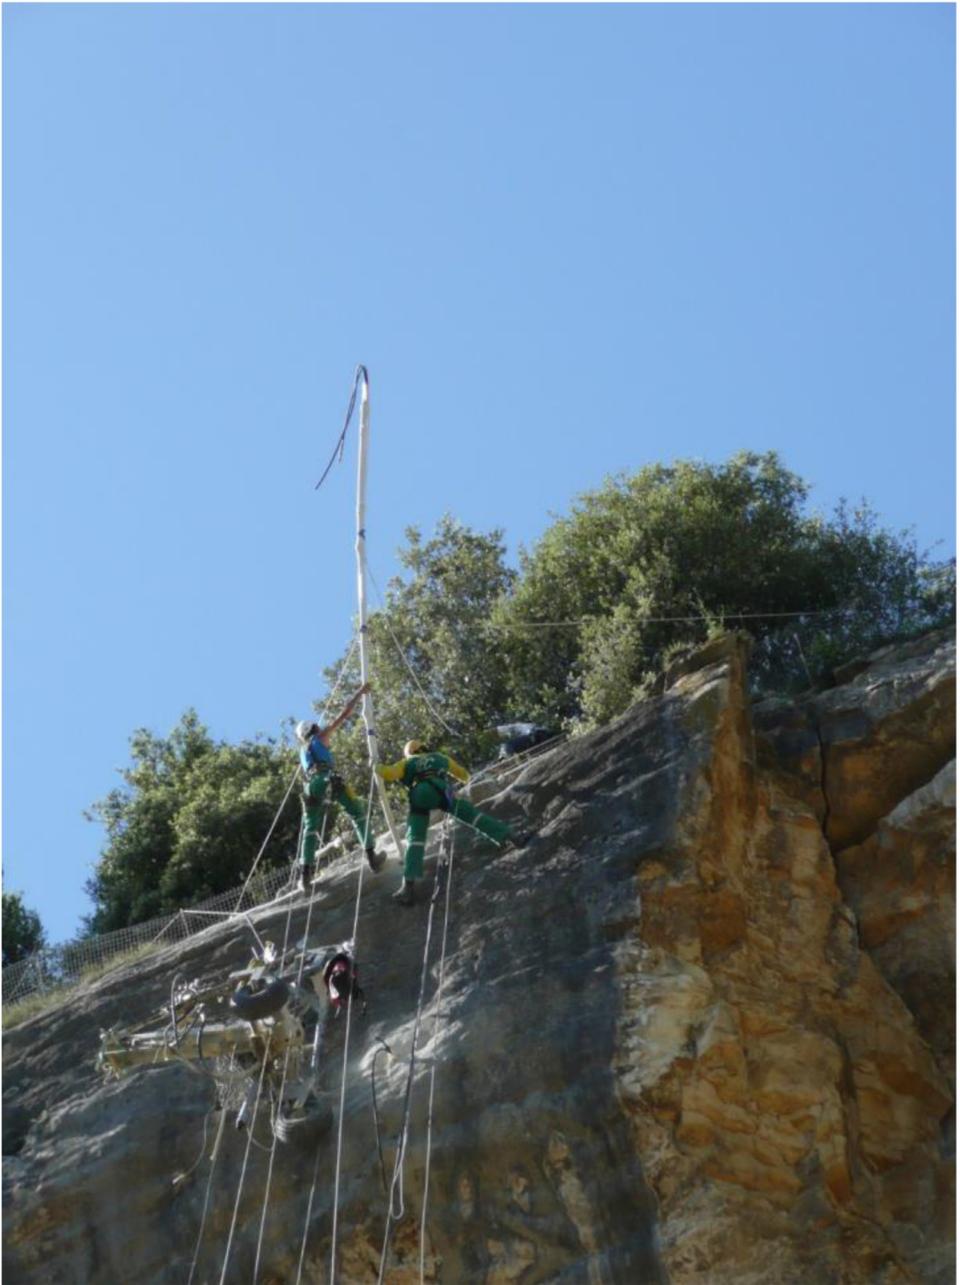
**Fig. 1.** Installation of borehole extensometer in pre-drilled borehole.

The borehole extensometers (D1 & D2) are RockTest / Télémac distoform<sup>TM</sup> anchored in the rock mass at the end of the borehole at a depth of 8 m from the cliff wall. Both were prepared by the manufacturer with three displacement-measuring points at depths of 2 m, 4 m and 6 m (see attached leaflet) from the cliff wall and temperature measuring points at 2 m and 6 m depth. The supplier gives a measuring range of 100 mm, a resolution lower than 0.01 mm. Given

the length of the rods used (8 m), the precision is about 0.05 mm. The operating temperature must remain between 0° and 50°C. The devices were placed acrobatically (Fig. 1), perpendicular to the rock face, about 4 m and 7.5 m above the roof of the cave cavity. Before that, boreholes were also drilled acrobatically. DATA-extenso.xlsx gives in the same table all data recorded with both borehole extensometers, 1 measurement point per hour. Columns are “time; displacements (mm) in D1 at 6, 4 and 2m depth, then in D2 at 6, 4 and 2m depth, temperature (°C) in D1 at 6 and 2m depth, then in D2 at 6 and 2m depth”.
