Application of Combined Geophysical Methods for the Examination of a Water Dam Subsoil

Abstract: The paper presents the results of geophysical measurements that were carried out in the vicinity of the water dam/water reservoir supplying the city of Bielsko-Biala with drinking water. The measurements were performed in order to non-invasively detect faults, fractured zones and areas filled with breccia, which may be, at the same time, a preferential path of groundwater flow. The aforementioned factors influence the stability of the dam. The general identification of the examined media was realized by the electrical resistivity tomography method. The ERT surveys were supplemented by capacitively-coupled resistivity. The electrical methods allowed them to recognize geological settings, indicate possible fault locations, and point out the fault plane as a path of water flow. The ground penetrating radar method detected fractured and filled water areas and underground water paths in the dam's forefield as a result of the method's very high resolution. The high resolution seismic reflection method provided a clear and high resolution image of the relatively deep geological structure and

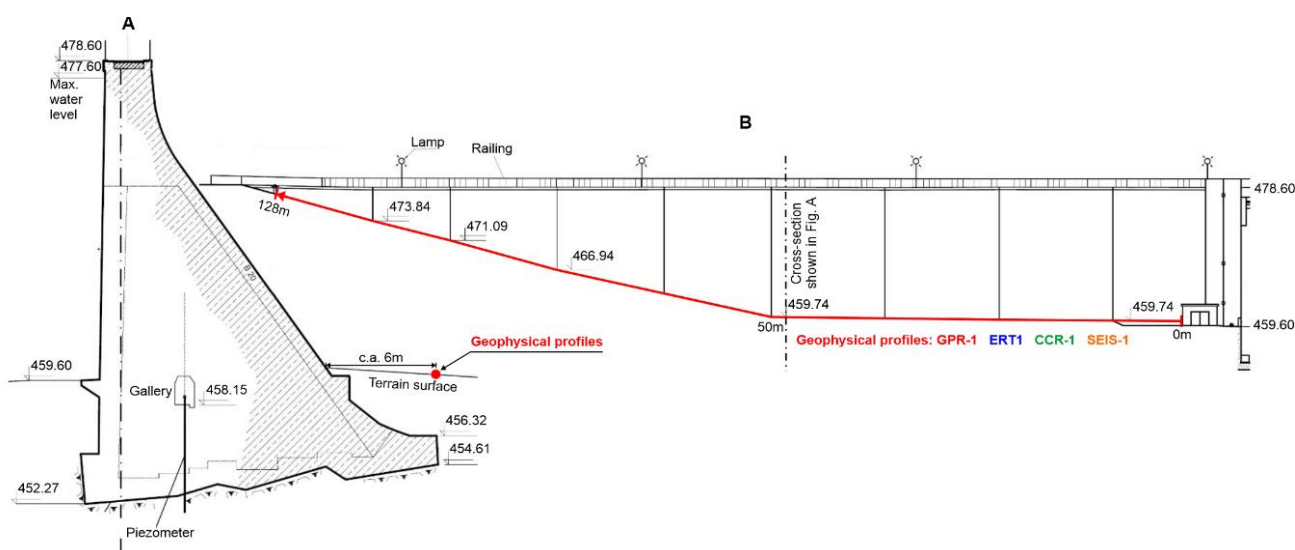
Figure 3. (A) Cross-section of the dam in central part of geophysical profiles [2]; (B) the south-eastern part of dam—concrete blocks and geophysical profiles were shown.

The water dam was built on the streams called Wapienica and Barbara, before World War II and its exploitation began in 1933. It was built to supply water to the city of Bielsko-Biala (Figure 1B). The body of dam, which has a length of 312 m, is made of concrete (Figure 1D), however the last 60 m of the water dam (Figure 2) was constructed as a concrete core earth dam. The height of the dam near the geophysical profiles equals 19 m measuring from the terrain surface, but the total height of the dam equals 27 m (Figure 3A). The body of dam consists of 17 concrete blocks (Figure 3B—only a small proportion of the blocks were shown) with dilatation gaps between several blocks; the gaps are sealed with copper plates and bitumen. The width of the dam at the base is 20 m and 3 m in the top part (Figure 3A).

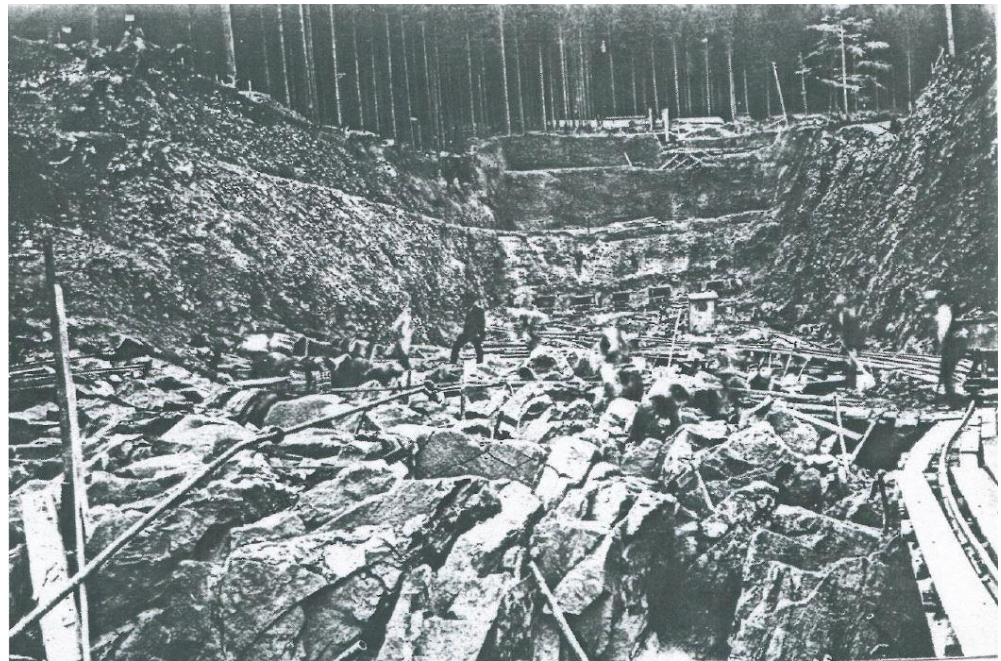
Figure 4. Excavation made in the slope of the Szyndzielnia mountain (the south-eastern part of the dam) during the building of the water dam in Wapienica site [4].

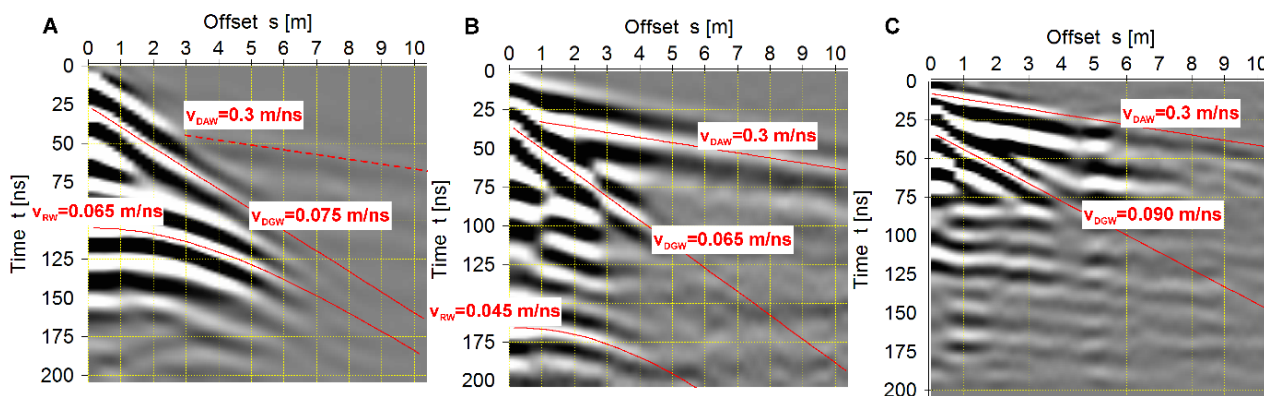
From among 10 WARR measurements, only 3 delivered satisfactory recordings (Figure 5). The velocity of the Direct Ground Wave (DGW) varied from 0.065 m/ns to 0.09 m/ns and the velocity of the Reflected Wave (RW) varied from 0.045 m/ns to 0.065 m/ns. Finally, for the time-depth conversion of radargrams, a constant mean velocity of electromagnetic wave equal to 0.066 m/ns was assumed. It should be noted that the velocity for consolidated, dry sandstone is equal to 0.15 m/ns; the estimation from the WARR velocities (i.e., 0.045–0.065 m/ns) shows that the rock mass (i.e., blocks of flysch sandstones) is fractured and fissures are filled with water or are colmatated with wet clay.

Figure 5. Selected results of WARR measurements carried out along profile GPR-2: (A) from 0m to 10m of profile; (B) from 40m to 50m of profile; (C) from 90m to 100m of profile.

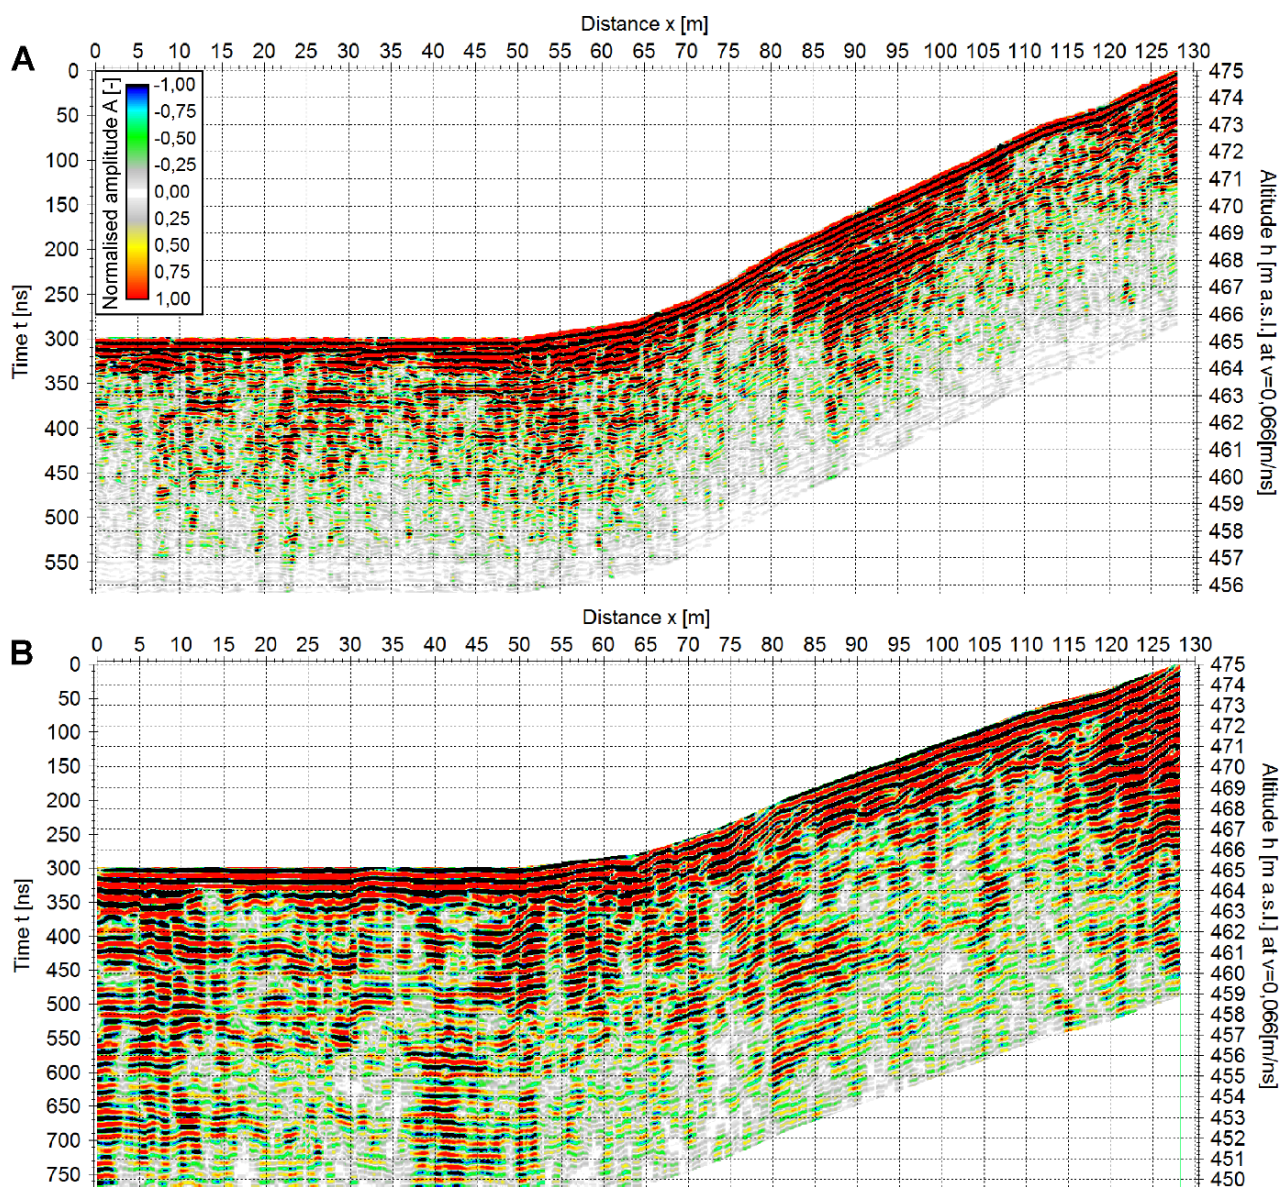
In Figure 6A, high-amplitude anomalies can be observed to the depth of 1 m, regionally to 2 m, and they depict heterogeneities in the soil and weathered sandstone. These heterogeneities may be correlated with the zones of higher porosity and water permeability and, in such zones, easy infiltration of water from precipitation and melted snow to the geological medium can be observed. The high value amplitudes in the near surface zones reveal that these zones are saturated by water, especially from $x = 40$ m to $x = 70$ m and between $x = 83$ and 104 m, as well as from $x = 117$ m to $x = 128$ m. Most important for the underground water flow are the GPR anomalies located in greater depths—in Figure 6A such a water saturated zone is easily noticed between $x = 83$ m and $x = 104$ m. Other anomalies with higher amplitudes located along the whole profile between the depths of 2 m and 6 m may be correlated with the fractures filled with different amount of air, water and clay.

In Figure 6B, high-amplitude anomalies were recorded in the near surface zone, to the depth of approximately 2 m, and these anomalies were interpreted above. At greater depths, interesting anomalies indicating water or wet clay saturated zones were noticed between $x = 0$ m and $x = 13$ m, $x = 37$ and $x = 85$ m, as well as $x = 115$ m and $x = 128$ m. Other anomalies with higher amplitudes may be correlated with fractured sandstone.

It is worth noting that in Figure 6A the most important anomaly was recorded between $x = 83$ m and $x = 104$ m but in Figure 6B a decrease in amplitudes in this region is instead observed. This phenomenon may be explained by the fact that the measurements using a 125 MHz antenna were carried out a few days before the measurements using the 70 MHz antenna, and as water flowed down, it led to high-amplitude anomalies being observed in the initial part of the profile (Figure 6B).

Figure 6. Radargrams recorded along profile GPR-1 with the use of: (A) 125 MHz and (B) 70 MHz antennae.

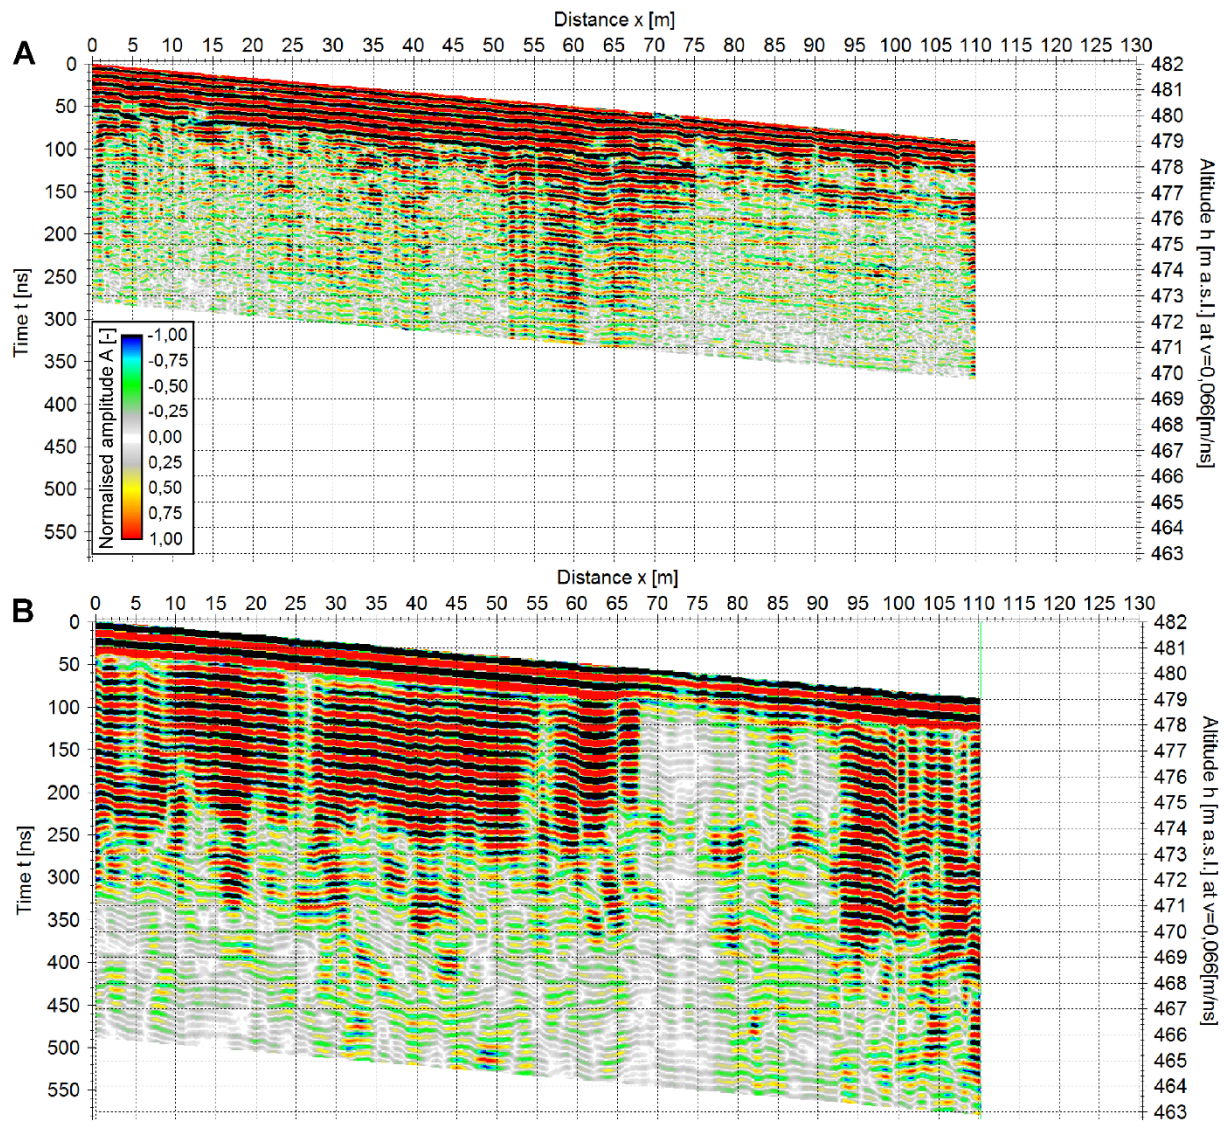
The results of the GPR surveys performed along profile GPR-2 were shown in Figure 7A (for 125 MHz antenna) and Figure 7B (for 70 MHz antenna). The effects recorded in radargrams in Figure 7 are quite different from those observed in Figure 6. This was caused by a number of facts (Figure 2), i.e., (a) profile 1 was designed along a geological medium highly changed by anthropogenic activity—profile 2 was designed over natural geological structures, (b) profile 1 was located on soil—profile 2 was located on a road covered

In Figure 7A, the high-amplitude reflections in the near surface zone (to the depth of 1–2 m) change their characteristic at $x = 70\text{--}75$ m. In the first part of the profile, 2 amplitudes are higher and the anomaly reaches deeper which may be caused by different constructions or different disintegrations of the basement of the road before and behind the turn (Figure 2). At greater depths, only one important anomaly may be distinguished, i.e., between $x = 50$ m and $x = 70$ m. It is highly likely that this anomaly depicts the fractured zone which carries the underground water from the Szyndzielnia mountain.

In Figure 7B, the distribution of anomalies at greater depths is different than that of anomalies observed in Figure 7A. Anomalies with very high amplitudes were recorded along the whole profile with a gap between $x = 67$ m and $x = 93$ m. Such distribution of anomalies might, theoretically, depict a large fractured zone filled with water. Such interpretation would be unreliable without additional information from boreholes or results obtained by means of other geophysical methods. Therefore, the GPR surveys along profile

Figure 7. Radargrams recorded along profile GPR-2 with the use of: (A) 125 MHz and (B) 70 MHz antennae.

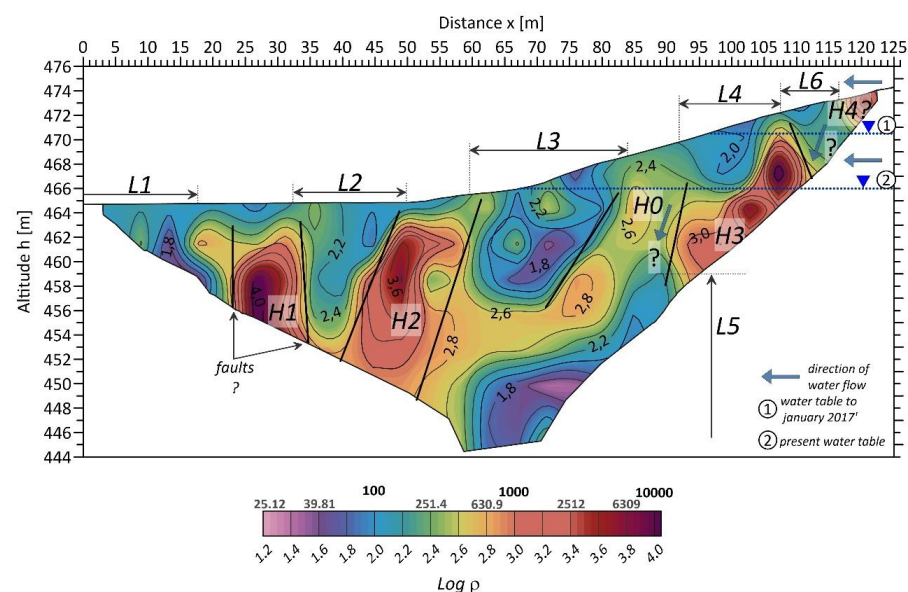
The high resistivity anomalies are in blocky form and were spotted for $x = 22$ –33, 40–58, 89–110 m of the profile line. The anomalies are characterized by resistivity values equal to approximately 10,000 Ωm . It is worth noting that the “H0” anomaly, located between the H2 and H3 anomalies, has a very similar shape to the other “H” anomalies but the resistivity value equals approximately 250 Ωm .

The low resistivity anomalies, “L1”–“L4” and “L6”, are located in the shallowest parts of the studied area with one exception, where anomaly “L5” is approximately 10 m below the ground surface. The anomalies' resistivity value is within a range between 60–150 Ωm .

Figure 10. Inverted resistivity cross-section for profile 1; RMS = 6.37%.

From a geological point of view, the low resistivity anomalies “L1” to “L4” may be interpreted as clay partly mixed with sands, which suggests the resistivity value is approximately 1.6 times greater than that of typical pure clays. It is worth noting, that the low resistivity anomalies are not completely homogeneous, which is especially visible for the “L1” and “L3” zones. In the above-mentioned areas, the presence of pure clay with a very low value of water permeability is noticeable. The “L5” anomaly should be interpreted as highly fractured and saturated sandstone.

In summary, the first geological layer consists of clay mixed with sands. The layer’s thickness is variable and, with the exception of the “L” anomalies, is equal to approximately 4 m for $x = 0\text{--}50$ m and for 51–120 m is approximately two times smaller. The second layer (sandstone), does not continue and occurs in blocky form. The thickness of the sandstone is approximately 12 m. Gaps between the sandstone blocks are filled with the material from the first layer. A discontinuity in the sandstone layer may be caused by an erosion/suffusion process related to the water flow from the Szyndzielnia mountain or the presence of tectonic forms like faults (cf. Figure 10). It is also highly probable that in the first step, the sandstone layer was broken by the faults, which consequently intensified the erosion process. Proof that the erosion/suffusion process (mainly water influence) is very active nowadays is the “H0” anomaly, which has a blocky form (like sandstone) but the resistivity value is approximately 40 times lower than the other sandstone cases.

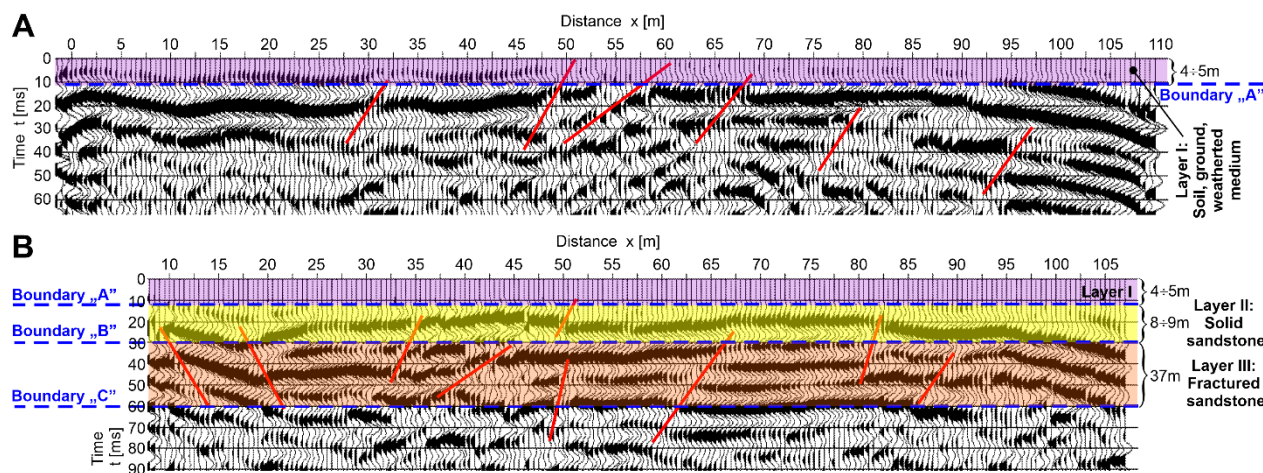
The obtained seismic sections and its interpretation are shown in Figure 14. During signal processing it was found that the OOW for boundary “A” fits the offset interval between 3 m and 8 m, however for the subsequent boundaries, the OOW starts from 15 m. Therefore, the results are presented on two separate sections (Figure 14A,B).

Figure 14. The high resolution seismic reflection profiles obtained along the top of dike and their interpretation. (A) 100 Hz profile, LRA symbols indicate the Loss of Reflection from A zones, straight black lines indicate shallow faults (B) 26 Hz profile.

The obtained results indicate the presence of three main layers marked I, II, III and this depth of layer I correlates with the depth previously obtained by the ERT technique (see Figure 10). The obtained interval velocities for layers I, II and III, and their geological interpretation are shown in Table 3 and illustrated in Figure 14 (on the right). These velocities were independently checked by refraction and provide similar results. It can be observed that the event noted as boundary “C” can constitute multiple reflections of boundary “B” and, therefore, it may not be considered as a geological boundary. The observed increase of the depth of boundaries “A”, “B” and “C” in the final part of the profile is caused by sloping of the profile (no static correction for this sloping is introduced); in fact the detected boundaries are not sloping.

It is worth noting that the boundaries “A” and “B” display numerous discontinuities which can be interpreted as shallow faults. These faults were previously detected by the ERT technique. This suggests that dam leakage (which is in the origin of this study) may be caused by the presence of the faults.

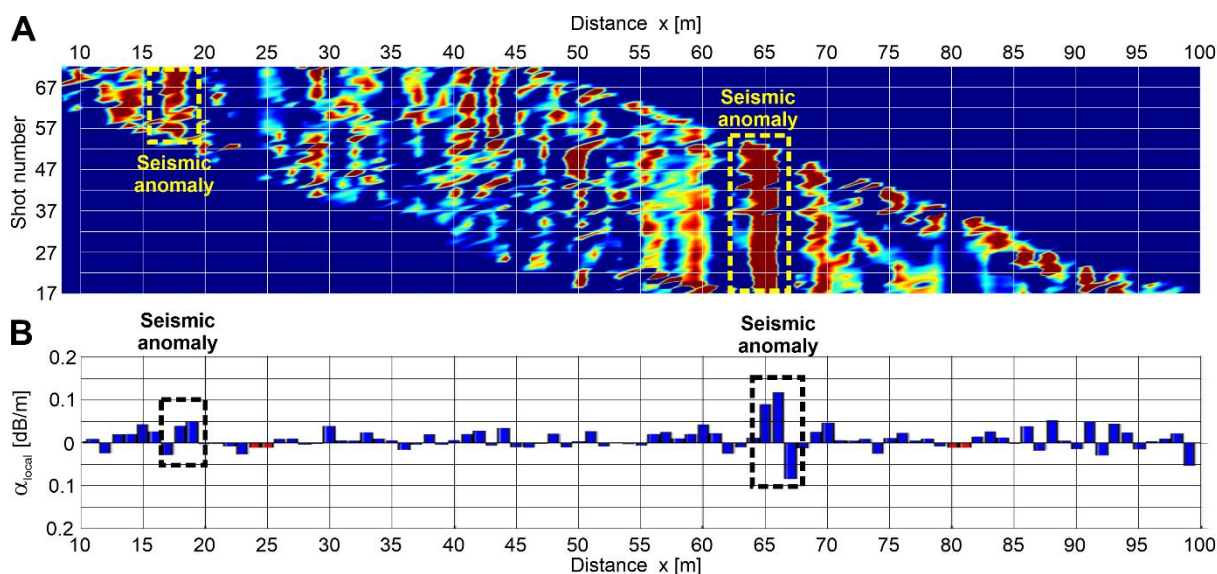
The $\alpha_{\text{local}}(x)$ parameter was obtained by using the following processing flow: the band-pass filtering in 30–60 kHz (a bandwidth of the SW), FK filtering in interval of the SW velocities 300–600 m/s, (the SW velocities), the $A(x)$ determination and, finally, the $\alpha_{\text{local}}(x)$ computed by using (equation1). Within this frequency band, the SW penetration (which can be assumed to be an SW wave length), can be estimated at 20 m. The obtained results are presented in Figure 15A,B. Notice that for the rolling of the acquisition channels, the anomalies of the SW associated with a given profile position form a vertical line. This is clearly seen in Figure 15A. In order to improve the $\alpha_{\text{local}}(x)$ reliability, the $\alpha_{\text{local}}(x)$ values obtained from each shot are stacked and the final result is shown in Figure 15B. It follows from this result that the most significant anomalies are located in the regions marked in Figure 15A,B. Both positions of anomalies correlate well with the faults indicated in Figure 14A,B. In general, the obtained results indicate that $\alpha_{\text{local}}(x)$ can help in classifying the faults quantitatively and such classification is not possible through a classic seismic section.

Figure 15. (A) α_{local} parameter as a function of the number of shots and the profile’s position; (B) stacked α_{local} as a function of profile position.
