# In Vitro Microleakage of Biodentine as a Dentin Substitute Compared to Fuji II LC in Cervical Lining Restorations

Anne Raskin, Geoffroy Eschrich, Jacques Dejou, Imad About

*J Adhes Dent* 2012;14:8 pages.  
doi: 10.3290/j.jad.a25690

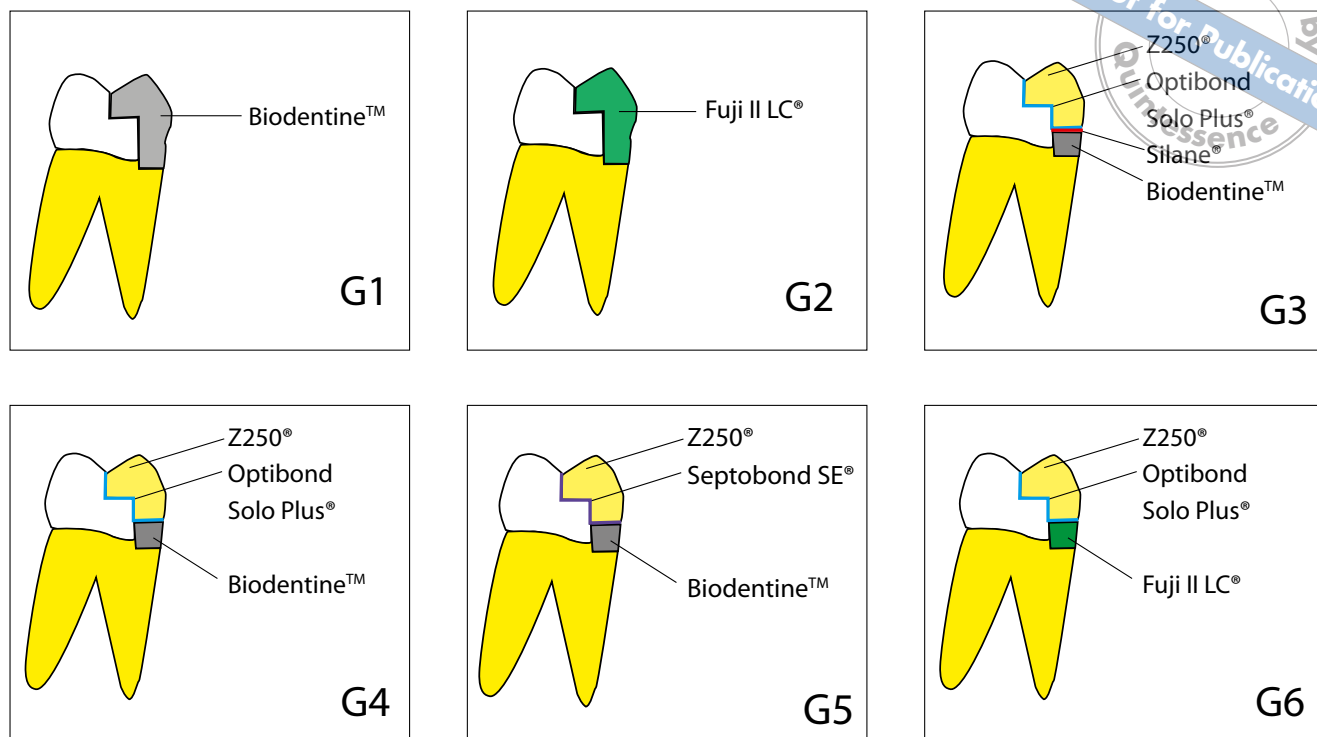
**Fig 1** Class II cavities designs in the 6 experimental groups. G1: Class II filled with Biodentine; G2: Class II filled with Fuji II LC; G3: dentin substitute (Biodentine) covered with silane, Optibond Solo Plus and filled with Z250; G4: dentin substitute (Biodentine) covered with Optibond Solo Plus and filled with Z250; G5: dentin substitute (Biodentine) covered with Septobond SE and filled with Filtek Z250; G6: dentin substitute (Fuji II LC) covered with Optibond Solo Plus and filled with Filtek Z250.

The teeth were scaled and cleaned with slurry of pumice before cavity preparation. The mesial and distal surfaces of each tooth were randomly attributed to one of 6 groups (n = 10 per group) (Fig 1) by using a random numbers table for assigning teeth, and randomizing by blocks so that (1) half of the restorations of a group were made on the mesial face and other half on the distal face, and (2) every restoration of a group was placed alternately with a restoration from the 5 other groups.

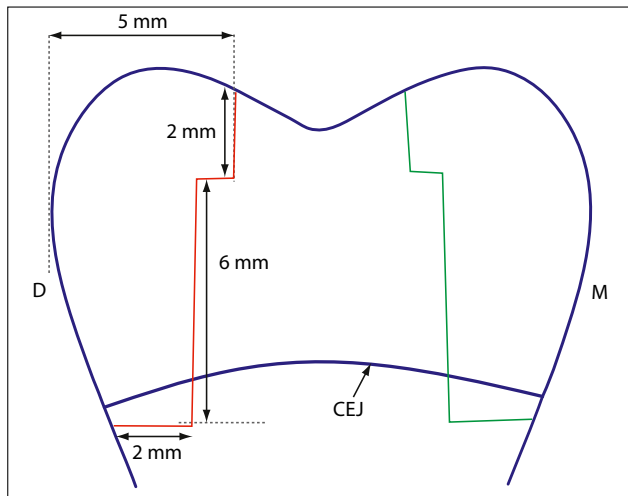
**Fig 2** Class II cavities designs and dimensions.

Cavity preparations were made using cylindrical diamond burs (Diatech, Heerbrugg, Switzerland, ISO-NO 806 314 173 524 031 10.0) under a water-cooled high-speed handpiece. Two standardized approximal cavities were prepared at the cemento-enamel junction (CEJ) on the mesial and distal surfaces of each tooth. The enamel and gingival margin in dentin/cementum was prepared to a butt joint. Cavity dimensions are described in Fig 2.

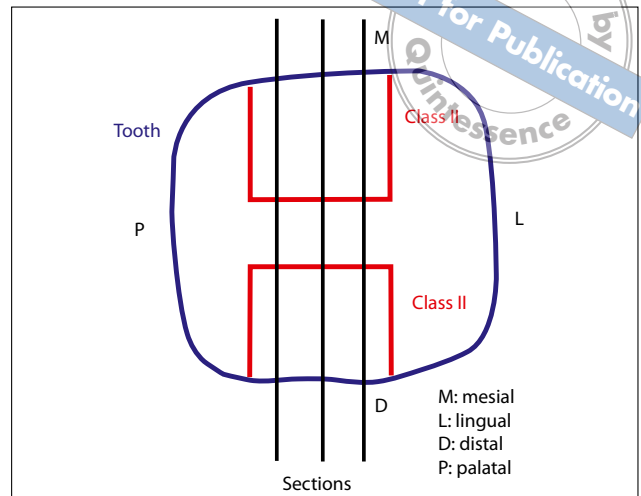
**Fig 3** Orientation and position of the three sections per restoration (occlusal face).

To prepare for the dye penetration test, all tooth root apices were sealed with Fuji II LC to prevent the tracer penetrating through the apex. The surfaces of the teeth were coated with two layers of red nail varnish (Sech'Express, Gemey; Orléans-Ormes, France) 1 mm beyond the restoration margins. All specimens were placed in a 50 wt% weight silver nitrate aqueous solution in the dark for 2 h. They were then rinsed with water and placed in a radiographic developing solution (Ilford, ID11; Mobberley, Cheshire, UK) for 6 h under a fluorescent light. The teeth were thoroughly washed with water and acetone to remove the nail varnish and embedded in a slow-curing polyester resin (Sody 33, ESCIL; Chassieu, France). After being embedded in the slow-curing resin, the teeth were sectioned with a low-speed Isomet saw as described in Fig 3.

Three sections per restoration of approximately 500 µm thickness were made. These provided 6 surfaces for the dye penetration evaluation.

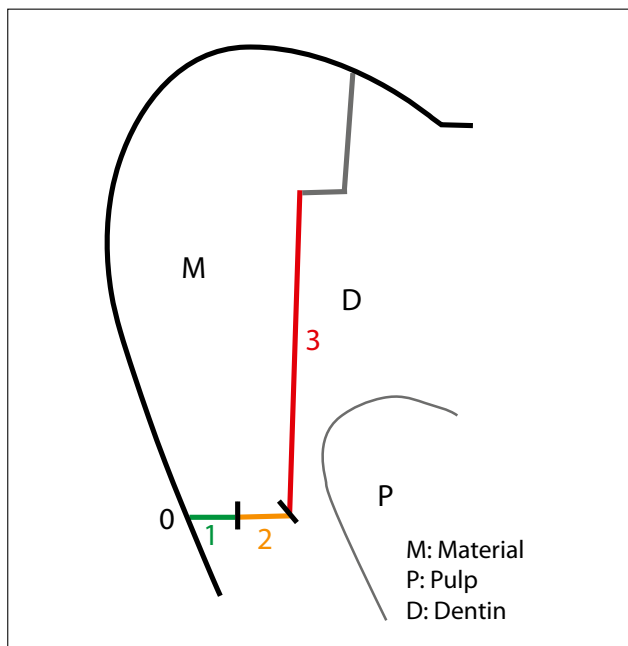
**Fig 4** Tracer penetration evaluation at dentin/biomaterial interface.

Photographs were obtained for each of the sections, and dye penetration evaluations were made directly under a binocular stereomicroscope at 125X and recorded as the penetration depth along the cavity walls (ordinal scale; Fig 4). Scores for cervical margins were: 0 = no penetration; 1 = leakage extending within first 1/2 of the cavity wall; 2 = leakage extending beyond 1/2, but not

as far as the cervical cavity floor; 3 = leakage extending beyond the cervical cavity wall and reaching the cavity floor. Scores for Biodentine/RMGIC to resin composite interfaces were: 0 = no penetration; 1 = leakage extending within first 1/2 of the interface wall; 2 = leakage extending beyond 1/2 but not as far as the interface wall; 3 = leakage extending beyond the interface wall and reaching the cavity floor. For enamel margins, the scores were: 0 = no penetration; 1 = leakage extending within first 1/2 of the enamel wall; 2 = leakage extending beyond 1/2, but not as far as the dentin-enamel junction; 3 = leakage extending beyond the enamel-dentin junction.

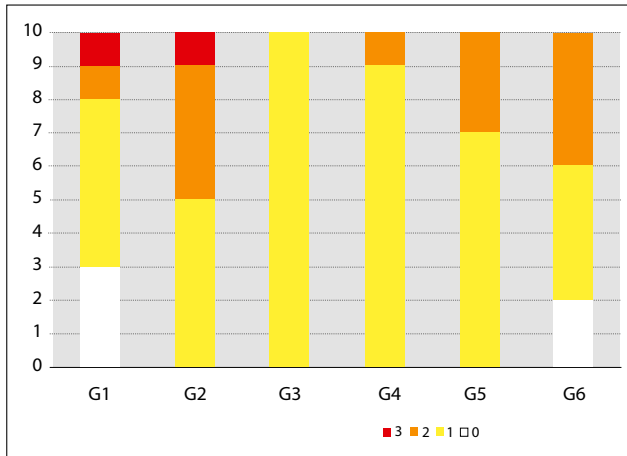
**Fig 5** Frequency of dentin microleakage scores.

No statistically significant differences were evident between the 6 groups (Kruskal-Wallis,  $p = 0.46$ ; Table 2). The median of maximum scores recorded was low (median score = 1.0) for all groups, except for G2, which was a little higher (1.5) (Table 2; Fig 5). Only G1 and G2 presented score 3. All groups, except G3, presented score 2. Only G1 and G6 presented score 0. Score 1 was predominant in all groups (Fig 5).

Statistically significant differences were observed between the dentin and enamel interface for G2 and G5. Dye penetration was higher at the dentin/Fuji II LC interface (G2; Wilcoxon,  $p = 0.043$ ) and higher at the enamel/Septobond SE interface (G5; Wilcoxon,  $p = 0.431$ ) (Figs 5 and 6).

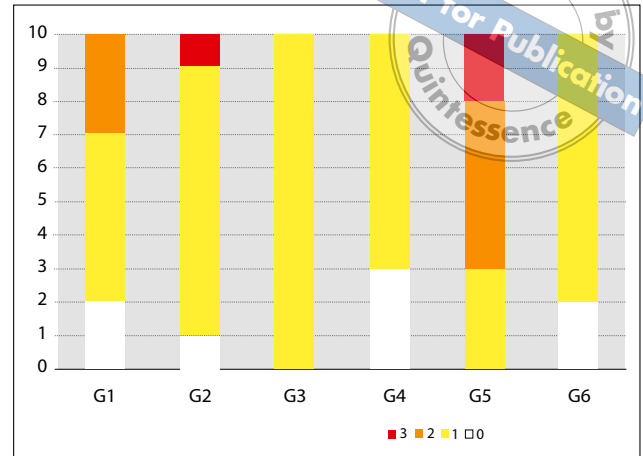
**Fig 6** Frequency of enamel microleakage scores.

Statistically significant differences were found between the groups (Kruskal-Wallis,  $p = 0.05$ ); Table 2). Dye penetration was higher at the enamel restoration interface of G5. The median of maximum scores recorded was also weak (1.0) for all groups, except for G5, which was higher (2.0). G2 and G5 presented score 3. G1 and G5 had score 2. G1, G2, G4, and G6 showed score 0. Score 1 was predominant in all groups, except for G5 (Fig 6).

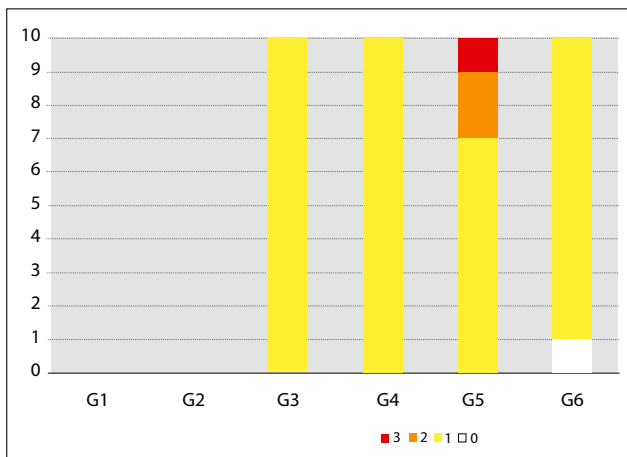
**Fig 7** Frequency of interface microleakage scores.

No statistically significant differences were noted between the 4 groups (Kruskal-Wallis,  $p = 0.43$ ; Table 2). The median of maximum scores was low (1.0) for all 4 groups (Table 2). Only G5 presented scores 2 and 3, while only G6 presented score 0. Score 1 was predominant in all groups (Fig 7).
