Using blister test to predict the failure pressure in bonded composite repaired pipes

Silvio DE BARROS, B.M. Fadhil, Fahmi Alila, J. Diop, J.M.L. Reis, et al.. Using blister test to predict the failure pressure in bonded composite repaired pipes. *Composite Structures*, 2019, 211, pp.125 - 133. 10.1016/j.compstruct.2018.12.030 . hal-03485856

aUsing blister test to predict the failure pressure in bonded composite repaired pipes

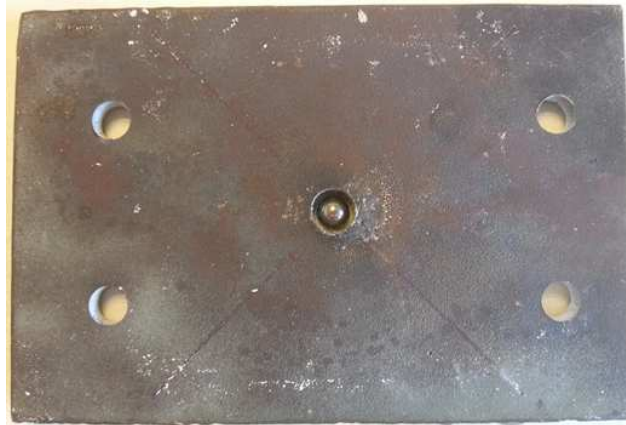
Figure 3. Specimen with the steel half ball placed for the test.

In order to ensure an axisymmetric evolution of the blister during the test, a half ball of steel with 8 mm diameter was glued on the composite material inside the central hole, once the specimens were ready to be tested (Figure 3).

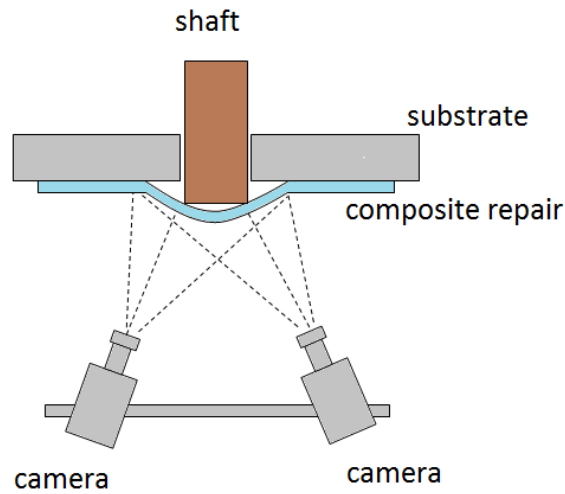
Figure 4. DIC schematic.

A digital image correlation (DIC) technique has been used to follow up the debonding propagation and evaluate the blister shape. By comparing two digital images features of the composite surface before and after deformation, total strain data can be obtained. For this purpose a two-camera system has been used to monitor the strain progressing on the surface. The schematic of DIC technique used for the blister test is shown in Figure 4. With these two cameras, the strain profile of the blister can be captured. The whole surface of the blister can be monitored by the two cameras to evaluate the blister shape.

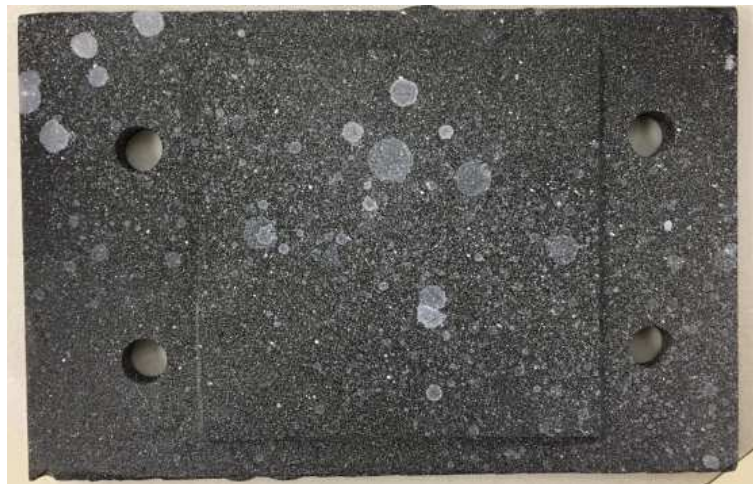
Figure 5. Specimen prepared for DIC.

In order to realize digital image correlation, a speckle has been realized. The chosen speckle was realized with a first layer of white paint a then a second one with a black paint pulverizing random points on the white layer (Figure 5).

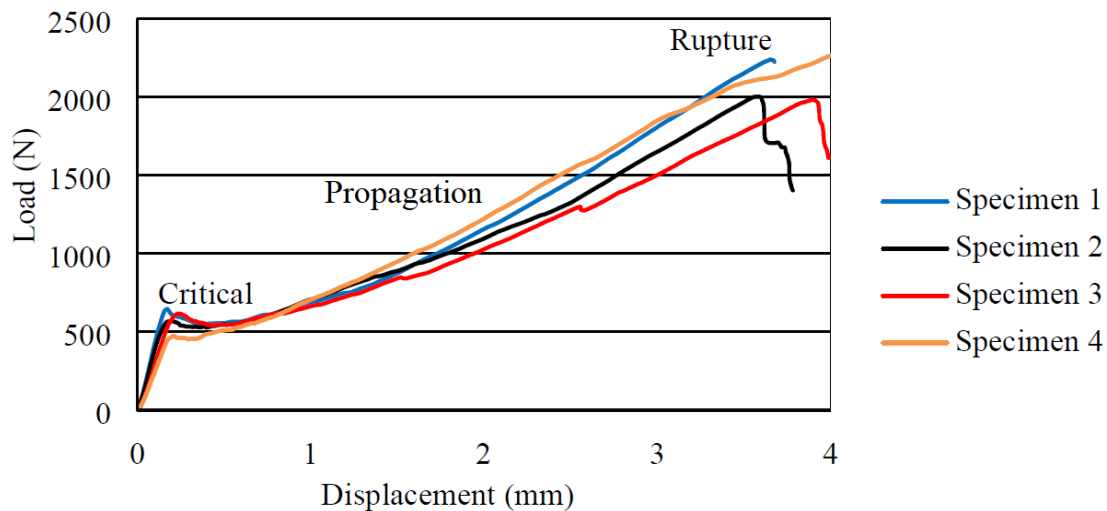
Figure 7. Blister tests - load displacement curves.

Four specimens were prepared in this work and the load versus vertical displacement of the shaft curves obtained from the blister tests are shown in Figure 7. As it was pointed out by Islam and Tong [23], three regions can be observed. Region 1 is where the critical load of initial debonding of the repair can be observed. Region 2 is where the interfacial debonding propagates and Region 3 is where the final rupture of the repair occurs. The average value of the critical load identified at the end of the Region 1 is used to calculate the total energy release rate (G_T).

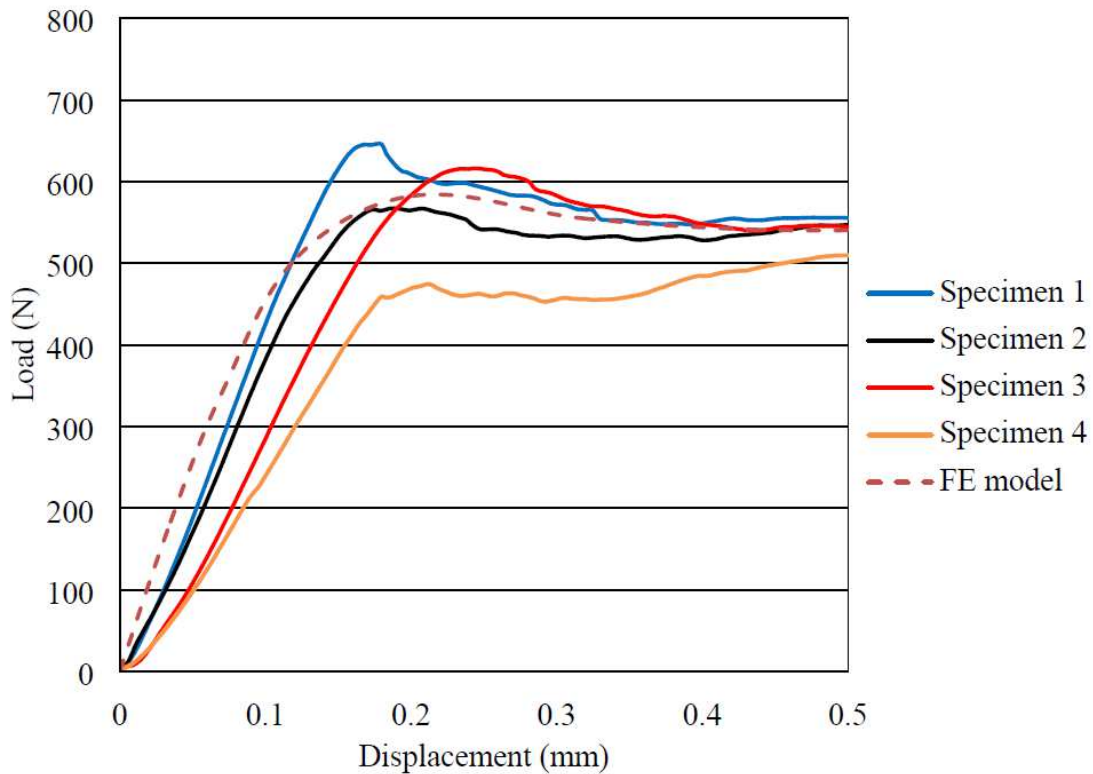
Figure 10. Load displacement curves in Region 1.

In order to validate the numerical model using the blister test results obtained here, the test was initially simulated with a composite repair of 1.3 mm thickness. Figure 10 shows a good correlation between numerical and the experimental results. Especially in the Region 1, where the critical load is identified to determine the G_T and consequently to get the failure pressure. The CZM parameters were adjusted in order to fit the experimental results. The traction stress T and the interfacial displacement δ which best fit the results were 6 MPa and 0.03 mm, respectively. The critical load identified in this simulation was 582 N. According to equations 1 and 3, this critical load corresponds to exactly the same total energy release rate ($G_T = 0.28$ N/mm) and a failure pressure (100 Bar) found in the experimental blister test.

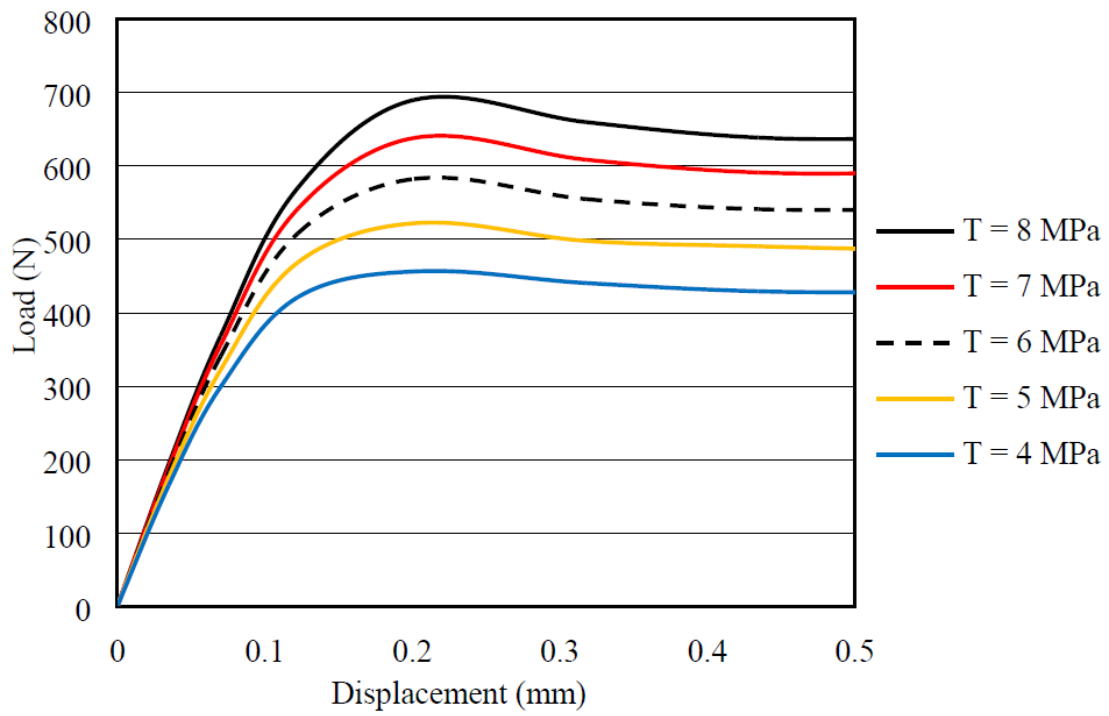
Figure 13. Influence of the parameter T in the critical load.

Simulations with different values for the CZM parameters were performed in order to investigate the influence of the traction stress T and the interfacial displacement δ on the critical load. The Figure 13 presents the load displacement curves obtained when keeping δ equal to 0.03 mm and Figure 14 presents the results obtained when keeping T equal to 6 MPa.

The Table 4 compiles the critical load values taken from curves on Figures 13 and 14. It also presents the correspondent values for G_T and the failure pressure, calculated according to equations 1 and 3, respectively. The differences (Δ) between the values of critical load, G_T and failure pressure when compared to the ones obtained using $T = 6$ MPa and $\delta = 0.03$ mm are also presented in separated columns.
