Bacteria accumulate copper ions and inhibit oxide formation on copper surface during antibacterial efficiency test

1 **Bacteria accumulate copper ions and inhibit oxide formation on copper**
2 **surface during antibacterial efficiency test**

12 Copper surface after antibacterial test against *E. coli* was examined in the aspect of corrosion. Results from
13 scanning electron microscope (SEM), grazing incidence X-ray diffractometer (GIXRD) and Raman spectroscopy
14 together confirmed less oxidation on copper surface with the presence of *E. coli*. The inhibition of the cuprous
15 oxide (Cu₂O) layer instead ensured the continuous exposure of copper surface, letting localised corrosion attacks
16 observable and causing a stronger release of copper ions. These phenomena are attributed to the fact that *E. coli*
17 act as ions reservoirs where high amount of copper accumulation were found by energy dispersive X-ray
18 spectroscopy (EDS).

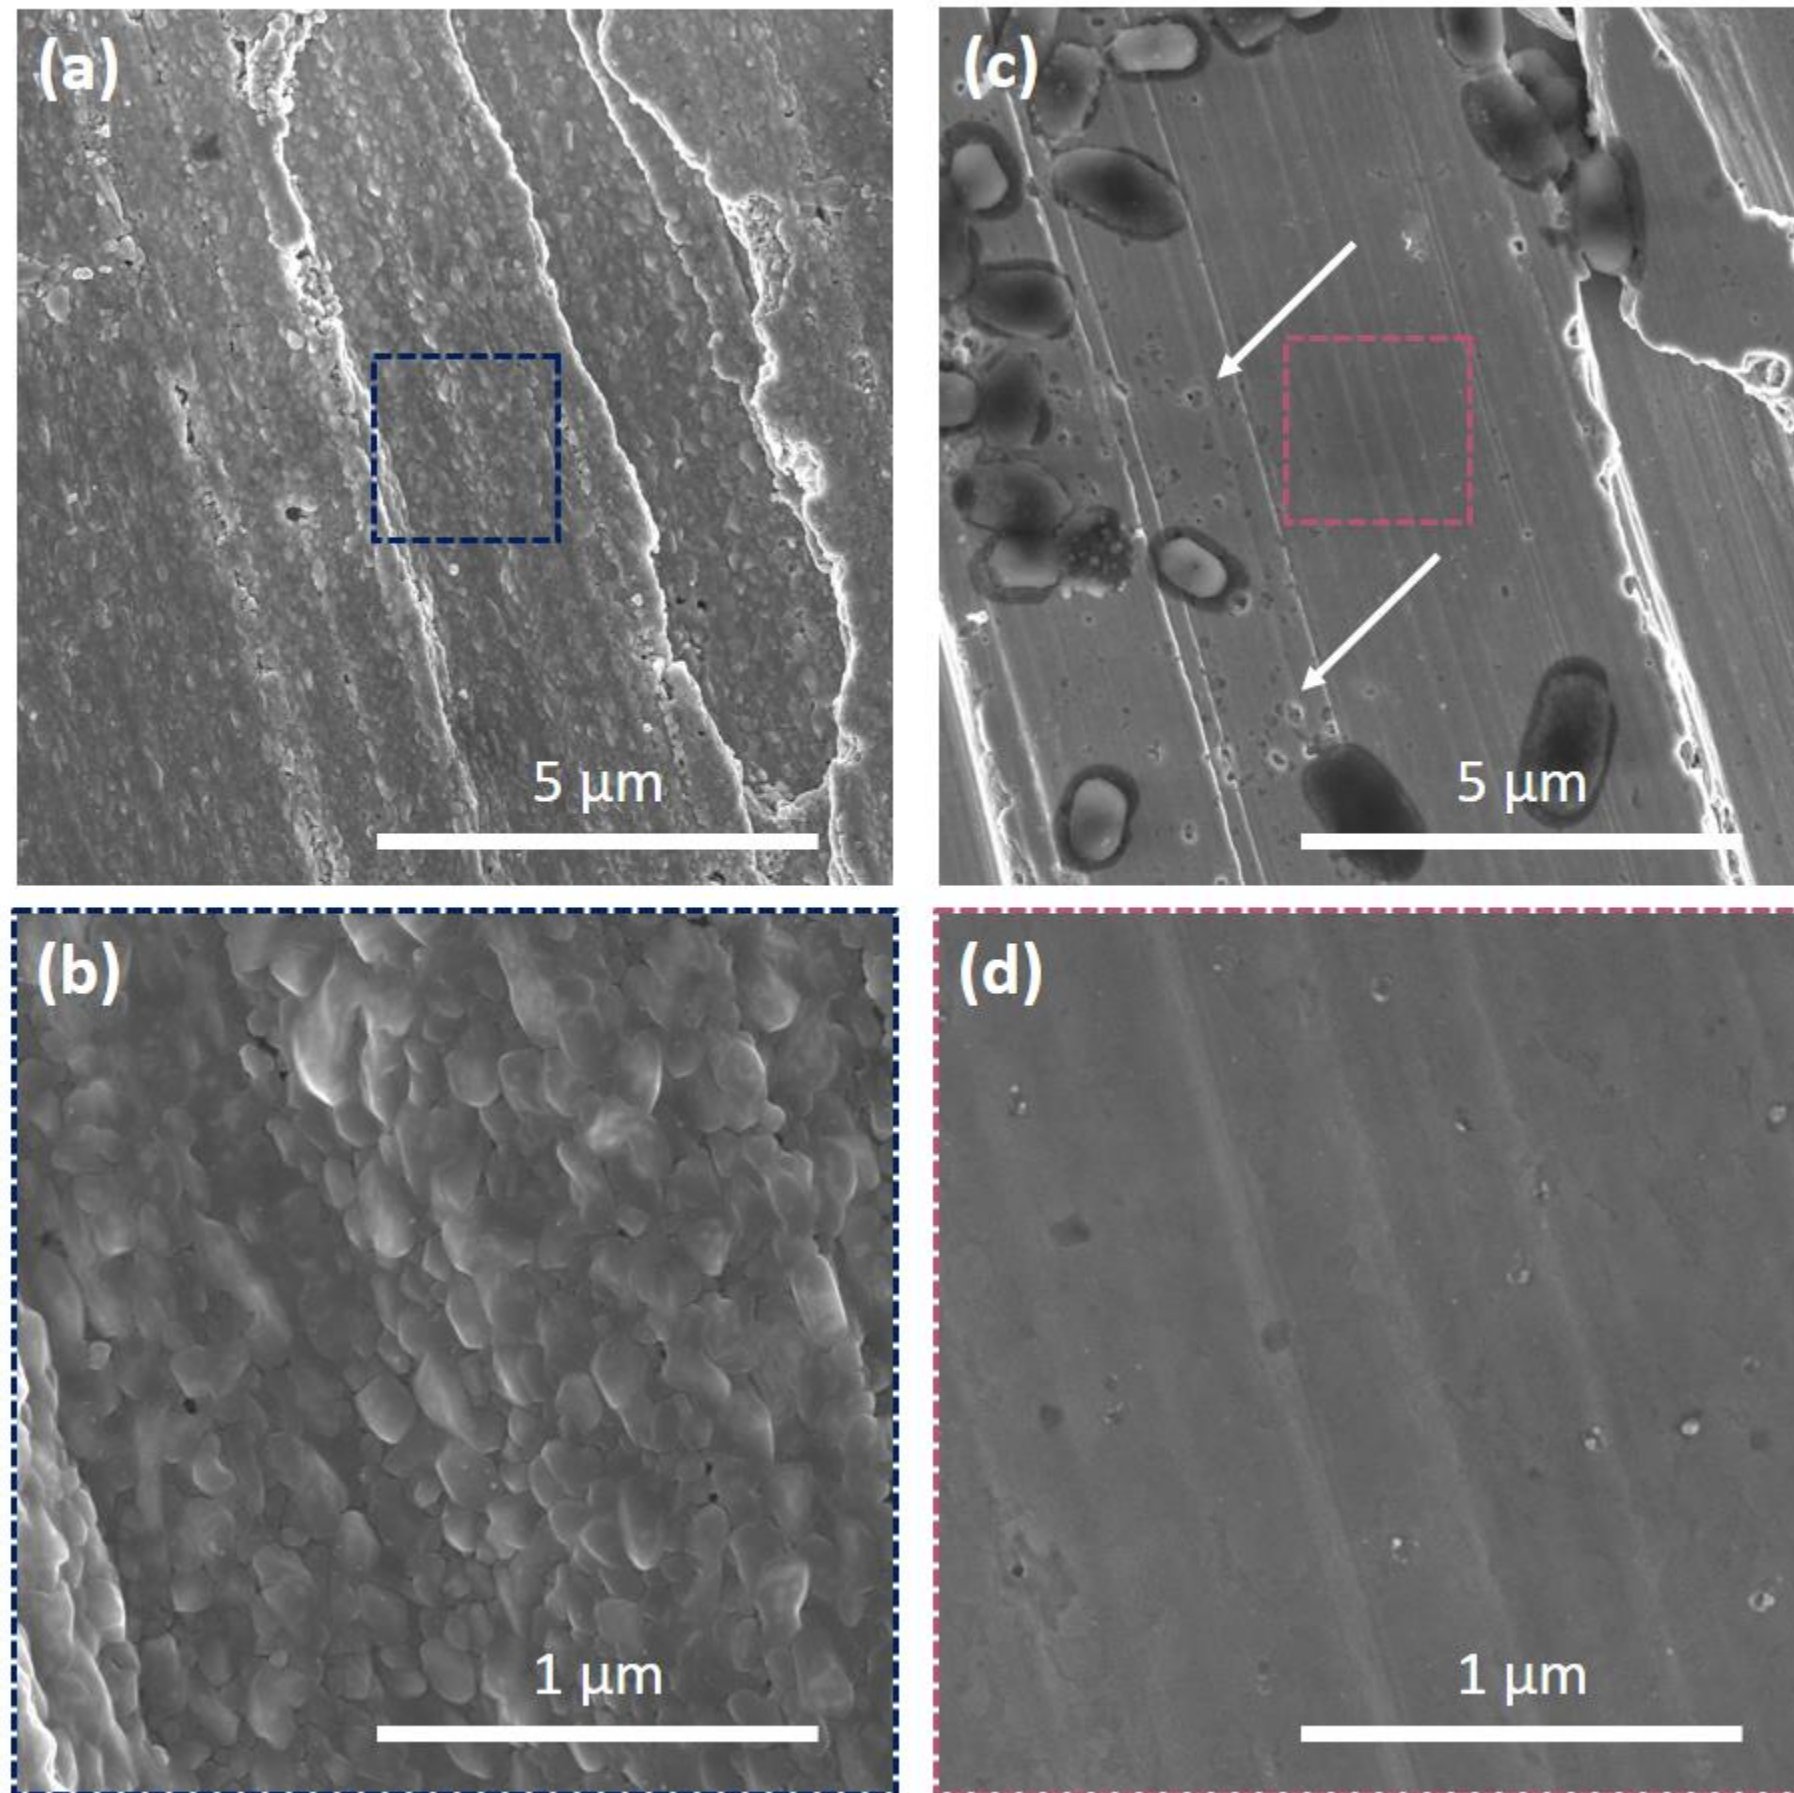
Figure 1

Typical SEM images of copper surfaces after 3 hours of exposure to PBS **(a-b)** and PBS with *E. coli* **(c-d)**. The dashed squares in **(a)** and **(c)** indicate the positions of the following higher magnification images **(b)** and **(d)**. The arrows indicate localised corrosion attacks.

Evolution of surface morphology always reflects the corrosion behaviours. Therefore, to directly observe the corrosion phenomena on copper surface, high resolution SEM images were taken and shown in Figure 1. After 3 hours in pure PBS, granular sub-micron formation were found on the copper surface. Consequently, the as-ground morphology becomes less obvious. However, with the addition of *E. coli*, similar corrosion products can hardly be found. In addition to the remained bacteria, some area were suffering localised corrosion attacks, resulting in sub-micron scale pits. No other SEM observable features that can be identified on this bacterial treated surface. On the other side, it almost kept the original morphology of the untreated as-ground copper surface (SI, Figure 1).

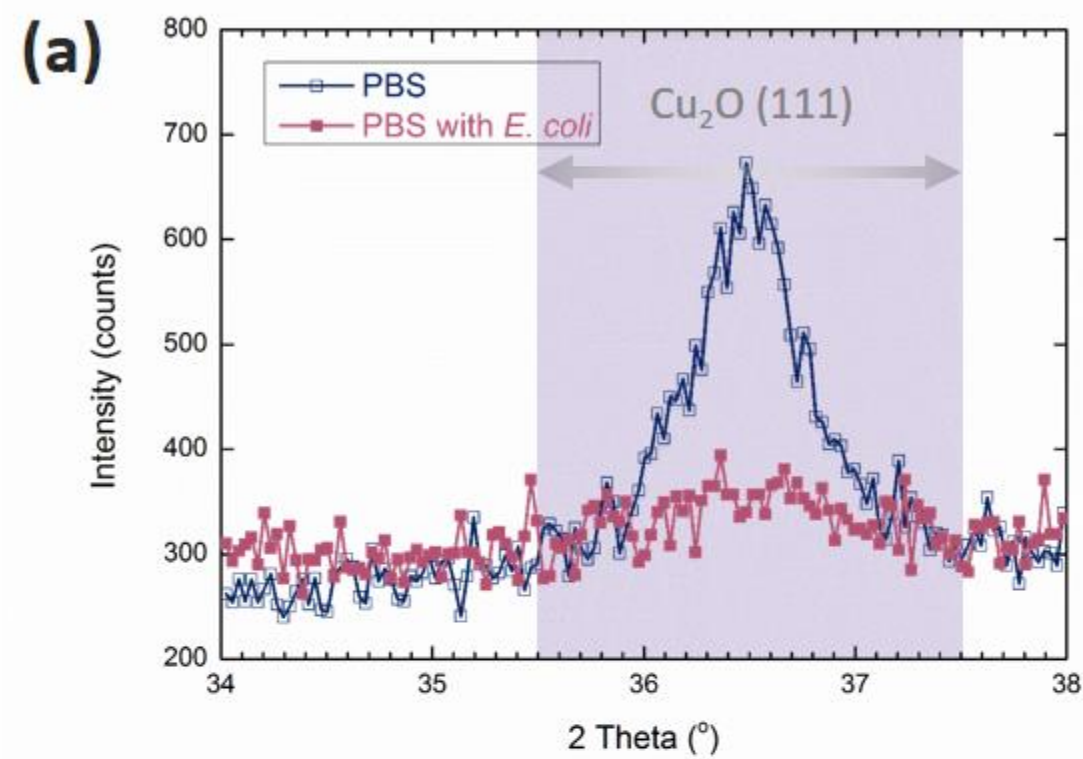
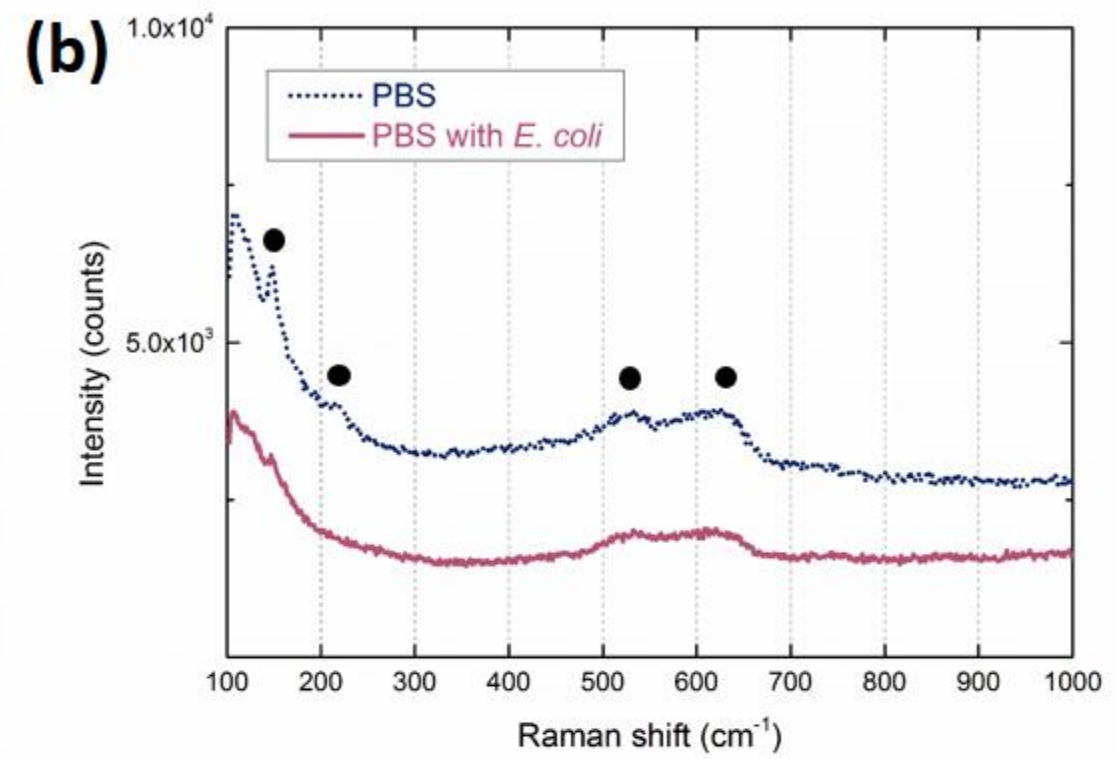
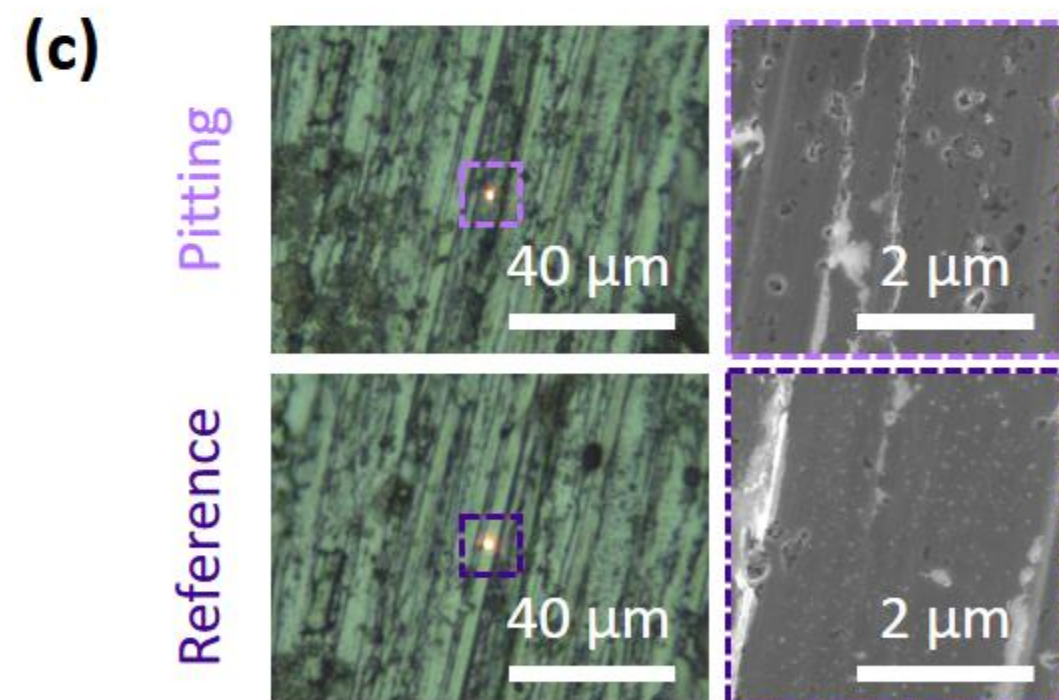
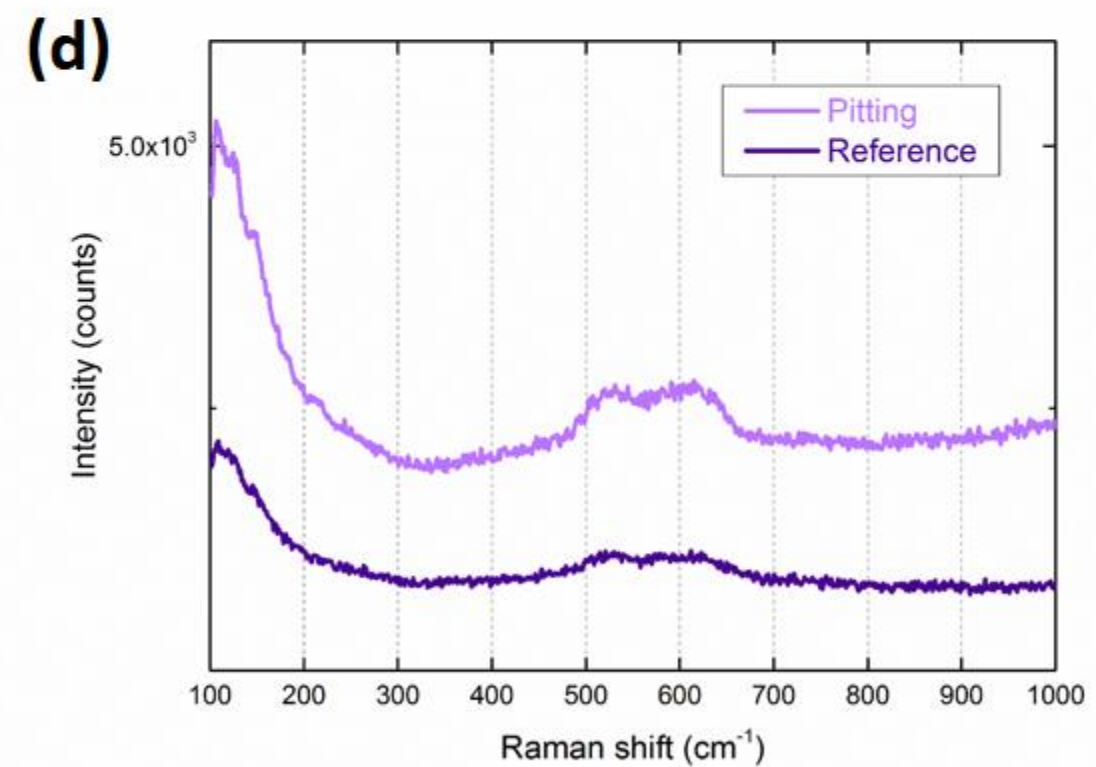
(a) High resolution grazing incidence X-ray diffractograms in the range of (111) planes of Cu_2O (#75-1531) and **(b)** typical Raman spectra obtained from copper surfaces after 3 hours exposure to PBS and PBS with *E. coli*. **(c)** OM images and SEM images of two typical features obtained from the bacterial treated surface and **(d)** their Raman spectra from the same areas.

To further identify these corrosion products, GIXRD were applied to collect the near surface phase information presented in Figure 2 (a). The range of diffraction peak of (111) planes of Cu_2O was chosen, since it is expected to be the strongest peak of the Cu_2O without any preferential orientation growth. A clear peak is recorded from the surface corroded by pure PBS, confirming the main corrosion products described above as crystallised Cu_2O . By contrast, the diffractogram from the coupon treated with *E. coli* suspension is rather flat.

Since no copper oxides related diffraction peaks could be assigned, Raman was applied owing to its higher sensitivity, where a slight oxidation is shown (Figure 2 (b)). Comparatively, these oxides signals are with lower background and less obvious oxides' peaks, especially around 149 cm^{-1} and 216 cm^{-1} . In addition, compared to the relatively large detection zone of GIXRD, Raman results could be correlated with more localised features. For example in Figure 2 (c), some dark areas found in OM are confirmed by SEM as the positions where localised corrosion attacks occurred. In these positions, higher Raman signal of Cu_2O were recorded and shown in Figure 2 (d). Although these localised corrosion sites are far smaller than the macroscopic pits that could be observed directly in OM, they do match the features described traditional pitting corrosion theories [33]. They describe the formation of corrosion products around the opening (cathode) of these cavities (anode). These product could gradually seal the pits, which has not yet been observed on our experiments though. Apart from small difference, all the abovementioned findings confirm the considerable changes on copper surface after adding *E. coli* into PBS: the Cu_2O formation becomes less dominant and more non-uniform on copper surface.

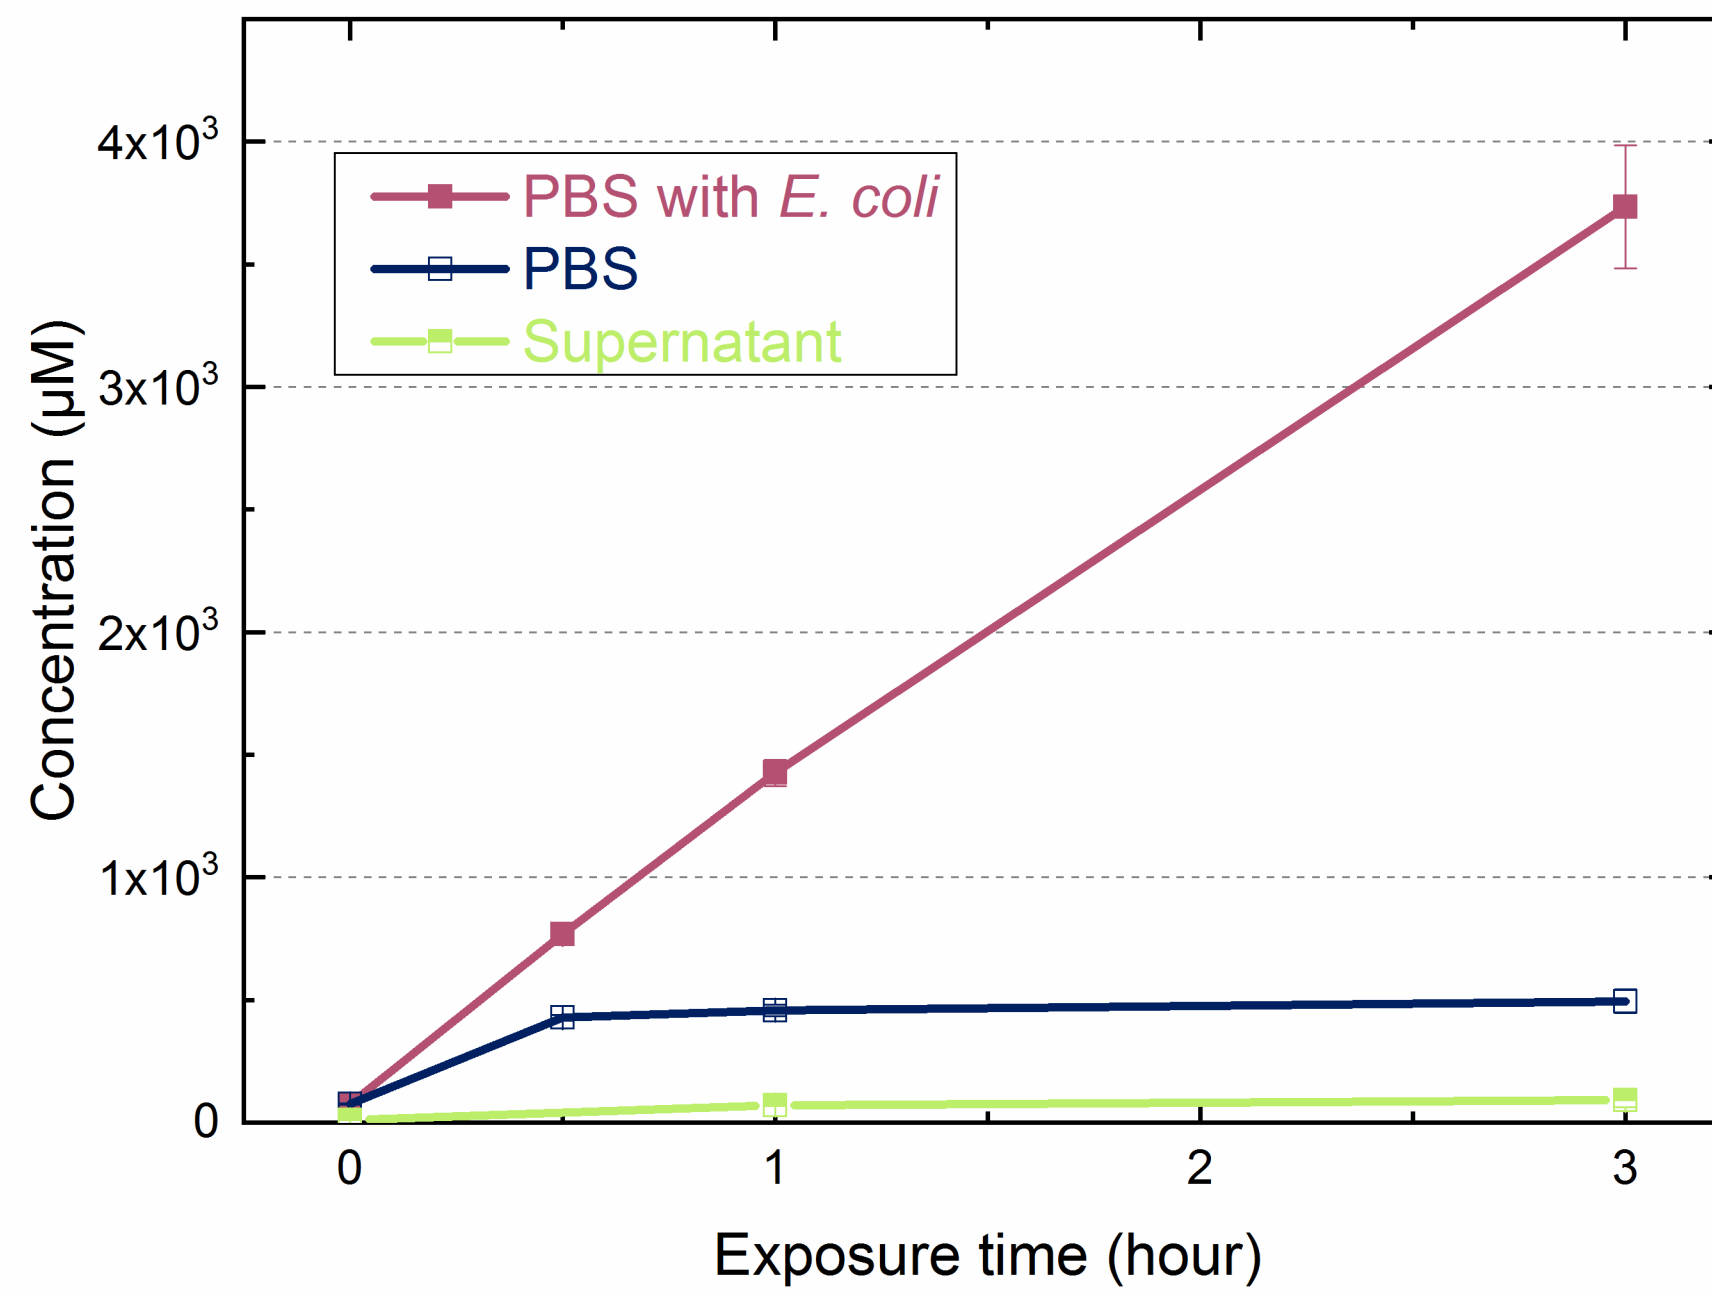
Figure 3

Concentration of copper content in PBS, PBS with *E. coli* and its supernatant following various exposure periods. The error bars indicate the standard deviations calculated from three independent measurements.

After the examination of the corrosion products on these surfaces, we then shifted the interest to the solution, namely the withdrawn droplets. Copper content in pure PBS and *E. coli* PBS suspension were measured and plotted in Figure 3. In pure PBS, the concentration of copper has quickly reached a plateau in 30 minutes, which at least lasted for 3 hours. With *E. coli* addition, on the other hand, the curve evidently follows another trend: it significantly becomes higher in the whole period. The variety of these two patterns could be ascribed to the barrier effect of copper oxides coverage. As fewer oxides were found in the latter case, a bigger portion of bare copper was exposed to the solution, that is to say, can still be corroded by the solution. For this reason, release of copper ion can be thus less hindered and therefore copper content gradually increase could be observed. In addition, the shown copper content data can also be transferred into weight loss of the original surface if needed. Because for pure copper coupons, the amount of copper measured in solution should be equal to the weight loss. However, it should be noted that the contribution from the oxide growth will not be considered in this way as they are still attached to the original surface.

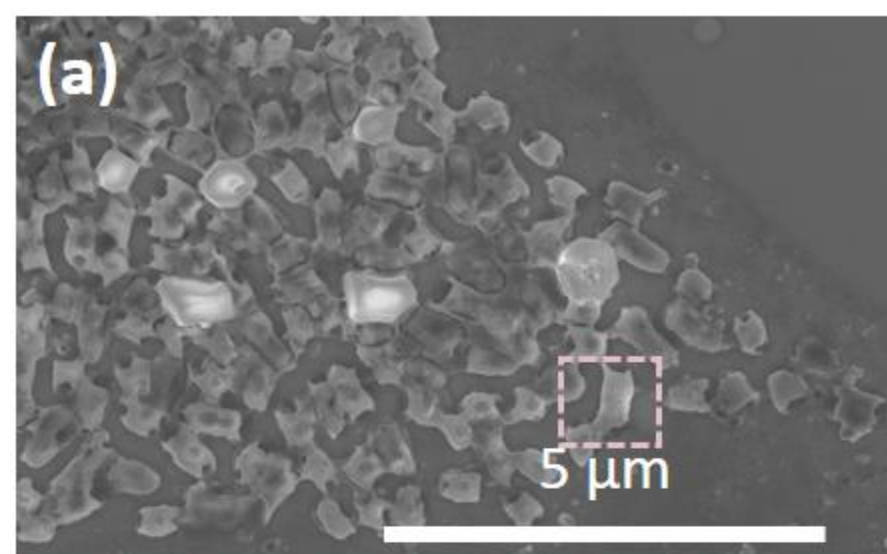
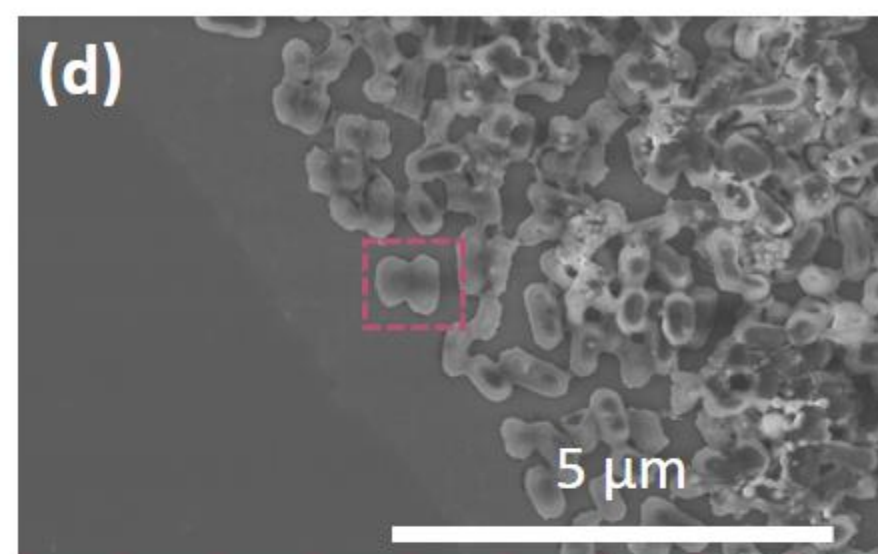
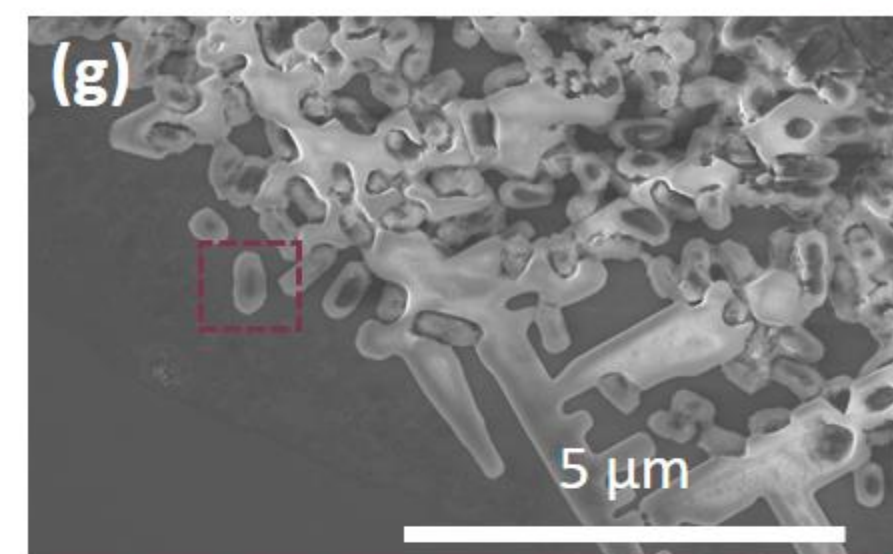
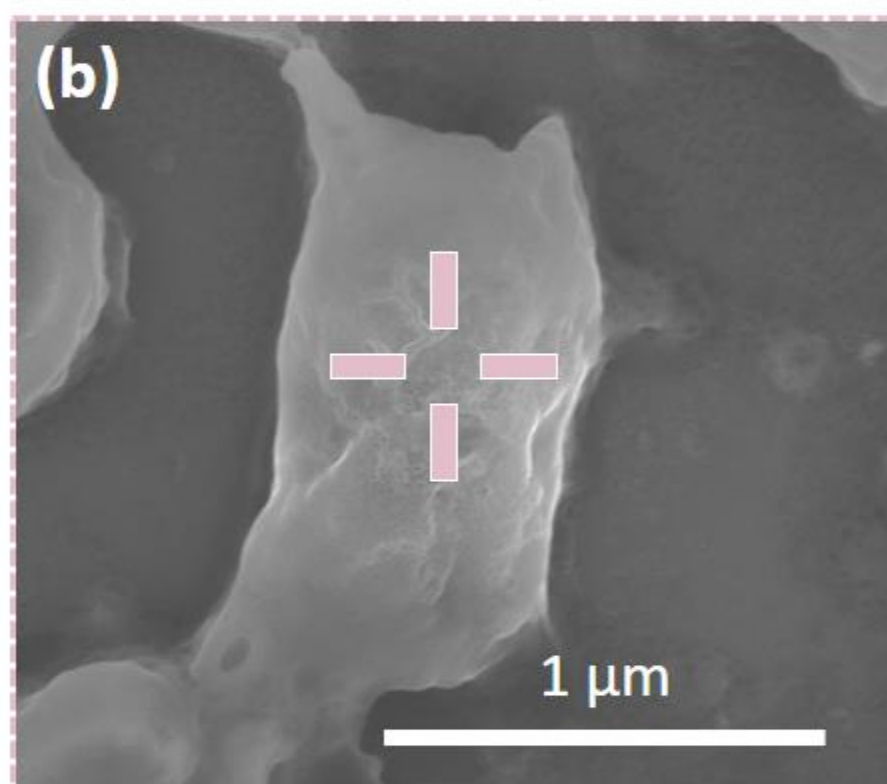
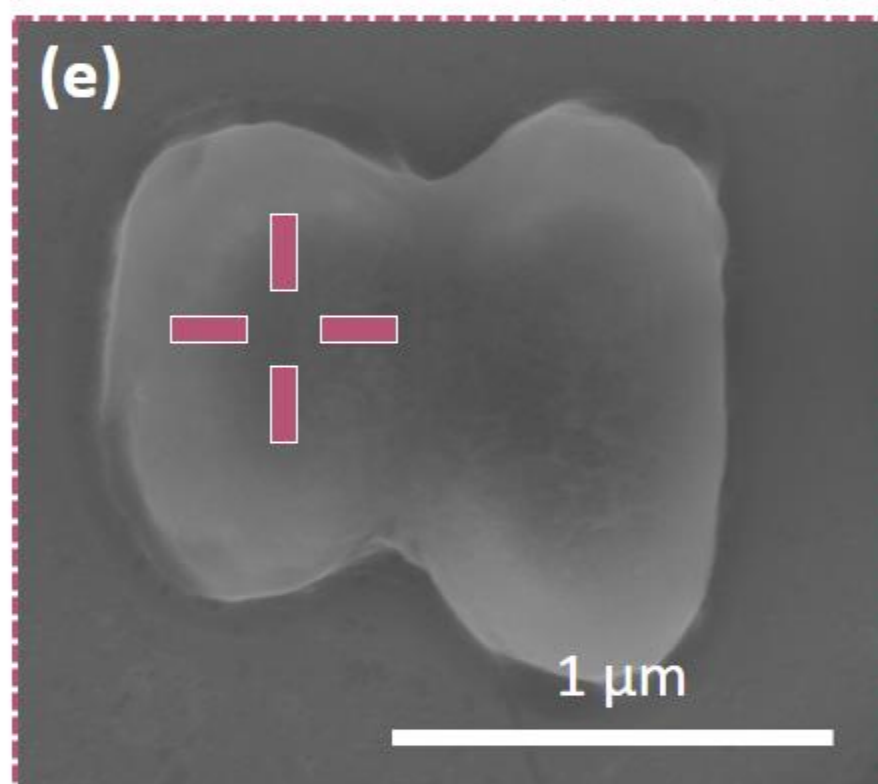
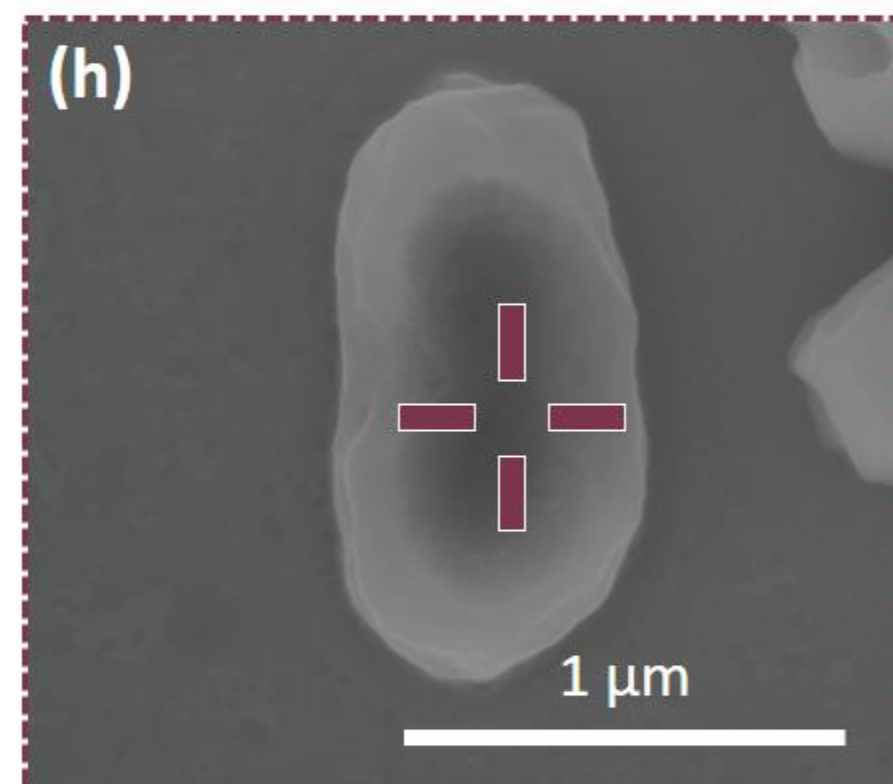
1 hour 3 hours 6 hours

Apparently, the following question needs to be answer could be: where are the rest of the huge amount of copper? Logically, if they are not in the supernatant, then they could only be with bacteria. Figure 4 presents the copper treated *E. coli*

observed by SEM. Prolonging the treatment time, in the first place, the shape of bacteria becomes more regular. However, since no fixation or drying steps were adopted in order to preserve the potential copper ion accumulation within bacteria, morphology of these bacteria might not be interpreted as their original state.

On the other hand, local elemental analysis done by EDS further provides more interesting information. First of all, the main elemental composition of *E. coli* itself is always considered as a combination of C, H, O and N [35]. Other elements should be thus considered to have an environmental source. Therefore, the actual EDS on untreated *E. coli* (shown in SI Figure 4) also revealed certain amounts of Na and P, which could come from the compositions of LB growth medium or PBS. Besides, signal of Si comes from the silicon substrate that is supporting the bacteria. The most significant finding belongs to those Cu peaks. Not only have their signal been successfully collected, their intensity also progressively increases proportional to treatment time. This trend indeed represents the copper amount accumulated by the bacteria, confirming both our results and the latest reported results obtained from ICP-MS measurements [36].

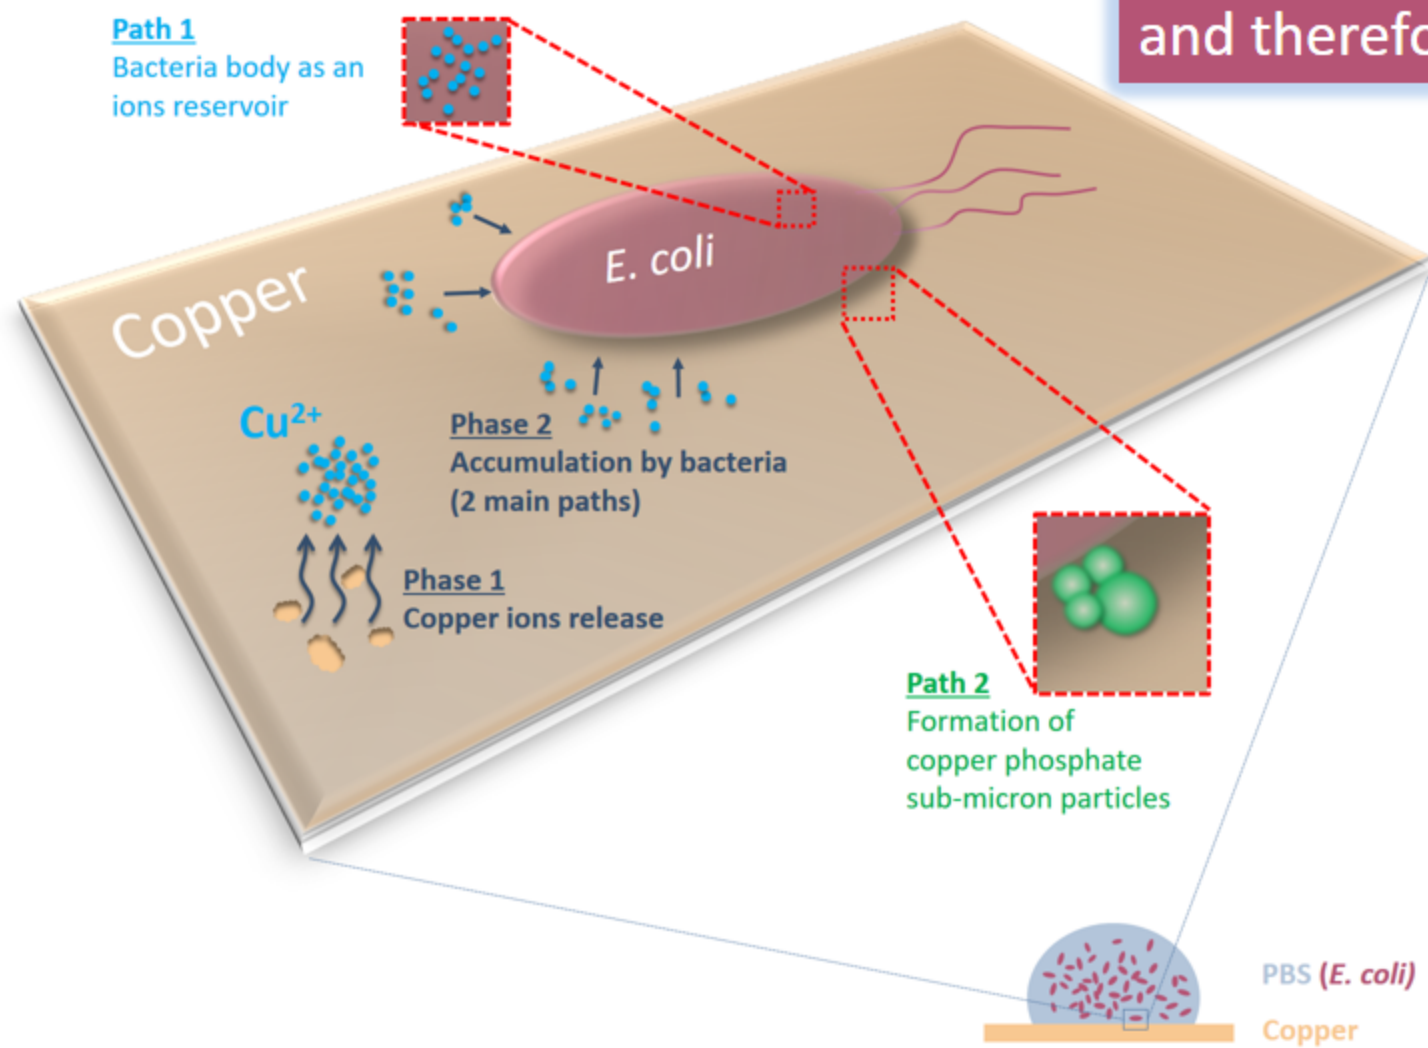
Accumulation of copper by bacteria inhibit the oxide formation and therefore dramatically promote the release of copper ions.
