## Microstructure and tribological property of selective laser melted Fe-Mn-Al-C alloy

Xingchen Yan, Shuohong Gao, Cheng Chang, Hanlin Liao, Min Liu

Xingchen Yan, Shuohong Gao, Cheng Chang, Hanlin Liao, Min Liu. Microstructure and tribological property of selective laser melted Fe-Mn-Al-C alloy. *Materials Letters*, 2020, 270, pp.127699 -. 10.1016/j.matlet.2020.127699 . hal-03489691

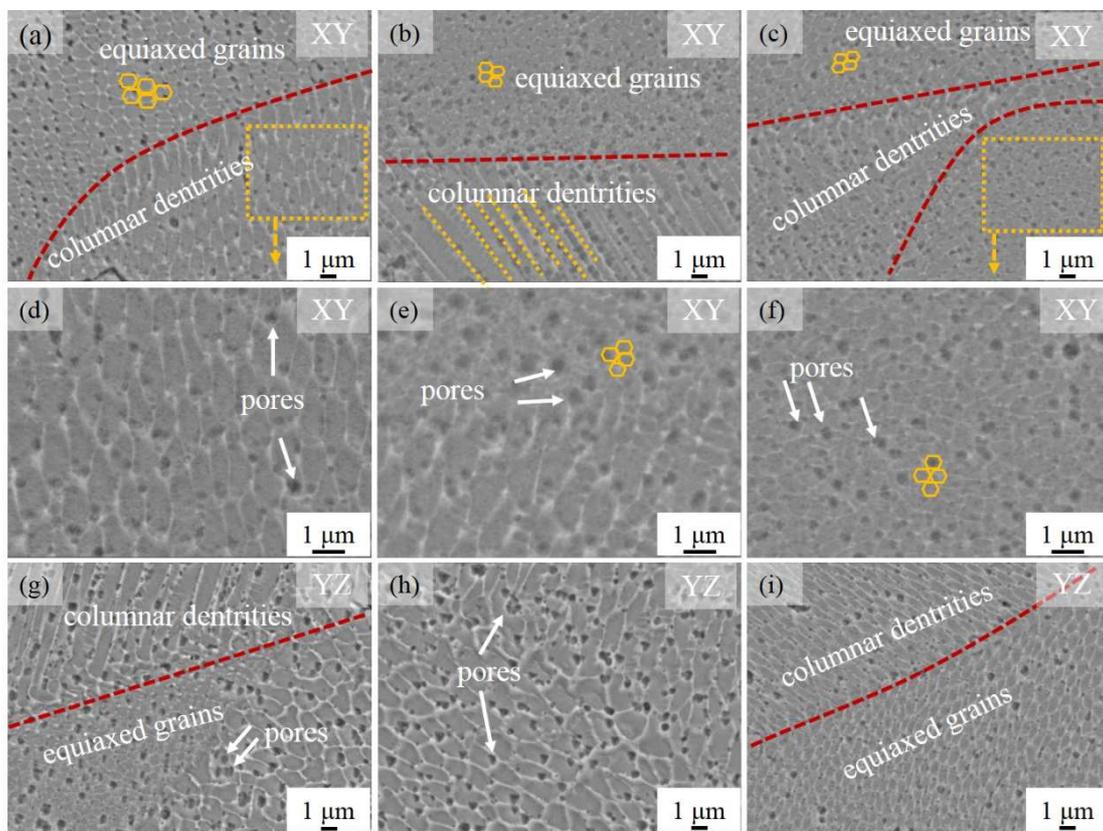
Fig.1: Microstructures of the XY planes: (a) V0.5; (b) V0.4; (c) V0.28; and (d-f) enlarged view, and YZ plane: (g-i): the V0.5, V0.4, V0.28 sample.

The microstructures (XY, YZ plane) of these alloys are presented in Fig. 1. As presented in Fig. 1(a)-(f), the microstructures of Fe-Mn-Al-C alloys are composed of equiaxed grains and columnar

dendrites [10]. It could be seen that some micron poles which were introduced during the SLM processing are presented in the macrostructure characterization. Comparing Fig. 1(a)-(c), the grain size in the fine grain region of the sample V0.5 is larger than that of V0.4 and V0.28. The grain size of V0.4 and V0.28 are nearly equivalent. Fig. 1(d)-(f) are enlarged views of Fig. 1(a)-(c). As shown in Fig. 1(e)-(f), it can be found that the grain size in the coarse grain regions of the sample V0.5 is almost equal to that of the sample V0.4. Similarly, the same conclusions as above can be obtained after comparing Fig. 1(g)-(i), which are presented the YZ plane microstructures of the specimens.

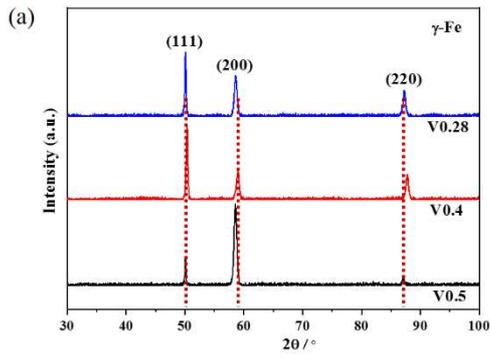
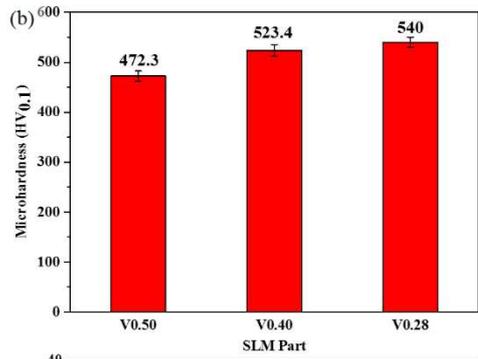
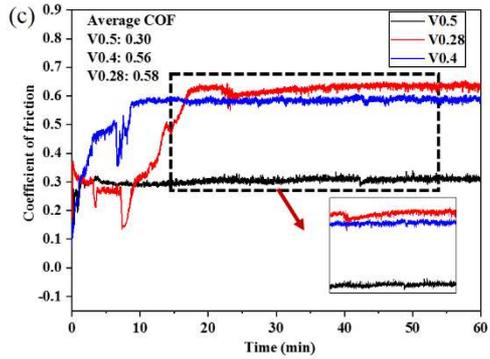
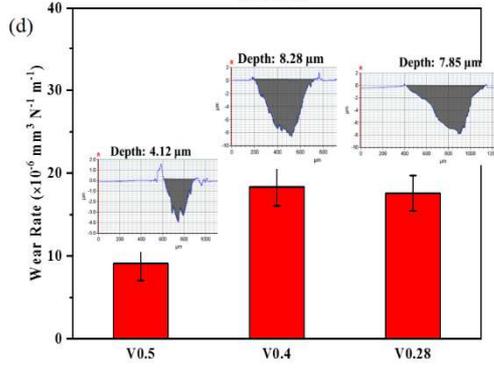
Fig. 2: (a) XRD patterns; (b) microhardness; (c) COF -Time profile; (b) wear rate.

The XRD patterns are shown in Fig. 2(a). Only peaks related to  $\gamma$ -Fe were found in the XRD patterns. It can be confirmed that Fe-Mn-Al-C alloys are mainly composed of  $\gamma$ -Fe. Meanwhile, it's clear that the intensity of diffraction peaks of each sample is a little difference, especially for the sample V0.5. It indicates that the grain orientations of SLM parts are inconsistent due to the different scanning speeds, which lead to different linear energy input. The average microhardness of them is 472.3 HV<sub>0.1</sub>, 523.4 HV<sub>0.1</sub>, 540 HV<sub>0.1</sub>, respectively as displayed in Fig. 2(b). As mentioned above, the cellular grain size of the sample V0.28 is the smallest in these three samples, hence, its microhardness is the highest. On the contrary, the average microhardness of the sample V0.5 is the lowest among these specimens with a coarse microstructure. The COF-Time profiles and wear rate are revealed in Fig. 2(c)-(d), respectively. It can be observed that the average COF of the sample V0.5 is only 0.3, while, V0.4 and V0.28 are 0.56 and 0.58, respectively. During the wear process, the load and the size of the ball used as counterpart was kept in a balance value, samples V0.28 and V0.4 with higher hardness presence more debris and pits (as shown in Fig. 3), which increase the roughness of the worn surface, and then increase the COF. As the microhardness of the V0.5 is the lowest amongst the three samples, its average COF is the lowest. Correspondingly, as shown in Fig. 2(d), the wear rate of V0.5 is

$9.05 \times 10^{-6} \text{ mm}^3/(\text{N}\cdot\text{m})$ , while V0.4 and V0.28 are  $18.34 \times 10^{-6} \text{ mm}^3/(\text{N}\cdot\text{m})$  and  $17.57 \times 10^{-6} \text{ mm}^3/(\text{N}\cdot\text{m})$ , respectively. Since its microhardness is already at a relatively high level, at this moment the key factor determining the wear rate is the COF, therefore, the wear rate of V0.5 is the smallest. Meanwhile, because of the almost similar microhardness of V0.4 and V0.28, their COF and wear rates are also almost similar.

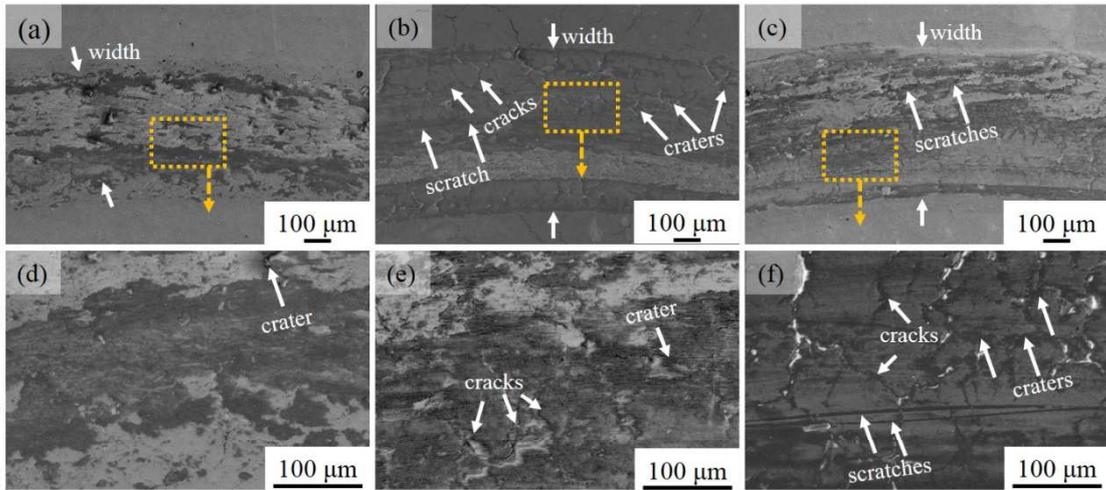
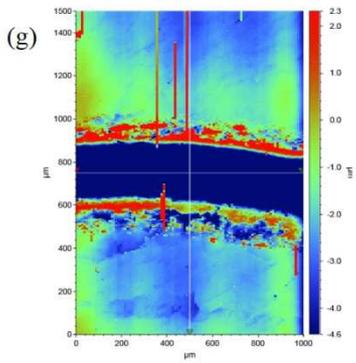
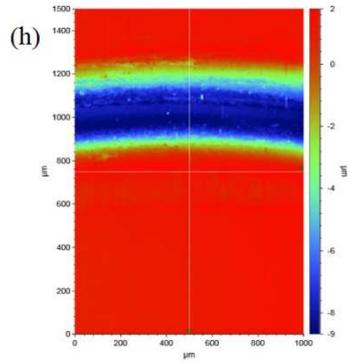
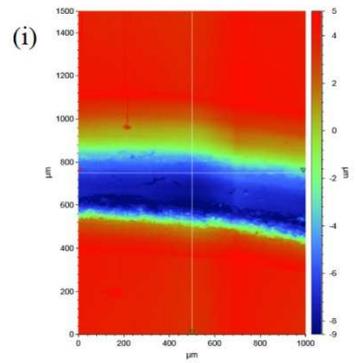
Fig. 3: Worn surface morphology of (a-c): V0.5, V0.4, V0.28 sample, and (d-f) enlarged view; 3D surface topography of (g-i): V0.5, V0.4, V0.28 sample.

Fig. 3(a)-(c) displays the worn surface morphology of the SLM parts. It can be observed that the worn track of sample V0.5 is relatively flat and smooth with no obvious cracks. However, obvious craters and cracks are found at the worn track of samples V0.4 and V0.28. Besides, some scratches distributed along the friction direction are observed, especially in sample V0.28. The reason for these phenomena is also that the hardness of the V0.4 and the V0.28 is higher than the V0.5. In the process of friction, the abrasive particles are affected by compressive stress and shear stress. Abrasive wear is in the case of hard particle and soft material and for soft particle the wear can be adhesive. Therefore, the wear mechanism of sample V0.5 is mainly abrasive wear and adhesive wear [11], and its worn track is relatively smooth, which can also be proved by its 3D surface topography (Fig.3(g)). Owing to the hardness of samples V0.4 and V0.28 are both similar, which are higher than that of sample V0.5. Hence, not only abrasive wear but also abrasive wear that produces grooves occurred during the friction process of these two samples [12]. As a result, the craters have remained in their worn track, which can also be observed from their 3D surface topography (Fig.3(h), (i)).
