Effect of the Cyclic Crack Opening-Closure during Epoxy-Curing Period of a CFRP Strengthening System Bonded on Concrete Substrate

Marc Quiertant ^{1,*} , Claude Boulay ¹, Laurent Siegert ¹ and Christian Tourneur ²

Abstract: This article investigates the potential detrimental effects of cyclic load during the installation of externally bonded (EB) carbon fiber-reinforced polymer (CFRP) on a damaged reinforced concrete (RC) structure. Four RC specimens were tested in three point bending to study the consequences of crack cyclic opening-closure during epoxy-curing period. A first RC specimen (without bonded CFRP) was loaded monotonically up to failure to serve as undamaged control sample. The three other specimens were pre-cracked before being subjected to a fatigue loading procedure to simulate service condition of a damaged RC structure. Two of the three pre-cracked specimens were strengthened by EB CFRP. One specimen was repaired before the fatigue test while the other one was repaired during the fatigue test. Finally, remaining capacities of all three pre-cracked specimens were measured through monotonic bending tests until failure. It was found that, although bonding of CFRP re

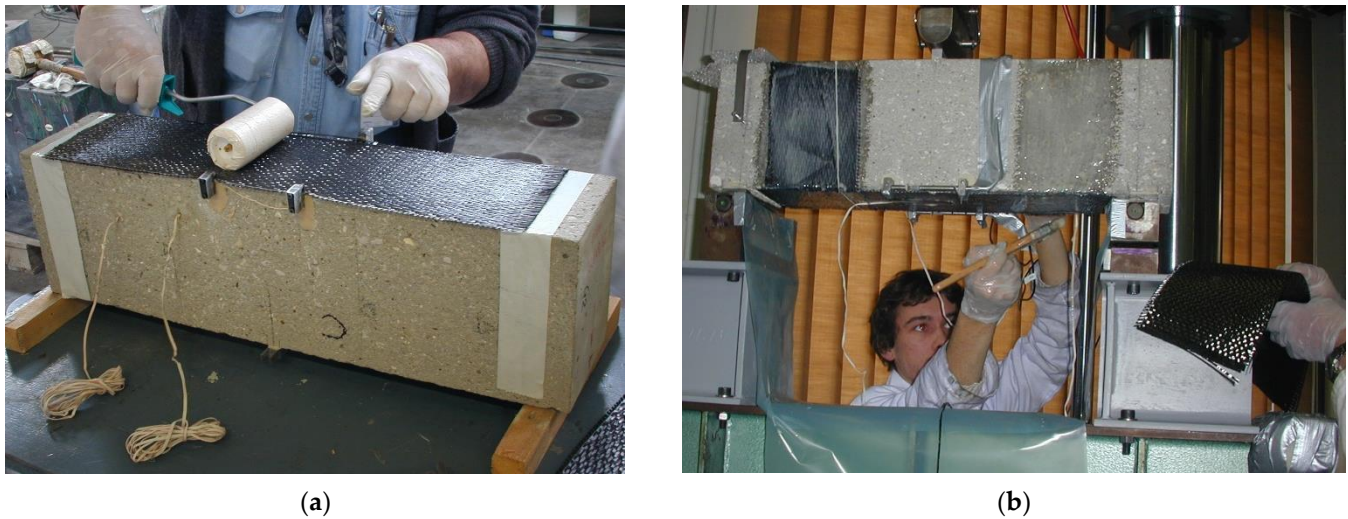
The specimen ES1 was strengthened by EB CFRP just after pre-cracking. A 7 day cure of the epoxy was achieved in the laboratory (without any moving of the specimen) before proceeding of fatigue flexural loading. For the ease of CFRP installation, the beam ES1 was lying upside down during bonding operation (i.e., the beam face subjected to tensile load during the bending test was positioned upward during bonding, see Figure 6a).

Figure 6. Strengthening of specimens: (a) beam ES1 positioned upside down; (b) CFRP strips bonded as in the field (technicians working under the beam ES2).

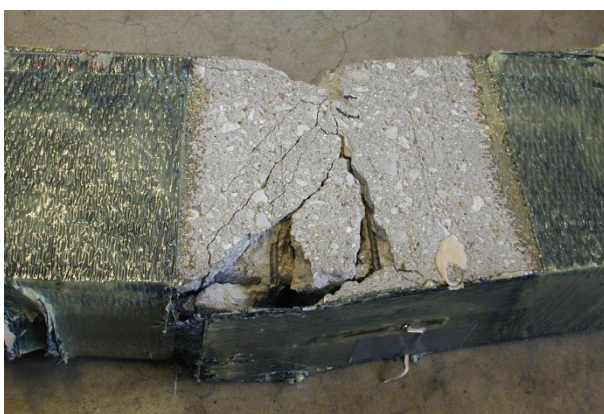
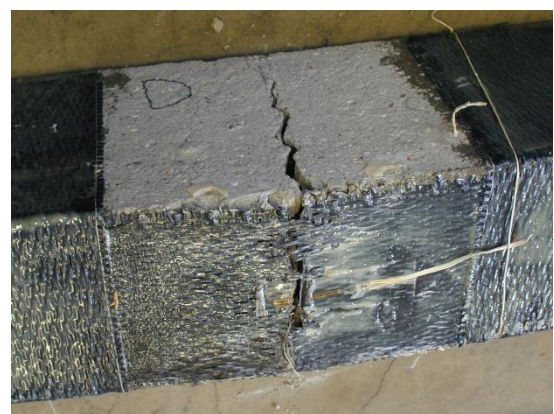
As previously explained, for all beams, the experimental program was achieved by a monotonic bending test to rupture. Failure of specimen NES1 was due to tensile rupture of one longitudinal reinforcing bar (rebar) at mid-span, below the stirrup at the exact location of the first crack. At failure, the initial crack formed a largely open flexural crack. Beam NES2 experimented a similar failure mode. Specimen ES1 failed through tensile fracture of the CFRP longitudinally bonded at the soffit of the beam. The transverse tearing of the carbon sheet occurred at the crossing of the longitudinal layer with the transverse one (Figure 7a). It is to note that the CFRP U-jackets were efficient to prevent debonding at the end of the longitudinal CFRP strengthening, as expected. Before total collapse of the beam, some inclined concrete cracks propagate from the soffit and rise to the initial vertical crack. Considering their inclination (approximately 45 degrees) typical of shear cracks and the location of their initiation (at the soffit) as flexural cracks, these cracks were considered as the consequence of a mixed shear/flexural failure. The large opening of one of this shear crack triggered the tensile failure of the CFRP. Differently, no new concrete cracks appeared with increasing load of the beam ES2 that failed by tensile rupture of CFRP below the largely opened initial flexural crack (Figure 7b).

Figure 7. Observed failure modes of strengthened beams: (a) specimen ES1 (CFRP bonded without cyclic loading); (b) specimen ES2 (CFRP bonded during cyclic loading).

specimens previously presented (Figure 7) show that the CFRP longitudinal strengthening, involving applying a higher load to rupture, changed the failure mechanism of specimens from flexural failure (NES2) to mixed failure mode (shear and flexure failure of ES1).

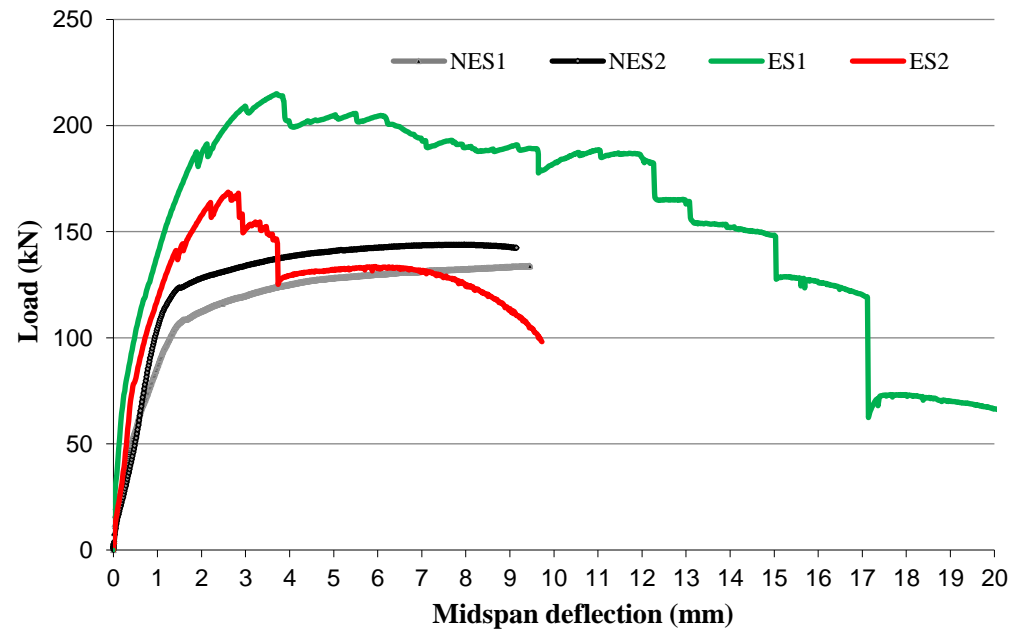
Performances of the beams can be evaluated by analysis of the load-deflection behavior experimented during the last monotonic load to failure. Recorded results are plotted on Figure 8 and summarized on Table 5. However, it must be specified that curve related to

the bending test of beam ES1 is not complete as the LVDT used for deflection measurement achieved its 20 mm maximum capacity before collapse of the specimen. However, only the end of the post-peak behavior of the specimen ES1 was not captured.

Figure 8. Load versus mid-span deflection behavior of samples under monotonic bending.

From Figure 8, it can be firstly clearly noticed that despite the fatigue conditioning, the cycled beam NES2 exhibited a load-carrying capacity 7% higher than that of the control beam (un-cycled) NES1. This result indicates that no significant damage accumulation results from fatigue conditioning of NES2. This conclusion is also supported by the similar deflection at failure of the two un-strengthened specimens (NES1 and NES2).

The two specimens strengthened with EB CFRP experimented an increase in the load-carrying capacity compared to un-strengthened specimens. However, if this result was expected, it was surprising to observe that specimen ES2 failed at the same deflection than that of the two un-strengthened specimens.

The comparison of the load-deflection behaviors of ES1 and ES2 presented on Figure 8 clearly shows that the cyclic loading during the curing period reduced the effectiveness of the EB CFRP (considering carrying capacity). Indeed, during the first step of the fatigue cycles of ES2 (cycled during bonding), it was observed, that the cyclic opening-closing of the crack locally prevented the formation of a continuous matrix below the initial crack. Consequently, the CRFP strengthening material bridging the crack was rather a non-impregnated carbon fabric (as the matrix neither formed or directly cracked below the initial concrete crack, see Figure 11). Then the CRFP strengthening material did not locally behave as a composite material but rather as a discontinuous group of individual fibers acting without transfer loads between each other. Such behavior was leading to the premature tensile failure of the fibers below the initial crack and consequently to the collapse of the specimen ES2 while the CFRP below the initial crack of ES1 was able to

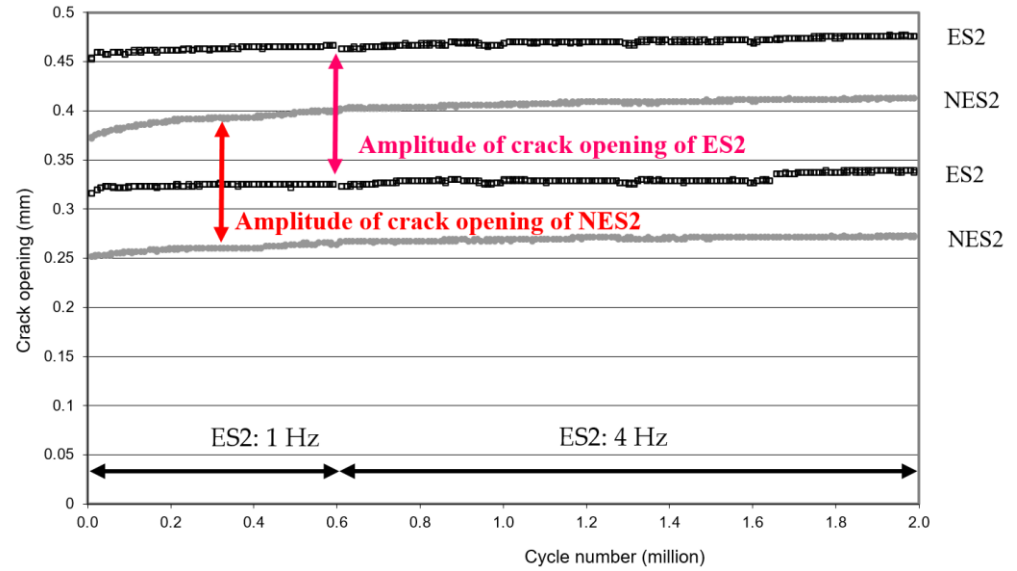
Results of the opening-(partial) closure of specimen ES2 (with CFRP bonded during cycles) are compared with those of specimen NES2 in Figure 10. As a first result, it can be observed that the extreme values of crack opening of ES2 are more important than those of NES2 during all the fatigue tests. This can be easily explained. It is recalled that all specimens were submitted to the same extreme loads (from 40–100% of 48.56 kN) during fatigue tests. However, during pre-cracking, it was observed that for a similar loading, crack opening of specimen NES2 was lower than crack opening of specimen ES2 (see Figure 5). Then, this difference in the crack opening load behavior during pre-cracking is reproduced during fatigue test. Due to this difference in the initial opening of the crack (i.e., opening of the crack at the beginning of fatigue test), it appears more relevant to discuss the evolution of the crack opening or its amplitude (defined as the crack opening at maximum load—crack opening at lower load of the same cycle, see red arrows in the Figure 10) rather than only focusing on the value of crack opening.

Considering the amplitude of crack opening during one cycle, it can be seen on Figure 10 that this amplitude is roughly the same with or without EB CFRP when the CFRP is bonded during fatigue cycles (i.e., for ES2 or NES2, respectively). However, CFRP bonded during fatigue cycles lowered the evolution of the maximum crack opening: ES2 experimented the low evolution of +4.15% (from 0.452 mm to 0.471 mm) while NES2 experimented a +10.98% evolution of its maximum crack opening (as previously mentioned).

Figure 10. Evolution of crack opening extremes during fatigue tests of NES2 and ES2.

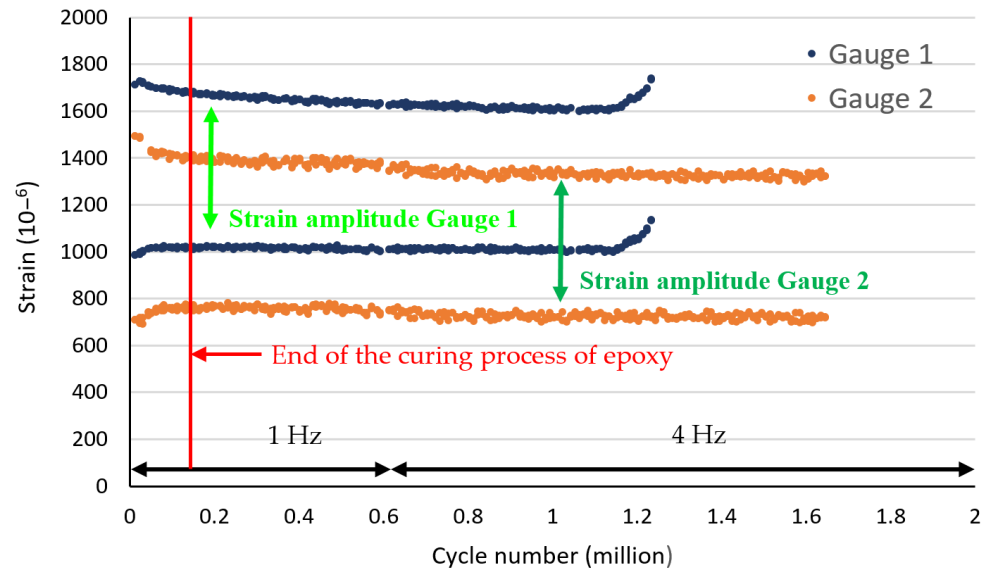
In the Figure 12 the measurements of the two gauges bonded on steel rebars of specimen ES2 (referred as Gauge 1 and Gauge 2) are plotted. These measures correspond to extreme values recorded during the fatigue test (first phase at 1 Hz and second phase at 4 Hz). Gauge 1 was ruptured after 1.225 million cycles while Gauge 2 ruptured after 1.645 million cycles. In Figure 12, at the end of the curve corresponding of the measurement of Gauge 1 (cycles between 1.115 and 1.225 million cycles), it appears that the strain of the steel rebar has a large increase corresponding to an increase in the tensile load carried by the

rebar. Considering that the maximum load of each cycle is kept constant (48.56 kN) during cycles and that tensile forces are carried jointly by steel rebars and bonded CFRP, this probably indicates that locally the fatigue test induced a damage in the CFRP. However, it can be concluded that this mechanism was only local as neither the other gauge (Gauge 2 in Figure 12) nor the crack opening (Figure 10) evolved during this phase (i.e., cycles between 1.115 and 1.225 million cycles). Moreover, no increase in the maximum deflection during fatigue tests of ES2 was noticed at this fatigue phase (see Figure 13).

Figure 12. Strain extremes in the two steel rebars (at mid-span) during fatigue test for beam ES2.

Nevertheless, it can be noticed from Figure 12 that after a certain period a decrease of the longitudinal steel strain amplitude appears (defined as the strain at maximum load—strain at lower load of the same cycle, see green arrow in the Figure 12). This period of approximately two days can be linked to the curing period of the adhesive, considering that the producer data sheet indicates a full hardening of the polymer (Shore D = 70) after a 3–4 days of curing at 20 °C [34]. However, it must be indicated that if the adhesive appeared to cure in the bonded zones, epoxy just located below the crack never formed a continuous matrix, as previously described and illustrated in Figure 11. Nevertheless,

from Figure 12, it can be concluded that tensile stress, initially carried by the steel rebar, is partially transferred to CFRP when the adhesion of this external strengthening is effective.

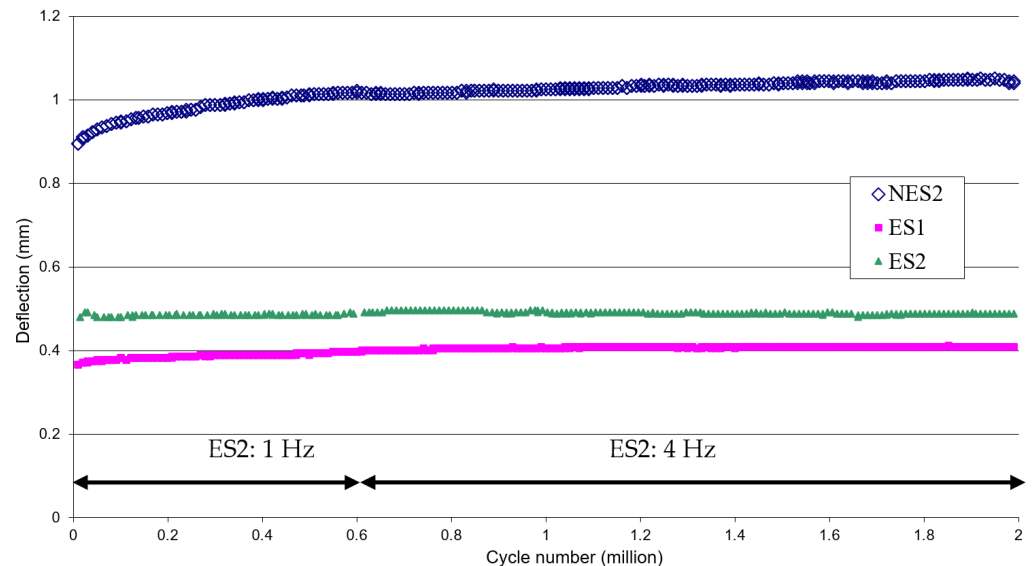
Figure 13. Evolution of maximum deflection during fatigue tests of NES2, ES1 and ES2.

Figure 13 shows the maximum deflection recorded during fatigue cycles (i.e., deflection at the maximum load of 48.56 kN). In this figure, it can be noticed that beams ES1 and ES2 exhibit comparable flexural stiffness while a noticeably more important deflection was experimented by specimen NES2. This result suggests that CFRP bonded during loading cycles is efficient with respect to service load (considering that it lowers the deflection).
