High resolution operational modal analysis of Sant'Agata del Mugello in light of its building history

High resolution operational modal analysis of Sant’Agata del Mugello in light of its building history.

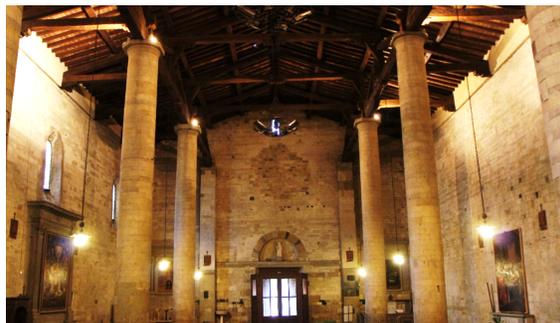
Figure 2: Internal view of Sant'Agata del Mugello (Photos credits: Maria Lancieri).

The rectangular nave ($15.7 \text{ m} \times 29.3 \text{ m}$, Fig. 3) draws its singularity by its unique wooden frame (Fig. 2); its walls are about 0.80 m thick. The central apse ($15.7 \text{ m} \times 29.3 \text{ m}$, Fig. 3) and the two squared lateral chapels ($4.4 \text{ m} \times 4.4 \text{ m}$ and $4.5 \text{ m} \times 4.5 \text{ m}$ for the North and South chapel, respectively) are overhung by a vault system; their wall thicknesses range from 0.40 m to 0.70 m. The bell tower (Fig. 1) is 21 m high. Its plan is almost square ($6.3 \text{ m} \times 6.0 \text{ m}$) and the masonry walls are 1.10 m thick.

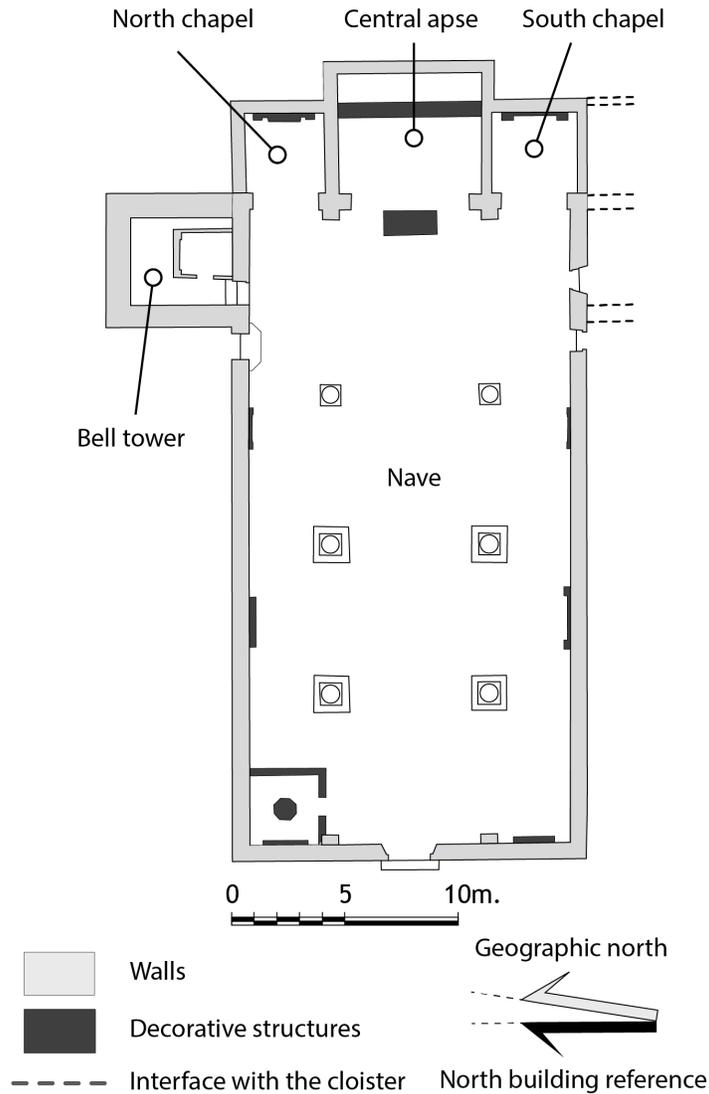
Figure 3: Plan of the Sant'Agata del Mugello church (adapted from [3]).

At present, the building is composed of several parts: the nave, the central apse, two lateral chapels, and the bell tower (Fig. 3). A cloister was built near the southern facade of the church. Since the two buildings are in contact only in the northeast corner of the nave, this study does not consider the cloister.

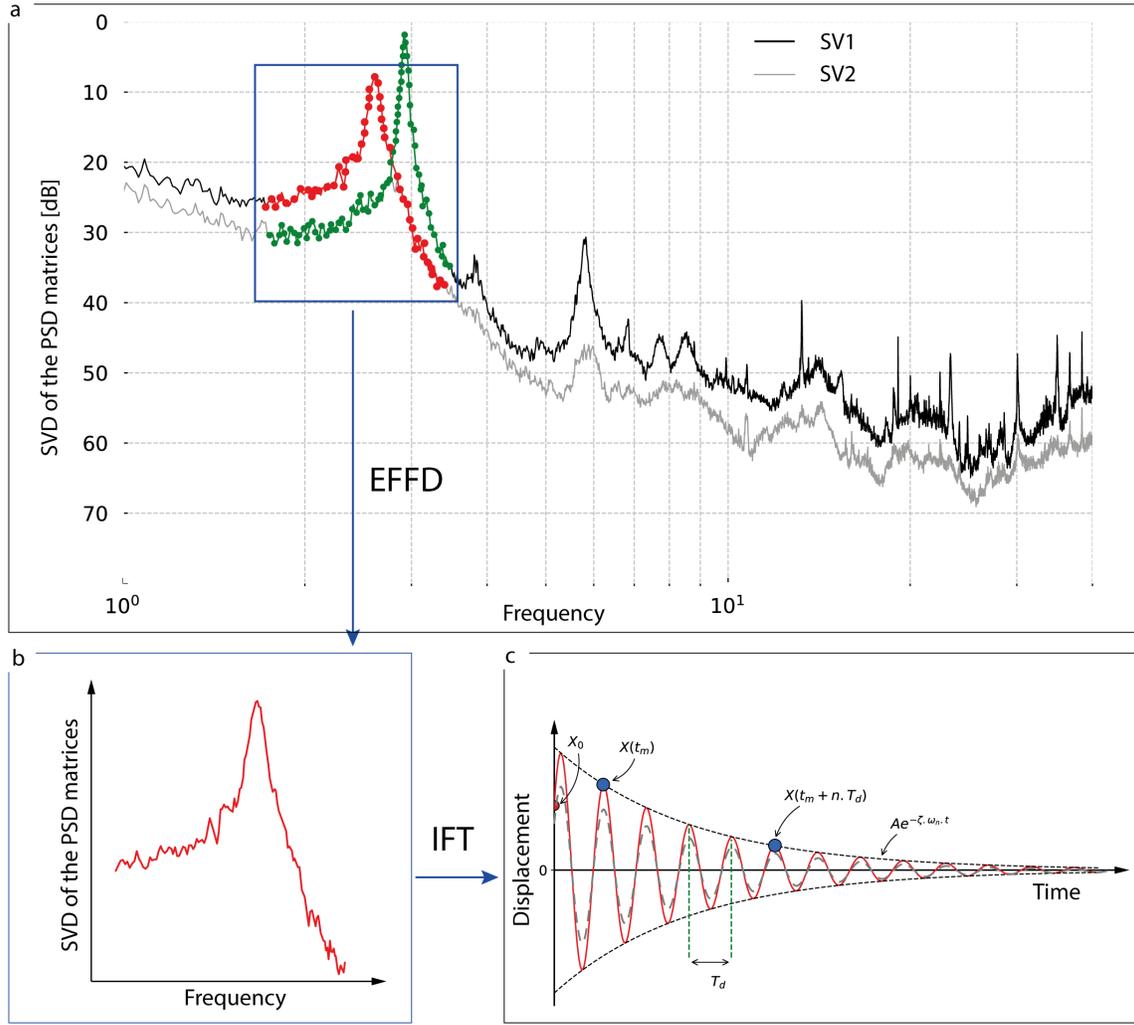
Figure 4: (a) Evolution of the first and second singular values (SV1 and SV2) in the case of the bell tower of Sant'Agata del Mugello. Red and green dots correspond to singular values for which the MAC value between the mode shape associated with the frequency peak (2.61 Hz and 2.92 Hz) and the mode shapes of the surrounding frequencies is over 80%. (b) SDOF density functions of the first bending mode were extracted using the MAC. (c) IFT of the identified SDOF density function provides the Impulse Response Function of the mode.

The identified SDOF density function that fits data represents the Transfer Function of the SDOF system (Fig. 4-b), characterized by its frequency peak. Its Inverse Fourier Transform (IFT) provides the Impulse Response Function (IRF) of the mode [76] and the damping value is then computed using the random decrement method (Fig. 4-c) [81].

The EFDD technique described in Fig. 4 is used to evaluate the modal parameters of the church summarized in Table 2. Fig. 9 shows the first six average singular values of the PSD matrices for the 4 setups recorded during the March 2019 campaign described in Fig. 5. Fig. 10 shows the first six average singular values of the PSD matrices for the 7 setups recorded during the June 2019 campaign described in Fig. 7. 10 peaks are identified in the first campaign (Fig. 9). 12 peaks are identified in the second one (Fig. 10). Modes 1 and 6 are observed on both surveys.

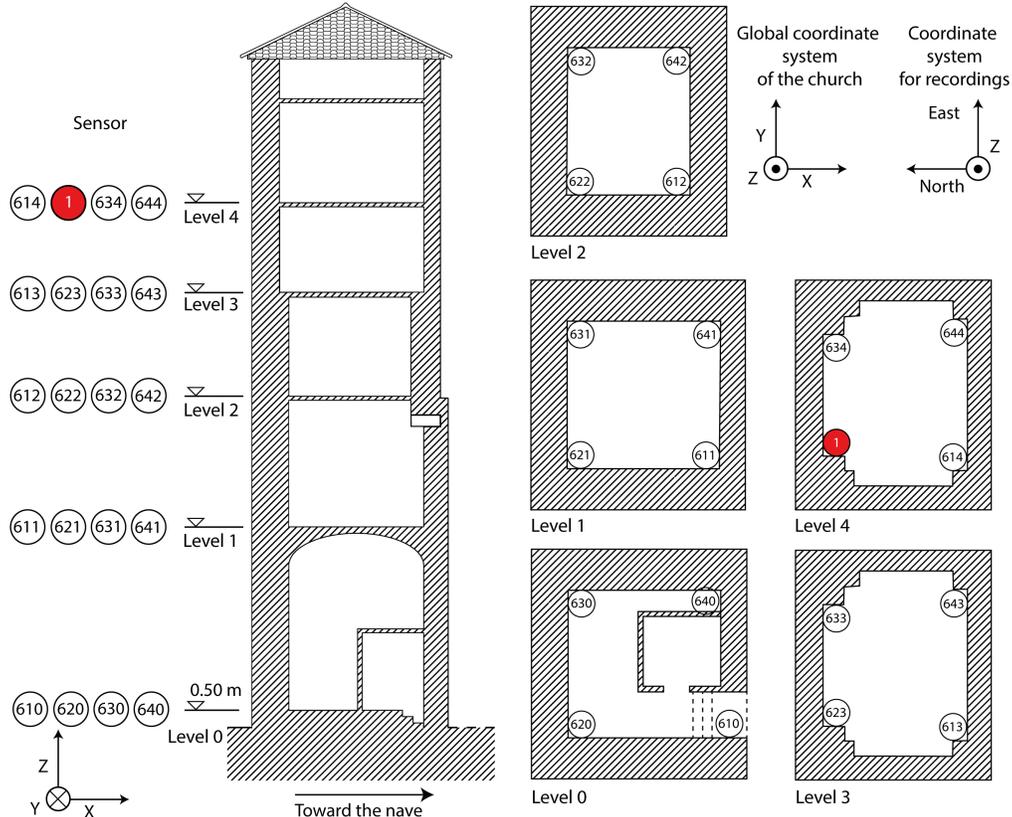
Figure 5: Location of the tri-axial sensors during the 2019 March survey in the bell tower. The reference sensor is shown in red. Numbers correspond to the ID of sensors used. The coordinate system for recordings is oriented along the North building reference shown in Fig. 3.

The March campaign was focused on the bell tower, the most accessible part of the church. It is composed of 5 floors, and we measured 4 vertical setups (Fig. 5). The reference sensor was located on top of the bell tower (Fig. 6-a, sensor ID 1 in Fig. 5). This provided a reference point to normalize and combine all the mode shape components. Several nodes were also added at level 0 of the church to detect potential bending at the basement.

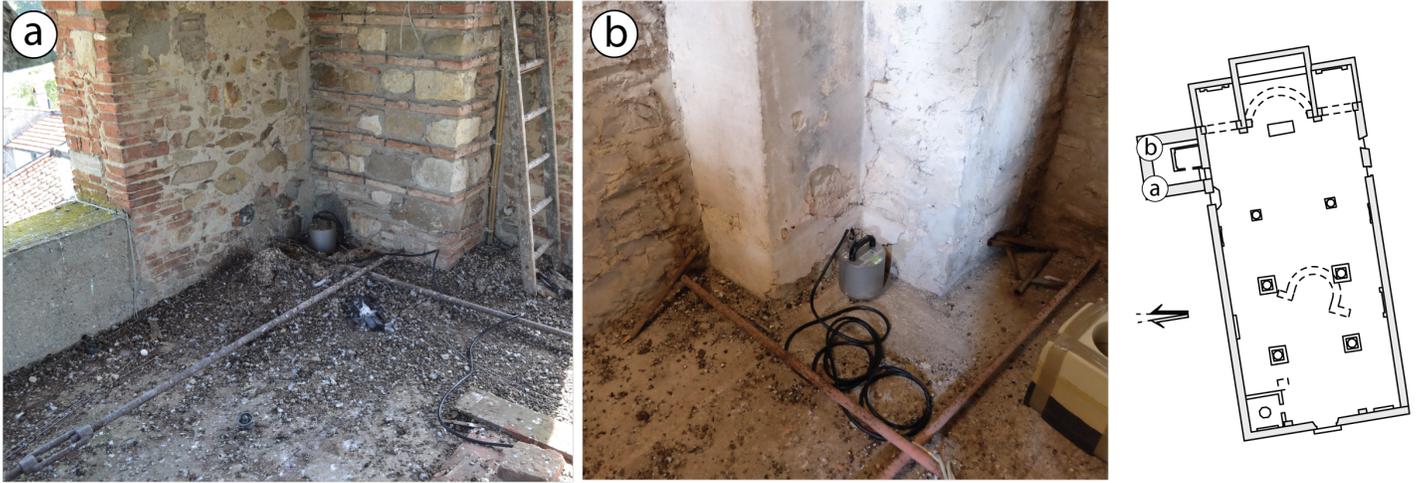
Figure 6: The tri-axial sensors (CMG40-T-1) in the bell tower during the March 2019 campaign. (a) Reference sensor installed at the top of the bell tower (node 1 in Fig. 5). (b) Sensor installed at level 1 of the bell tower (node 631 in Fig. 5). The location of the two sensors is depicted on a plan on the right of the figure. (Photos credits: Arnaud Montabert)

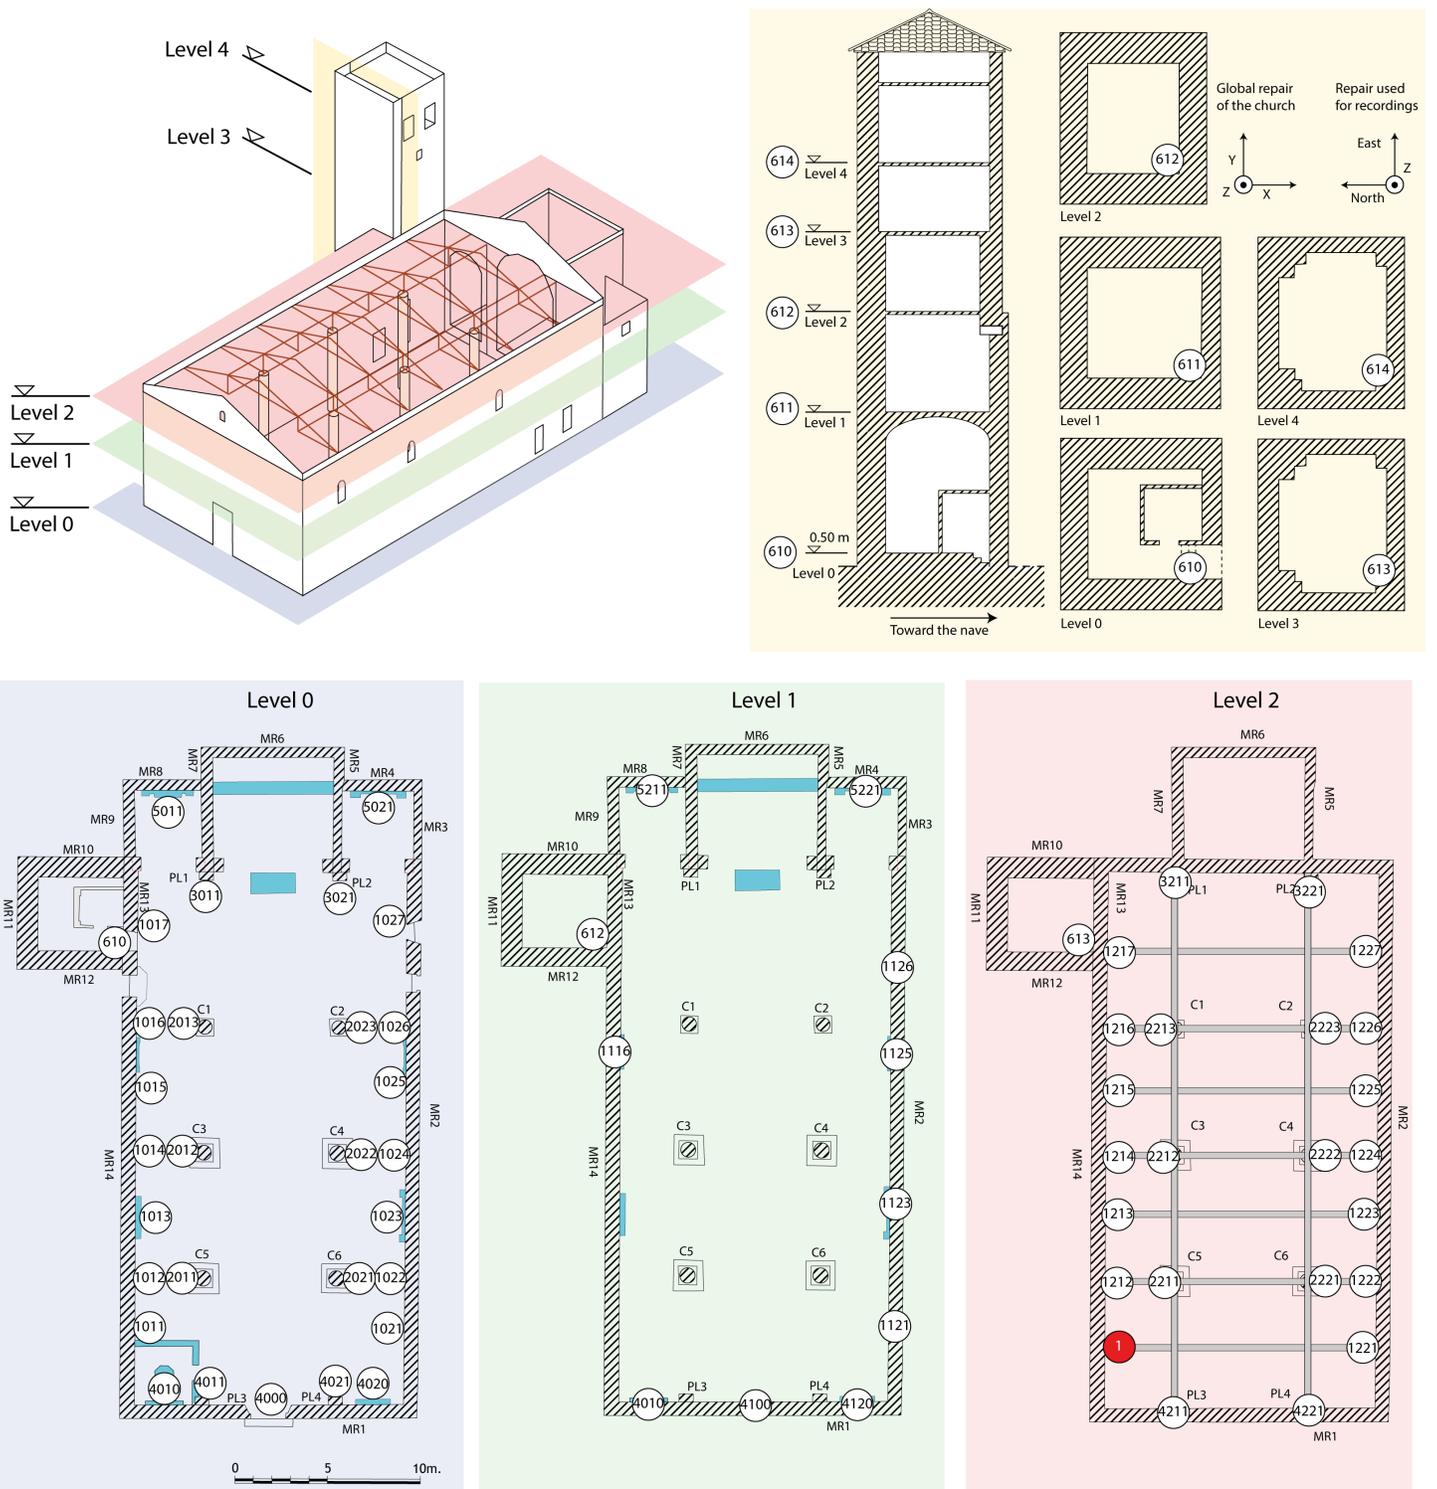
Figure 7: Location of the sensors during the June 2019 survey in the church at three levels. Level 0 : the ground floor, level 1: openings and tabernacles, level 2: wood frame of the church. 5 seismometers were also installed in the bell tower. The reference sensor is shown in red.

The June 2019 campaign was focused on the nave. Ambient vibrations were recorded at several levels (Fig. 7): the lower part of the building at ground level (level 0), the middle part of the building (level 1), and the top part (level 2), which is the most likely to record the largest amplitudes. As level 1 offers few possibilities to install seismometers, only 11 points were measured. This sensor strategy was validated by computing the first modes of the church by using a preliminary FE model. It was a real technical challenge to instrument level 2 since there was no direct access (no vaults system). We had to use a “spider” aerial platform (Fig. 8-a) with two operators (one operator at the top to control the platform and one operator at the bottom to ensure a second visual control). The sensors were thus installed on wooden beams as the only flat surfaces at level 2. Although wood may affect the signal, it was also impossible to stick any miniature accelerometers to the wall at his height. The sensors were thus installed as close as possible to the walls of the nave using straps (Fig. 8-b), preventing the fall of sensors. There were also strapped at the top of the columns of the central nave at a height of about 10 m. The reference sensor was installed on the North–West beam (location ID 1 shown in Fig. 7). Sensors (CMG40-T-1) were deployed on the ground (level 0) at the foot of level 2 sensors (LE-3Dlite). Some sensors were installed in the middle part of the nave at the level of the openings in the walls, or on the tabernacles when the coupling between the latter and the walls was proven (CMG40-T-1 and LE-3Dlite at level 1). Ambient vibrations were also recorded in the bell tower since the interface between the bell tower and the nave is a sensitive area. Pounding effects are indeed expected since the bell tower was built after the nave without any obvious mechanical link. We measured only one vertical line to compare modal parameters with those obtained in March 2019.

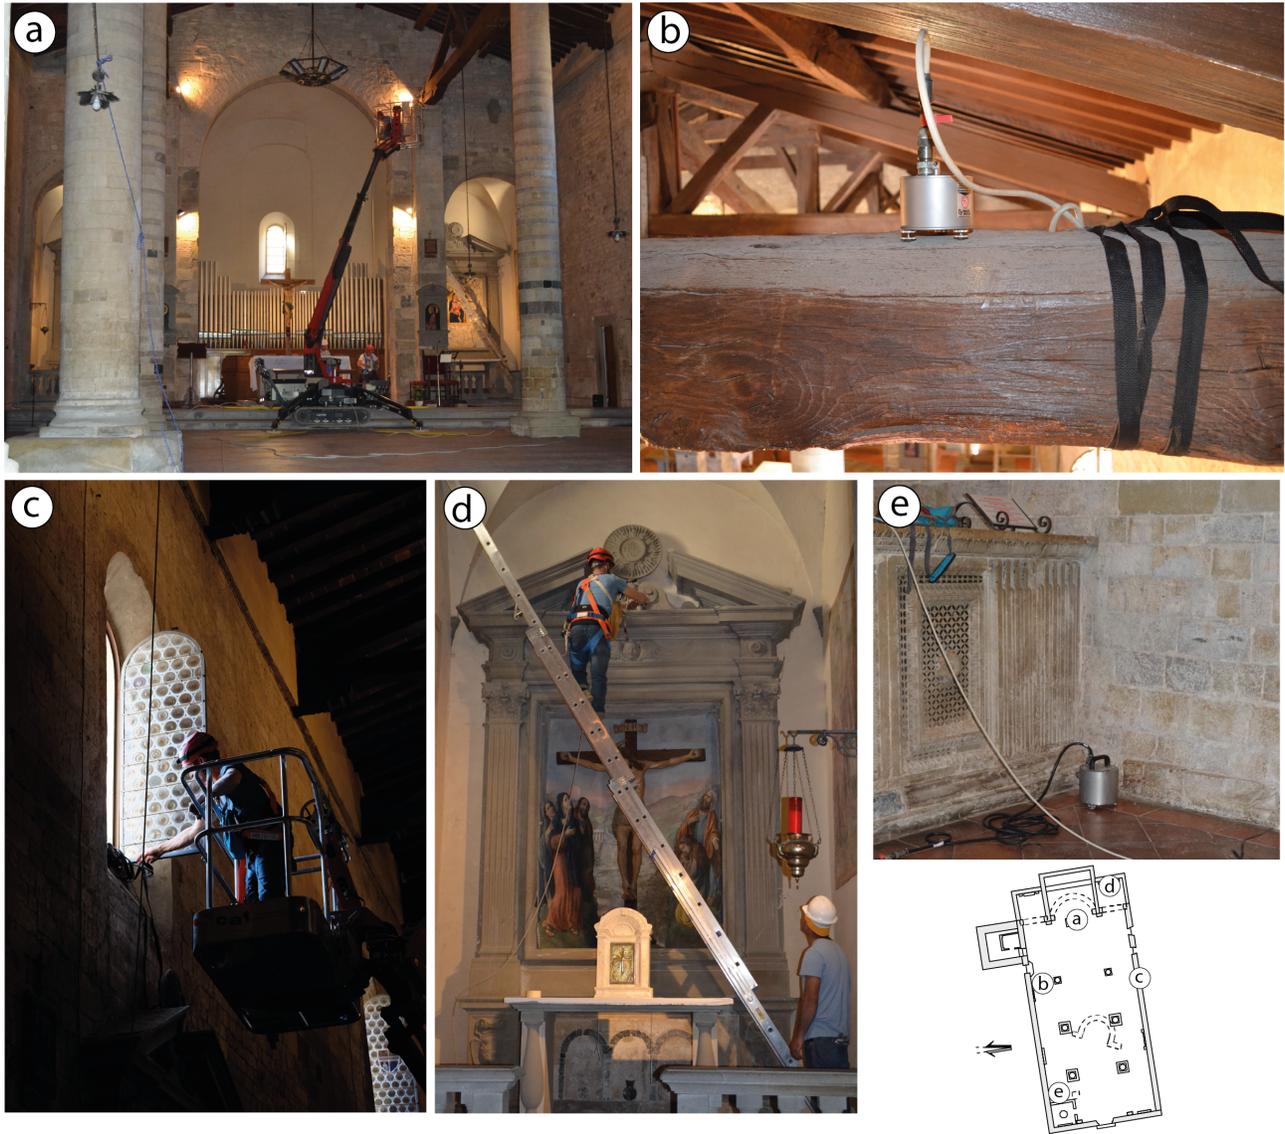
Figure 8: Location of the sensors during the June 2019 survey. (a) Use of a “spider” aerial platform to install sensors on the beams of the wooden frame with two operators. (b) LE-3Dlite MkIII strapped on a beam at level 3. (c) Installation of a sensor on one of the three windows of the church. (d) Installation of a sensor on a tabernacle in the south side chapel. (e) Installation of a sensor (CMG40-T-1) on the ground floor. We specify the location of the five seismometers in the plan of the church on the right in the Figure. Photo credits: H el ene Lyon-Caen (a, c) and Arnaud Montabert (b, d, e).

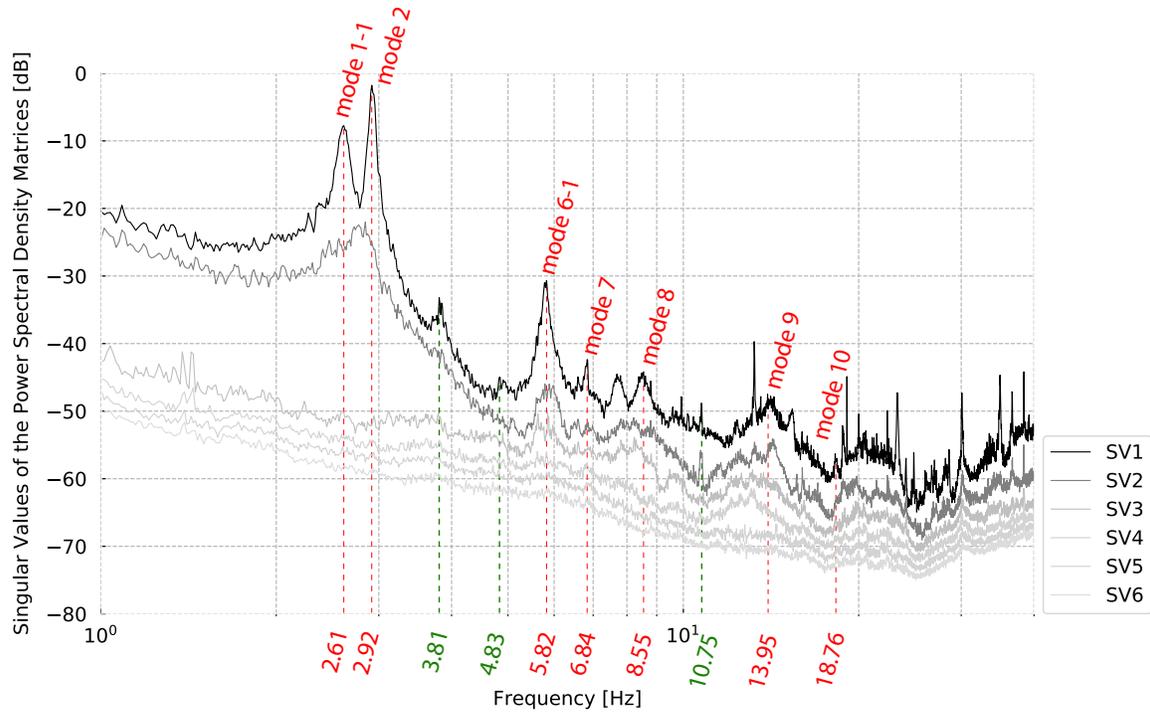
Figure 9: Evolution of the 6 first average singular values (SV1, SV2, SV3, SV4, SV5, SV6) of the Power Spectral Density matrix extracted from the 4 setups in the bell tower (March 2019 campaign) as a function of frequency. 10 peaks are identified. Red values correspond to the identified natural frequencies of the bell tower. Green values correspond to the natural frequencies of the nave that cannot be characterized since the instrumentation is focused on the bell tower.

Mode 7 identified at $f_7^B = 6.84$ Hz corresponds to a second-order bending mode of the bell tower towards the North–South direction (Fig. 11-i). As for the first bending mode of the bell tower in the North–South direction (mode 1-1 in Fig. 11-a), a tilting of the base of the bell tower is also observed. The second order bending mode (mode 8) of the bell tower in the West–East direction (Fig. 11-j) is identified at $f_7^B = 8.55$ Hz in Fig. 9. The tilting of the base of the bell tower is again observed.

Third order bending modes of the bell tower were also observed (Fig. 9). Mode 9 is identified at $f_9^B = 13.95$ Hz and mode 10 at $f_{10}^B = 18.76$ Hz. The two modes are confirmed with the wide SDOF distribution (Fig. 12-k, l).

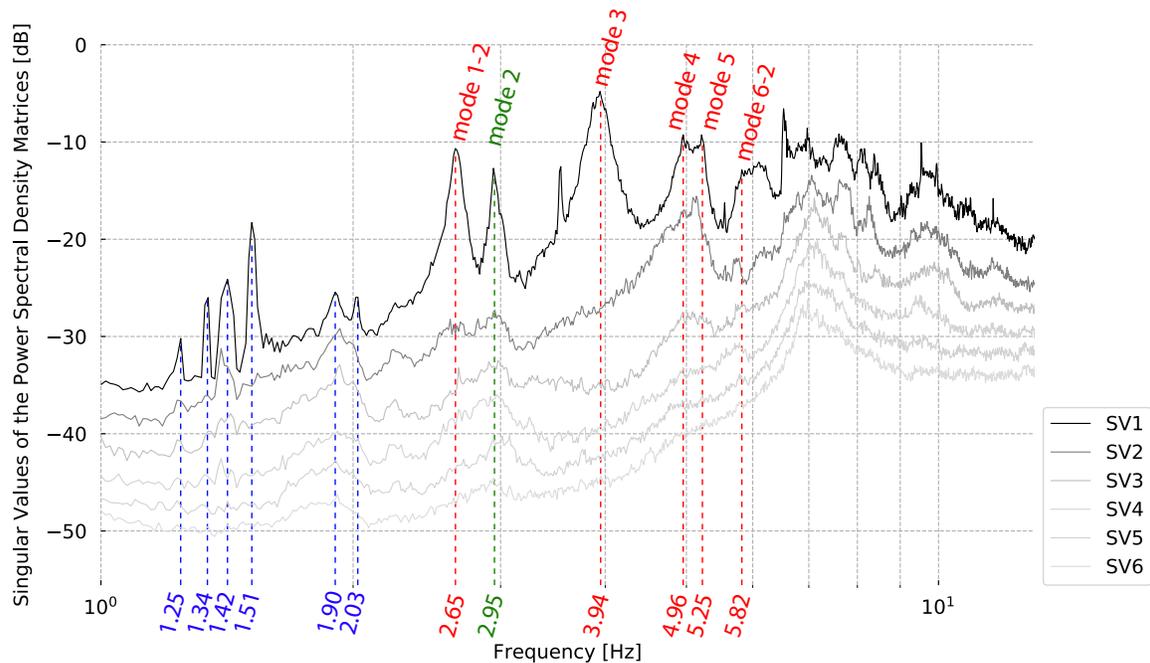
Figure 10: Evolution of the 6 first average singular values (SV1, SV2, SV3, SV4, SV5, SV6) of the Power Spectral Density matrices extracted from the 7 setups in the nave (June 2019 campaign). Red values correspond to the natural frequencies of the nave. The green value corresponds to the natural frequencies of the bell tower that cannot be characterized since the instrumentation is focused on the nave. Blue values highlight frequencies of non-structural modes, as explained in the text.

Two closely spaced modes are observed between 4.96 Hz and 5.25 Hz (Fig. 10) related to mode 4 (Fig. 11-e) and mode 5 (Fig. 11-f). The MAC is used to discriminate the SDOF distribution of these two modes (Fig. 12-e and -f). A first peak is identified in Fig. 10 at $f_4^N = 4.96$ Hz. Mode 4 shows a tilting of the church facade (Fig. 11-e). This natural frequency highlighting a mode of the nave is identified in the SV1 spectrum shown in Fig. 9 at $f_4^B = 4.83$ Hz. The MAC value is obviously too small to identify a mode shape associated to the bell tower. The second peak is observed at $f_5^N = 5.25$ Hz (Fig. 10). The associated mode shape highlights an opening mode of the church (Fig. 11-f).

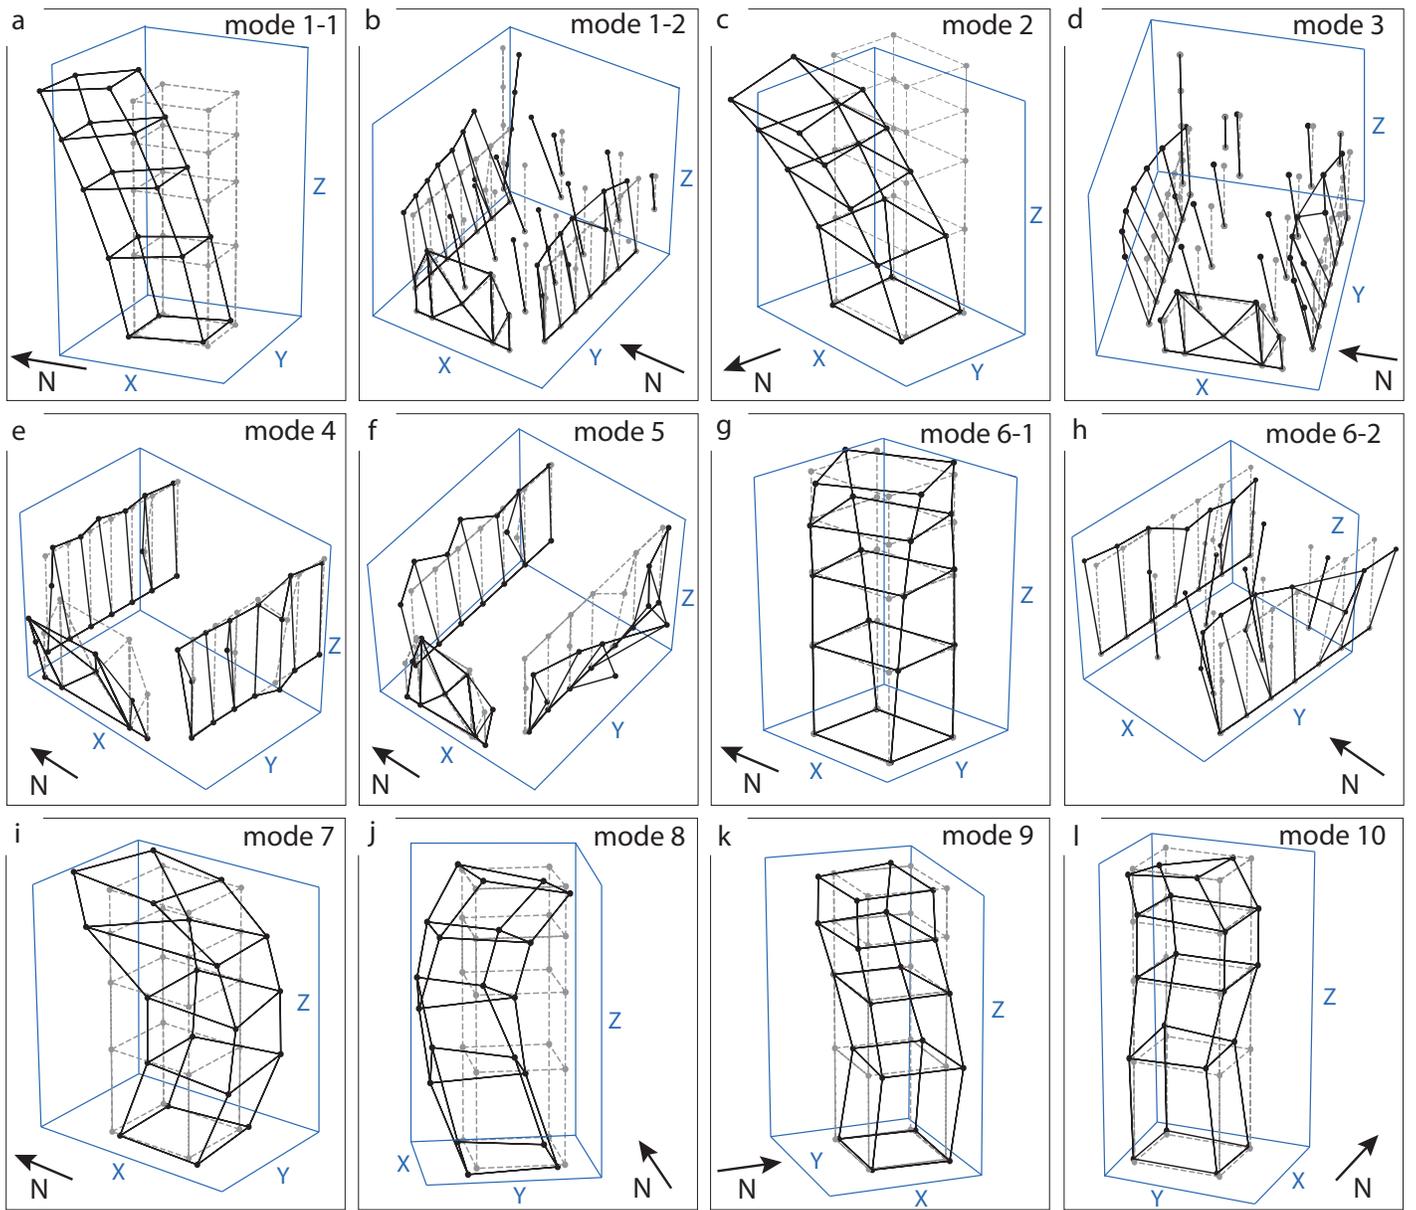
Figure 11: Mode shapes are associated with the selected peaks of the singular values extracted from the singular vector matrices. Dashed gray lines highlight the setup strategy. Black lines are related to the extracted mode shape. The black arrow indicates the North building reference.

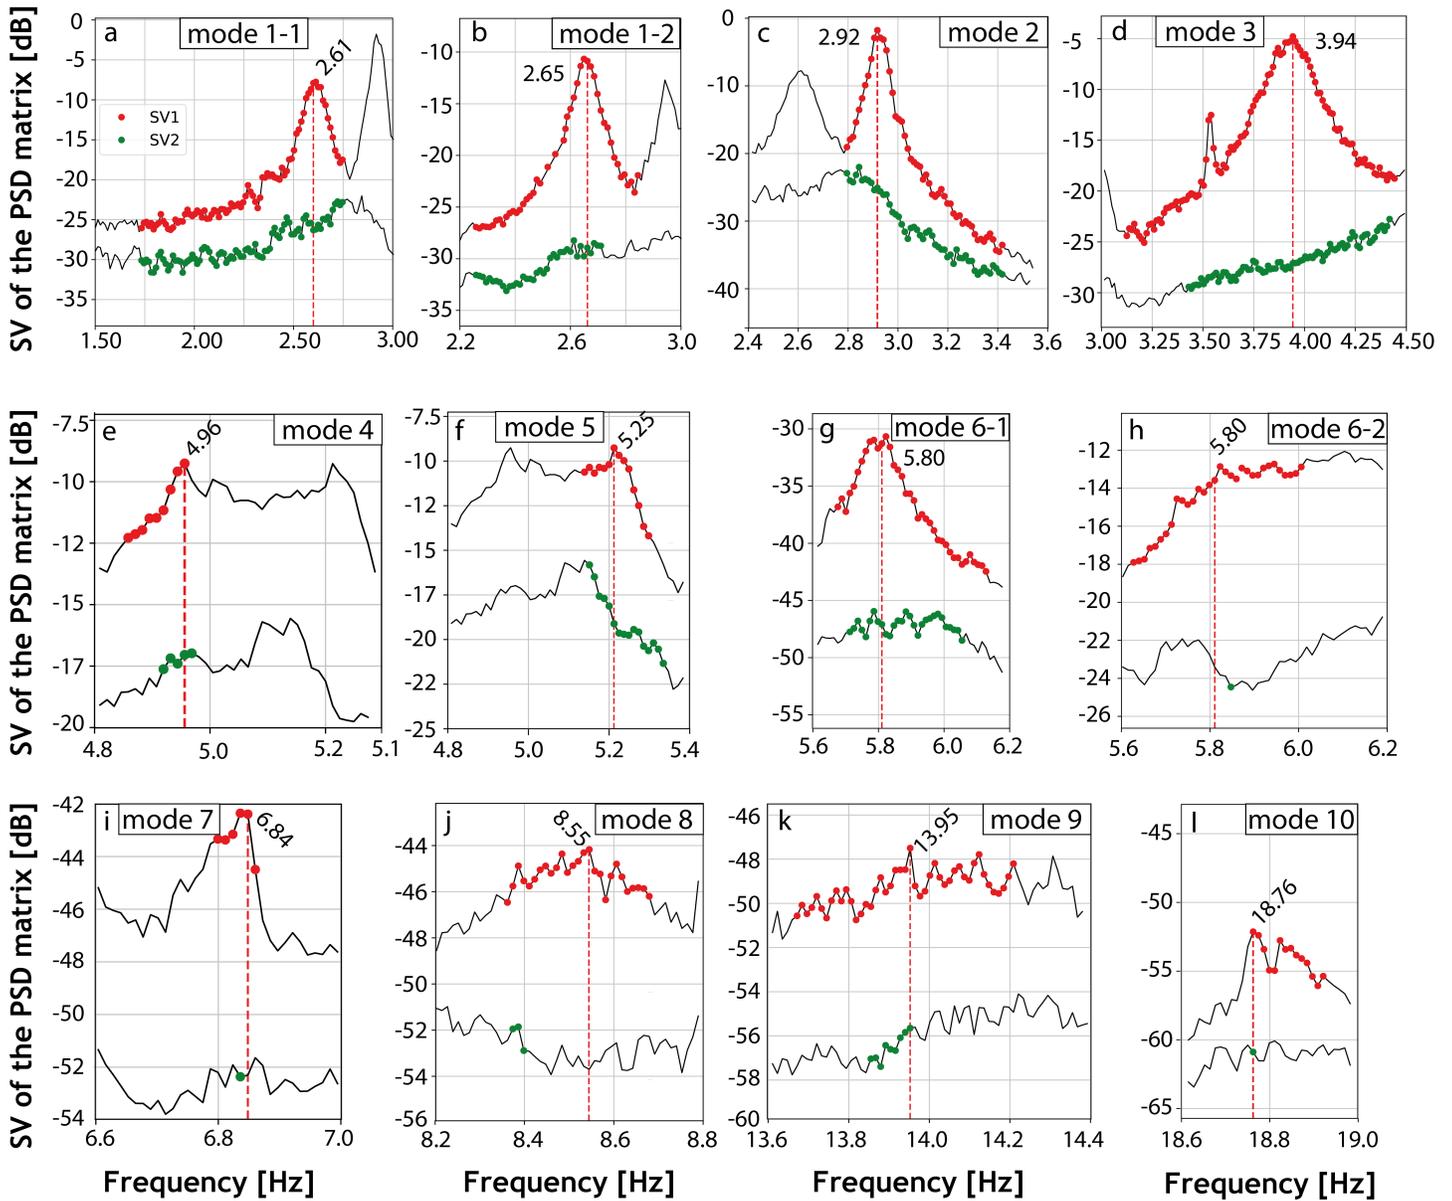
Figure 12: MAC evaluation close to the picked peak associated with the identified mode. The red dots correspond to the frequencies of the first singular value belonging to the same SDOF density function. The green dots correspond to the frequencies of the second singular value belonging to the same SDOF density function.

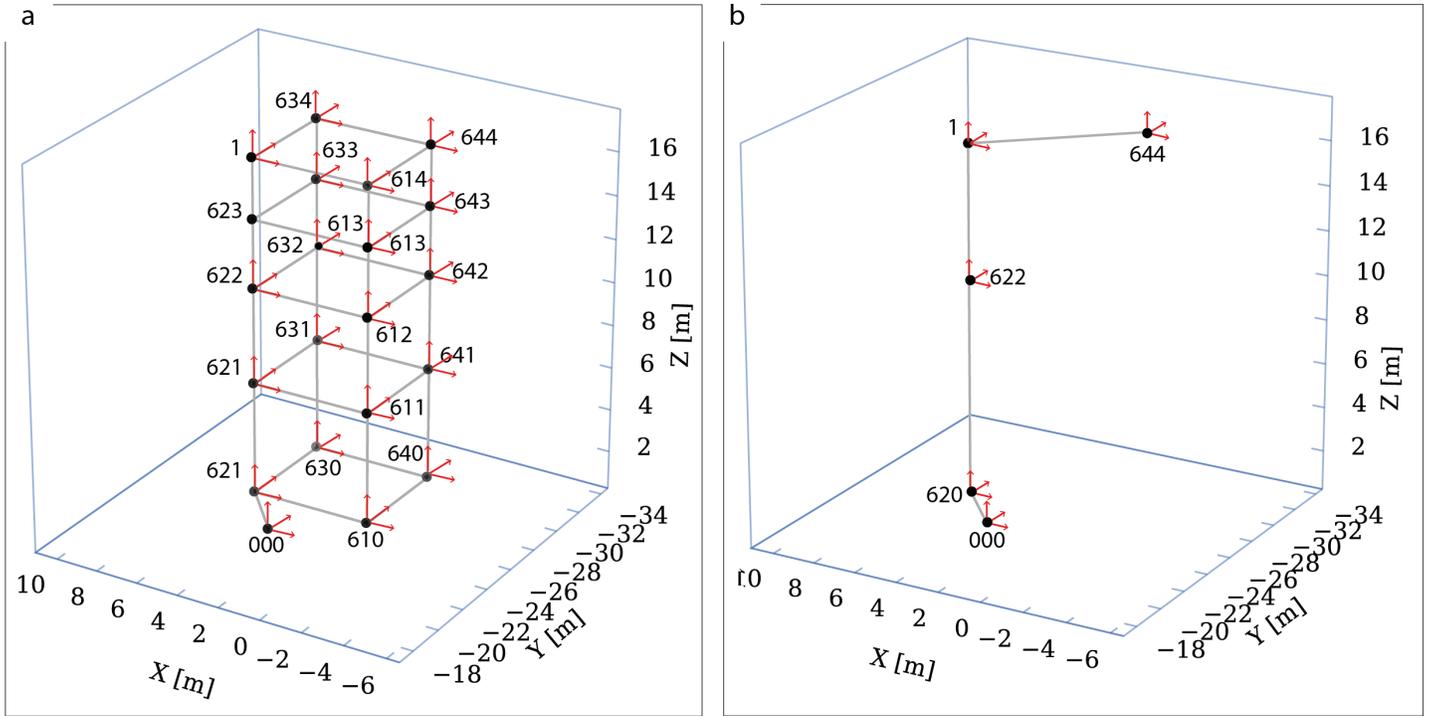
Figure 13: a — Strategy SB0: setup design used in March 2019. b — Strategy SB1: alternative setup design for the survey in March 2019.

The sensor placement strategy (SB0) using 21 tri-axial sensors (63 DoFs) applied during the March 2019 campaign is shown in Fig. 13-a. Fig. 14-a illustrated the autoMAC matrix for the SB0 strategy. The correlation between the modes of the same modal base is less than 40%. The highest correlations are only for pairs of modes: mode 1-1/mode 7 (35.0%) and mode 2/mode 8 (37.3 %). By contrast, an alternative strategy SB1 (Fig. 13-b) using only

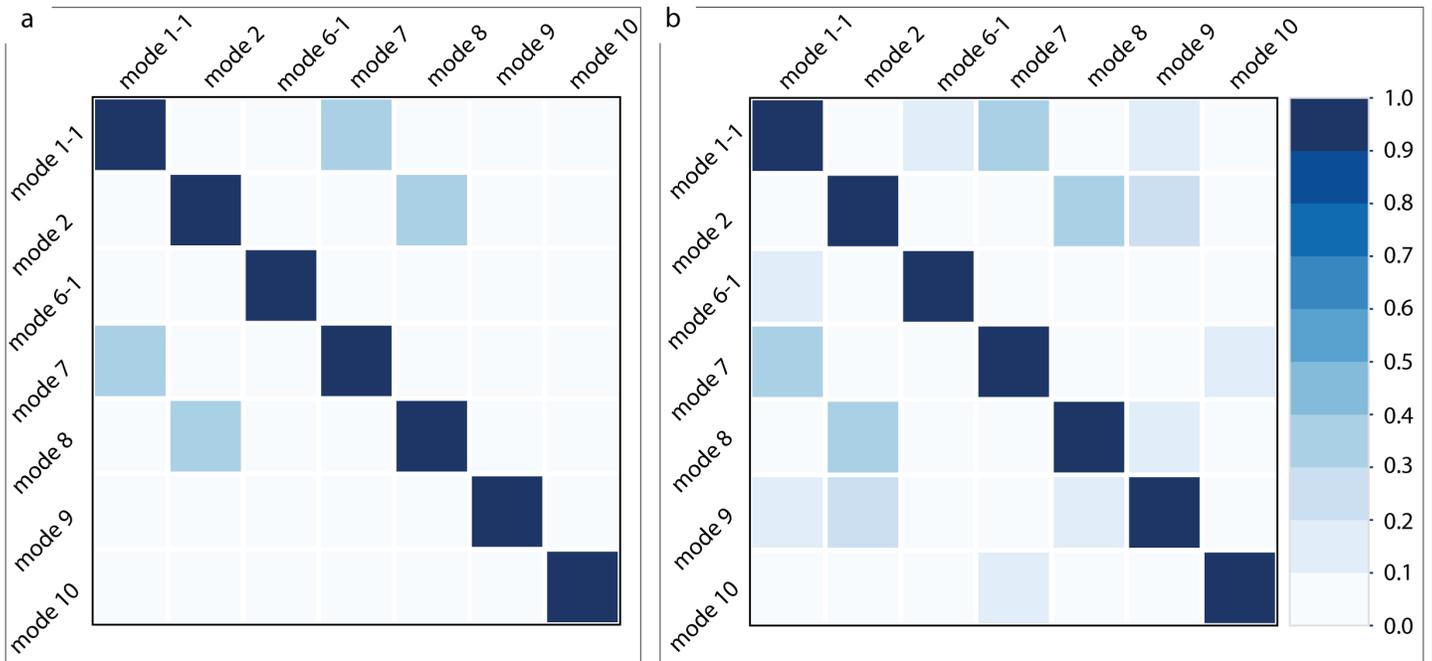
Figure 14: a — AutoMAC related to strategy SB0. b — AutoMAC related to strategy SB1.

5 tri-axial sensors (15 DoFs) is tested. This sensor placement strategy is often used as a minimal configuration to identify the first modes [15, 64]. The autoMAC matrix of the SB1 strategy (Fig. 14-b) shows again MAC values below 40% between the pairs of modes of the experimental base. However, the MAC value is higher for some mode pairs for the SB1 strategy than for the SB0 strategy. As an example, $\text{MAC}(\{\phi_{1-1}\}, \{\phi_{6-1}\}) = 16.0\%$ in SB1 strategy whereas $\text{MAC}(\{\phi_{1-1}\}, \{\phi_{6-1}\}) = 0.02\%$ in SB0 strategy.

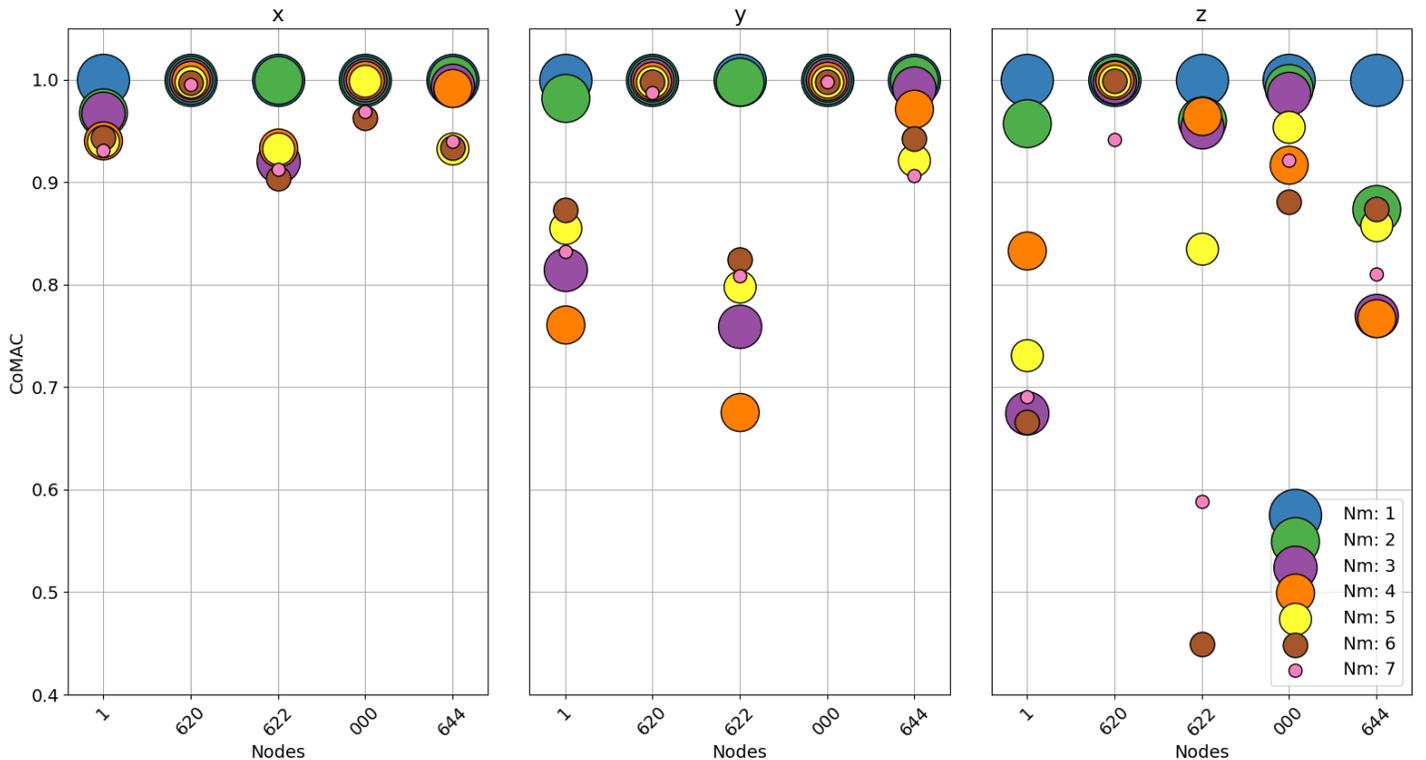
Figure 15: CoMAC between the nodes common to strategy 0 (SB0) and strategy 1 (SB1). Each column corresponds to the degree of freedom of the considered sensor (x, y, z). The sensor number is indicated on the x-axis. The $N_m = 7$ modes are used to compute the CoMAC.

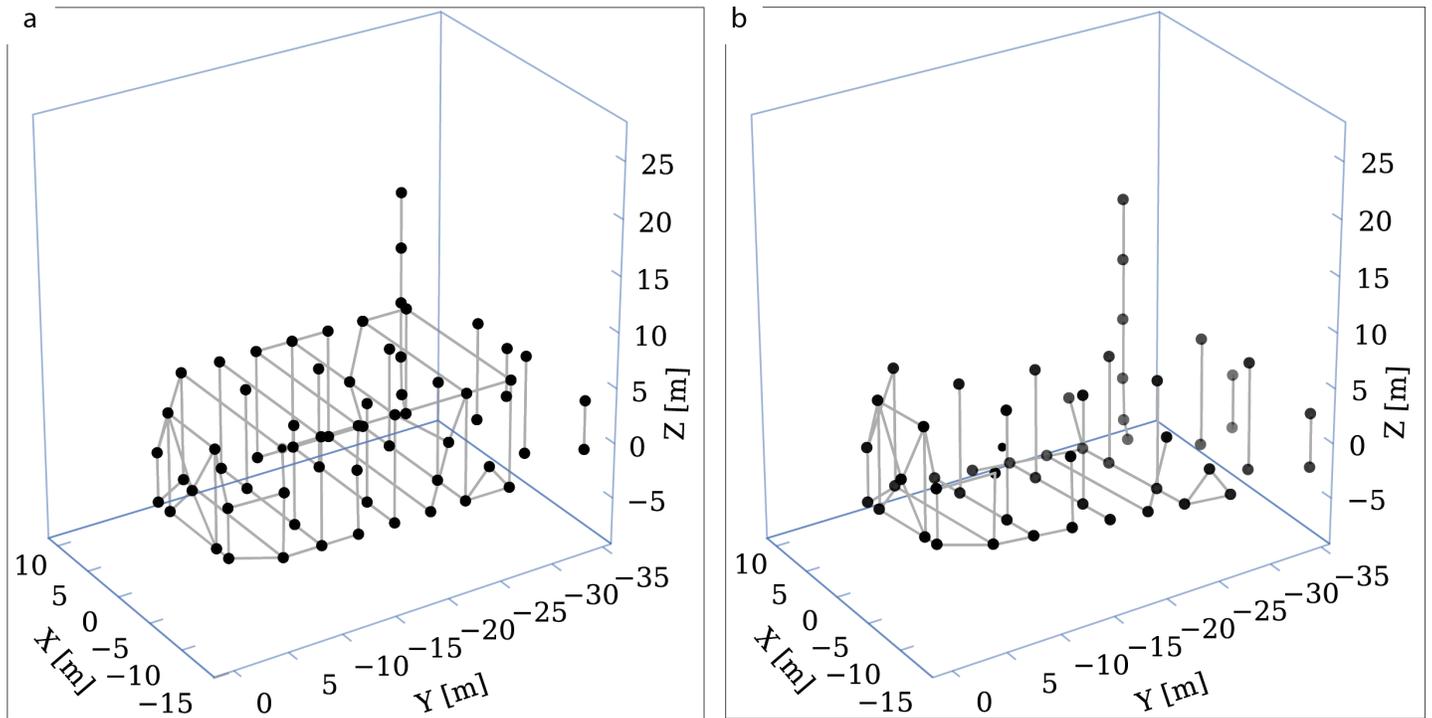
Figure 16: a — Strategy SN0: sensor system used in June 2019. b — Strategy SN1: alternative sensor system used to perform OMA from the survey in June 2019 by removing the majority of sensors of level 2 that are inaccessible without the “spider” aerial platform.

Strategies of instrumentation of the nave SN0 and SN1 are compared (Fig. 16). SN1 is an alternative strategy with less sensors (Fig. 16-b). In the SN1 strategy, level 2 is not instrumented. In other words, this strategy corresponds to the position that the sensors would have had if the “spider” aerial platform had not been used. We observe that $\text{MAC}(\{\phi_{1-2}\}, \{\phi_3\}) = 48.4\%$ (Fig. 17-a). For the other pairs of modes, the MAC is less than 1.6%. The autoMAC

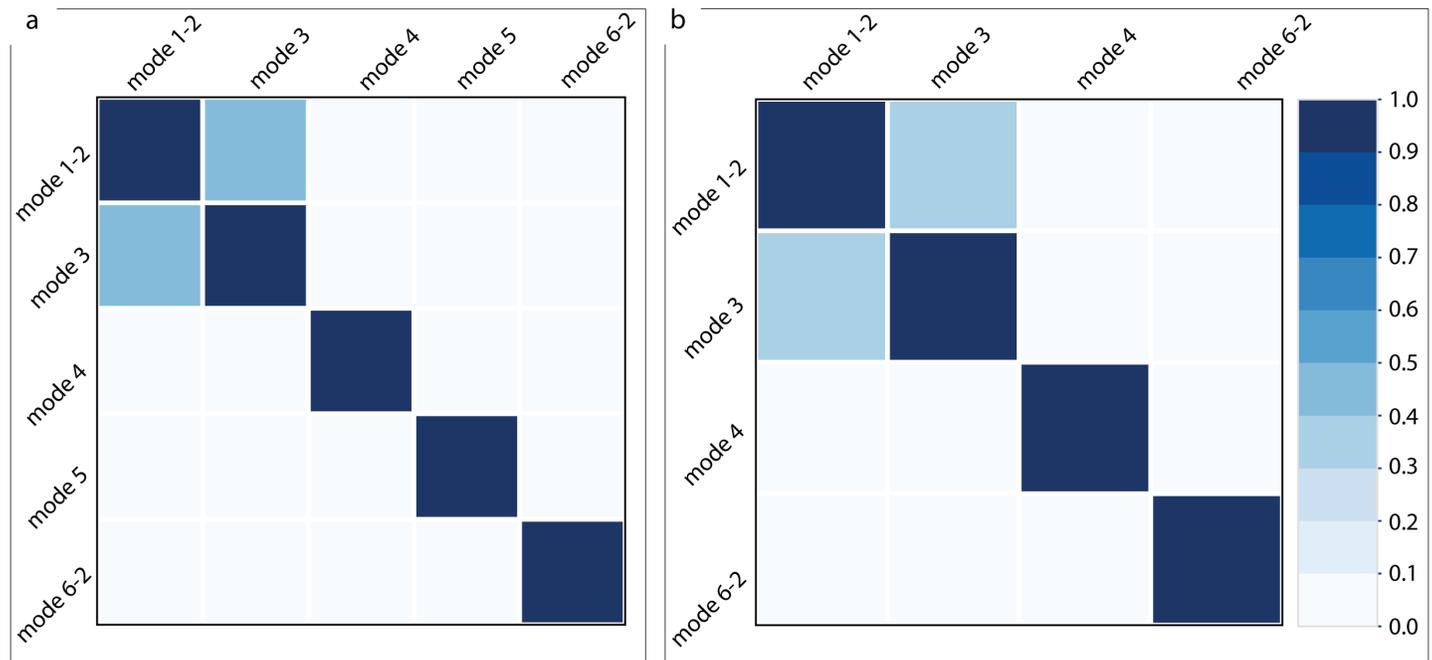
Figure 17: a — AutoMAC related to strategy SN0. b — AutoMAC related to strategy SN1.

of SN1 shows that only 4 modes (mode 1-2, mode 3, mode 4 and mode 6-2) composed the modal base (Fig. 17-b). The alternative SN1 strategy does not allow to identify mode 5. The pair of mode mode1-2/mode 3 presents the most important MAC value (34.7%). The other MAC values are lower than 1.6%.

The autoMAC shown in Fig. 17-a demonstrates the ability of the strategy used during the June 2019 campaign (SN0 strategy) to separate the modes correctly. Although mode 1-2 is identified in SN1, the lack of a sensor at the top of the nave does not allow a sufficient resolution to observe the mode shape of the nave. In particular, the application of SN1 would have led to the impossibility of identifying the opposition phase between the nave and the bell tower. This has a crucial impact on the church’s vulnerability assessment. Since the information is missing, this can lead to a major error in the modeling process, inducing a bias in the simulation of the seismic response of the church. The second limitation of the SN1 strategy is its inability to detect mode 5. It induces a truncated knowledge of the dynamic behavior of the church. Mode 5 is particularly important since it can potentially activate a pre-existing tilting of the north and south walls of the nave induced by the 1542 earthquake [3].
