High resolution operational modal analysis of Sant'Agata del Mugello in light of its building history

High resolution operational modal analysis of Sant’Agata del Mugello in light of its building history.

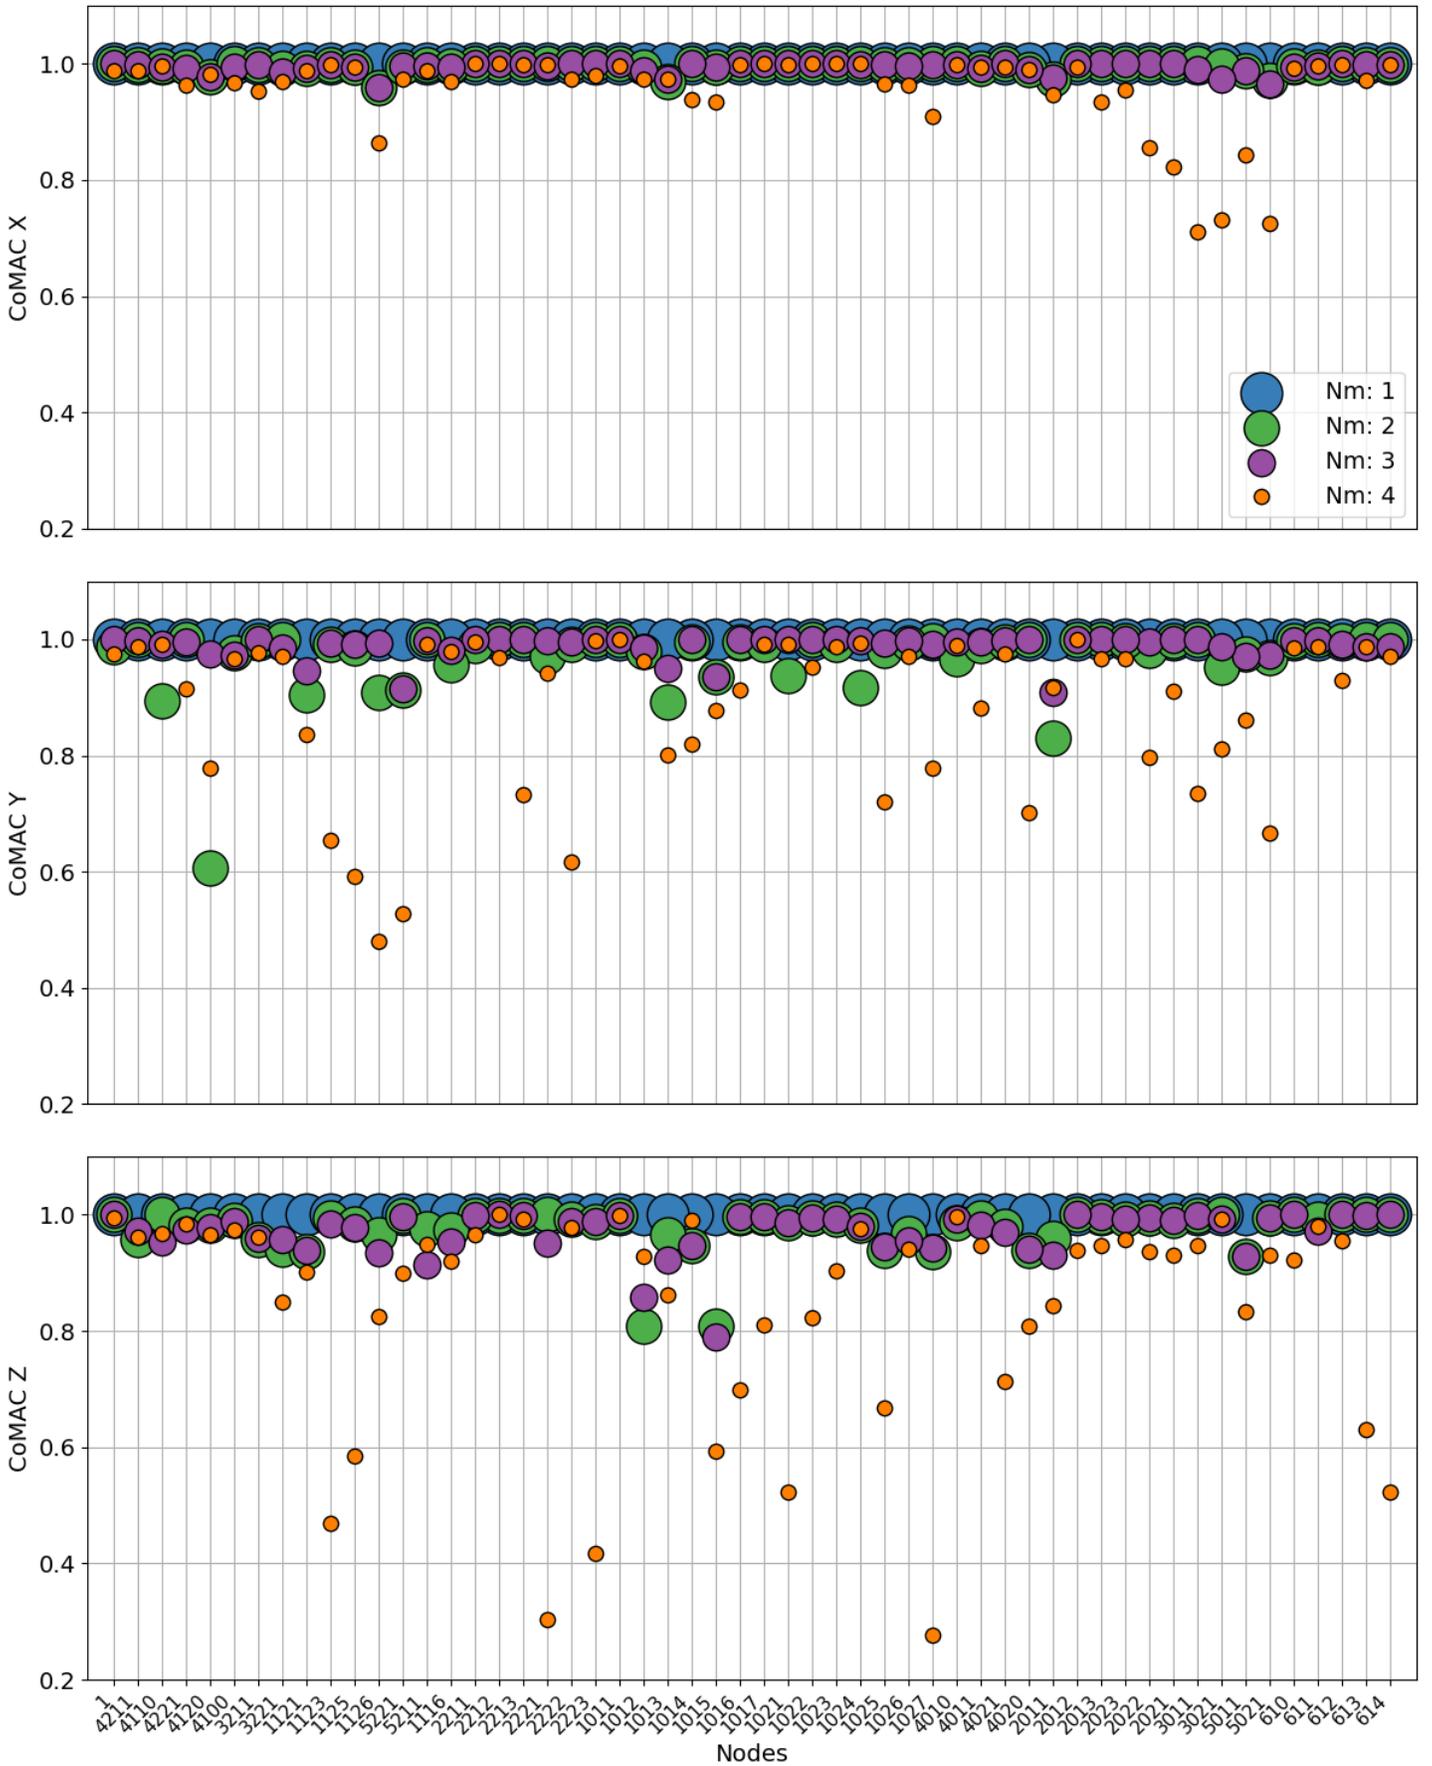
Figure 18: CoMAC between the nodes common to strategy 0 (SN0) and strategy 1 (SN1) of the 2019 June campaign. $N_m = 4$ modes are used to compute the CoMAC.

Fig. 18 shows the value of the CoMAC calculated from the two experimental bases of the two strategies, SN0 and SN1. This value only takes into account $N_m = 4$ modes since mode 5 was not detected by the SN1 strategy.

Moreover, the value of the CoMAC drops when integrating the higher-order modes (from mode 6-1). This demonstrates that the identification of mode shapes of the higher-order modes are different from a sensor placement strategy to another. It highlights the importance of a high enough sensor density to identify mode shapes correctly. This difference can have a significant impact. In the context of Structural Health Monitoring, an incorrect evaluation of the mode shapes can have consequences on the interpretation of the dynamic behavior of the building and the interpretation of potential damage.

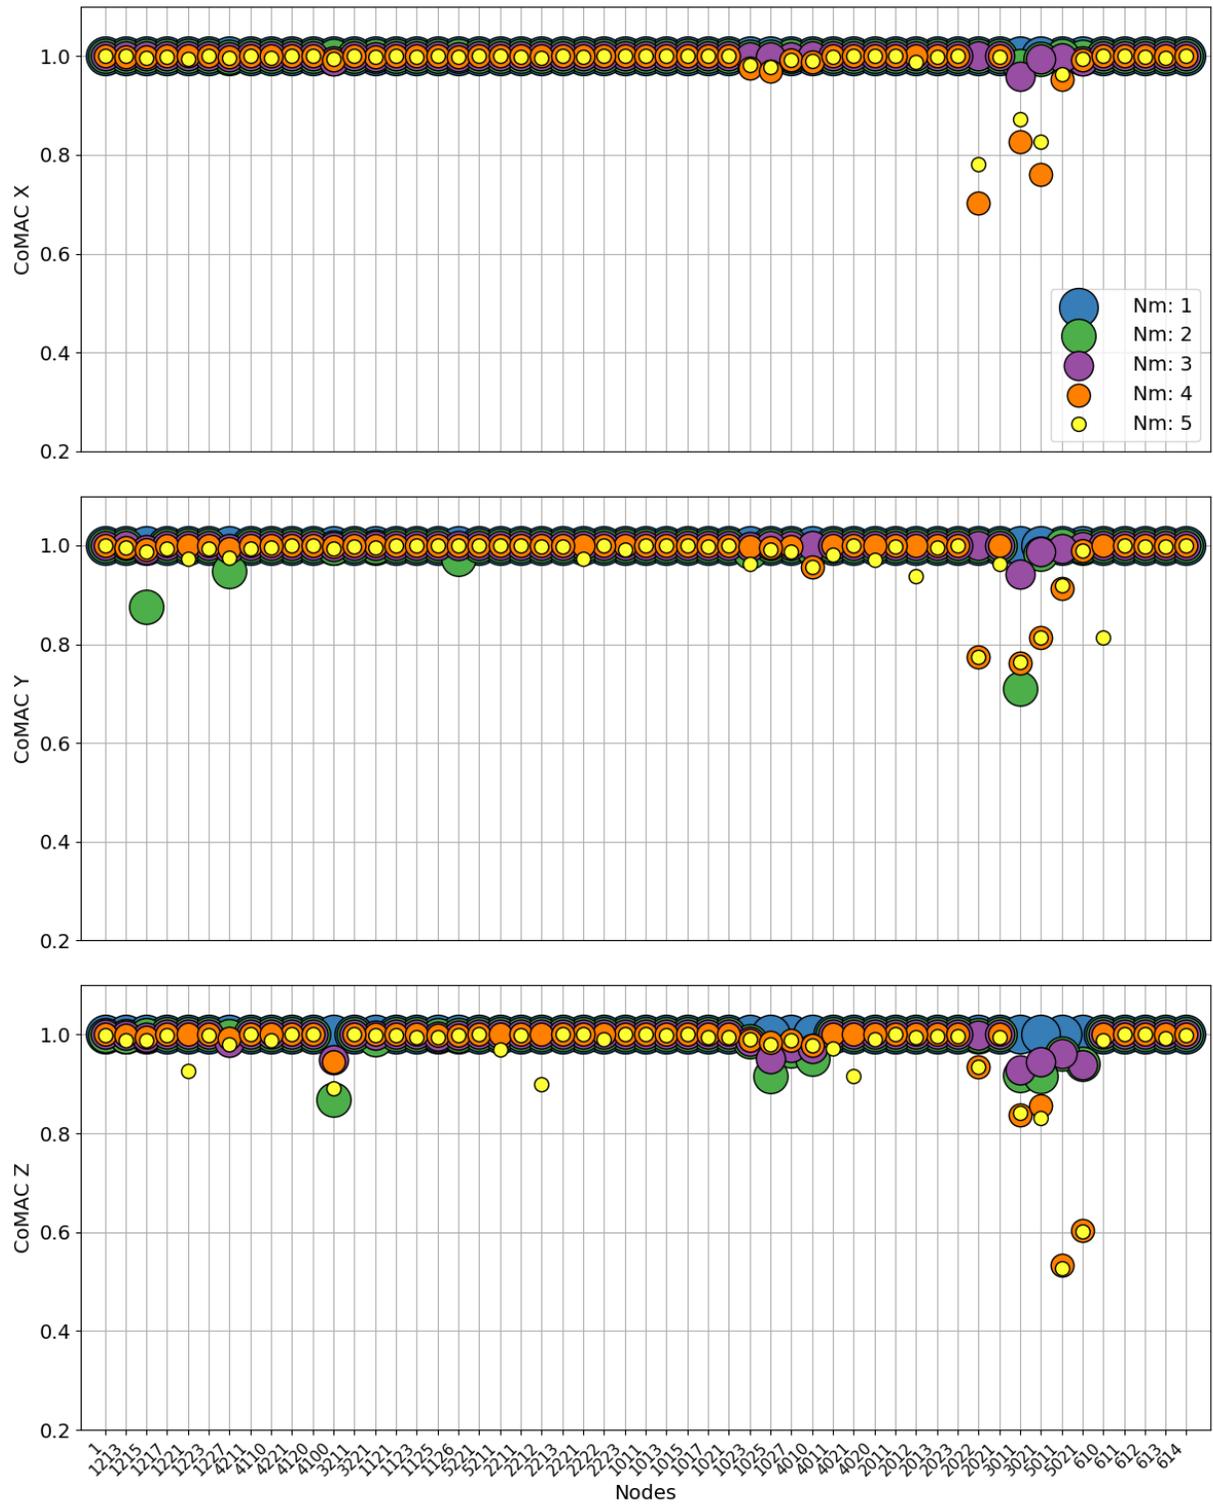
Figure A. 1: CoMAC between the nodes common to strategy 0 (SN0) and strategy 2 (SN2) of the 2019 June campaign. $N_m = 5$ modes are used to compute the CoMAC.

This appendix details two additional alternative strategies tested called SN2 and SN3. The strategy SN2 intended to instrument one wood beam out of two (sensors 1212, 1214, 1216, 1222, 1224 and 1226 were removed from level 2, Fig. 7). Mode 5 was successfully identified but also led to a decrease in the correlation between modes compared to the SN0 strategy at the scale of degree of freedom (Fig. A. 1). CoMAC decay involves fewer sensors than the SN1 strategy. The sensors concerned are mainly in the two lateral chapels (5011, 5021, and 3011). The value of the CoMAC between the two modal bases for all degrees of freedom positioned on the beams of the wood frame remains greater than 80%. It means that the SN1 sensor placement strategy had a small impact on the quality of the mode shapes. The strategy SN2 is thus accurate enough to identify modal parameters.

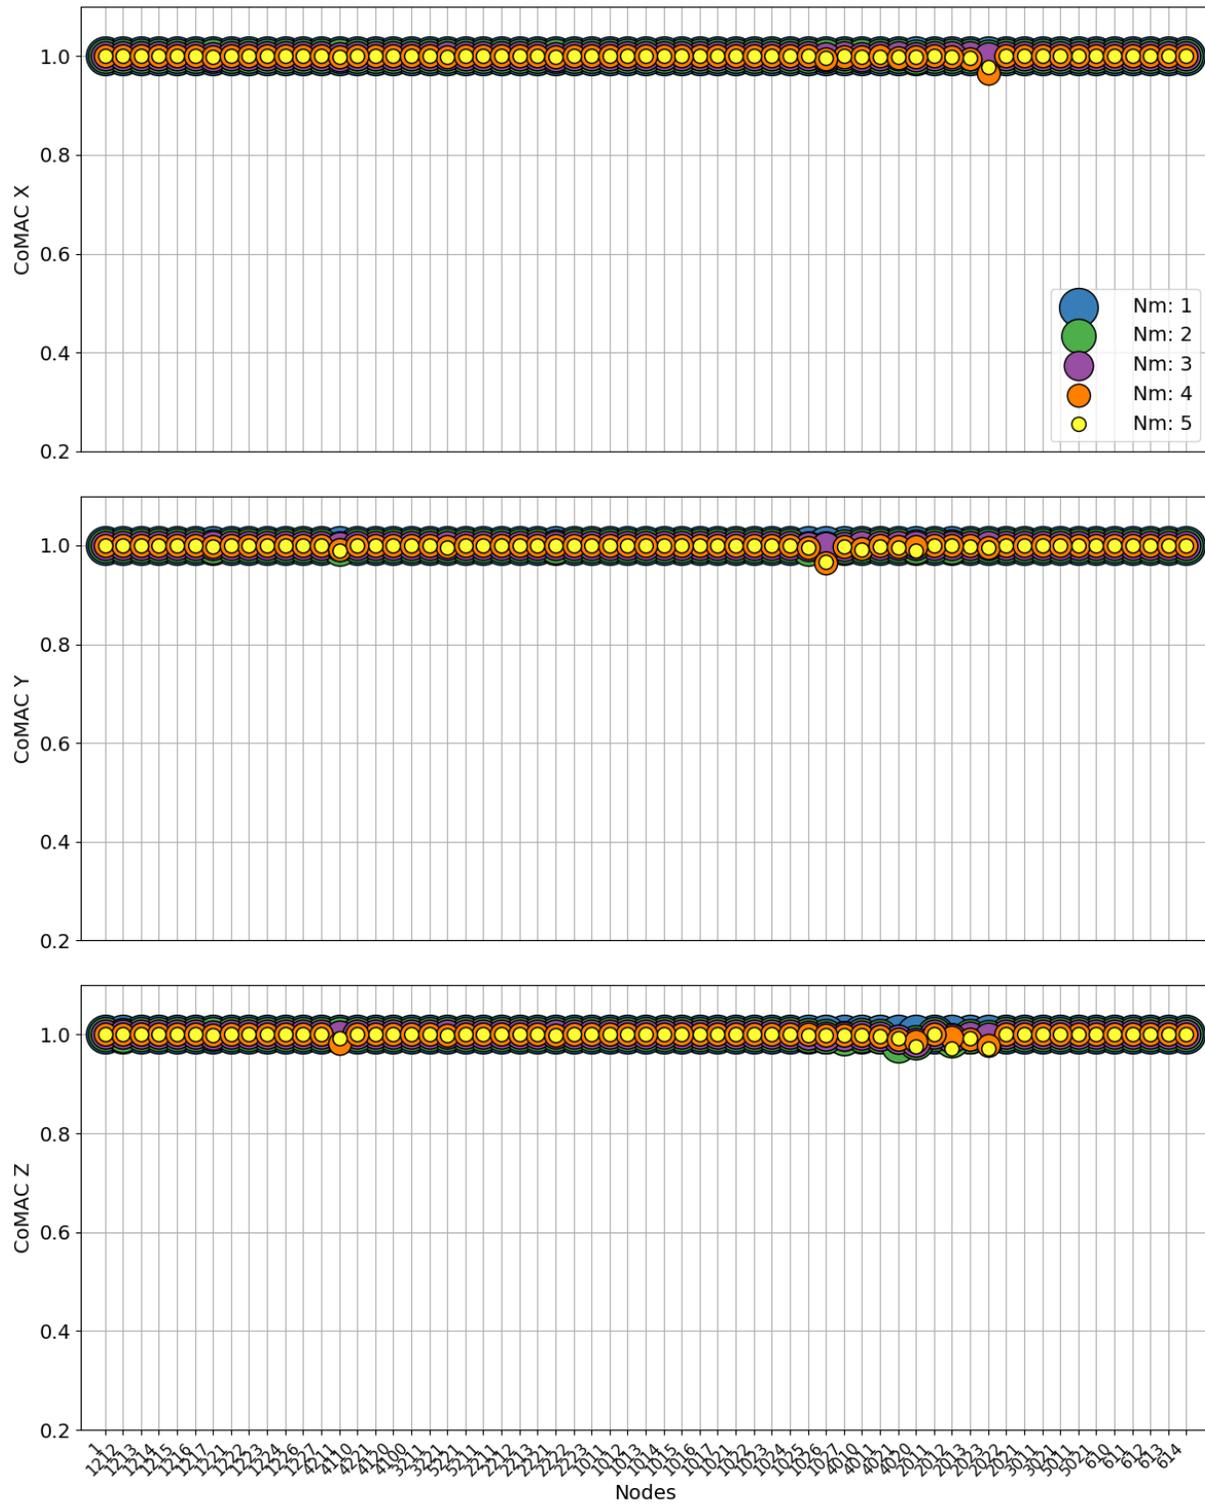
Figure B. 1: CoMAC between the nodes common to strategy 0 (SN0) and strategy 3 (SN3) of the 2019 June campaign. $N_m = 5$ modes are used to compute the CoMAC.

The sensor placement strategy SN3 excluded sensors from level 1 (sensors 1116, 1121, 1123, 1125, and 1126 are removed from level 1). Only a very slight drop of the CoMAC has been noted (Fig. B. 1, the value of the CoMAC is higher than 95% whatever the degree of freedom considered). This strategy had a small impact on the quality of the mode shapes again.
