# Theoretical and Experimental Investigation of Bonded Patch Repairs of a Rubber Reinforced Composite Conveyor Belt

Rawdha Kessentini, Olga Klinkova, Imad Tawfiq, Mohamed Haddar

Rawdha Kessentini, Olga Klinkova, Imad Tawfiq, Mohamed Haddar. Theoretical and Experimental Investigation of Bonded Patch Repairs of a Rubber Reinforced Composite Conveyor Belt. *Polymers*, 2021, 13 (11), pp.1710. 10.3390/polym13111710 . hal-03558788

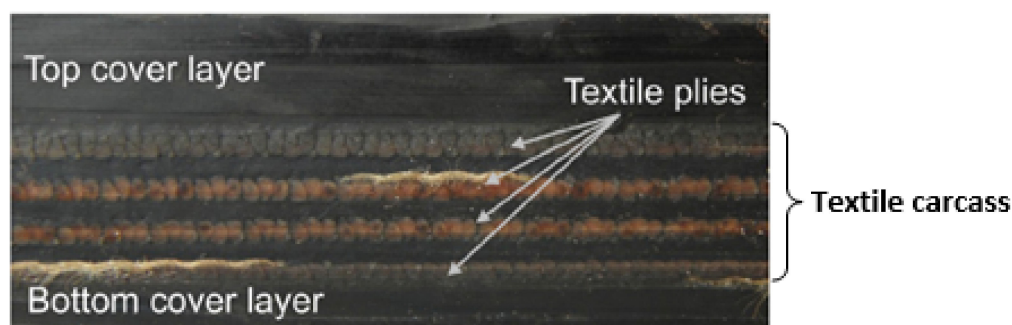
Figure 1. Rubber-textile composite conveyor belt.

A rubber-textile conveyor belt represented in Figure 1 was repaired according to the structural reparation method. The fabric textile carcass was designed to be layered with four plies of polyester (PET) yarn in the warp direction and polyamide (PA6) yarn in the weft direction.

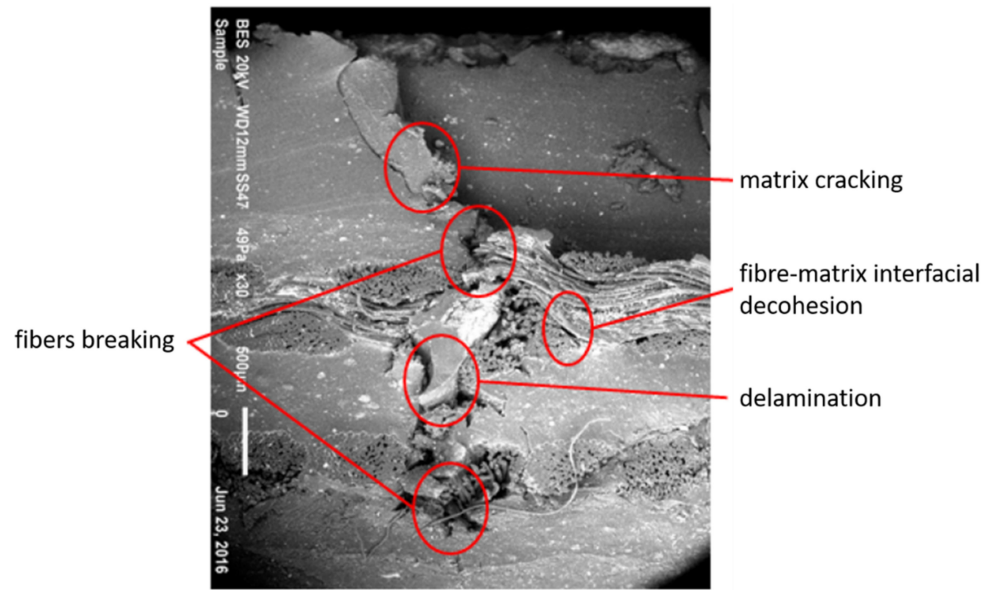
Figure 2. Micrograph of the cross-sectional area of the impacted specimen at 48.51 Joule.

During conveyor belt operation, damage can occur. Due to the heterogeneity of the structural composite belt, four major damage mechanisms were identified and can be seen in Figure 2: (1) matrix cracking (at a microscopic scale), (2) delamination (at a meso-scale), (3) breaking and buckling of fibers (at a microscale) and finally (4) fiber-matrix interfacial decohesion (at a microscale). This damage presented the critical case when the damage occurred at the half of the conveyor belt thickness. The reparation of such a rubber reinforced composite will be described in the next section.

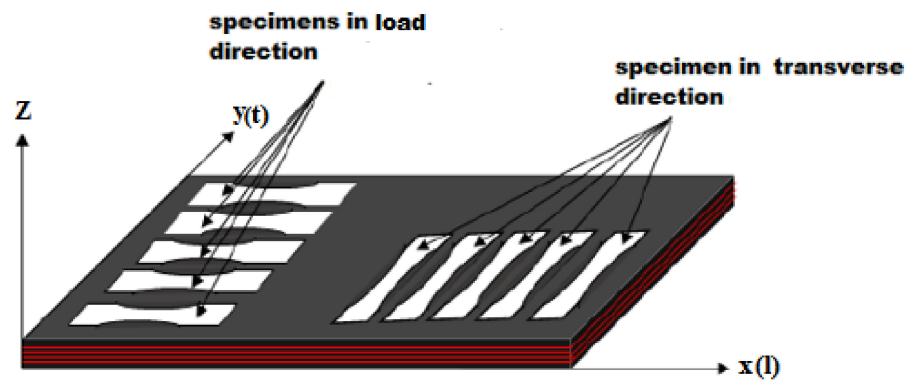
Figure 3. Belt view of the tensile specimen distribution with respect to longitudinal and transverse directions.

Two series of five repaired specimens were prepared in a load and a transverse direction, as shown in Figure 3. The dimensions of all specimens are shown in Figure 4.

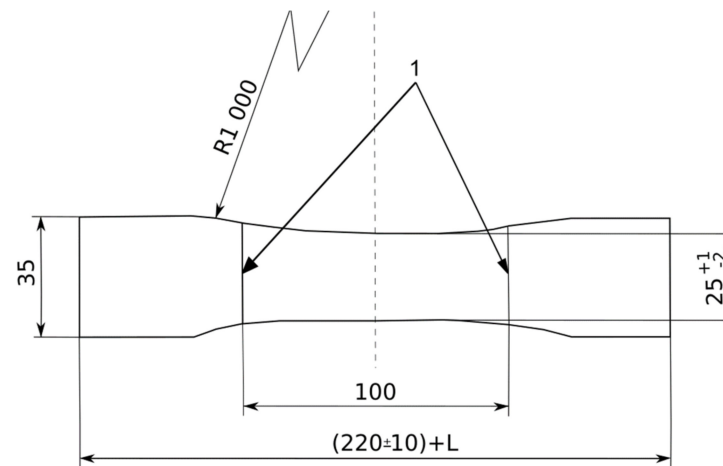
Figure 4. Standardized belt specimen for the uniaxial tensile test according to ISO 283.

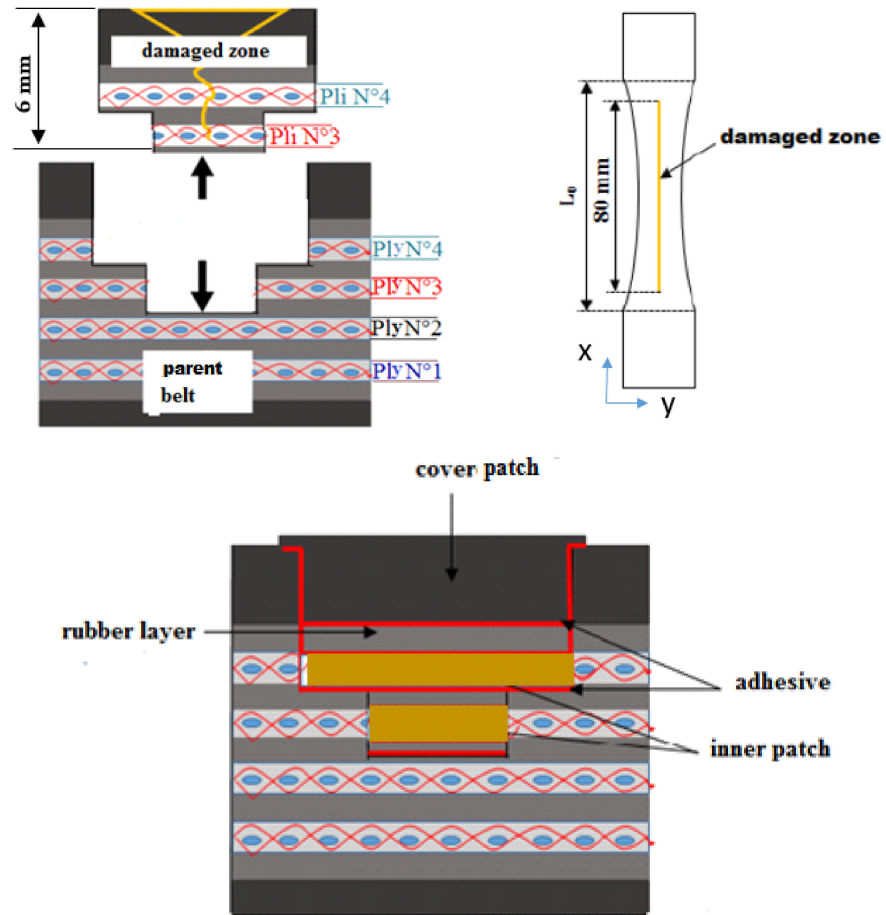
Figure 5. Diagram of the bonded belt patch repair technology specimen.

The represented diagram of the bonded patch repair technology of the specimens is shown in Figure 5. The 80 mm length across 6 mm thickness in the parent specimen was to simulate the damage zone that had been cleaned up. The damage had to be removed. While roughness plays an important role in adhesion phenomena, the surface topography of the peeling and milling damage removing processes was measured by surface scan means, as shown in Figure 6.

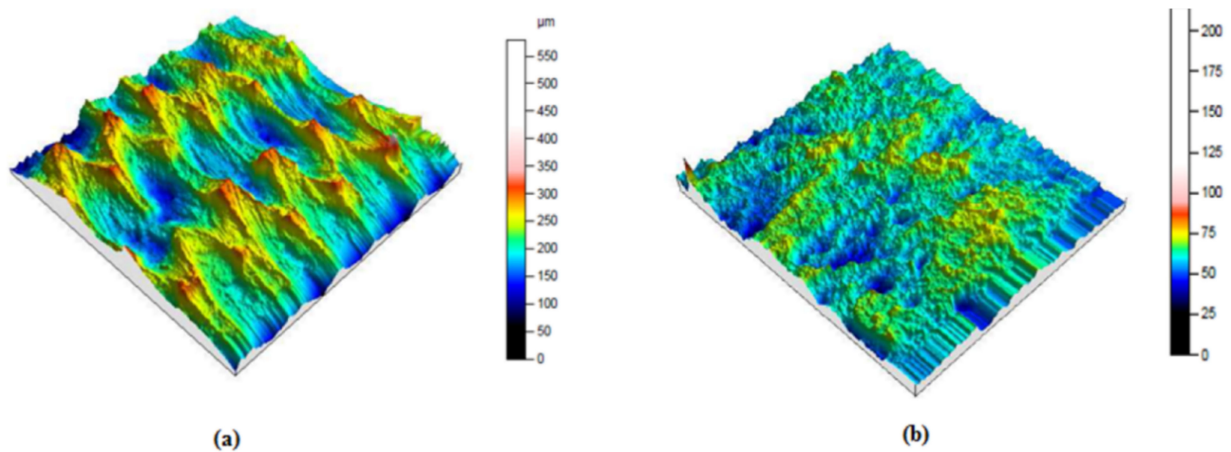
Figure 6. Topography of the processed strip sample on 36 mm<sup>2</sup> with a path of 20 mm. (a) by a peeling process, Ra = 13.8 mm (b) by a milling process, Ra = 7.76 mm.

The peeling was compared with the milling techniques in terms of surface roughness, surficial fiber damage, process rapidity and quantity of dust generated. With respect to the roughness results obtained (Figure 6) and with the above-described parameters, the upper rectangular covered patch was cut from the belt material using the peel technique (Figure 7a). The inner patch was prepared from textile ply made with the same plies as the carcass fabric of the belt (Figure 7b). Two sequences of inner patches  $[0]_2$  and  $[90]_2$  were prepared to repair the specimens in the longitudinal and the transverse directions, respectively, as shown in Figure 7b.

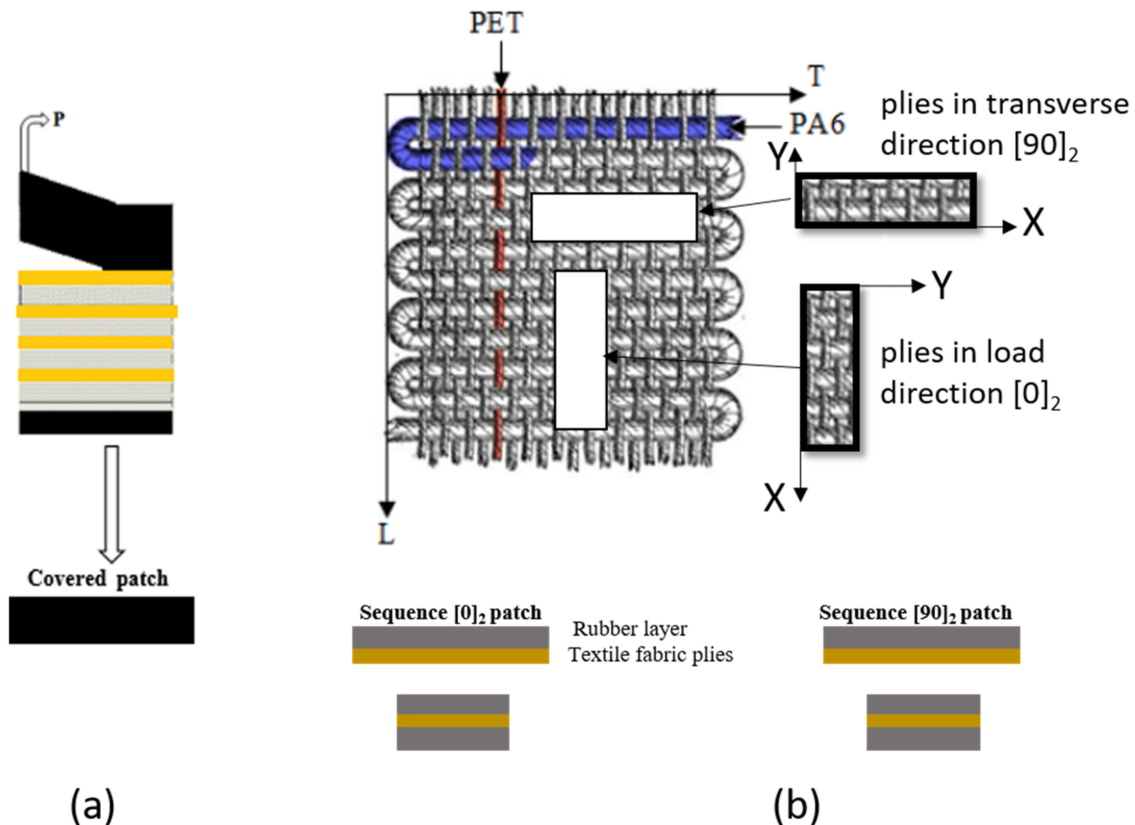
Figure 7. Preparation of the inner and covered patch: (a) peel technique; (b) cutting fiber textile ply.

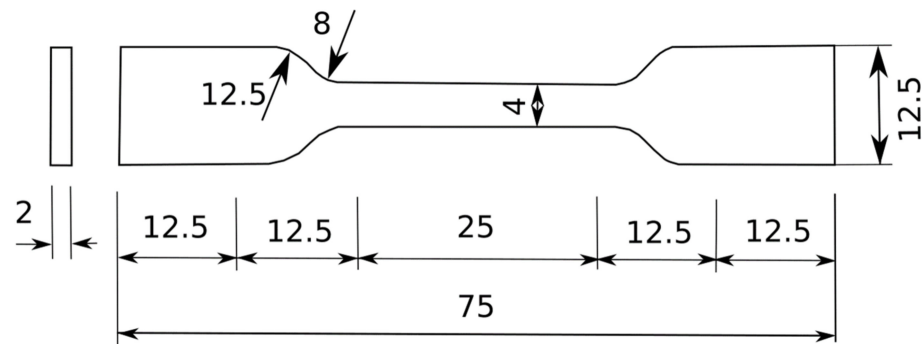
**Figure 8.** Standardized adhesive specimen for the uniaxial tensile test according to ISO37: 2011.

To be able to characterize the ELASTOGLUE 2000, the adhesive tensile specimens were cut from a molded plate of  $250 \times 250 \text{ mm}^2$ , which was molded using a two-mold set-up covered with a Teflon coating. The adhesive was prepared and thoroughly mixed in the portion mentioned before (1 kg/60 g), then placed in the mold using a spatula. Finally, the mold was closed and then inserted into a climatic chamber to stabilize the temperature (23 °C) and humidity (40%) environment. After three days, the plaque was polymerized. Three adhesive specimens were cut following the dimensions presented in Figure 8.

Furthermore, a tensile test was conducted for the ELASTOGLUE 2000 adhesive specimens with normalized dimensions [10] as described in Figure 8 with a loading speed of 2 mm/min.

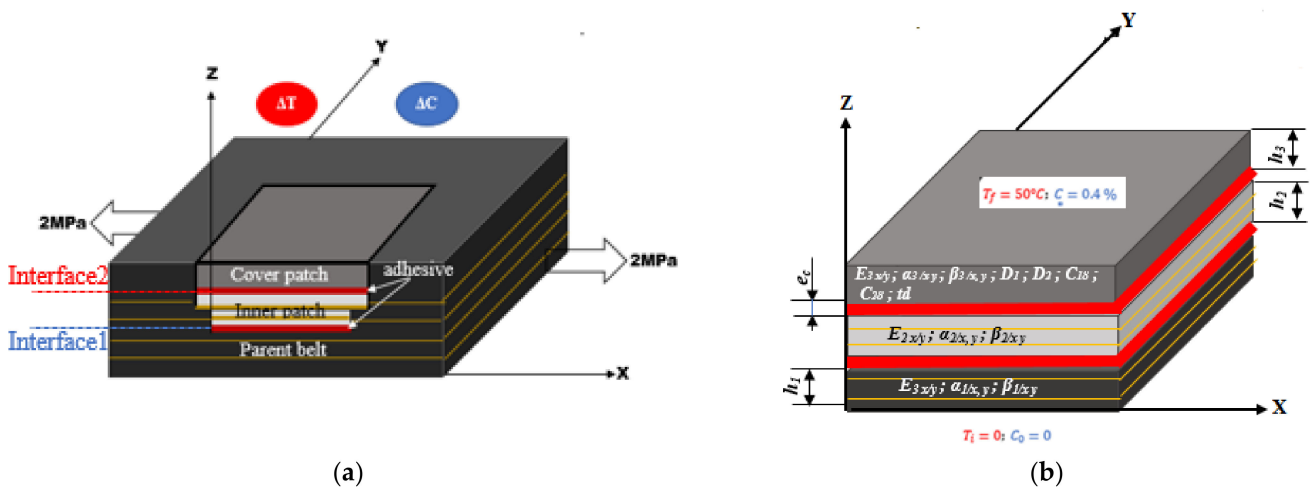
Figure 9. Schematic representation of the belt repaired composite structure under mechanical tension in the presence of the temperature gradient  $\Delta T$  and the humidity concentration  $\Delta C$ : (a) transverse section with two interfaces; (b) geometric parameters and material properties needed for the 2D model.

The bonded patch repair of the conveyor belt was composed of the parent belt, an inner patch and a covered patch, as shown in Figure 9. The bidirectional model detailed in [11] was used in order to determine the stress distribution in the patches and the parent belt. A previous study had shown that this model was well suited to the analysis of composite materials [11]. The belt had an elastic-visco-plastic behavior but only the elastic domain was considered in this analysis. The adhesive had a hyper-elastic behavior and it was modeled by the Ogden model ( $N = 3$ ) as demonstrated in Figure 10. More details

The effect of moisture diffusion was modelled by means of the moisture concentration induced in the covered patch as described in Figure 9. As demonstrated in the last study [12], the effect of moisture diffusion of this material was achieved by using a sequential dual Fickian (SDF) model. The moisture concentration was determined at any time  $t$  at each spatial coordinate  $Z$  by Equation (1):

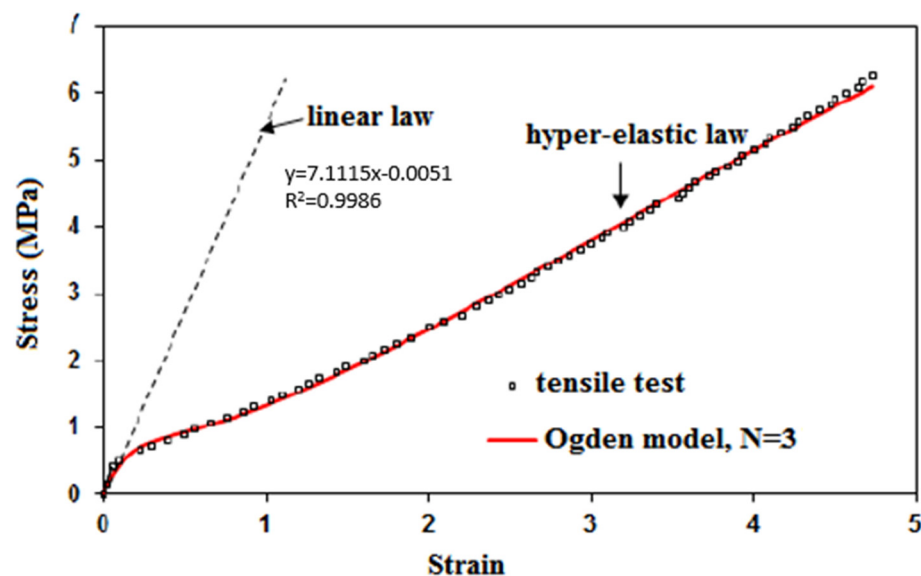
Figure 10. Tensile behavior of cold polymerized adhesive ELASTOGLUE 2000.

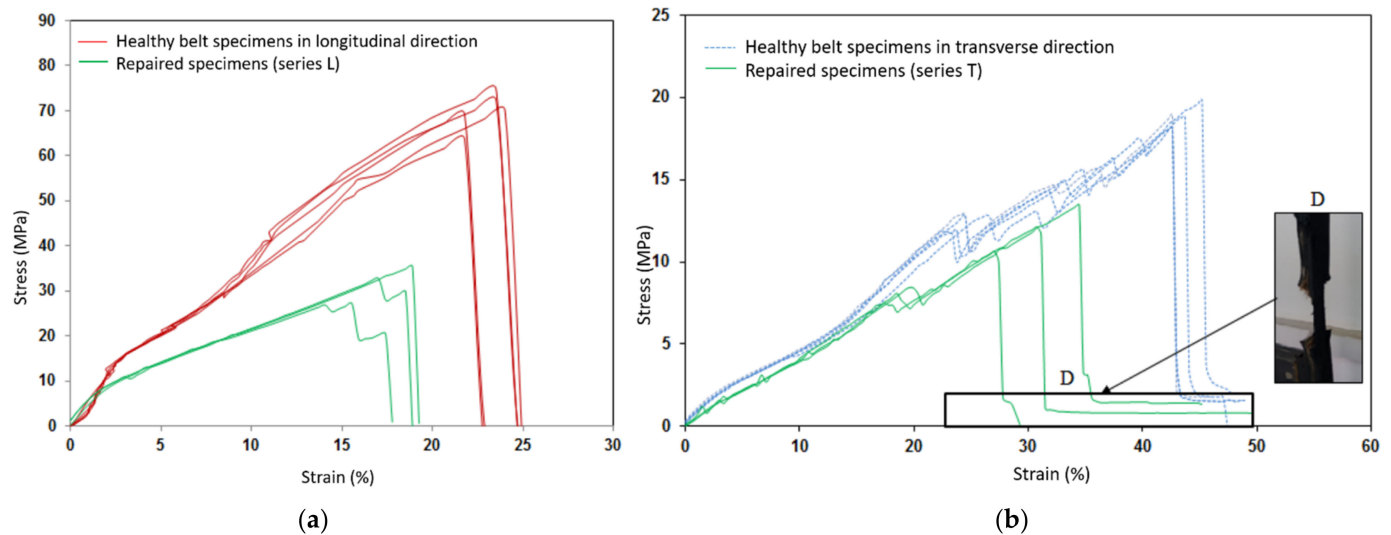
Figure 11. Comparison of the tensile behavior of the healthy and repaired specimens by the cold polymerization process: (a) in a longitudinal direction (b) in a transverse direction.

Experimental tests of the healthy belt and the bonded repaired specimens were carried out with two sequences of the inner patch. Figure 11 shows the stress-strain curves for the transverse and longitudinal repaired specimens using a polymerization bonding process compared with healthy belt specimens. Series (L) were designed to use  $[0]_2$  inner patches. For series (T), patches  $[90]_2$  were used to repair the specimen in the transverse direction. The fiber orientation of the patch was the same as those specimens' directions. The results are resumed in Table 6 where  $E^{rep}$  and  $R^{rep}$  referred to the Young's modulus and failure resistance of the repaired specimen.  $E^{ref}$  and  $R^{ref}$  were the Young's modulus and the failure resistance of the healthy specimen. The following statements of experimental research were:

- The stress-strain curves obtained on the two sets of repaired specimens by the polymerization process presented the same behavior as those on the healthy specimens. However, a loss of tensile strength in the repaired structure was estimated at 57% for series (L) and at 39% for series (T) as listed in Table 6.

- An attenuation of the director coefficient in the elastic domain was observed. Consequently, the reduction of the Young's modulus of the repaired structure was estimated at 20% for series (L) and at 13% for series (T).

- On the curves, an important decrease of the director coefficient in the elastic and plastic domains was observed for series (L) of the repaired specimens because of the concentration of high stresses located in the joint's interfaces, which favored the important damage in the repaired specimens and led to premature failure.

- Series (T) repairs using the  $[90]_2$  stacking sequence have the best performance in terms of resistance, which was up to 68.73% (Table 6) while repairs of series (L) by means of the most rigid patch  $[0]_2$  seemed the least effective. It was then observed that the performance of the repairs by the polymerization process decreased when the rigidity of the plies and test specimen increased. The repair was not perfect if the inner patch was too soft or too rigid. Therefore, optimization of the inner patch was necessary to achieve the best repair performance.

- For series (T), the cover patch was still attached to the parent belt as shown in Figure 11 even if the fibers were broken and completely separated from the parent belt. This implied that the cover patch in the parent belt, which was adjacent to the top adhesive layer, was particularly not damaged and the hyper-elastic behavior led to the absorption of the transfer shear stress. The observation of the covered patch in domain D

proved that the orientation of the specimens relative to the stacking sequence and the rigidity of the inner patch had a significant effect on the rupture mechanism and the mode of repaired specimen damage.

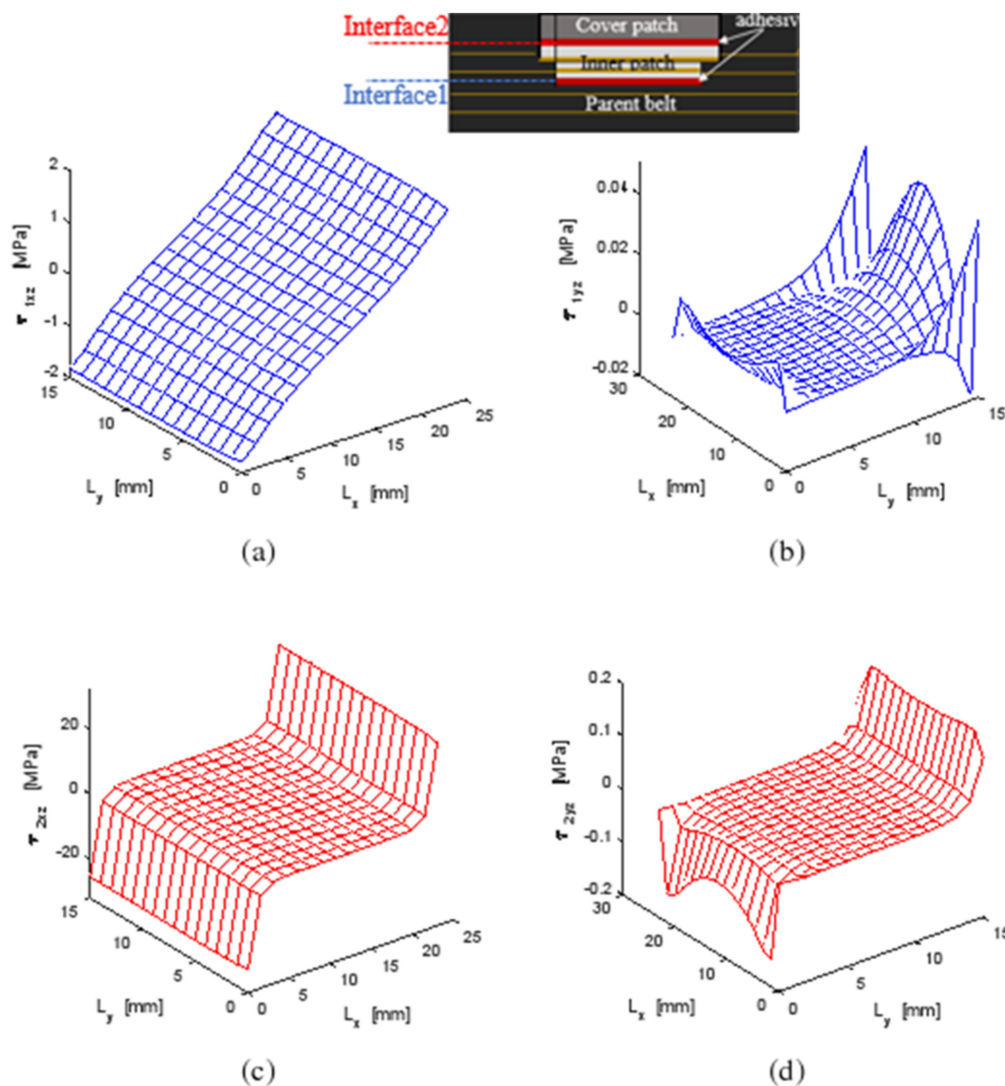
**Figure 12.** Shear stress distribution under a hygro-thermomechanical load on XZ and YZ planes in (a,b) Interface (1); (c,d) Interface (2).

Making the repaired structure more durable under external loading was the objective of this study. In fact, joints are the most critical elements in a bonded structure; they assume the load transfer mechanism between the adhesive and the adherents. Figure 12 shows the shear stress distribution in both interfaces of the repaired belt structure.  $\tau_{ixz}$  and  $\tau_{iyz}$  referred to the shear stress in the XZ and YZ planes of the interface (1)  $i = 1$  between the parent belt and the inner patch and for the interface (2) between the inner patch and the covered patch,  $i = 2$ . It was found that the maximum shear stress was always in the interface (2). This was due to the residual stresses generated in the covered patch as a result of the moisture diffusion. The covered patch was the most sensitive component to water expansion so the strain fields accumulated at the interface between the covered patch and the inner patches. The shear stresses in the XZ plane were the most important; this was the direction of the mechanical load. The most stressed zone in both joints was located near the end edges.

A repair will be efficient and effective when each component is chosen so that the distribution of normal and shear stresses is evenly spread and the maximum value in the repair system defined as normalized normal  $\sigma^*$  and normalized shear  $\tau^*$  repair is at minimal. In Figure 13, the stress concentrations were situated at the edges of the repaired specimen, which was in accordance with Gong et al. [13]. When the composite and the repairing patch was assembled by bonding onto the specimen, the stresses were redistributed between the patch and the parent composite so a new zone of stress concentration might be located. According to the location of stress concentration, the critical zones in a patch repaired system may occur in six possible locations, as indicated in Figures 12 and 13:

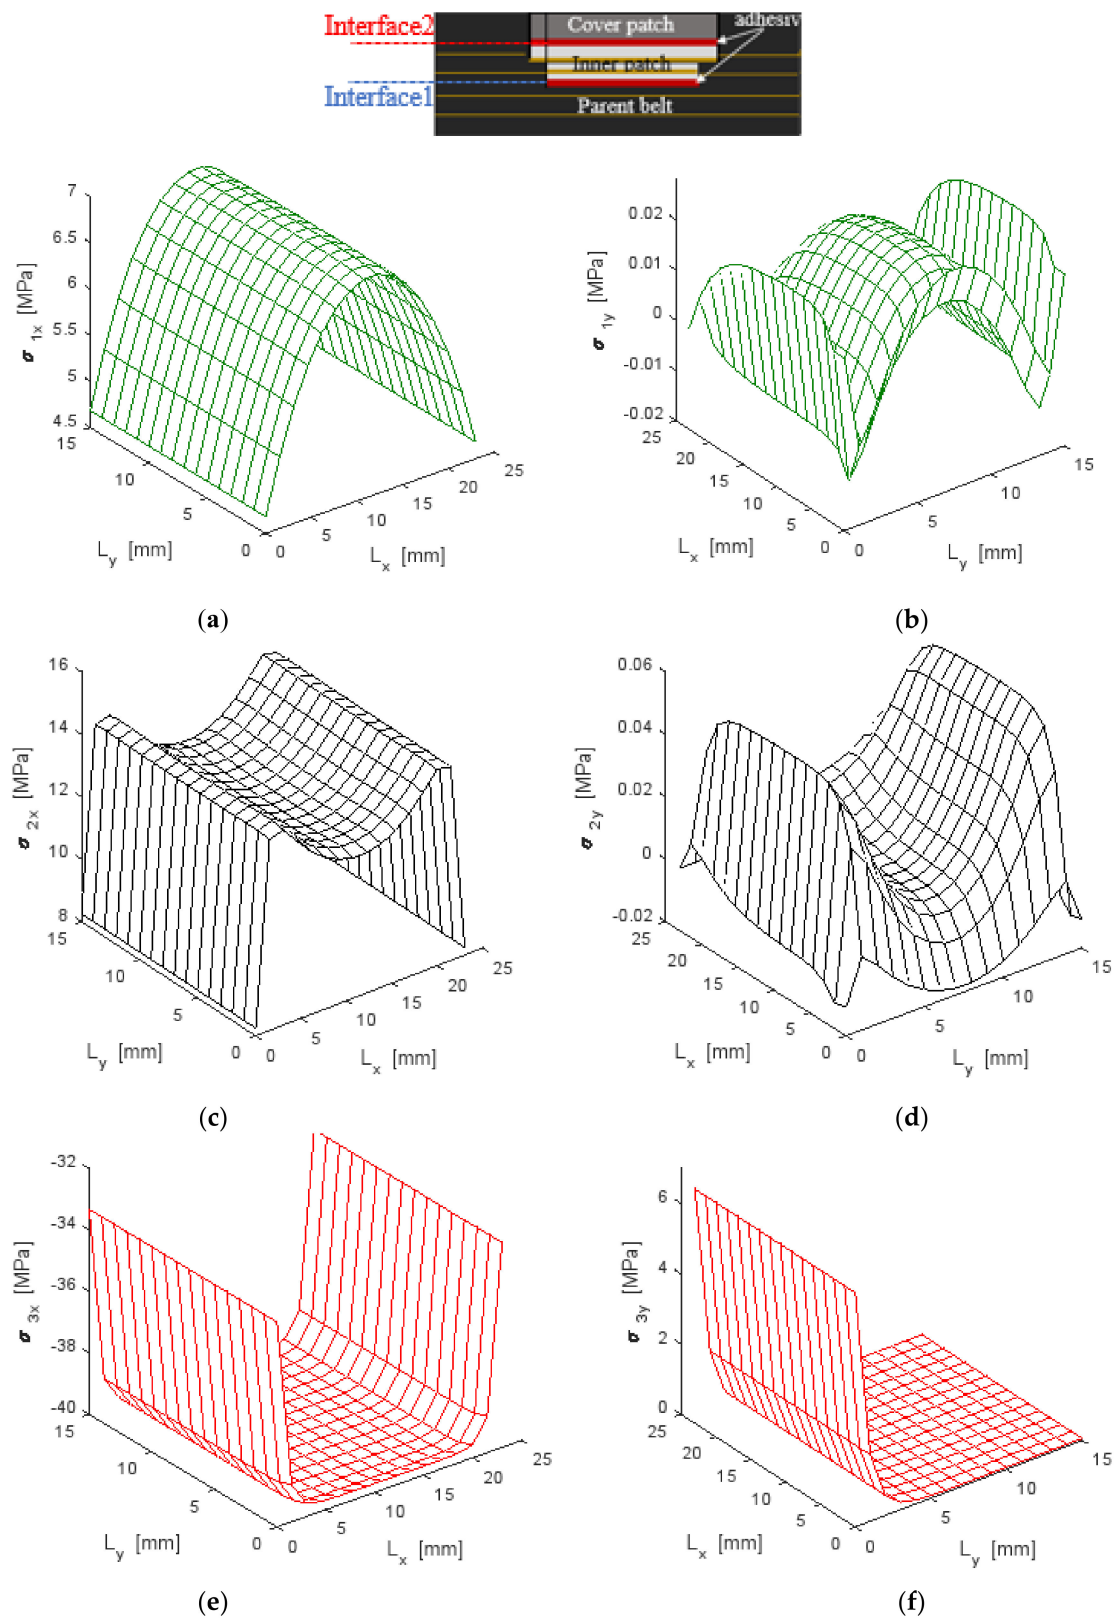
**Figure 13.** Normal stress distribution under a hydro-thermomechanical load (2 MPa, 50 °C and 40% RH) in longitudinal and transverse directions in (a,b) a parent belt; (c,d) an inner patch; (e,f) a cover patch.

Figure 13 shows the normal distribution generated on the parent belt, inner patch and covered patch under hygro-thermomechanical loads. It was found that the inner patch absorbed approximately twice the maximum stresses generated in the parent belt so that the contribution of the composite patch therefore played an important role in the equilibrium mechanism of the stress distribution in the repaired structure. A tension distribution was defined in both the parent belt and the inner patch while compressive distribution was seen in the covered patch, which was due to the residual stress generated from the coupled effect on the covered patch subjected to moisture diffusion and a thermal field. According to the experiment results, normal stress in the covered patch was equal to zero near the width end so that the cover patch was still attached to the parent belt, as seen in zone D of Figure 11.

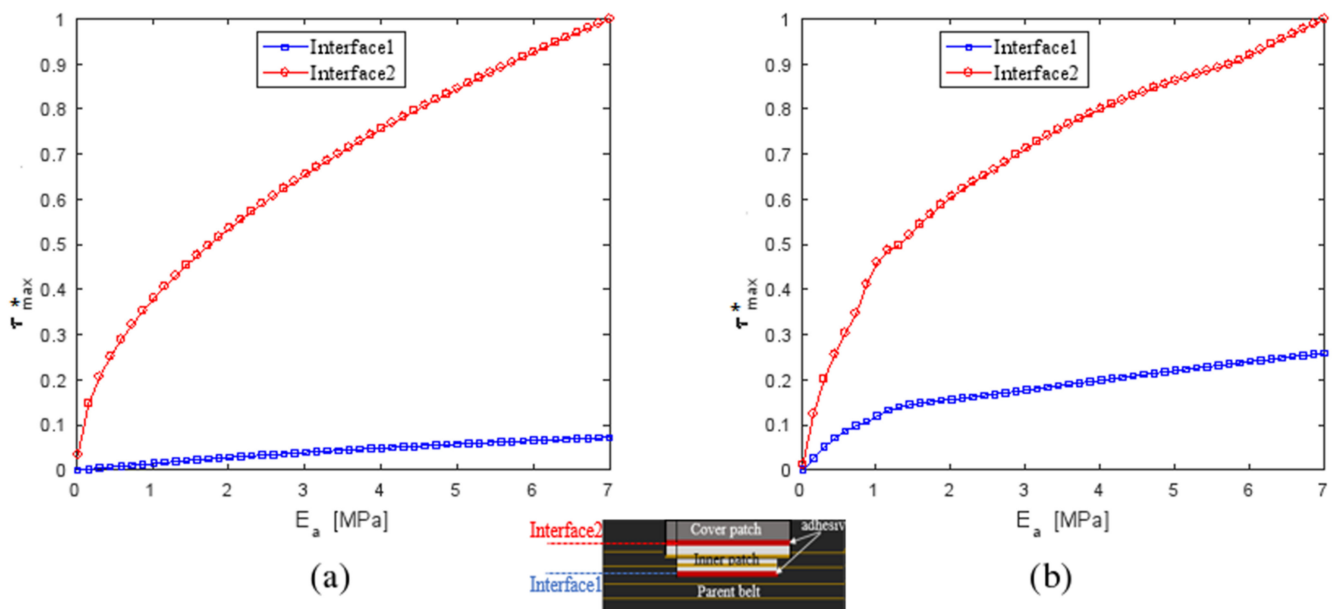
**Figure 14.** Variation of the maximal normalized shear stress ratio  $\tau_{max}^*$  in Interface (1) and Interface (2) as a function of the adhesive Young's modulus  $E_a$  in: (a) XZ plane; (b) YZ plane.

The effect of Young's modulus of the adhesive,  $E_a$ , on the performance of a patched repair was studied by varying  $E_a$  from 0.05 to 7 MPa while the thickness of the patches, the parent belt and of the adhesive joint was constant. The results are plotted in Figures 14 and 15.  $\tau_{max}^*$  is the normalized shear stresses obtained by the square between the shear stresses and the maximum shear stress obtained in the joint adjacent to the cover patch for a reparation with composite patches at  $0^\circ$ . As shown, the maximum shear in the XZ and YZ plane depended on the adhesive Young's modulus. Increasing the  $E_a$  value resulted in an important increase in  $\tau_{max}^*$  of the second interface. The maximum normal stress  $\sigma_{max}^*$  in the patches and the parent belt was still invariant with the variation of the adhesive Young's modulus.

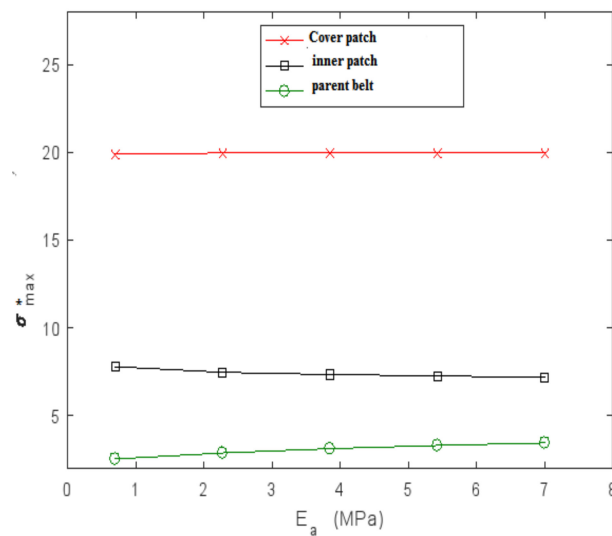
**Figure 15.** Variation of the maximal normalized normal stress ratio  $\sigma_{max}^*$  in adherents as a function of adhesive Young’s modulus  $E_a$ .

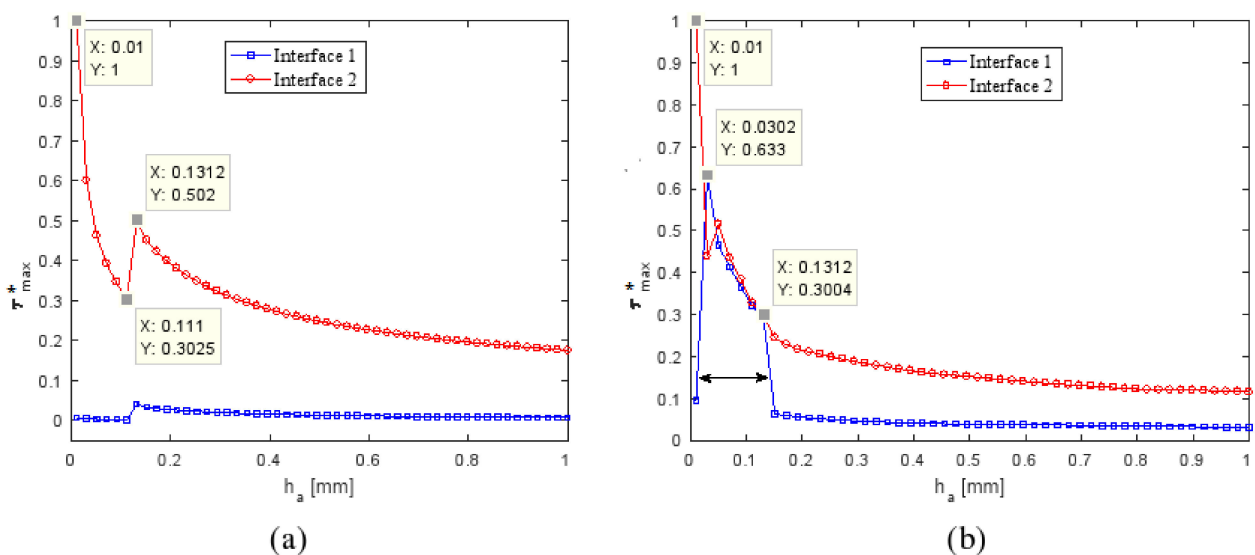
**Figure 16.** Variation of the maximal normalized shear stress ratio  $\tau_{max}^*$  in interface (1) and interface (2) as a function of adhesive thickness  $h_a$  in: (a) XZ plane; (b) YZ plane.

The effect of adhesive thickness was studied by keeping a constant adhesive modulus ( $E_a = 7$  MPa) and constant patch and parent belt thicknesses. In practice, the variation of the adhesive thickness was confined to a range between 0.01 and 1 mm. As shown in Figures 16 and 17, both  $\tau_{max}^*$  and  $\sigma_{max}^*$  of the inner patch and the parent belt depended on the adhesive thickness; keeping  $h_a$  between 0.01 and 1 mm led to an increase of the  $\tau_{max}^*$  in both interfaces. In the range 0.03–0.13 of varying  $h_a$ , both interfaces in the YZ plane had the same  $\tau_{max}^*$ . It could be deduced that the intersection of these two curves would give the optimum system performance. The values of  $h_a$  at the points shown in Figure 16 corresponding with the value of  $\sigma_{max}^*$  in interface (1) and equal to  $\sigma_{max}^*$  in interface (2) were defined as the optimal adhesive thickness for the repaired system.

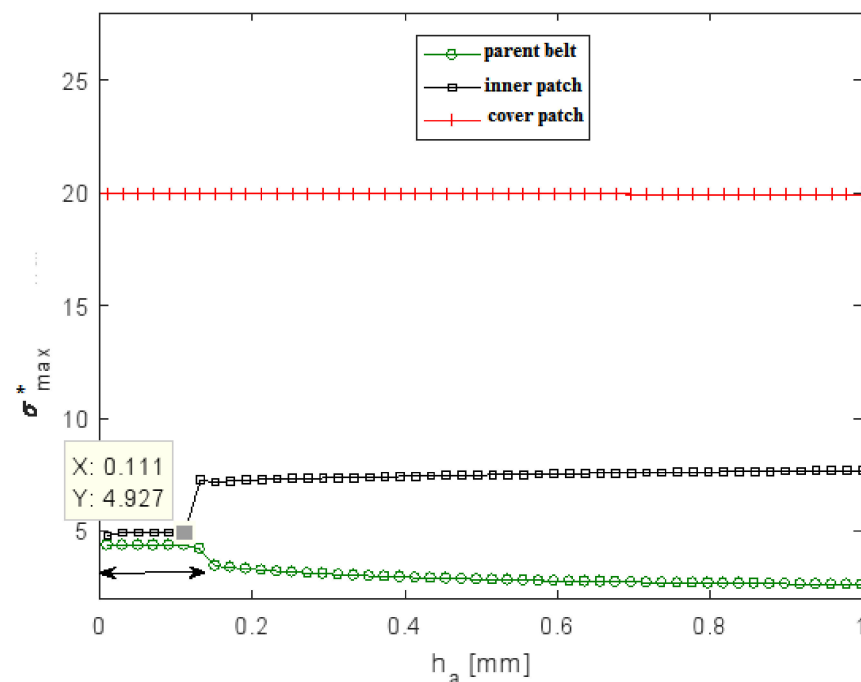
**Figure 17.** Variation of the maximal normalized normal stress ratio  $\sigma_{max}^*$  in adherents as a function of thickness  $h_a$ .

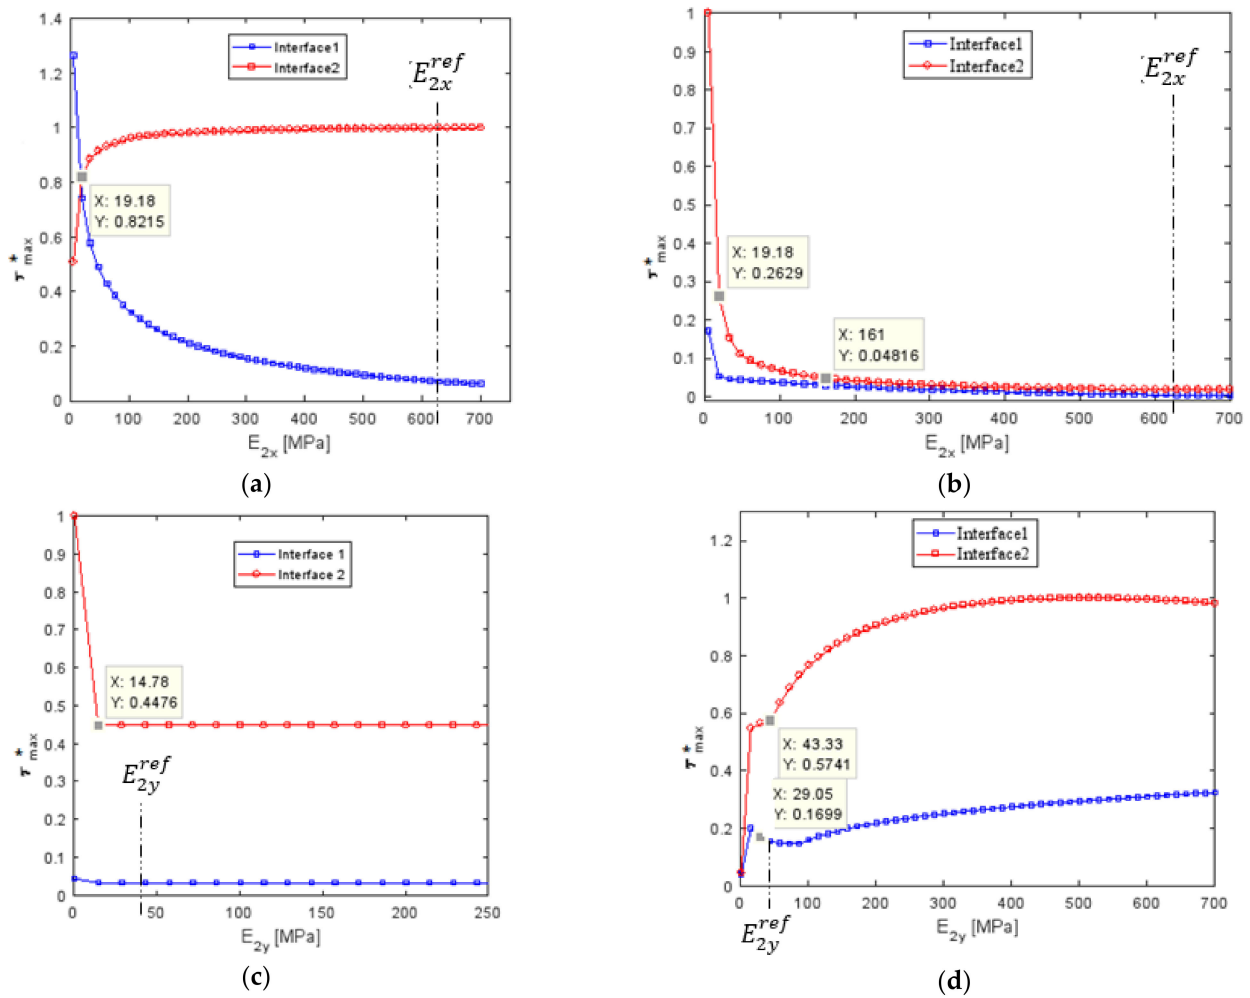
Figure 18. Variation of the maximal normalized shear stress in XZ-YZ plane as a function of: (a,b) longitudinal Young's modulus; (c,d) transverse Young's modulus.

To better understand the role of the inner patch made with two textile plies and three rubber layers on the behavior of the repair belt system, the sensitivity of the rigidity of composite patch was investigated. Within one repair, the fiber orientation was uniform plies. However, the orientations of each layer in the repair could change independently of the other repair layers. In this section, the influence of the rigidity of the polyester (PET) fibers was studied by keeping a constant composite patch and parent belt Young's modulus. The influence of the rigidity of polyamide (PA6) fibers was studied by keeping a constant composite patch modulus in a longitudinal direction ( $E_{2x}^{ref} = 626$  MPa) and a constant cover patch and a parent belt Young's modulus. At first, the decrease of the Young's modulus in a longitudinal direction led to a slight decrease in the maximum shear stress of interface (2) but an increase in the shear stress in interface (1), as shown in Figure 18a. The intersection of these two curves in the intersection point value of  $E_{2x} = 19$  MPa should give the optimum shear stress distribution. The distribution of the maximum normal stress in the parent belt and the inner patch had a significant influence with the variation of the Young's modulus in a longitudinal direction, as shown in Figure 19a. The optimum normal stress distribution was obtained with the decrease of (1/5) of the reference longitudinal Young's modulus. As a result, the reducing of fiber rigidity in the load direction gave the optimum system performance but the fiber rigidity in a transverse direction did not have a significant influence on the performance of the repaired system. For the conveyer belt, it was better to use the stacking sequence  $[90]_2$  for the reparation of the specimen.
