# Theoretical and Experimental Investigation of Bonded Patch Repairs of a Rubber Reinforced Composite Conveyor Belt

**Abstract:** The present study proposes a reparation method for designing and optimizing a rubber to rubber and rubber to textile reinforcement. The present application is the conveyor belt used in the transport industry. The tensile behavior of the repaired specimens was studied using experimental results. A bidirectional linear analysis allows us to predict the effect of geometric parameters on the stress concentration zone of the repaired belt under hygro-thermo mechanical loading and its consequence on the integrity of the structure. A tensile test was carried out in order to investigate the behavior of a repaired specimen made with a rubber cover patch and an inner composite patch. Two stacking sequences of an inner composite patch and the material properties are considered in the parametric study in order to reduce the stress concentration in the parent belt. The correlation between the theoretical and experimental results allows us to define a strength tool to understand the load transfer from rubber to a textile rubber patch.

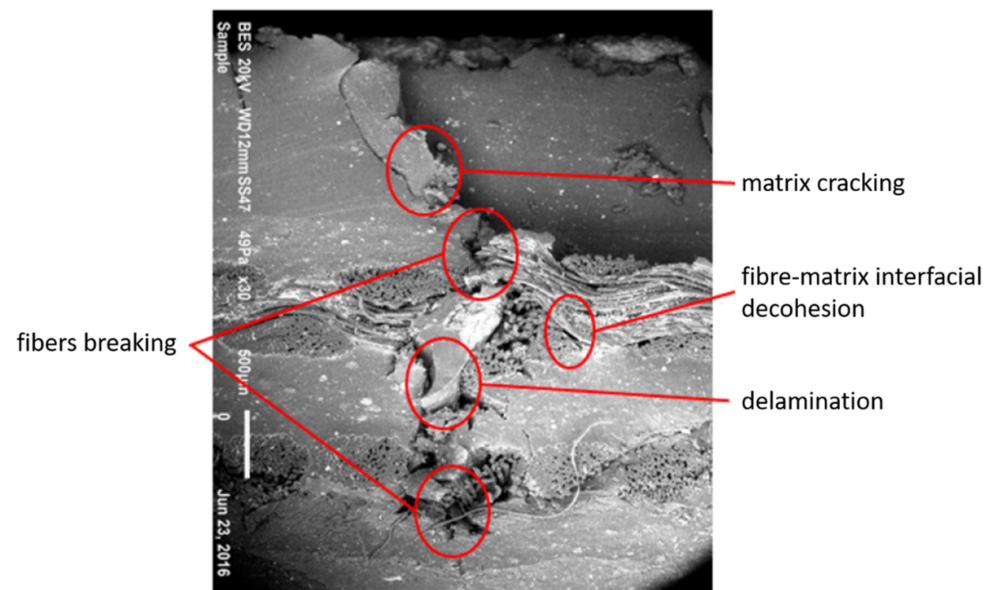
**Figure 2.** Micrograph of the cross-sectional area of the impacted specimen at 48.51 Joule.

During conveyor belt operation, damage can occur. Due to the heterogeneity of the structural composite belt, four major damage mechanisms were identified and can be seen in Figure 2: (1) matrix cracking (at a microscopic scale), (2) delamination (at a meso-scale), (3) breaking and buckling of fibers (at a microscale) and finally (4) fiber-matrix interfacial decohesion (at a microscale). This damage presented the critical case when the damage occurred at the half of the conveyor belt thickness. The reparation of such a rubber reinforced composite will be described in the next section.

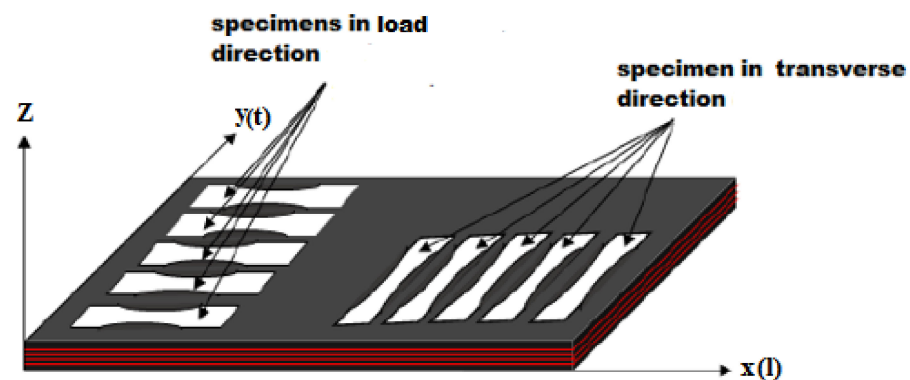
**Figure 3.** Belt view of the tensile specimen distribution with respect to longitudinal and transverse directions.

Two series of five repaired specimens were prepared in a load and a transverse direction, as shown in Figure 3. The dimensions of all specimens are shown in Figure 4.

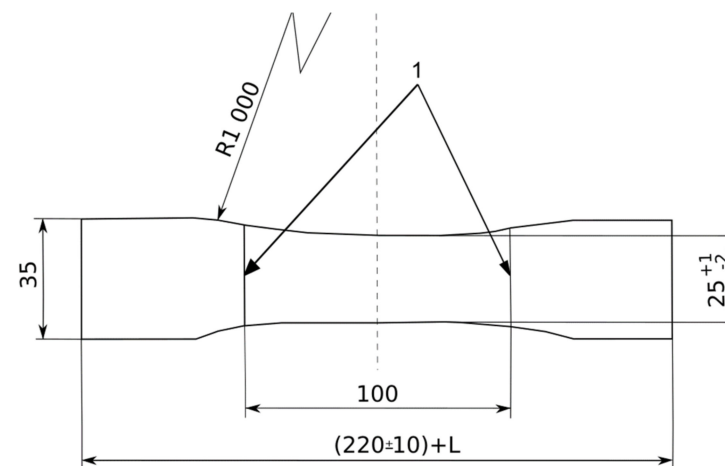
**Figure 4.** Standardized belt specimen for the uniaxial tensile test according to ISO 283.

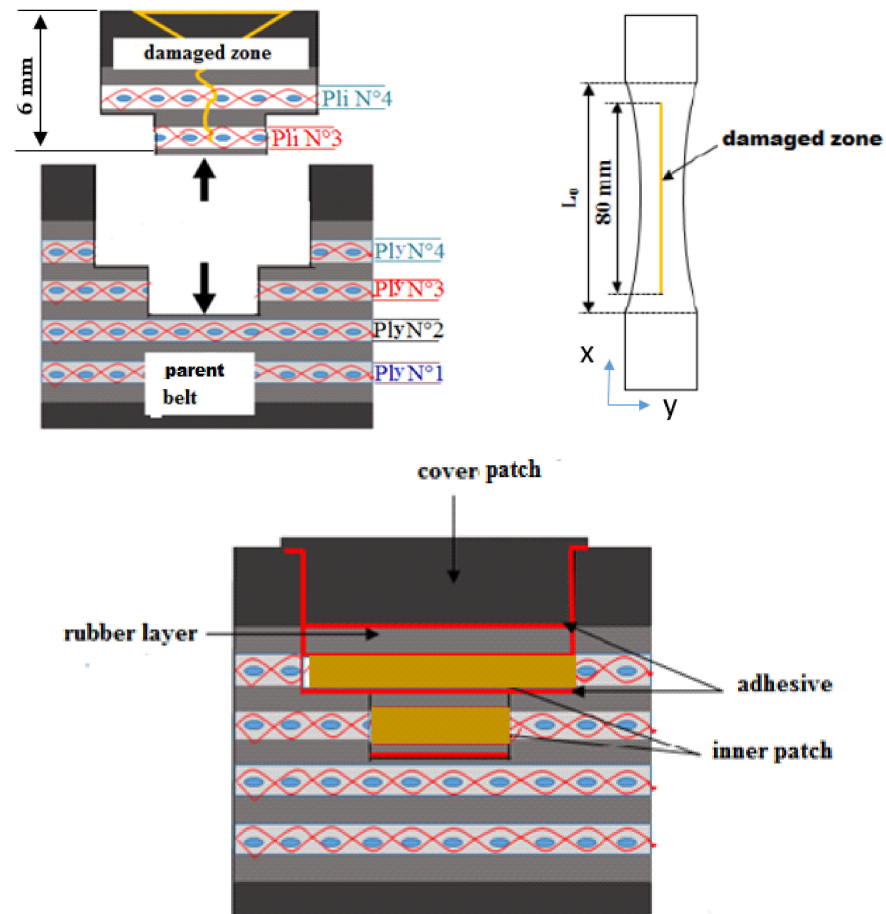
Figure 5. Diagram of the bonded belt patch repair technology specimen.

The represented diagram of the bonded patch repair technology of the specimens is shown in Figure 5. The 80 mm length across 6 mm thickness in the parent specimen was to simulate the damage zone that had been cleaned up. The damage had to be removed. While roughness plays an important role in adhesion phenomena, the surface topography of the peeling and milling damage removing processes was measured by surface scan means, as shown in Figure 6.

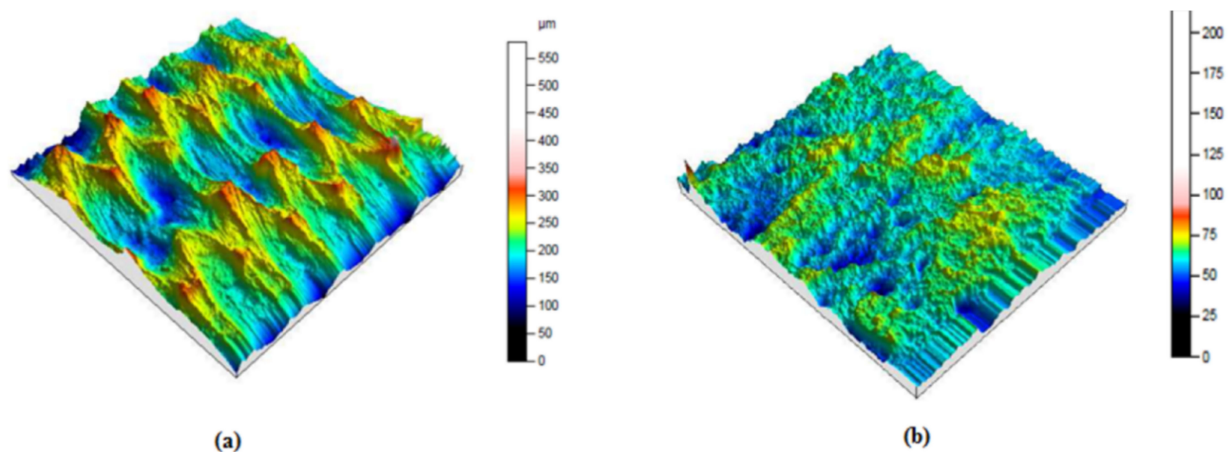
Figure 6. Topography of the processed strip sample on 36 mm<sup>2</sup> with a path of 20 mm. (a) by a peeling process,  $R_a = 13.8$  mm (b) by a milling process,  $R_a = 7.76$  mm.

The peeling was compared with the milling techniques in terms of surface roughness, surficial fiber damage, process rapidity and quantity of dust generated. With respect to the roughness results obtained (Figure 6) and with the above-described parameters, the upper rectangular covered patch was cut from the belt material using the peel technique (Figure 7a). The inner patch was prepared from textile ply made with the same plies as the carcass fabric of the belt (Figure 7b). Two sequences of inner patches  $[0]_2$  and  $[90]_2$  were prepared to repair the specimens in the longitudinal and the transverse directions, respectively, as shown in Figure 7b.

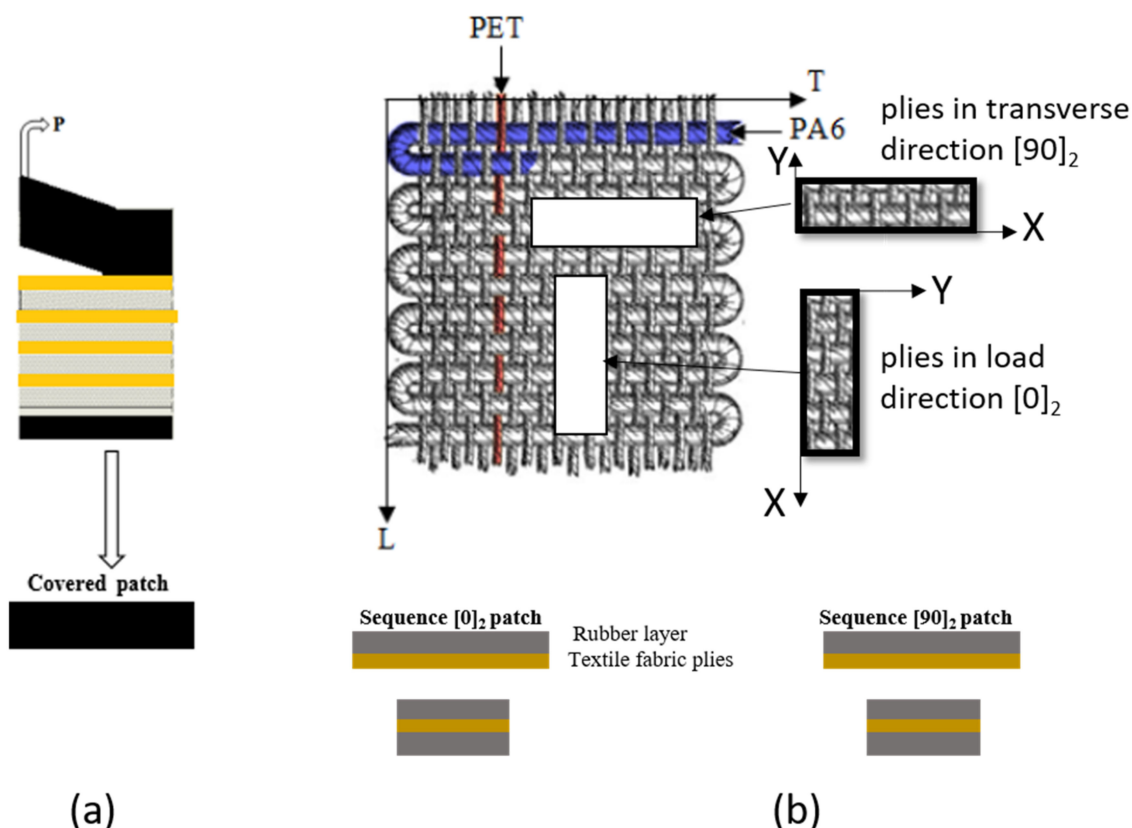
Figure 7. Preparation of the inner and covered patch: (a) peel technique; (b) cutting fiber textile ply.

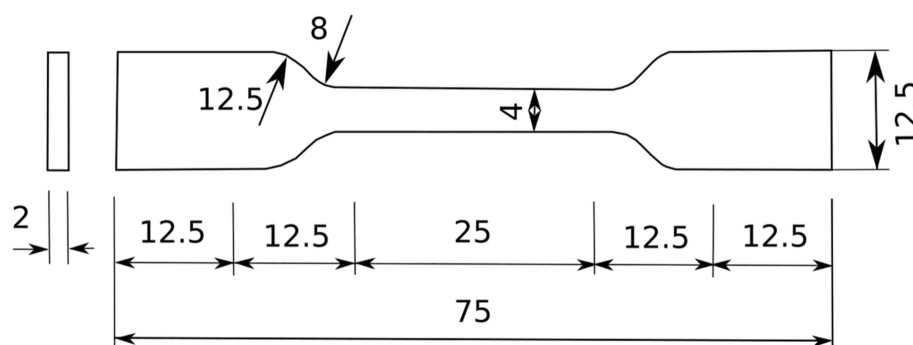
**Figure 8.** Standardized adhesive specimen for the uniaxial tensile test according to ISO37: 2011.

To be able to characterize the ELASTOGLUE 2000, the adhesive tensile specimens were cut from a molded plate of  $250 \times 250 \text{ mm}^2$ , which was molded using a two-mold set-up covered with a Teflon coating. The adhesive was prepared and thoroughly mixed in the portion mentioned before (1 kg/60 g), then placed in the mold using a spatula. Finally, the mold was closed and then inserted into a climatic chamber to stabilize the temperature (23 °C) and humidity (40%) environment. After three days, the plaque was polymerized. Three adhesive specimens were cut following the dimensions presented in Figure 8.

Furthermore, a tensile test was conducted for the ELASTOGLUE 2000 adhesive specimens with normalized dimensions [10] as described in Figure 8 with a loading speed of 2 mm/min.

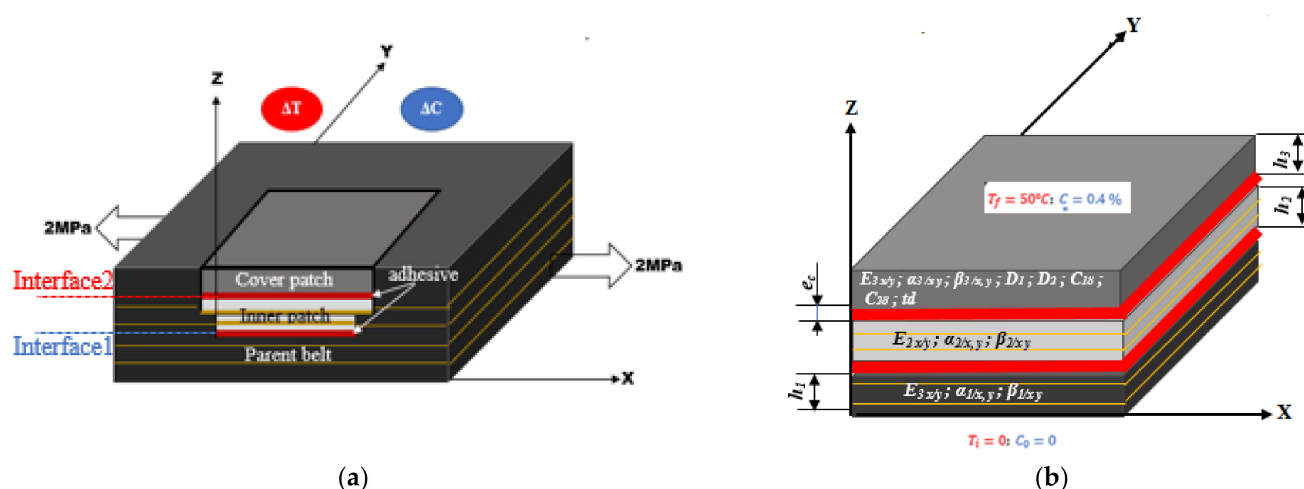
**Figure 9.** Schematic representation of the belt repaired composite structure under mechanical tension in the presence of the temperature gradient  $\Delta T$  and the humidity concentration  $\Delta C$ : (a) transverse section with two interfaces; (b) geometric parameters and material properties needed for the 2D model.

The bonded patch repair of the conveyor belt was composed of the parent belt, an inner patch and a covered patch, as shown in Figure 9. The bidirectional model detailed in [11] was used in order to determine the stress distribution in the patches and the parent belt. A previous study had shown that this model was well suited to the analysis of composite materials [11]. The belt had an elastic-visco-plastic behavior but only the elastic domain was considered in this analysis. The adhesive had a hyper-elastic behavior and it was modeled by the Ogden model ( $N = 3$ ) as demonstrated in Figure 10. More details

The effect of moisture diffusion was modelled by means of the moisture concentration induced in the covered patch as described in Figure 9. As demonstrated in the last study [12], the effect of moisture diffusion of this material was achieved by using a sequential dual Fickian (SDF) model. The moisture concentration was determined at any time  $t$  at each spatial coordinate  $Z$  by Equation (1):

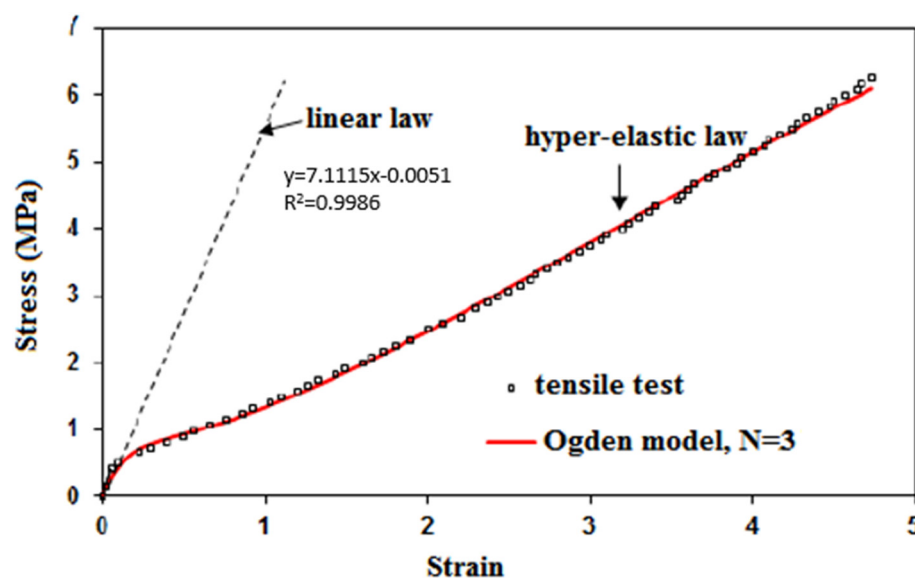
**Figure 10.** Tensile behavior of cold polymerized adhesive ELASTOGLUE 2000.

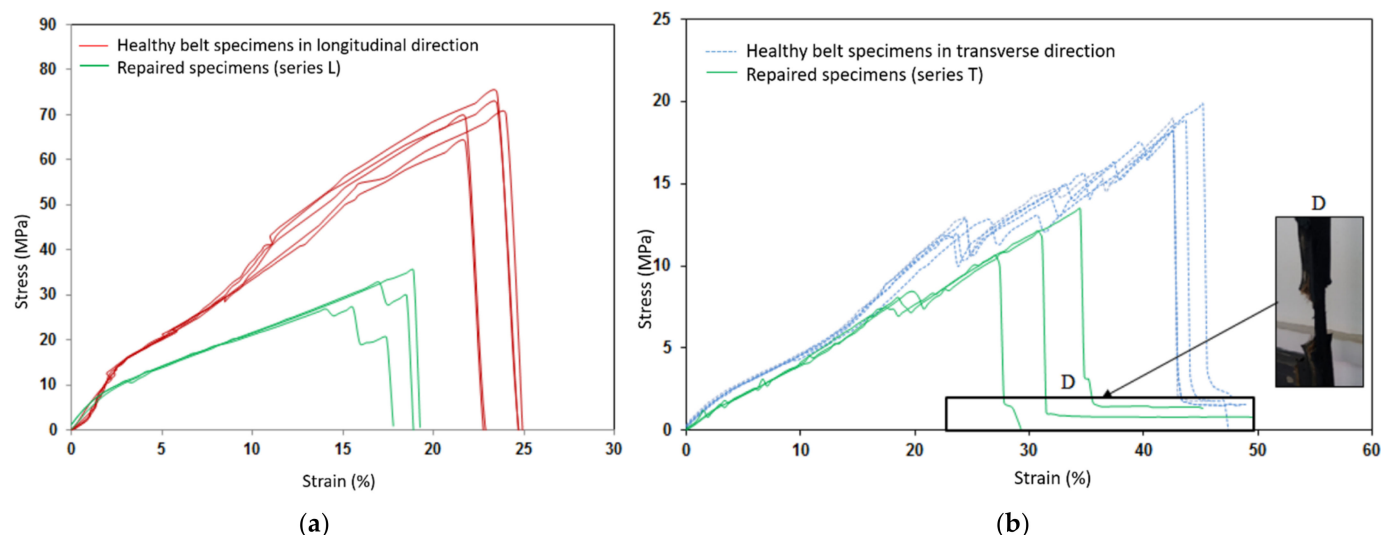
**Figure 11.** Comparison of the tensile behavior of the healthy and repaired specimens by the cold polymerization process: (a) in a longitudinal direction (b) in a transverse direction.

Experimental tests of the healthy belt and the bonded repaired specimens were carried out with two sequences of the inner patch. Figure 11 shows the stress-strain curves for the transverse and longitudinal repaired specimens using a polymerization bonding process compared with healthy belt specimens. Series (L) were designed to use  $[0]_2$  inner patches. For series (T), patches  $[90]_2$  were used to repair the specimen in the transverse direction. The fiber orientation of the patch was the same as those specimens' directions. The results are resumed in Table 6 where  $E^{rep}$  and  $R^{rep}$  referred to the Young's modulus and failure resistance of the repaired specimen.  $E^{ref}$  and  $R^{ref}$  were the Young's modulus and the failure resistance of the healthy specimen. The following statements of experimental research were:

- For series (T), the cover patch was still attached to the parent belt as shown in Figure 11 even if the fibers were broken and completely separated from the parent belt. This implied that the cover patch in the parent belt, which was adjacent to the top adhesive layer, was particularly not damaged and the hyper-elastic behavior led to the absorption of the transfer shear stress. The observation of the covered patch in domain D

Figure 13 shows the normal distribution generated on the parent belt, inner patch and covered patch under hygro-thermomechanical loads. It was found that the inner patch absorbed approximately twice the maximum stresses generated in the parent belt so that the contribution of the composite patch therefore played an important role in the equilibrium mechanism of the stress distribution in the repaired structure. A tension distribution was defined in both the parent belt and the inner patch while compressive distribution was seen in the covered patch, which was due to the residual stress generated from the coupled effect on the covered patch subjected to moisture diffusion and a thermal field. According to the experiment results, normal stress in the covered patch was equal to zero near the width end so that the cover patch was still attached to the parent belt, as seen in zone D of Figure 11.

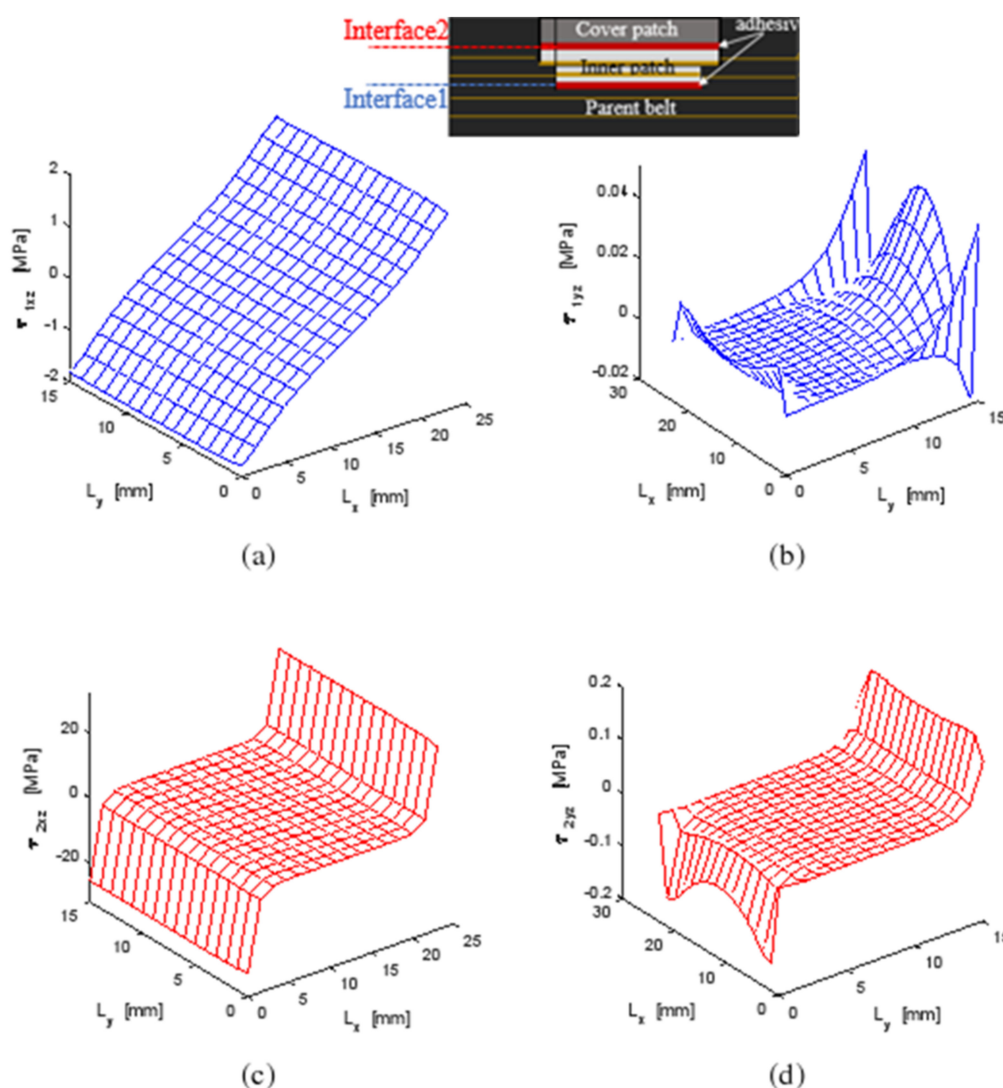
**Figure 12.** Shear stress distribution under a hygro-thermomechanical load on XZ and YZ planes in (a,b) Interface (1); (c,d) Interface (2).

Making the repaired structure more durable under external loading was the objective of this study. In fact, joints are the most critical elements in a bonded structure; they assume the load transfer mechanism between the adhesive and the adherents. Figure 12 shows the shear stress distribution in both interfaces of the repaired belt structure.  $\tau_{ixz}$  and  $\tau_{iyz}$  referred to the shear stress in the XZ and YZ planes of the interface (1)  $i = 1$  between the parent belt and the inner patch and for the interface (2) between the inner patch and the covered patch,  $i = 2$ . It was found that the maximum shear stress was always in the interface (2). This was due to the residual stresses generated in the covered patch as a result of the moisture diffusion. The covered patch was the most sensitive component to water expansion so the strain fields accumulated at the interface between the covered patch and the inner patches. The shear stresses in the XZ plane were the most important; this was the direction of the mechanical load. The most stressed zone in both joints was located near the end edges.

A repair will be efficient and effective when each component is chosen so that the distribution of normal and shear stresses is evenly spread and the maximum value in the repair system defined as normalized normal  $\sigma^*$  and normalized shear  $\tau^*$  repair is at minimal. In Figure 13, the stress concentrations were situated at the edges of the repaired specimen, which was in accordance with Gong et al. [13]. When the composite and the repairing patch was assembled by bonding onto the specimen, the stresses were redistributed between the patch and the parent composite so a new zone of stress concentration might be located. According to the location of stress concentration, the critical zones in a patch repaired system may occur in six possible locations, as indicated in Figures 12 and 13:

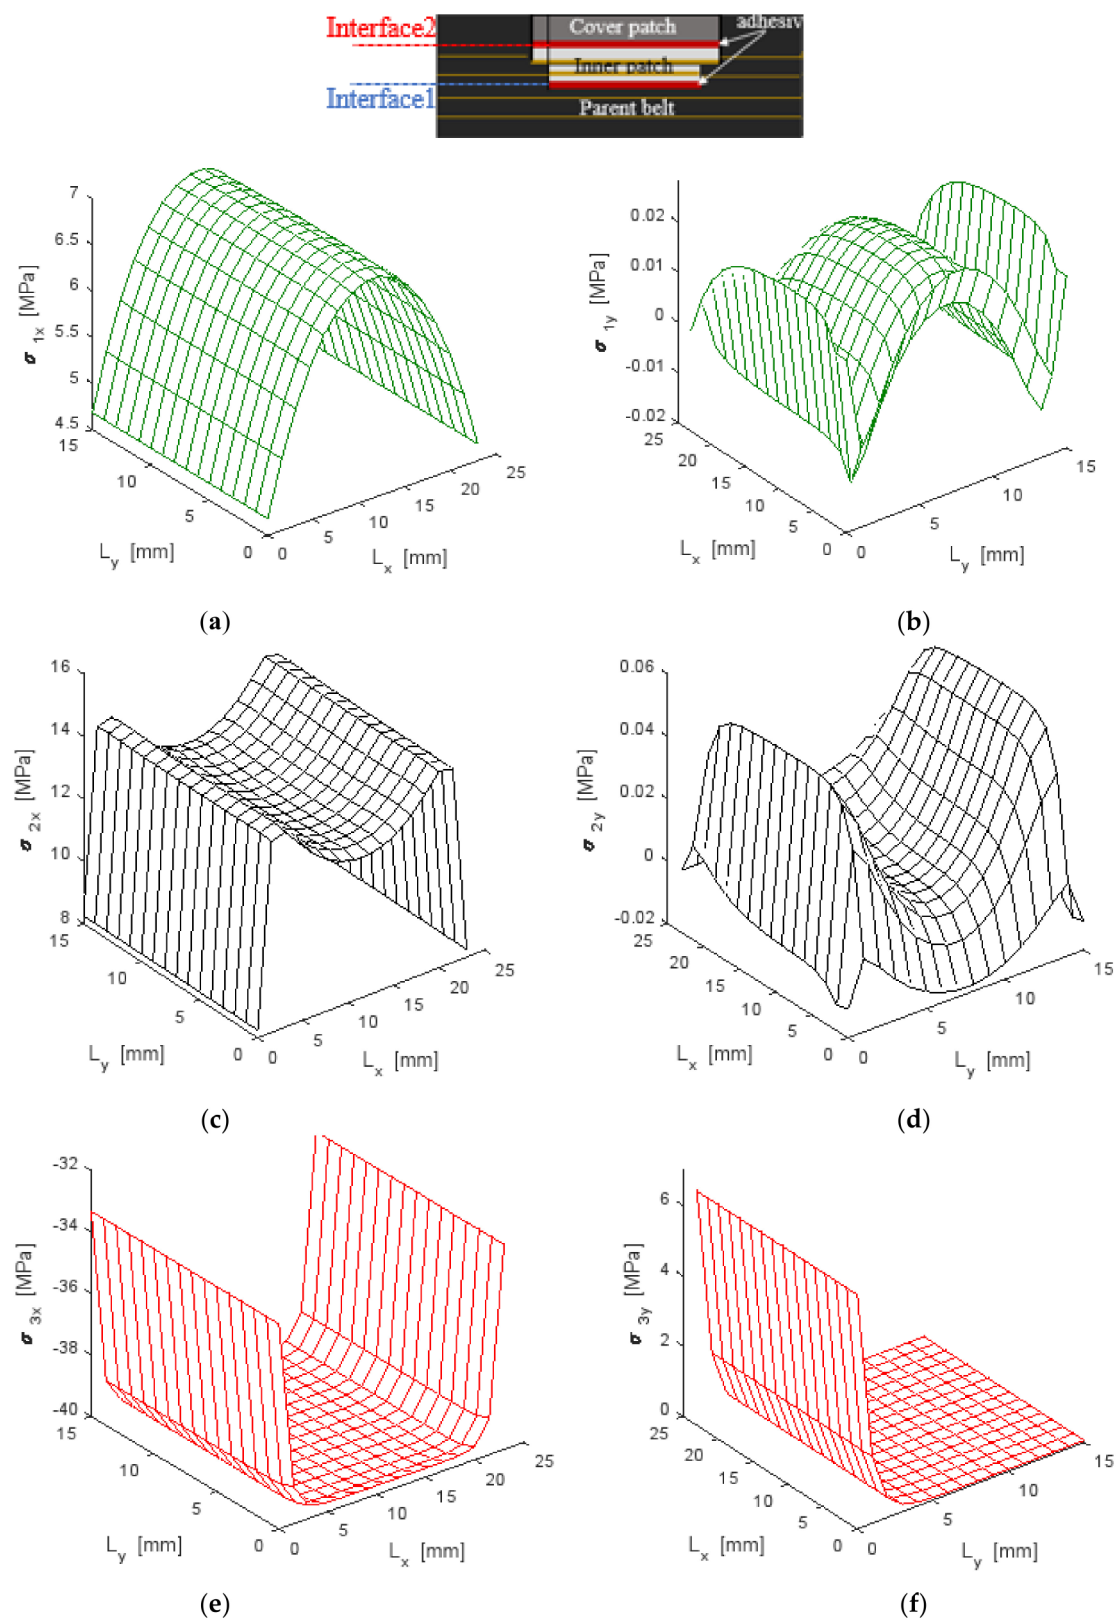
**Figure 13.** Normal stress distribution under a hygro-thermomechanical load (2 MPa, 50 °C and 40% RH) in longitudinal and transverse directions in (a,b) a parent belt; (c,d) an inner patch; (e,f) a cover patch.

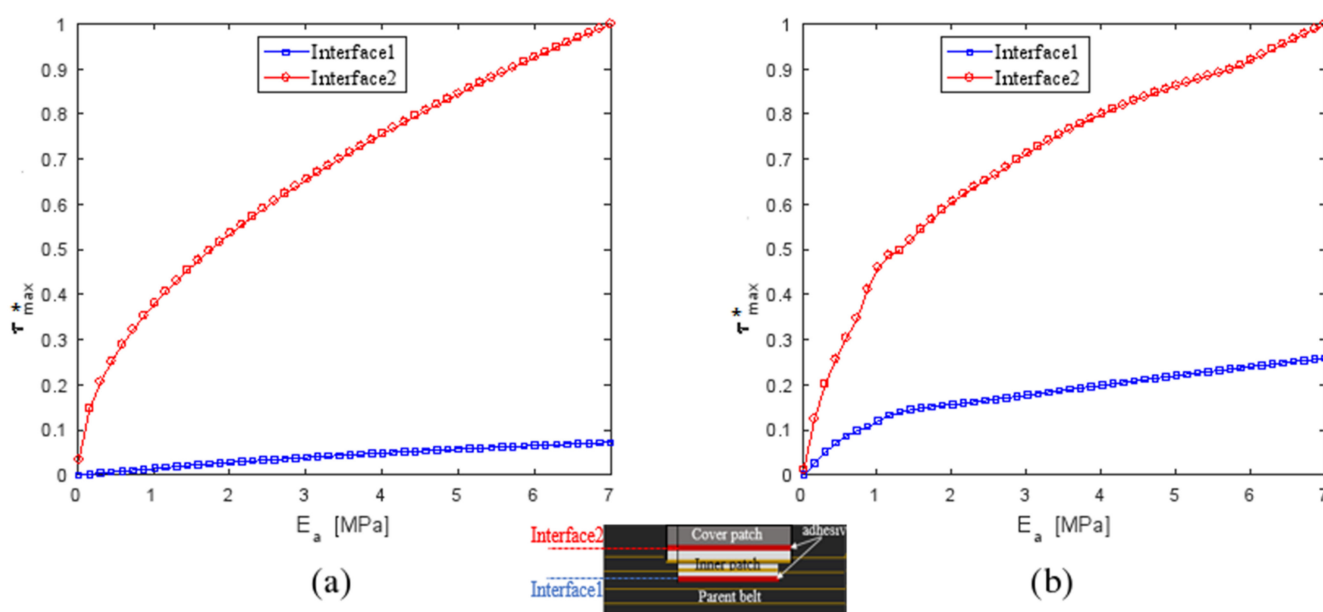
**Figure 14.** Variation of the maximal normalized shear stress ratio  $\tau_{max}^*$  in Interface (1) and Interface (2) as a function of the adhesive Young's modulus  $E_a$  in: (a) XZ plane; (b) YZ plane.

The effect of Young's modulus of the adhesive,  $E_a$ , on the performance of a patched repair was studied by varying  $E_a$  from 0.05 to 7 MPa while the thickness of the patches, the parent belt and of the adhesive joint was constant. The results are plotted in Figures 14 and 15.  $\tau_{max}^*$  is the normalized shear stresses obtained by the square between the shear stresses and the maximum shear stress obtained in the joint adjacent to the cover patch for a reparation with composite patches at  $0^\circ$ . As shown, the maximum shear in the XZ and YZ plane depended on the adhesive Young's modulus. Increasing the  $E_a$  value resulted in an important increase in  $\tau_{max}^*$  of the second interface. The maximum normal stress  $\sigma_{max}^*$  in the patches and the parent belt was still invariant with the variation of the adhesive Young's modulus.

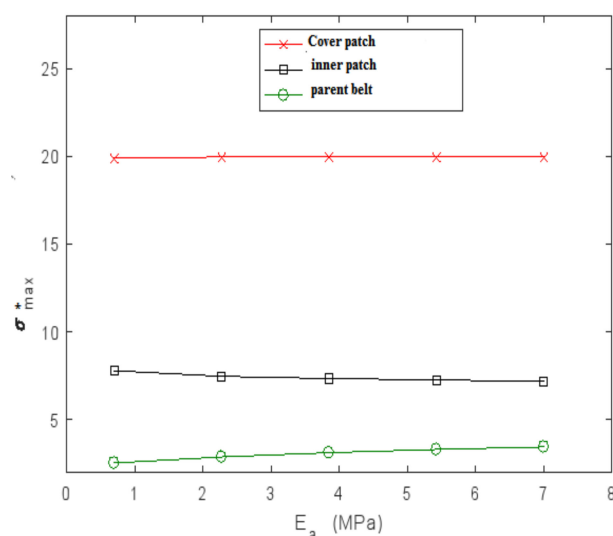
**Figure 15.** Variation of the maximal normalized normal stress ratio  $\sigma_{max}^*$  in adherents as a function of adhesive Young's modulus  $E_a$ .

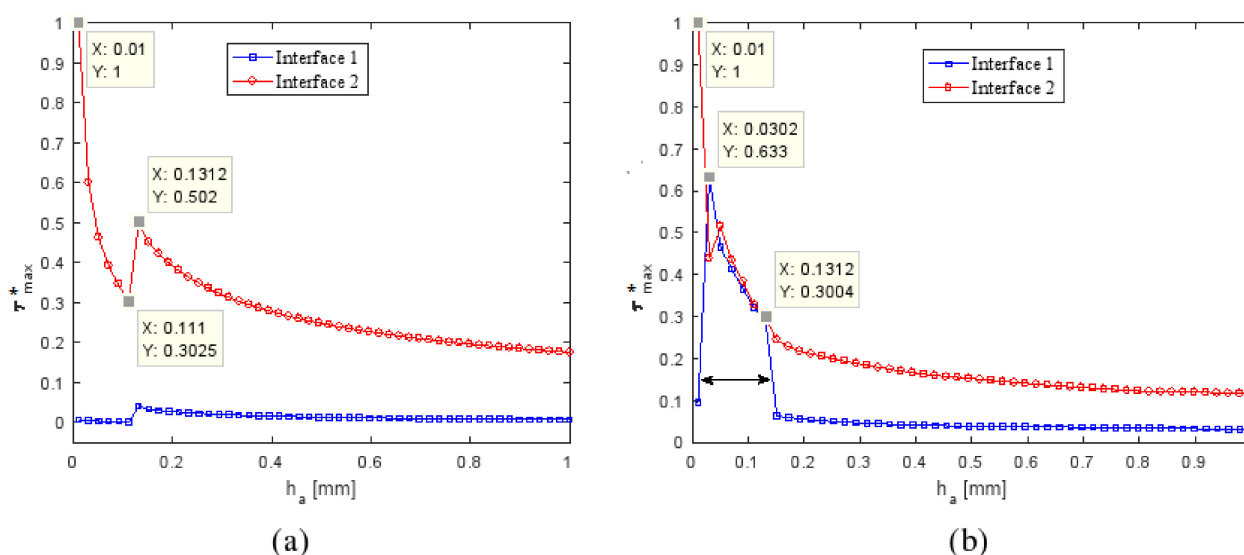
**Figure 16.** Variation of the maximal normalized shear stress ratio  $\tau_{max}^*$  in interface (1) and interface (2) as a function of adhesive thickness  $h_a$  in: (a) XZ plane; (b) YZ plane.

The effect of adhesive thickness was studied by keeping a constant adhesive modulus ( $E_a = 7$  MPa) and constant patch and parent belt thicknesses. In practice, the variation of the adhesive thickness was confined to a range between 0.01 and 1 mm. As shown in Figures 16 and 17, both  $\tau_{max}^*$  and  $\sigma_{max}^*$  of the inner patch and the parent belt depended on the adhesive thickness; keeping  $h_a$  between 0.01 and 1 mm led to an increase of the  $\tau_{max}^*$  in both interfaces. In the range 0.03–0.13 of varying  $h_a$ , both interfaces in the YZ plane had the same  $\tau_{max}^*$ . It could be deduced that the intersection of these two curves would give the optimum system performance. The values of  $h_a$  at the points shown in Figure 16 corresponding with the value of  $\sigma_{max}^*$  in interface (1) and equal to  $\sigma_{max}^*$  in interface (2) were defined as the optimal adhesive thickness for the repaired system.

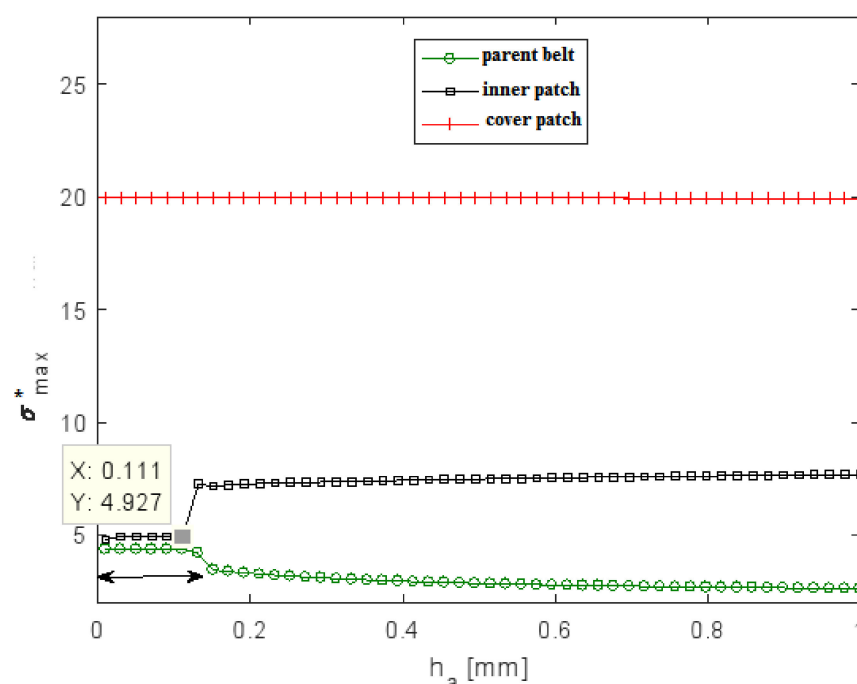
**Figure 17.** Variation of the maximal normalized normal stress ratio  $\sigma_{max}^*$  in adherents as a function of adhesive thickness  $h_a$ .

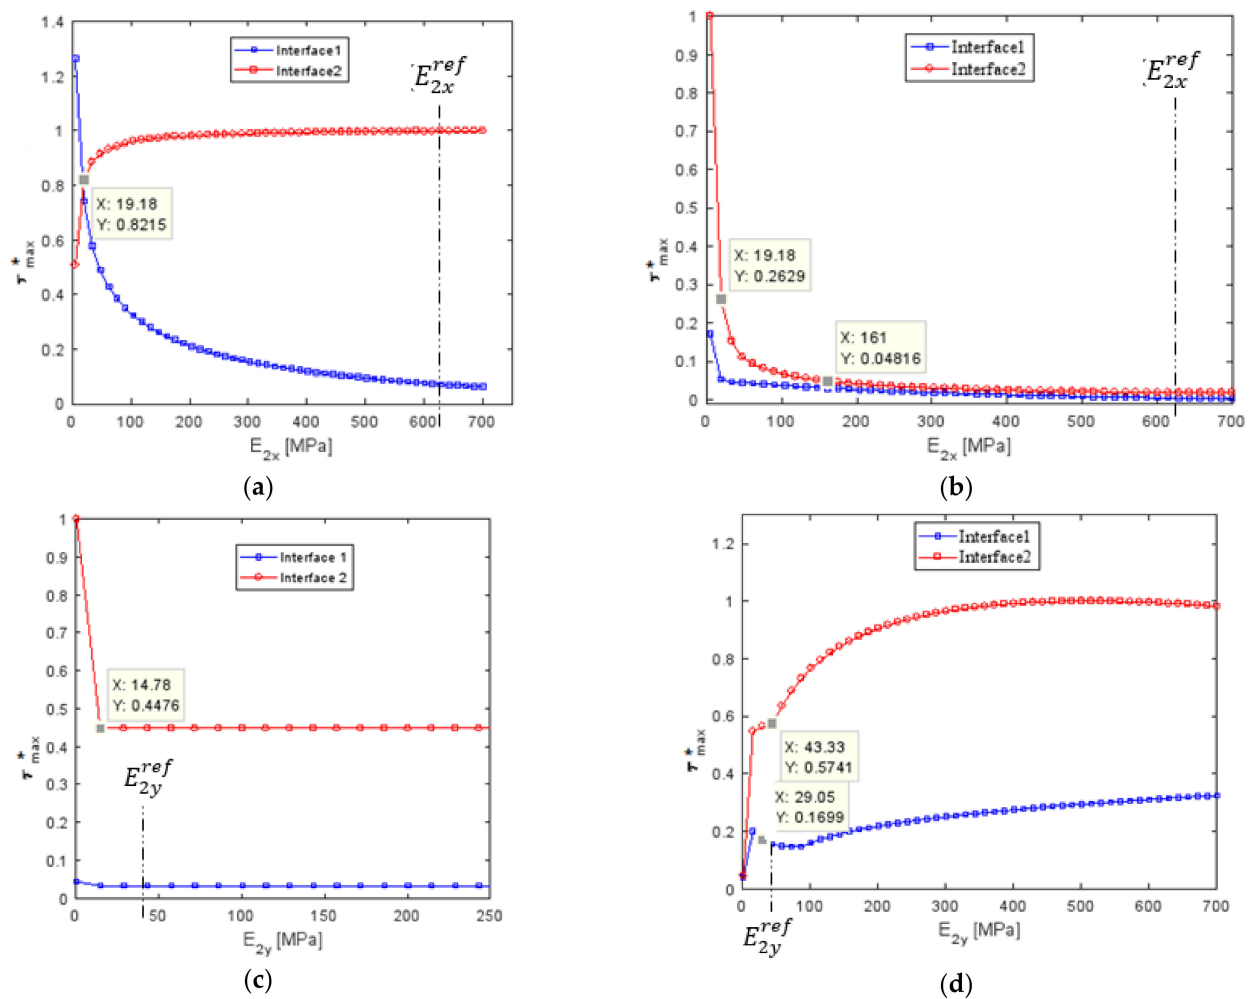
**Figure 18.** Variation of the maximal normalized shear stress in XZ-YZ plane as a function of: (a,b) longitudinal Young's modulus; (c,d) transverse Young's modulus.

To better understand the role of the inner patch made with two textile plies and three rubber layers on the behavior of the repair belt system, the sensitivity of the rigidity of composite patch was investigated. Within one repair, the fiber orientation was uniform plies. However, the orientations of each layer in the repair could change independently of the other repair layers. In this section, the influence of the rigidity of the polyester (PET) fibers was studied by keeping a constant composite patch modulus in a transverse direction ( $E_{2y}^{ref} = 46.54$  MPa) and a constant cover patch and parent belt Young's modulus. The influence of the rigidity of polyamide (PA6) fibers was studied by keeping a constant composite patch modulus in a longitudinal direction ( $E_{2x}^{ref} = 626$  MPa) and a constant cover patch and a parent belt Young's modulus. At first, the decrease of the Young's modulus in a longitudinal direction led to a slight decrease in the maximum shear stress of interface (2) but an increase in the shear stress in interface (1), as shown in Figure 18a. The intersection of these two curves in the intersection point value of  $E_{2x} = 19$  MPa should give the optimum shear stress distribution. The distribution of the maximum normal stress in the parent belt and the inner patch had a significant influence with the variation of the Young's modulus in a longitudinal direction, as shown in Figure 19a. The optimum normal stress distribution was obtained with the decrease of (1/5) of the reference longitudinal Young's modulus. As a result, the reducing of fiber rigidity in the load direction gave the optimum system performance but the fiber rigidity in a transverse direction did not have a significant influence on the performance of the repaired system. For the conveyor belt, it was better to use the stacking sequence  $[90]_2$  for the reparation of the specimen.

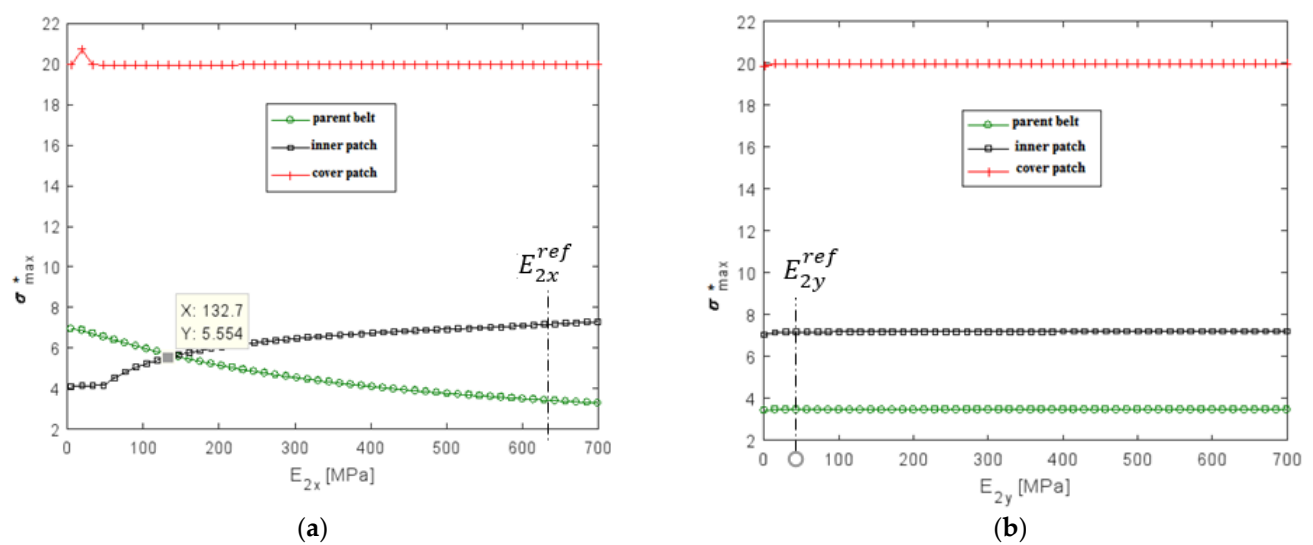
**Figure 19.** Variation of the maximal normalized normal stress as a function of (a) longitudinal Young's modulus; (b) transverse Young's modulus.
