Theoretical and Experimental Investigation of Bonded Patch Repairs of a Rubber Reinforced Composite Conveyor Belt

Rawdha Kessentini, Olga Klinkova, Imad Tawfiq, Mohamed Haddar

Rawdha Kessentini, Olga Klinkova, Imad Tawfiq, Mohamed Haddar. Theoretical and Experimental Investigation of Bonded Patch Repairs of a Rubber Reinforced Composite Conveyor Belt. *Polymers*, 2021, 13 (11), pp.1710. 10.3390/polym13111710 . hal-03558788

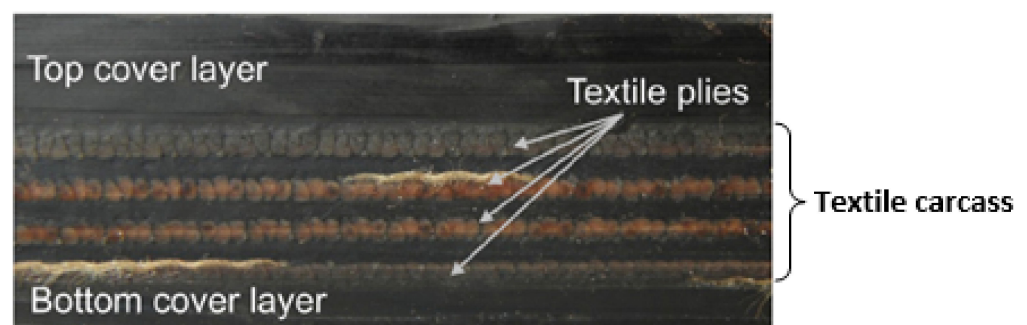
Figure 1. Rubber-textile composite conveyor belt.

A rubber-textile conveyor belt represented in Figure 1 was repaired according to the structural reparation method. The fabric textile carcass was designed to be layered with four plies of polyester (PET) yarn in the warp direction and polyamide (PA6) yarn in the weft direction.

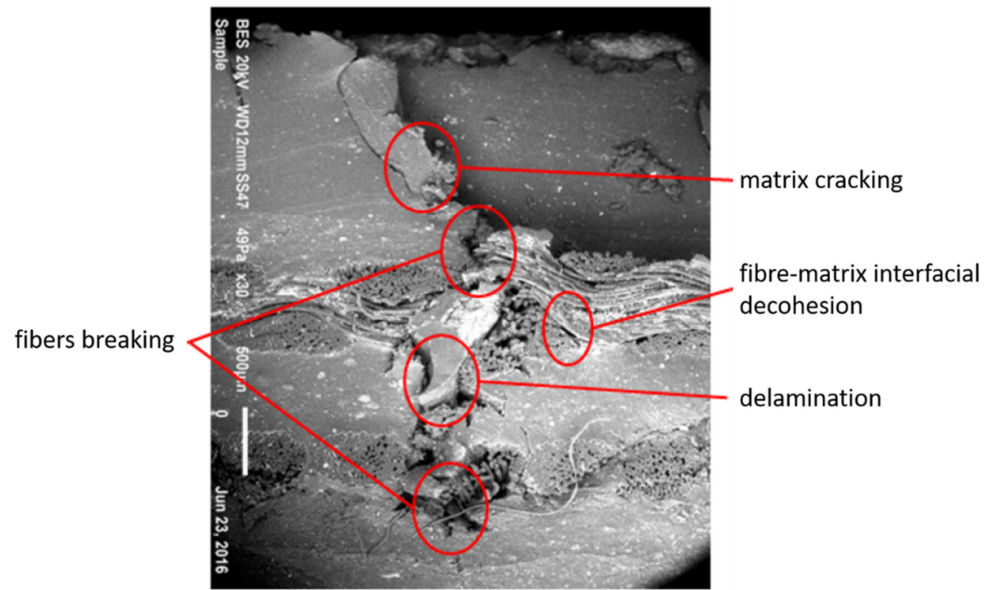
Figure 2. Micrograph of the cross-sectional area of the impacted specimen at 48.51 Joule.

During conveyor belt operation, damage can occur. Due to the heterogeneity of the structural composite belt, four major damage mechanisms were identified and can be seen in Figure 2: (1) matrix cracking (at a microscopic scale), (2) delamination (at a meso-scale), (3) breaking and buckling of fibers (at a microscale) and finally (4) fiber-matrix interfacial decohesion (at a microscale). This damage presented the critical case when the damage occurred at the half of the conveyor belt thickness. The reparation of such a rubber reinforced composite will be described in the next section.

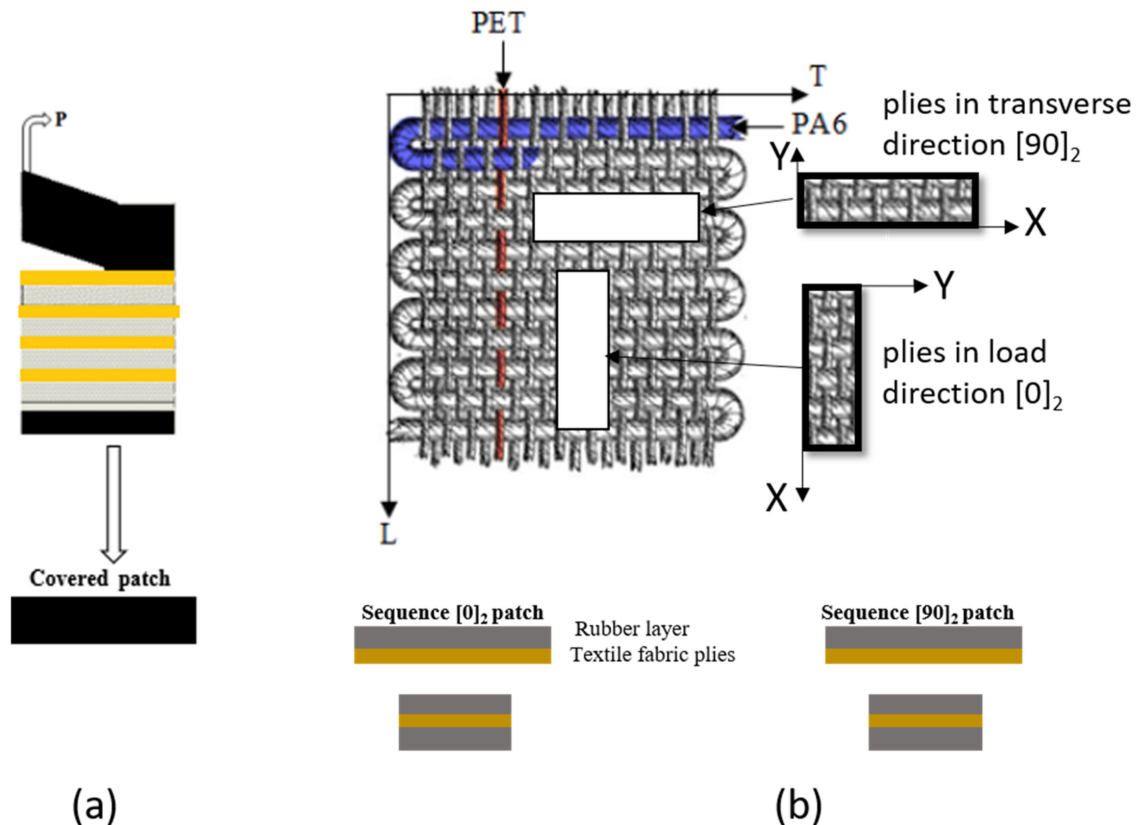
Figure 7. Preparation of the inner and covered patch: (a) peel technique; (b) cutting fiber textile ply.

The peeling was compared with the milling techniques in terms of surface roughness, surficial fiber damage, process rapidity and quantity of dust generated. With respect to the roughness results obtained (Figure 6) and with the above-described parameters, the upper rectangular covered patch was cut from the belt material using the peel technique (Figure 7a). The inner patch was prepared from textile ply made with the same plies as the carcass fabric of the belt (Figure 7b). Two sequences of inner patches $[0]_2$ and $[90]_2$ were prepared to repair the specimens in the longitudinal and the transverse directions, respectively, as shown in Figure 7b.

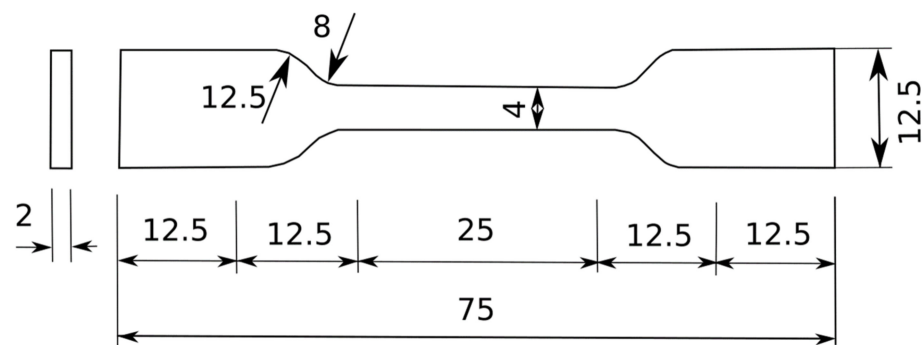
Figure 8. Standardized adhesive specimen for the uniaxial tensile test according to ISO37: 2011.

To be able to characterize the ELASTOGLUE 2000, the adhesive tensile specimens were cut from a molded plate of $250 \times 250 \text{ mm}^2$, which was molded using a two-mold set-up covered with a Teflon coating. The adhesive was prepared and thoroughly mixed in the portion mentioned before (1 kg/60 g), then placed in the mold using a spatula. Finally, the mold was closed and then inserted into a climatic chamber to stabilize the temperature ($23 \text{ }^\circ\text{C}$) and humidity (40%) environment. After three days, the plaque was polymerized. Three adhesive specimens were cut following the dimensions presented in Figure 8.

Furthermore, a tensile test was conducted for the ELASTOGLUE 2000 adhesive specimens with normalized dimensions [10] as described in Figure 8 with a loading speed of 2 mm/min.

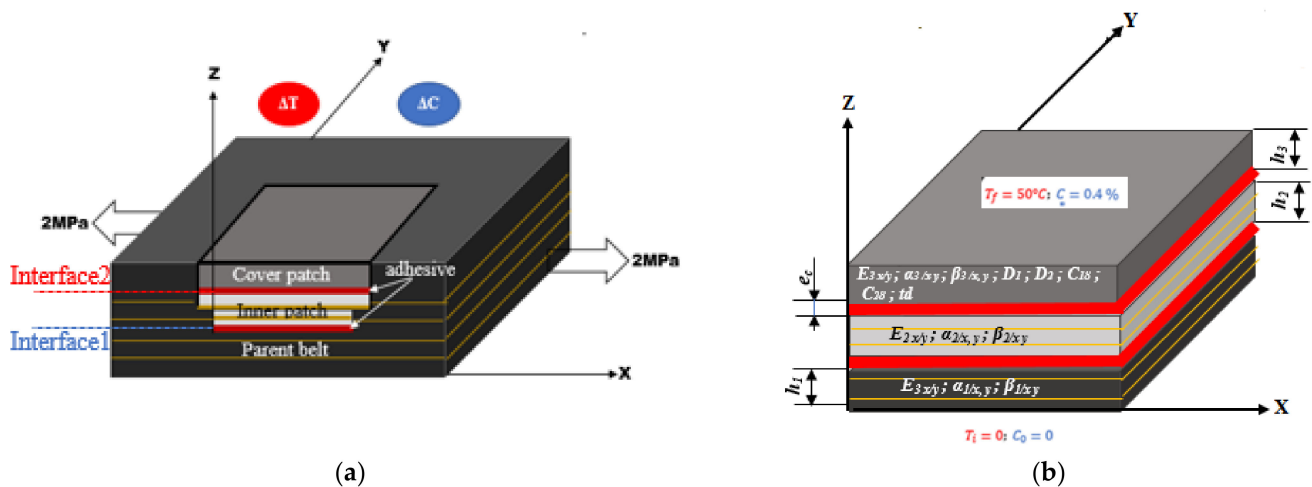
Figure 9. Schematic representation of the belt repaired composite structure under mechanical tension in the presence of the temperature gradient ΔT and the humidity concentration ΔC : (a) transverse section with two interfaces; (b) geometric parameters and material properties needed for the 2D model.

The bonded patch repair of the conveyor belt was composed of the parent belt, an inner patch and a covered patch, as shown in Figure 9. The bidirectional model detailed in [11] was used in order to determine the stress distribution in the patches and the parent belt. A previous study had shown that this model was well suited to the analysis of composite materials [11]. The belt had an elastic-visco-plastic behavior but only the elastic domain was considered in this analysis. The adhesive had a hyper-elastic behavior and it was modeled by the Ogden model ($N = 3$) as demonstrated in Figure 10. More details

The effect of moisture diffusion was modelled by means of the moisture concentration induced in the covered patch as described in Figure 9. As demonstrated in the last study [12], the effect of moisture diffusion of this material was achieved by using a sequential dual Fickian (SDF) model. The moisture concentration was determined at any time t at each spatial coordinate Z by Equation (1):

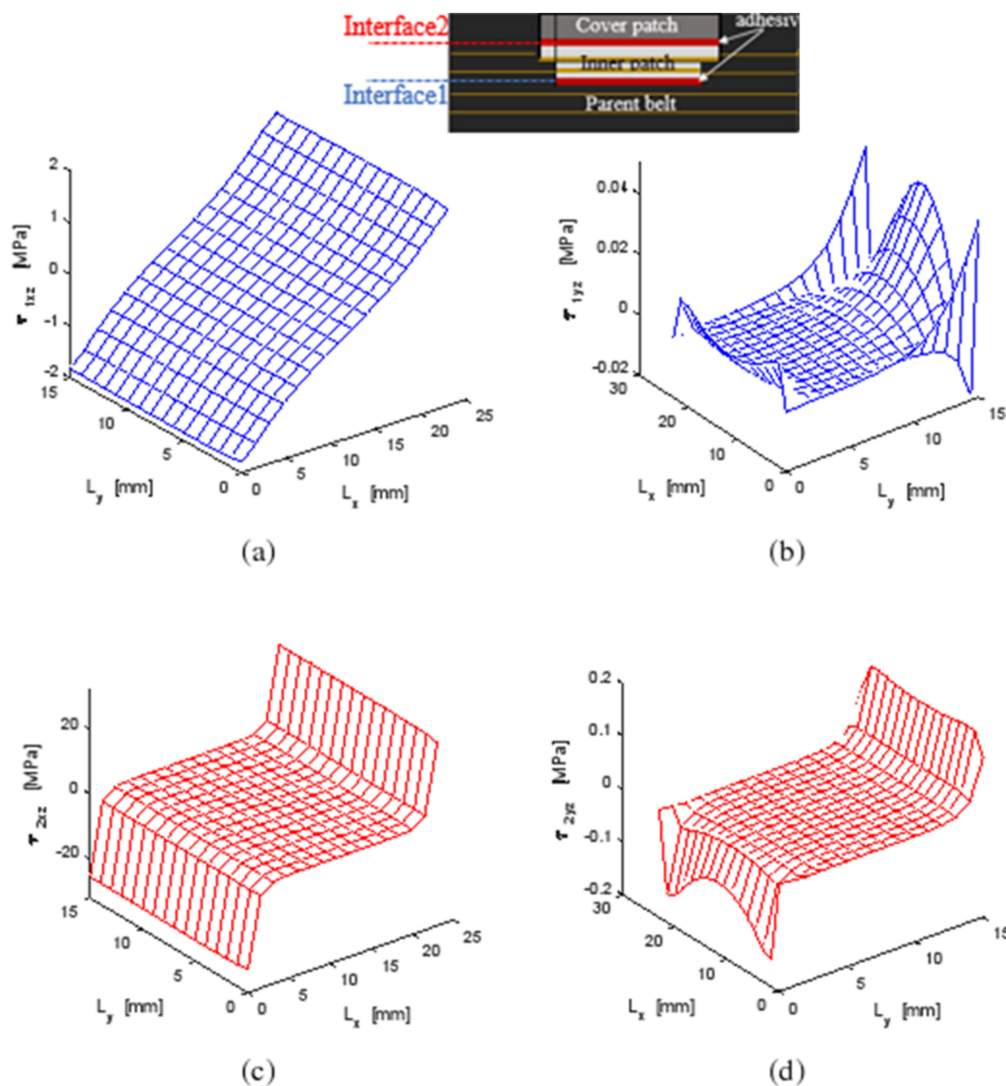
Figure 12. Shear stress distribution under a hygro-thermomechanical load on XZ and YZ planes in (a,b) Interface (1); (c,d) Interface (2).

Making the repaired structure more durable under external loading was the objective of this study. In fact, joints are the most critical elements in a bonded structure; they assume the load transfer mechanism between the adhesive and the adherents. Figure 12 shows the shear stress distribution in both interfaces of the repaired belt structure. τ_{ixz} and τ_{iyz} referred to the shear stress in the XZ and YZ planes of the interface (1) $i = 1$ between the parent belt and the inner patch and for the interface (2) between the inner patch and the covered patch, $i = 2$. It was found that the maximum shear stress was always in the interface (2). This was due to the residual stresses generated in the covered patch as a result of the moisture diffusion. The covered patch was the most sensitive component to water expansion so the strain fields accumulated at the interface between the covered patch and the inner patches. The shear stresses in the XZ plane were the most important; this was the direction of the mechanical load. The most stressed zone in both joints was located near the end edges.

A repair will be efficient and effective when each component is chosen so that the distribution of normal and shear stresses is evenly spread and the maximum value in the repair system defined as normalized normal σ^* and normalized shear τ^* repair is at minimal. In Figure 13, the stress concentrations were situated at the edges of the repaired specimen, which was in accordance with Gong et al. [13]. When the composite and the repairing patch was assembled by bonding onto the specimen, the stresses were redistributed between the patch and the parent composite so a new zone of stress concentration might be located. According to the location of stress concentration, the critical zones in a patch repaired system may occur in six possible locations, as indicated in Figures 12 and 13:

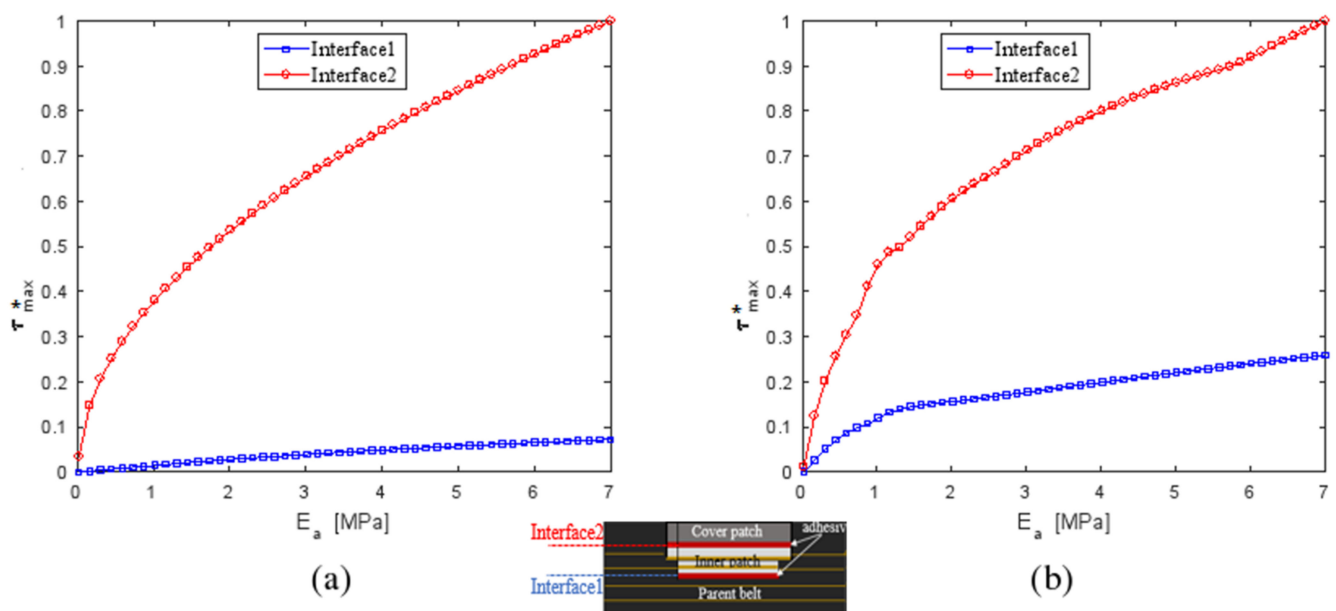
Figure 14. Variation of the maximal normalized shear stress ratio τ_{max}^* in Interface (1) and Interface (2) as a function of the adhesive Young's modulus E_a in: (a) XZ plane; (b) YZ plane.

The effect of Young's modulus of the adhesive, E_a , on the performance of a patched repair was studied by varying E_a from 0.05 to 7 MPa while the thickness of the patches, the parent belt and of the adhesive joint was constant. The results are plotted in Figures 14 and 15. τ_{max}^* is the normalized shear stresses obtained by the square between the shear stresses and the maximum shear stress obtained in the joint adjacent to the cover patch for a reparation with composite patches at 0° . As shown, the maximum shear in the XZ and YZ plane depended on the adhesive Young's modulus. Increasing the E_a value resulted in an important increase in τ_{max}^* of the second interface. The maximum normal stress σ_{max}^* in the patches and the parent belt was still invariant with the variation of the adhesive Young's modulus.

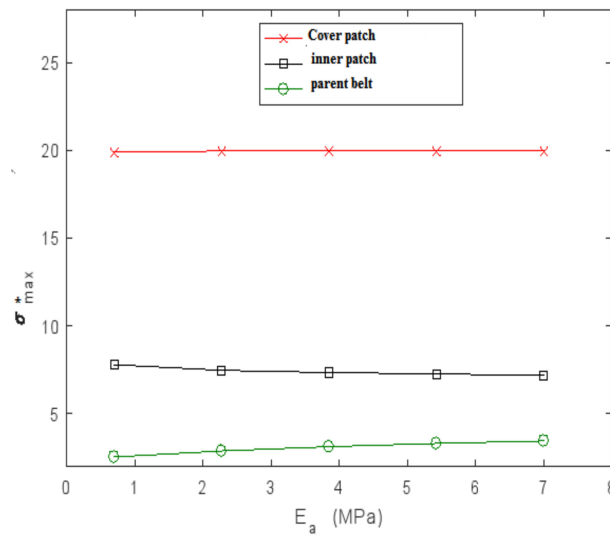
Figure 15. Variation of the maximal normalized normal stress ratio σ_{max}^* in adherents as a function of adhesive Young’s modulus E_a .

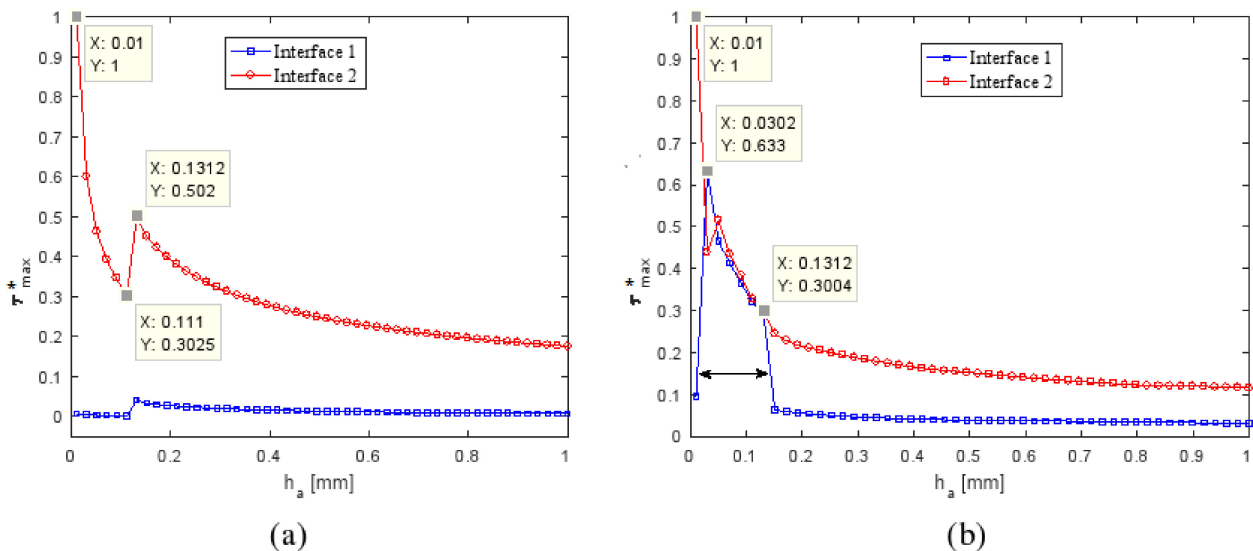
Figure 16. Variation of the maximal normalized shear stress ratio τ_{max}^* in interface (1) and interface (2) as a function of adhesive thickness h_a in: (a) XZ plane; (b) YZ plane.

The effect of adhesive thickness was studied by keeping a constant adhesive modulus ($E_a = 7$ MPa) and constant patch and parent belt thicknesses. In practice, the variation of the adhesive thickness was confined to a range between 0.01 and 1 mm. As shown in Figures 16 and 17, both τ_{max}^* and σ_{max}^* of the inner patch and the parent belt depended on the adhesive thickness; keeping h_a between 0.01 and 1 mm led to an increase of the τ_{max}^* in both interfaces. In the range 0.03–0.13 of varying h_a , both interfaces in the YZ plane had the same τ_{max}^* . It could be deduced that the intersection of these two curves would give the optimum system performance. The values of h_a at the points shown in Figure 16 corresponding with the value of σ_{max}^* in interface (1) and equal to σ_{max}^* in interface (2) were defined as the optimal adhesive thickness for the repaired system.

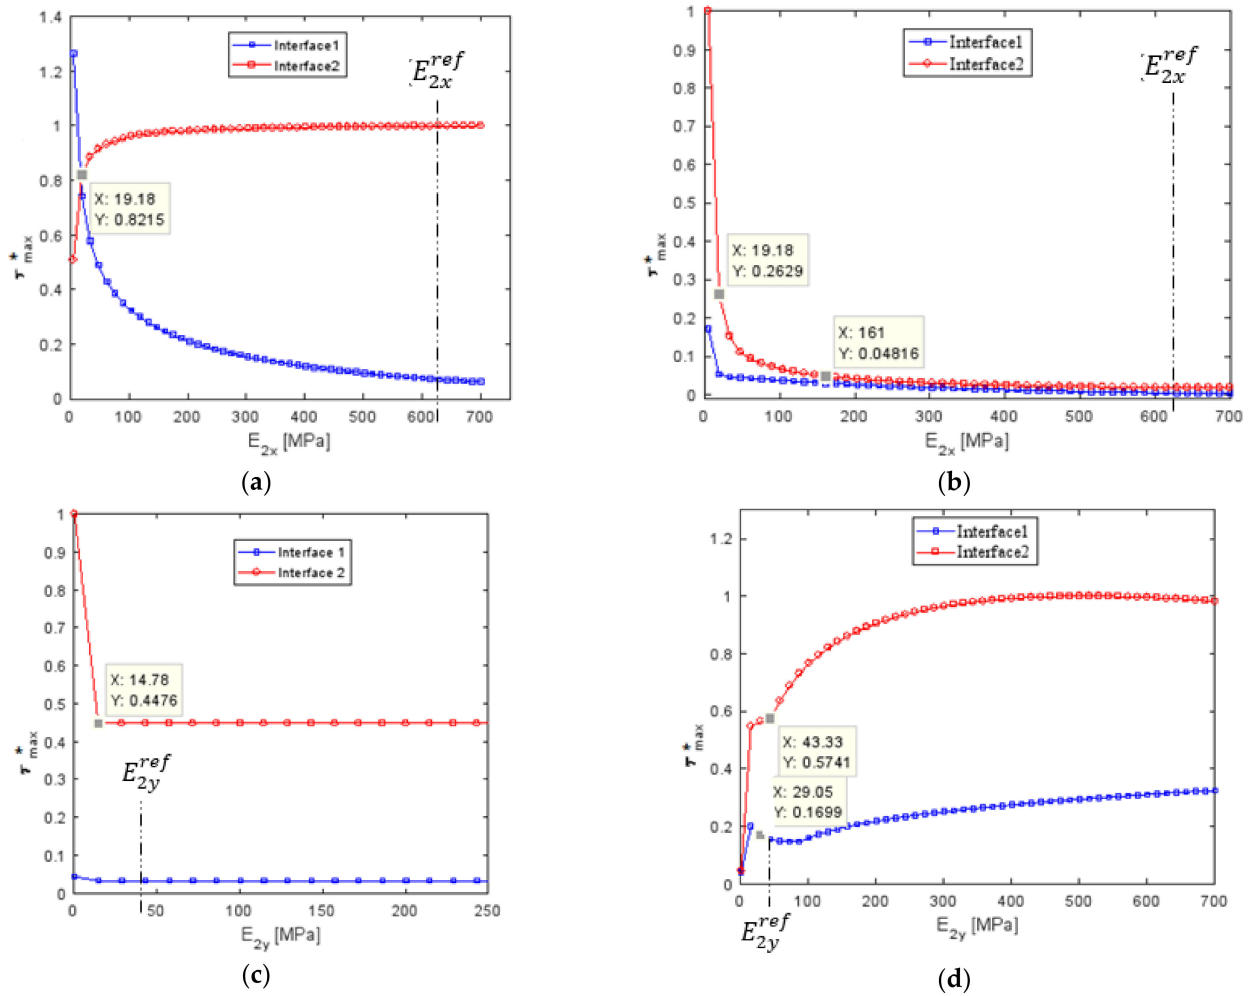
Figure 18. Variation of the maximal normalized shear stress in XZ-YZ plane as a function of: (a,b) longitudinal Young's modulus; (c,d) transverse Young's modulus.

To better understand the role of the inner patch made with two textile plies and three rubber layers on the behavior of the repair belt system, the sensitivity of the rigidity of composite patch was investigated. Within one repair, the fiber orientation was uniform plies. However, the orientations of each layer in the repair could change independently of the other repair layers. In this section, the influence of the rigidity of the polyester (PET) fibers was studied by keeping a constant composite patch and parent belt Young's modulus. The influence of the rigidity of polyamide (PA6) fibers was studied by keeping a constant composite patch modulus in a longitudinal direction ($E_{2x}^{ref} = 626$ MPa) and a constant cover patch and a parent belt Young's modulus. At first, the decrease of the Young's modulus in a longitudinal direction led to a slight decrease in the maximum shear stress of interface (2) but an increase in the shear stress in interface (1), as shown in Figure 18a. The intersection of these two curves in the intersection point value of $E_{2x} = 19$ MPa should give the optimum shear stress distribution. The distribution of the maximum normal stress in the parent belt and the inner patch had a significant influence with the variation of the Young's modulus in a longitudinal direction, as shown in Figure 19a. The optimum normal stress distribution was obtained with the decrease of (1/5) of the reference longitudinal Young's modulus. As a result, the reducing of fiber rigidity in the load direction gave the optimum system performance but the fiber rigidity in a transverse direction did not have a significant influence on the performance of the repaired system. For the conveyer belt, it was better to use the stacking sequence $[90]_2$ for the reparation of the specimen.

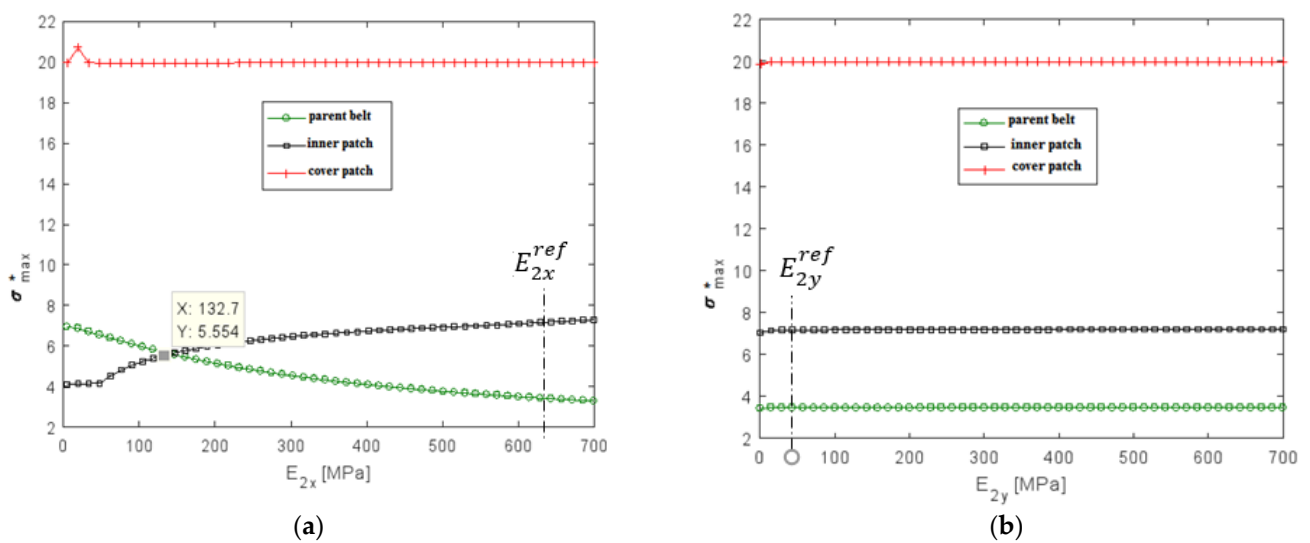
Figure 19. Variation of the maximal normalized normal stress as a function of (a) longitudinal Young's modulus; (b) transverse Young's modulus.
