## **Coupling infrared thermography and acoustic emission for damage study in CFRP composites**

Victor Alfonso Munoz Cuartas, Benjamin Valès, Marianne Perrin, Marie-Laetitia Pastor, Hélène Weleman, Arthur Cantarel, Moussa Karama

Victor Alfonso Munoz Cuartas, Benjamin Valès, Marianne Perrin, Marie-Laetitia Pastor, Hélène Weleman, et al.. Coupling infrared thermography and acoustic emission for damage study in CFRP composites. The 12th International Conference on Quantitative InfraRed Thermography - QIRT 2014, Jul 2014, Bordeaux, France. pp.1-8. <hal-03665206>

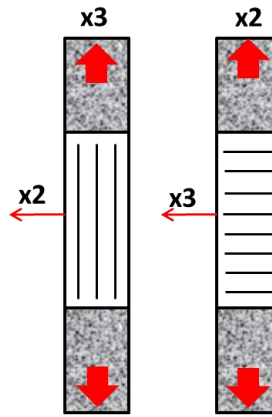
Fig. 1. Fibre direction for each kind of specimen

A carbon fibre reinforced laminate is considered for this study. The composite is made of 14 unidirectional plies of prepreg Hexply M10R/38%/UD150/CHS leading to a 2 mm thickness composite with fibre volume  $f_v$  of 62%. The reference of the fibre is TORAY T700S. Sample fabrication is carried out using the manual lay up technique. Then the sample is cured at 125°C during 90 minutes at a pressure of 2 bars. This sample is representative of a transversely isotropic composite. To obtain the tensile samples, the cured plate is cut according to the standard ISO 527-5 [12]. Two composite directions are obtained after cutting the plate (0° and 90°). Figure 1 shows the axis fibre direction (direction x3) for each category of specimen.

The tensile tests are made at ambient temperature. These tests are performed with an electromechanical testing machine INSTRON 5500. 2 tests are carried out according to the fibre direction, 0° (axial load along the direction x3) and 90° (axial load along direction x2) (figure1). To check the reproducibility of the response, three specimens are considered for each loading direction.

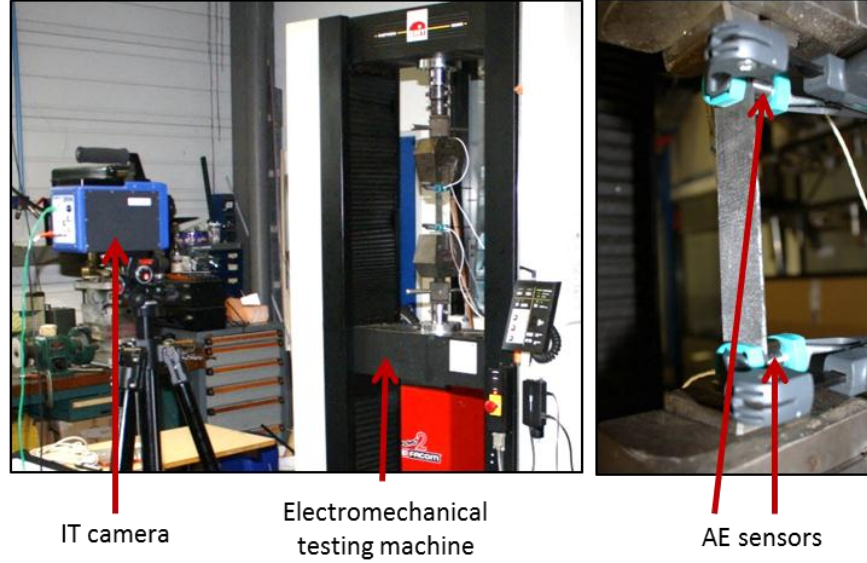
**Fig. 2.** Experimental setup

dB. The acquired signals are amplified by 40 dB. Two sensors have been positioned at the top and bottom of the specimen in order to derive the location of the AE events. The full experimental setup is shown in figure 2.

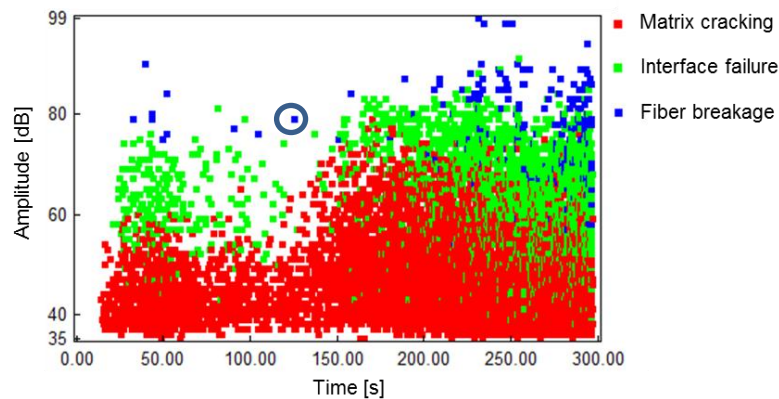
Fig. 3. Cluster results of acoustic emission for 0° tensile test

Figure 3 shows on the amplitude versus time graph the classes of AE data obtained after the application of the pattern recognition method. Three groups are clearly distinguished. The red group with the lowers amplitudes corresponds to the matrix cracking, the green group refers to the debonding and interphase failure and the last blue group corresponds to the fibre breaking. We can see that the fibre breaking generates AE at high amplitudes in regards to the others damage mechanisms.

Regarding the specific event highlighted in figures 3 and 4b, we can see that the location of the heat source and acoustic event stand in the same zone of the specimen (lower part) near the sensor number 2 (indicated by the green number 2 in figure 4c). The error of the AE location in regards to the heat source is 25%. However, it is important to note here that the location in AE is done by measuring the velocity of the wave for each specimen in the initial state. The slight difference in location may thus be explained by velocity change induced by the damage and load applied.

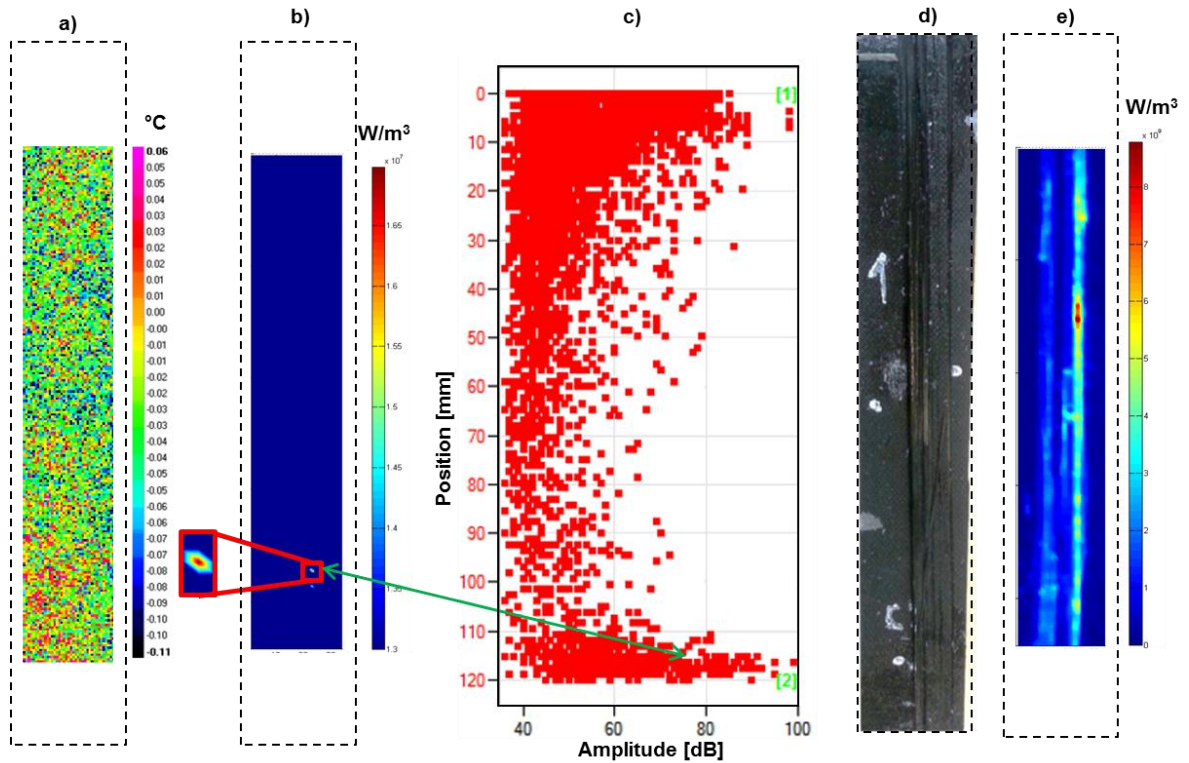
**Fig. 4.** Correlation between heat source and acoustic emission amplitude for the  $0^\circ$  specimen

Correlations between AE and TI measurements have been done between several heat sources and acoustic events of high amplitude and high energy. As an illustration of the analysis, the procedure and results are explained here on the case of the one specific AE event selected on figure 3. Figure 4 shows the thermogram (figure 4a), the heat source (figure 4b) and the located amplitude (figure 4c) for this damage that appeared at 128.428 seconds after the beginning of the tensile test. According to the figure 3, this damage (at this specific time) corresponds to a fibre breaking. We can see that the amplitude of the analyzed acoustic event is around 79 dB (figure 4c). To correlate that specific AE to

the heat source, it is needed to analyse the maximum of heat source at a specific timespan. We have considered an interval of 1 s around the AE event ( $128.428 \pm 0.5$  s) which includes 150 thermal frames. During this timespan the maximal heat source is obtained at 128.407 s. (error of 0.02%) for the pixel highlighted in figure 4b. Figure 5 shows that for such analyzed pixel, the heat source gets indeed its maximal value at the AE event time.

Figure 4c provides the location of AE events during the test. Events take place all along the specimen length, which stands in agreement with the post-mortem observation shown in figure 4d and its heat source (breaking time) (figure 4e). We can clearly see that the final breaking of  $0^\circ$  specimens results from macroscopic debonding in the fibre direction.

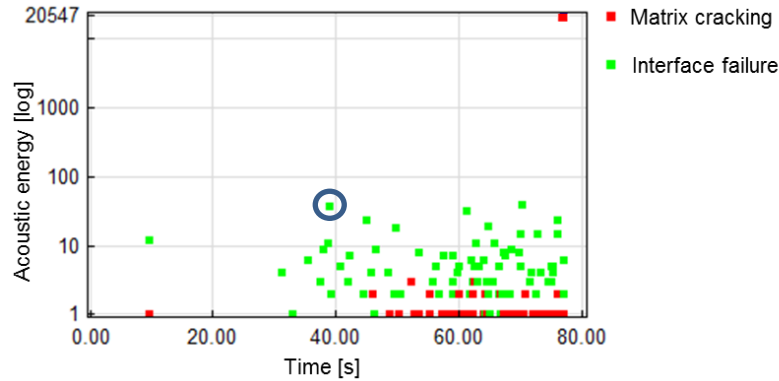
**Fig. 6.** Cluster results of acoustic emission for 90° tensile test

Figure 6 shows the classes of AE for the 90° specimen. As explained before, only two groups are needed according to the damage mechanisms for this fibre direction: the red group represents the matrix cracking and the green group refers to debonding. The AE corresponding to the matrix cracking have the lowest energy and amplitude. In this case the analyzed AE corresponds to a debonding (selected AE event in figure 6). This allows observing that debonding or delamination also create heat sources as important as the fibre breaking.

In the same way, a specific timespan is selected for the analysis. Figure 7 shows the thermogram (figure 7a), the heat source (figure 7b) and the located acoustic energy (figure 7c) for the selected damage at 42.220 seconds after beginning the tensile test. As explained above and according to figure 6, this damage (at this specific time) corresponds to an internal debonding. The acoustic energy for this specific damage is 38 aJ (figure 7c) which is high in regards to the others AE. For the analysis we have considered an interval of 1 s ( $42.220 \pm 0.5$  s) which leads to 148 thermal frames to be analyzed. During this timespan the maximal heat source is founded at 42.216 s. (error of 0.01%) (Figure 7b). Again, figure 8 shows the correspondence between AE event and maximal value of the heat source for the analyzed pixel. Some high heat sources can be seen some milliseconds before and after the analyzed instant but should be considered as parasite events generated by some thermal noise since they do not correspond to any AE.

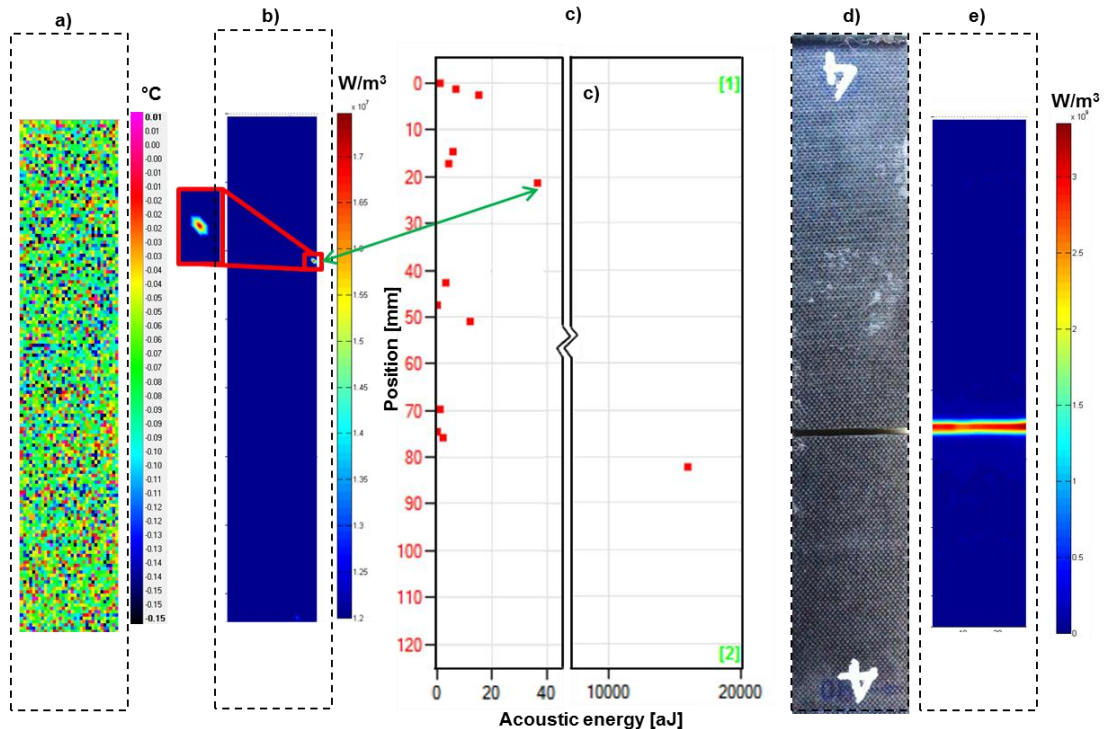
**Fig. 7.** Correlation between heat source and acoustic emission energy for the 90° specimen

In this case, the location of the heat source and the acoustic event are also in the same zone of the sample (near sensor number 1) with an error of 21%. In addition to the changes in velocity, such difference may be related to much more brittle character, and therefore instable of the failure in that case. Indeed, it is shown in figures 7d and 7e the final failure breakdown occurs in the fibre axis, induced by the failure of the weakest point of the epoxy matrix (the breakdown is transversal to the load axis). The full load of the tensile test is supported by the matrix (epoxy) and so the break takes place transversally to the load axis.
