An uncommon cause of nerve stimulator's malfunction during a dual guidance lumbar plexus block: A technical brief report and an algorithm for prevention of complications

Short Title: Short circuit during nerve stimulation

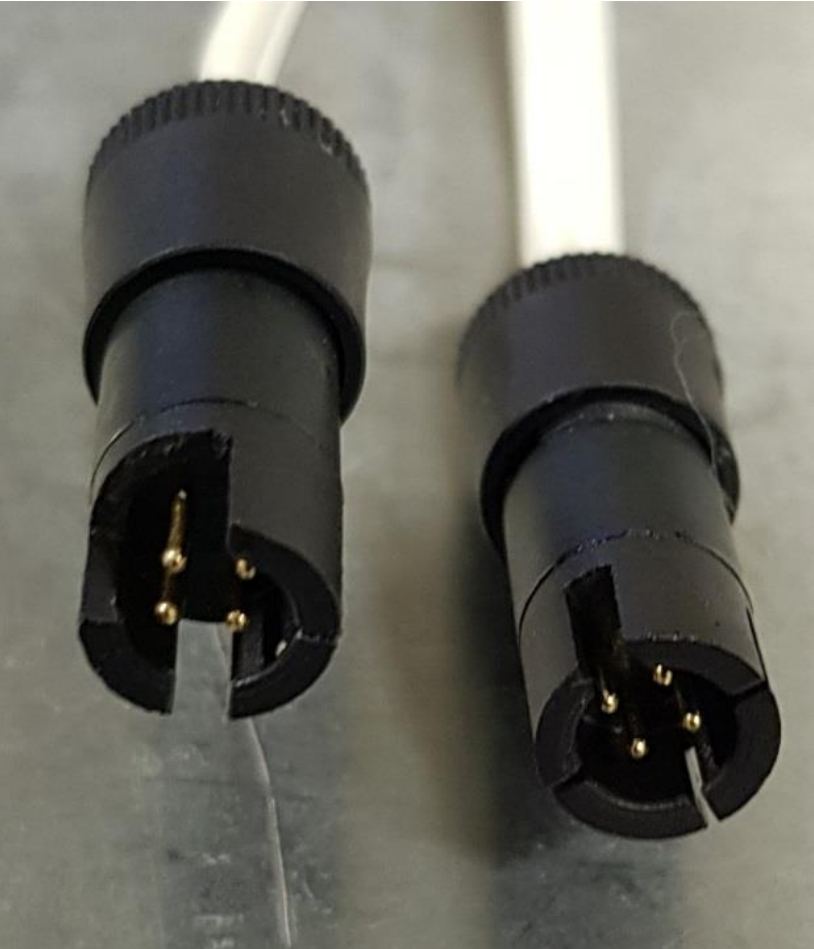
Figure 1

Figure 1: Image of a normal plug connection system (left side of the pic) and the damaged plug connection system (right side of the pic)

Failure in electrical nerve location may be related to a short circuit, misconnection or disconnection¹². The short circuit occurs when the cable or the electrode are in contact and leads to the direct channel of current from one to the other bypassing the patient. It is easy to detect short circuit if the NS is turn on before closing the circuit. The real current does not remain at 0 mA when the set current is increased. In this technical brief report, the problem has not been diagnosed because the nerve stimulator has been turned on after skin puncture (video). To ensure the absence of a short circuit, the user must turn on the stimulator before closing the circuit (i.e., before the needle passes the skin) and check that effective current remains at zero while the set current is increased. Only after excluding a short circuit, the set current must be adjusted and the skin penetrated. In our case report, the consequences have been more needle movements than expected and a delay before malfunction diagnosis (too low resistance). The resistance of the circuit is usually several KOhm due to skin resistance. A short circuit is difficult to diagnose because there is no warning signal of low resistance displayed by the nerve stimulator.

When an electrical failure is supposed, the anaesthetist should try to find the cause and resolve the problem (nerve stimulator, electrode cable, needle). The first step is to check the device, and this is described in the algorithm below with the HNS12 nerve stimulator. If the physician does not consistently check for an electrical failure with nerve stimulation, it could lead to severe adverse events.
