# New Composite Material for Masonry Repair: Mortar Formulations and Experimental Studies

Walid Deboucha, Ibrahim Alachek, Jean-Patrick Plassiard, Olivier Ple

Walid Deboucha, Ibrahim Alachek, Jean-Patrick Plassiard, Olivier Ple. New Composite Material for Masonry Repair: Mortar Formulations and Experimental Studies. *Materials*, 2021, 14 (4), pp.912. 10.3390/ma14040912 . hal-03687535

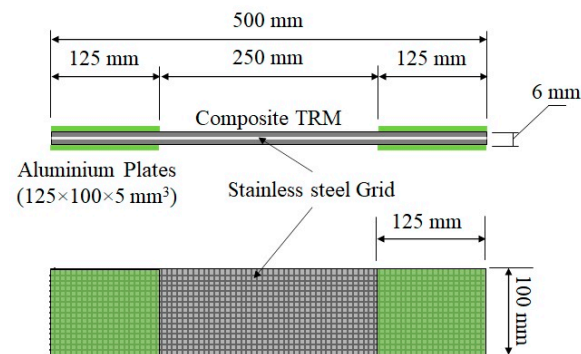
**Figure 1.** Tensile specimen geometry.

The axial behaviour of tensile composite specimens made of a stainless-steel grid embedded in a mortar-based matrix (SSGRM) was studied experimentally. The tests were similar to those proposed in the RILEM TC 232-TDT [29]. The specimens have an overall cross section of 100 mm  $\times$  6 mm ( $\pm 0.5$ ) and a length of 500 mm, as shown in Figure 1. The tests were performed after 7 days of curing by means of a testing machine equipped with a 120 kN electric actuator, under monotonic increasing load with displacement control at a constant stroke rate of 0.017 mm/s. During the tests, the load and machine displacement were recorded in a data acquisition system (sampling rate of 10 Hz). Only the side of the

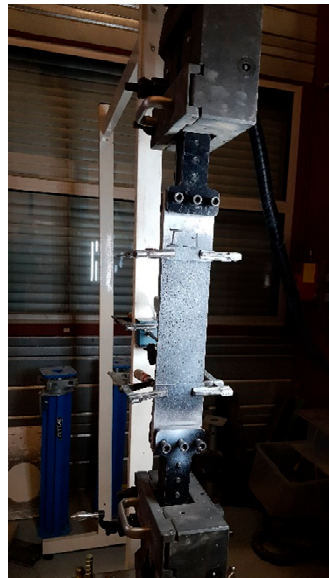
**Figure 2.** Tensile test setup.

In order to guarantee a uniform load transfer and to prevent stress localization within the clamping regions, four aluminium plates ( $125\text{ mm} \times 100\text{ mm} \times 5\text{ mm}$ ) were glued using an epoxy structural adhesive (Sikadur 31-EF) at the loaded ends of specimens. During the tests, the tabs were clamped within the wedges of the testing machine. The pressure was adjusted to prevent slippage between the clam and the specimen. Two clamps were also used to avoid delamination between the specimens and the lower ends of the aluminium plates [15], as shown in Figure 2.

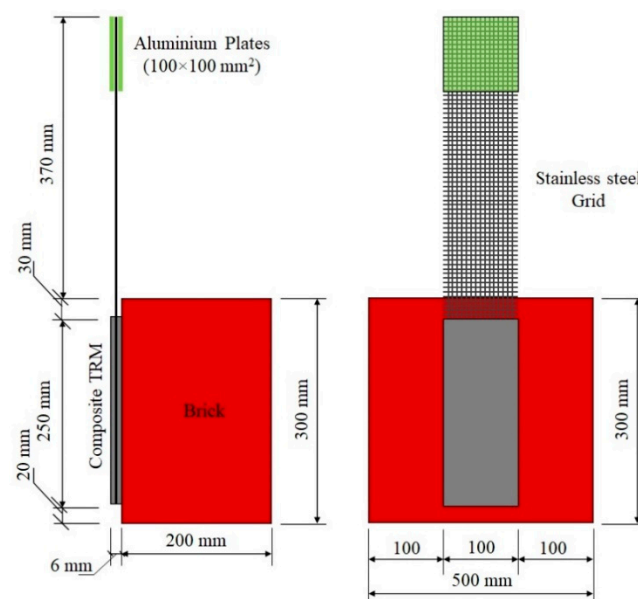
Figure 3. Bond specimen geometry.

The shear bond behaviour of the SSGRM applied on a clay brick was experimentally evaluated. The tests were similar to those proposed in the RILEM TC 250-CSM [30]. The geometry of the bond specimens is shown in Figure 3. The following procedure was adopted for the preparation of specimens. The contact surface of clay brick was first humidified. Next, a  $3 \pm 1$  mm-thin mortar layer was applied on the brick surface and the steel grid was pressed slightly into the fresh mortar for approximately 30 s. During this process, the mortar protruded through the openings of the grid slightly upward. After that, the second mortar layer was applied to achieve a total thickness of approximately 6 mm. The specimens were cured under ambient laboratory conditions (ca. 15–20 °C and 50–60 % relative humidity) and the tests were performed after 28 days of curing by means of a testing machine equipped with a 120 kN electric actuator, under monotonic increasing load with displacement control at a constant stroke rate of 0.017 mm/s. During the tests, the load and machine displacements were recorded in a data-acquisition system (sampling rate of 10 Hz) and two linear variable differential transducers (LVDTs with 30 mm stroke), mounted at the loaded end, were used to measure the relative displacements between the free part of the SSG and the clay brick. The displacement is expressed as the mean value of the two LVDTs in the following. Three repetitions were performed for each mortar formulation.

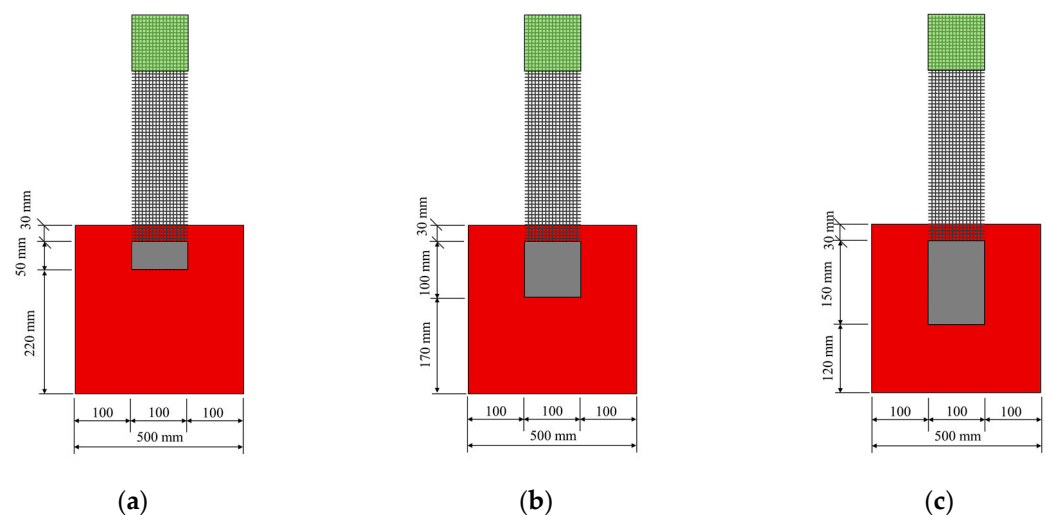
**Figure 4.** Bond specimen geometries for the anchoring length of: (a) 50 mm, (b) 100 mm, and (c) 150 mm.

The bond tests, presented in Section 2.4, have the advantage of comparing the effect of several formulations. Thus, the most appropriate formulation can be selected. Nevertheless, the bond test does not indicate the anchoring length that is required in order to prevent a failure by debonding [15]. This parameter is called optimal anchoring length in the following. It is of fundamental importance, especially if a local repair [20] or a repair by strips is considered. To characterize the bond behaviour of the SSGRM-Brick of the five selected mortar formulations, an anchoring length of 250 mm was used, as recommended in the RILEM TC 250-CSM [30]. This is considered as the reference test in the following. A new series of bond tests was carried out, in which the anchorage length was varied. As described previously, three identical samples were created for each anchorage length tested. The smallest anchorage length considered was 50 mm. This length was then increased for each trio of samples by increments of 50 mm, until the exploitation ratio obtained converged with that of the reference bond test. Samples with anchorage lengths of 50, 100, and 150 mm were built; all three geometries are presented in Figure 4.

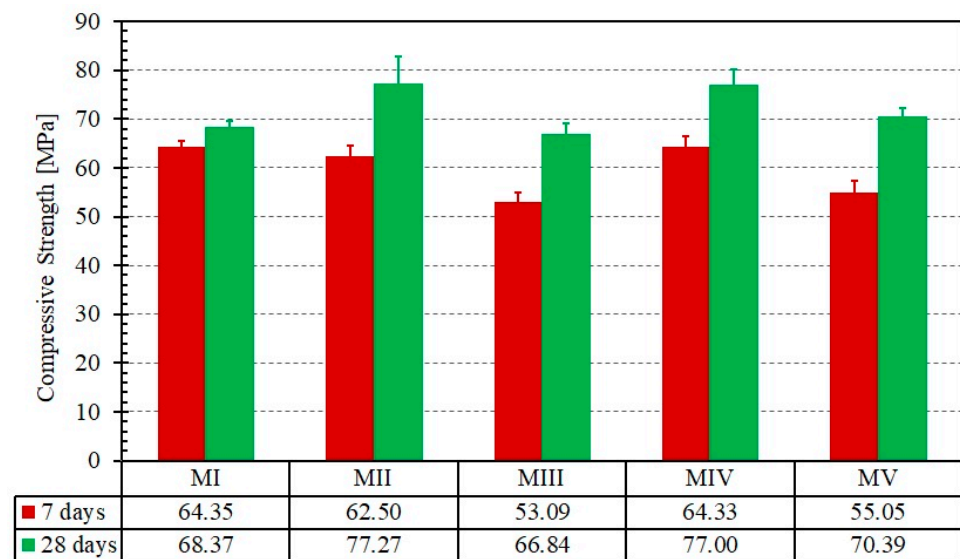
**Figure 5.** Compression test results for the five mortar formulations at different curing times. Error bars represent the standard deviation of the mean.

The mechanical properties of the mortar (cubic compressive strength, flexural tensile strength) after 7 and 28 days of curing time were quantified and presented in Figures 5 and 6, respectively.

First, each of the five mortars exhibited a low discrepancy in both tensile and compression strengths, which allowed for a sound comparison of the results. This confirms the results obtained in [24,27] where a similar strength was recorded for mortars prepared using Portland cement with or without mineral additives, i.e., blast furnace slag, at a replacement level of 20%. Regarding the development of compressive strength, the mortar matrix prepared with blast-furnace slag (MII) and the mortar matrix prepared with both blast-furnace slag and silica fume (MIV) were the most suitable for the preparation of composite and for the repair of masonry walls from a mechanical and workability perspective. For these two formulations, a suitable consistency and slowly rate of losing workability were noticed. The mortar matrix prepared with blast-furnace slag (MII) exhibited the highest tensile strength of the four mortars that included additives. Its strength is about the same as that of MI, for which no additive was used. It is worth noting that both the compressive and tensile strengths are twice the values of a commercial repair mortar used in previous works [20]. The high tensile strength should help in achieving a higher cracking strength as will be discussed in Section 3.2.

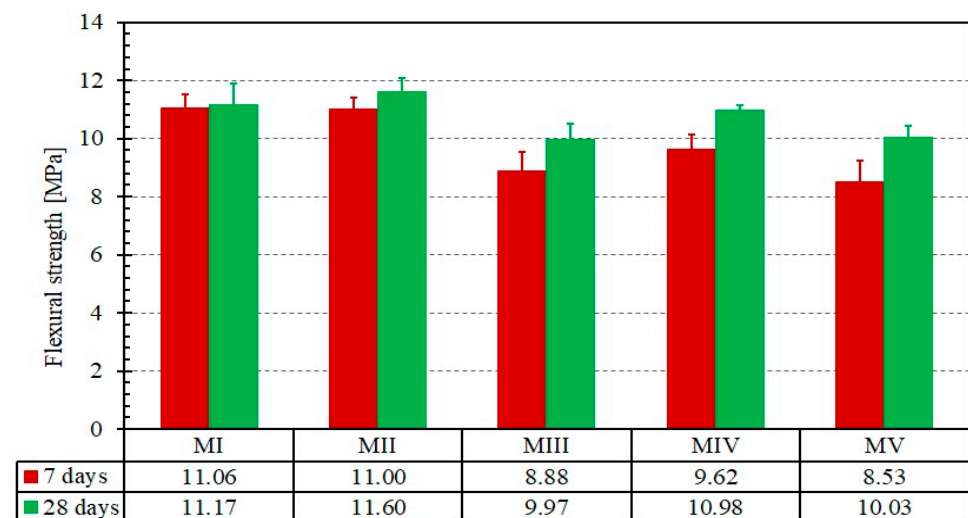
**Figure 6.** Flexural test results for the five mortar formulations at different curing times. Error bars represent the standard deviation of the mean.

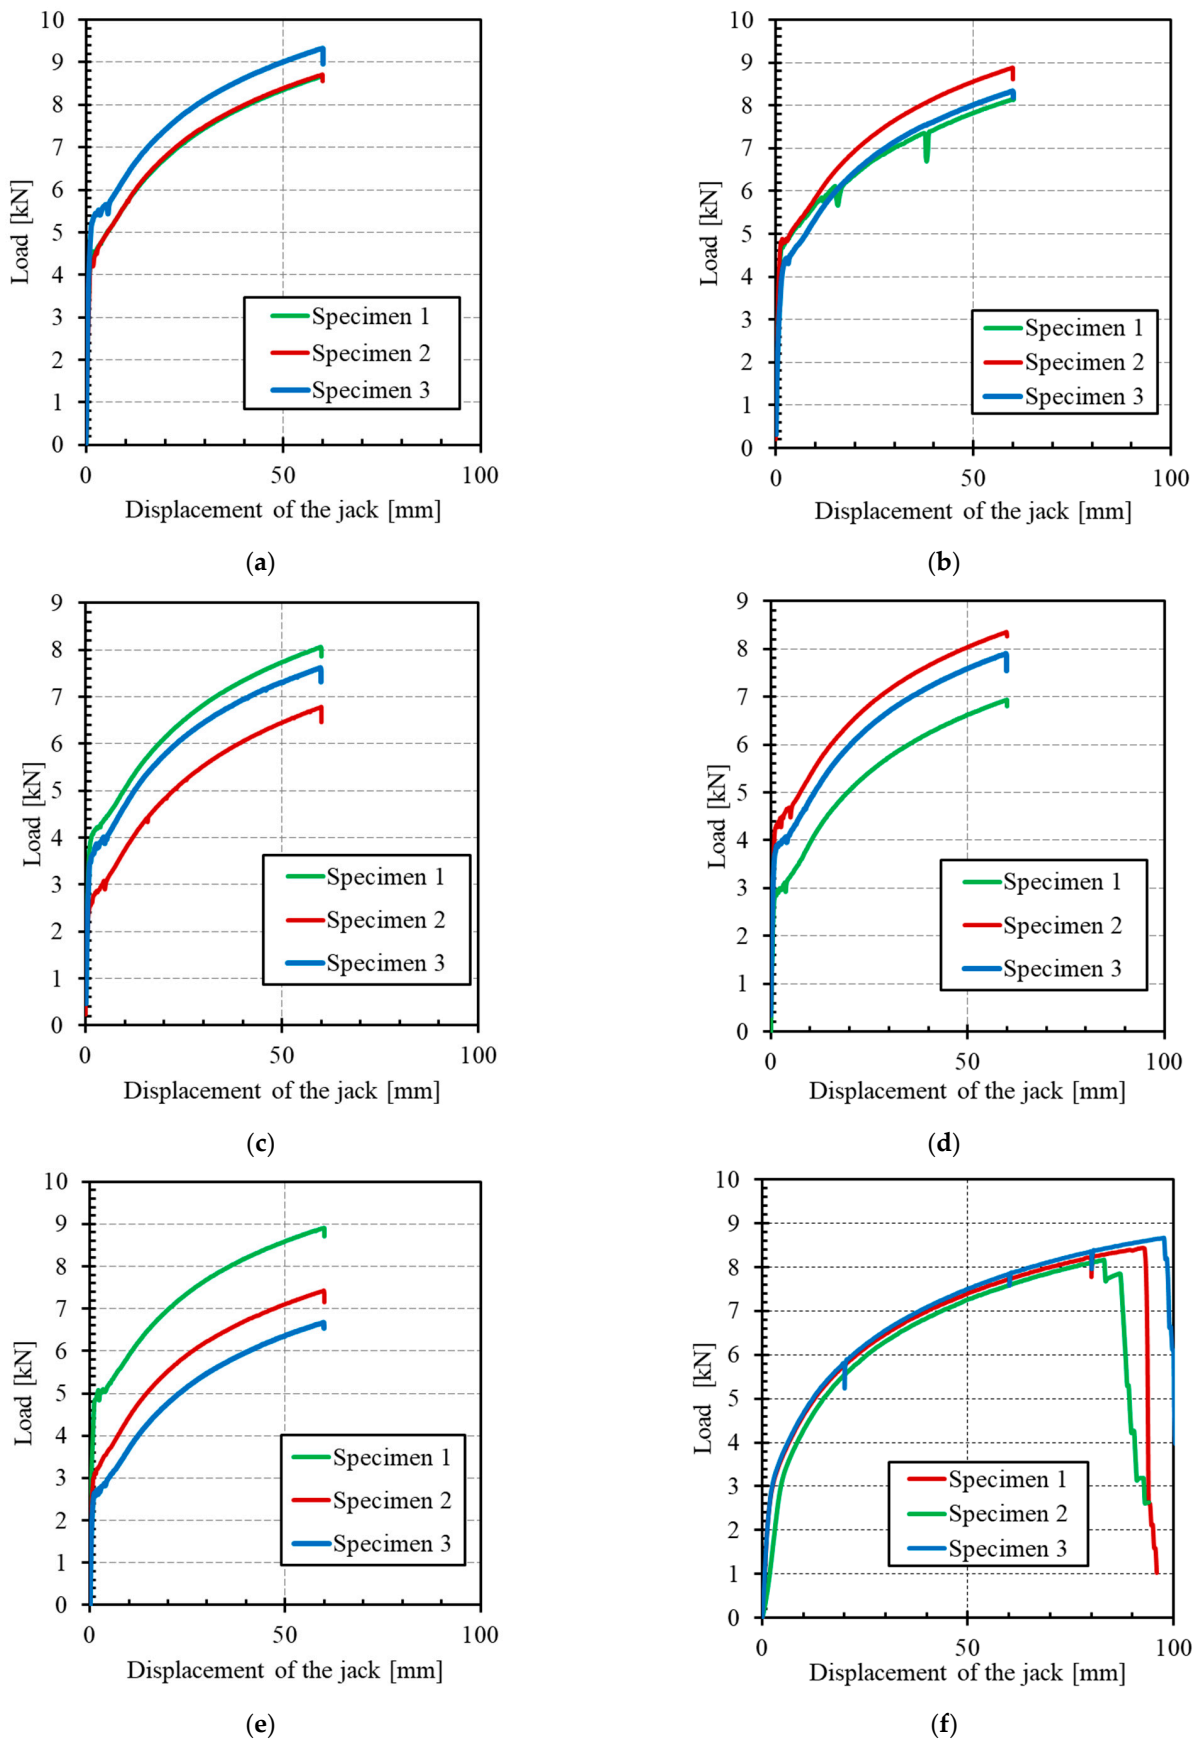
**Figure 7.** Load–displacement curves for the tensile specimens: (a) formulation MI, (b) formulation MII, (c) formulation MIII, (d) formulation MIV, (e) formulation MV, and (f) stainless-steel grid (SSG).

A summary of the tensile test results is presented in Table 3. The load–jack–displacement relationships obtained for the five different mortar formulations and that of the stainless-steel grid alone are shown in Figure 7. Figure 8 illustrates the cracking patterns of the specimens tested.

The curves obtained reflect the typical trilinear behaviour of TRM materials, consisting of a first linear-elastic branch, a second multiple crack formation phase and a third region dominated by the textile response [15,31]. However, the distinctiveness of the current composite is the absence of brittle failure that is encountered with FRP, as already noted elsewhere [32]. The ultimate tensile strength of the composite specimens, despite the differences in mortar formulation, was found to be close to that of the stainless steel-grid alone (in the order of 8 kN). The scatter of results and the low values of the stress level at the end of the tests for some specimens, especially in the third branch, can be explained by the misalignment of the textile layer (parasite flexure, out of plan movement, etc.), the alignment of end plates, the matrix heterogeneity, and the local stress concentration.

several jolts were noted in previous experiments. Nevertheless, the curves in Figure 7 appear to be much more regular, compared to other TRM made from textiles such as basalt [33], aramid [34], glass-aramid [15], steel cords, and carbon [35], among others. This last observation could be very useful in terms of the safety coefficients to be used for design purposes.

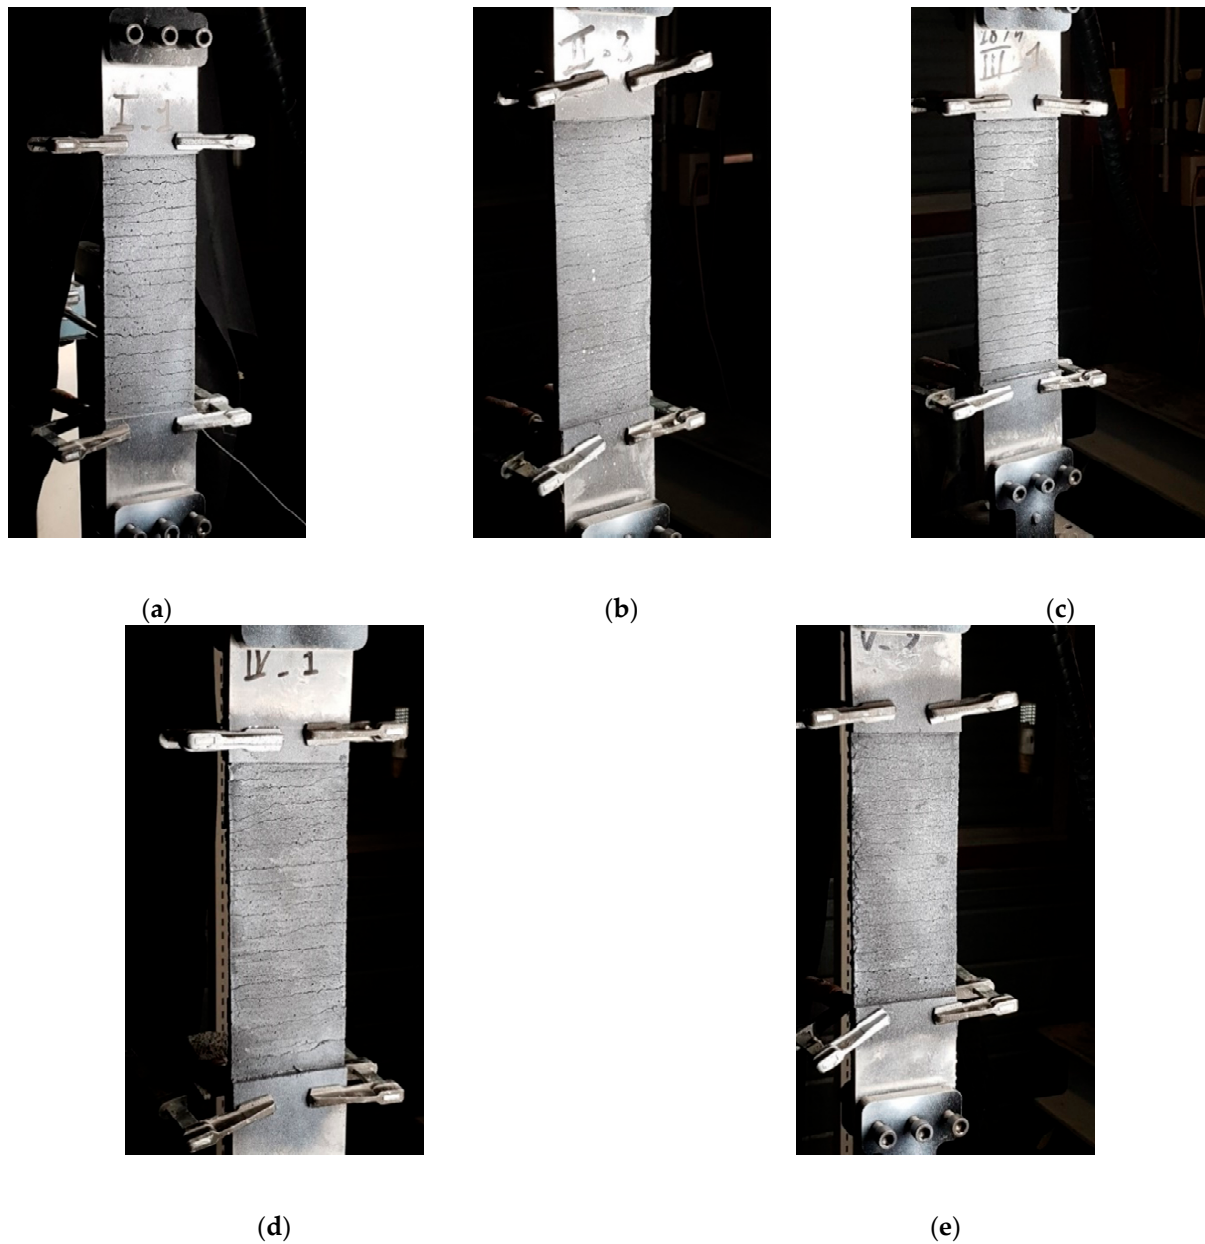
**Figure 8.** Cracking pattern of the tensile specimens for the different mortar formulations: (a) formulation MI, (b) formulation MII, (c) formulation MIII, (d) formulation MIV, (e) formulation MV.

Concerning the crack pattern, the development of cracks observed during tensile tests on composites was characterized by the appearance of transversal cracks perpendicular to the direction of the applied load. Cracking first occurs when the tensile strength of the matrix is reached (theoretically), after which multiple cracking of the matrix occurs in the strain-hardening stage (stage II). The number of cracks and their spacing and width were found to be similar for the five mortar-formulations tested in this study. Compared to other mortar, i.e., lime or fly ash mortars, De Santis and de Felice [6] and Dong et al. [22] found that the use of cement mortar instead of lime mortar or cement mortar with a high replacement level of fly ash (65%) produced a better stiffness in cracking. Considering each formulation independently, the progression of the strength was very similar after the first crack from one test to another, since the gap between the three curves remained constant for the direction of stage II (Figure 7). Moreover, the force-vs-displacement curves were much smoother than those obtained in a previous study with the same stainless-steel grid [20]. One main reason is the lesser strain rate applied during the current study, while

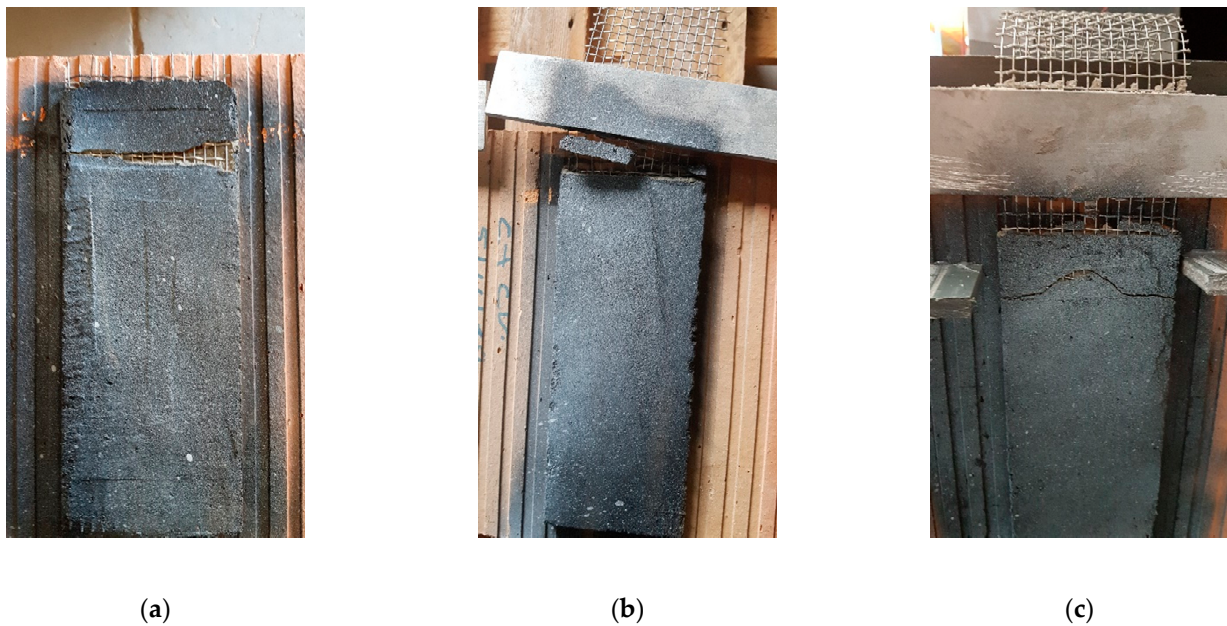
**Figure 9.** Failure mode of the specimens of the mortar formulations: (a) MI, (b) MII, and (c) MIII.

- Mixed failure mode: tensile rupture of the steel grid out of the bonded area with mortar splitting at the loaded end. The failure was initiated by the formation of a single transversal crack on the top part of the bonded area (at an early stage of loading). This crack opened further at the end of the test and the top 1–3 cm of the matrix detached completely from the clay brick. The development of this crack can be explained by the textile elongation within the mortar matrix during the elastic behaviour stage. The rest of the interface was visibly intact, and no cracks/separation was observed. Finally, the failure was ended by rupture of the longitudinal steel cords progressively. This might be attributed to the bonding capacity between fabric and mortar matrix as well as the adherence between composite (fabric and mortar) and clay brick [6,13]. Examples of this failure mode are shown in Figure 9.

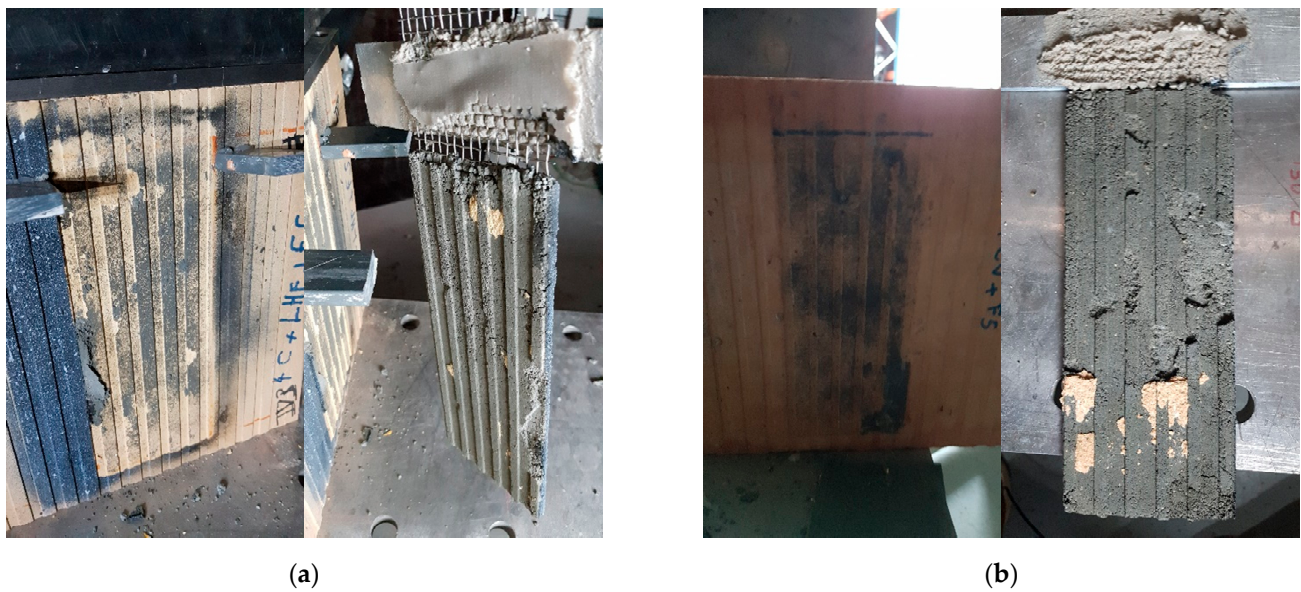
**Figure 10.** Failure mode of the specimens of mortar formulations: (a) MIV and (b) MV.

- Debonding of TRM from the clay substrate without peeling off parts of the clay brick (as shown in Figure 10). Here, the TRM composite remains almost intact after failure and detaches from the substrate as a single body.

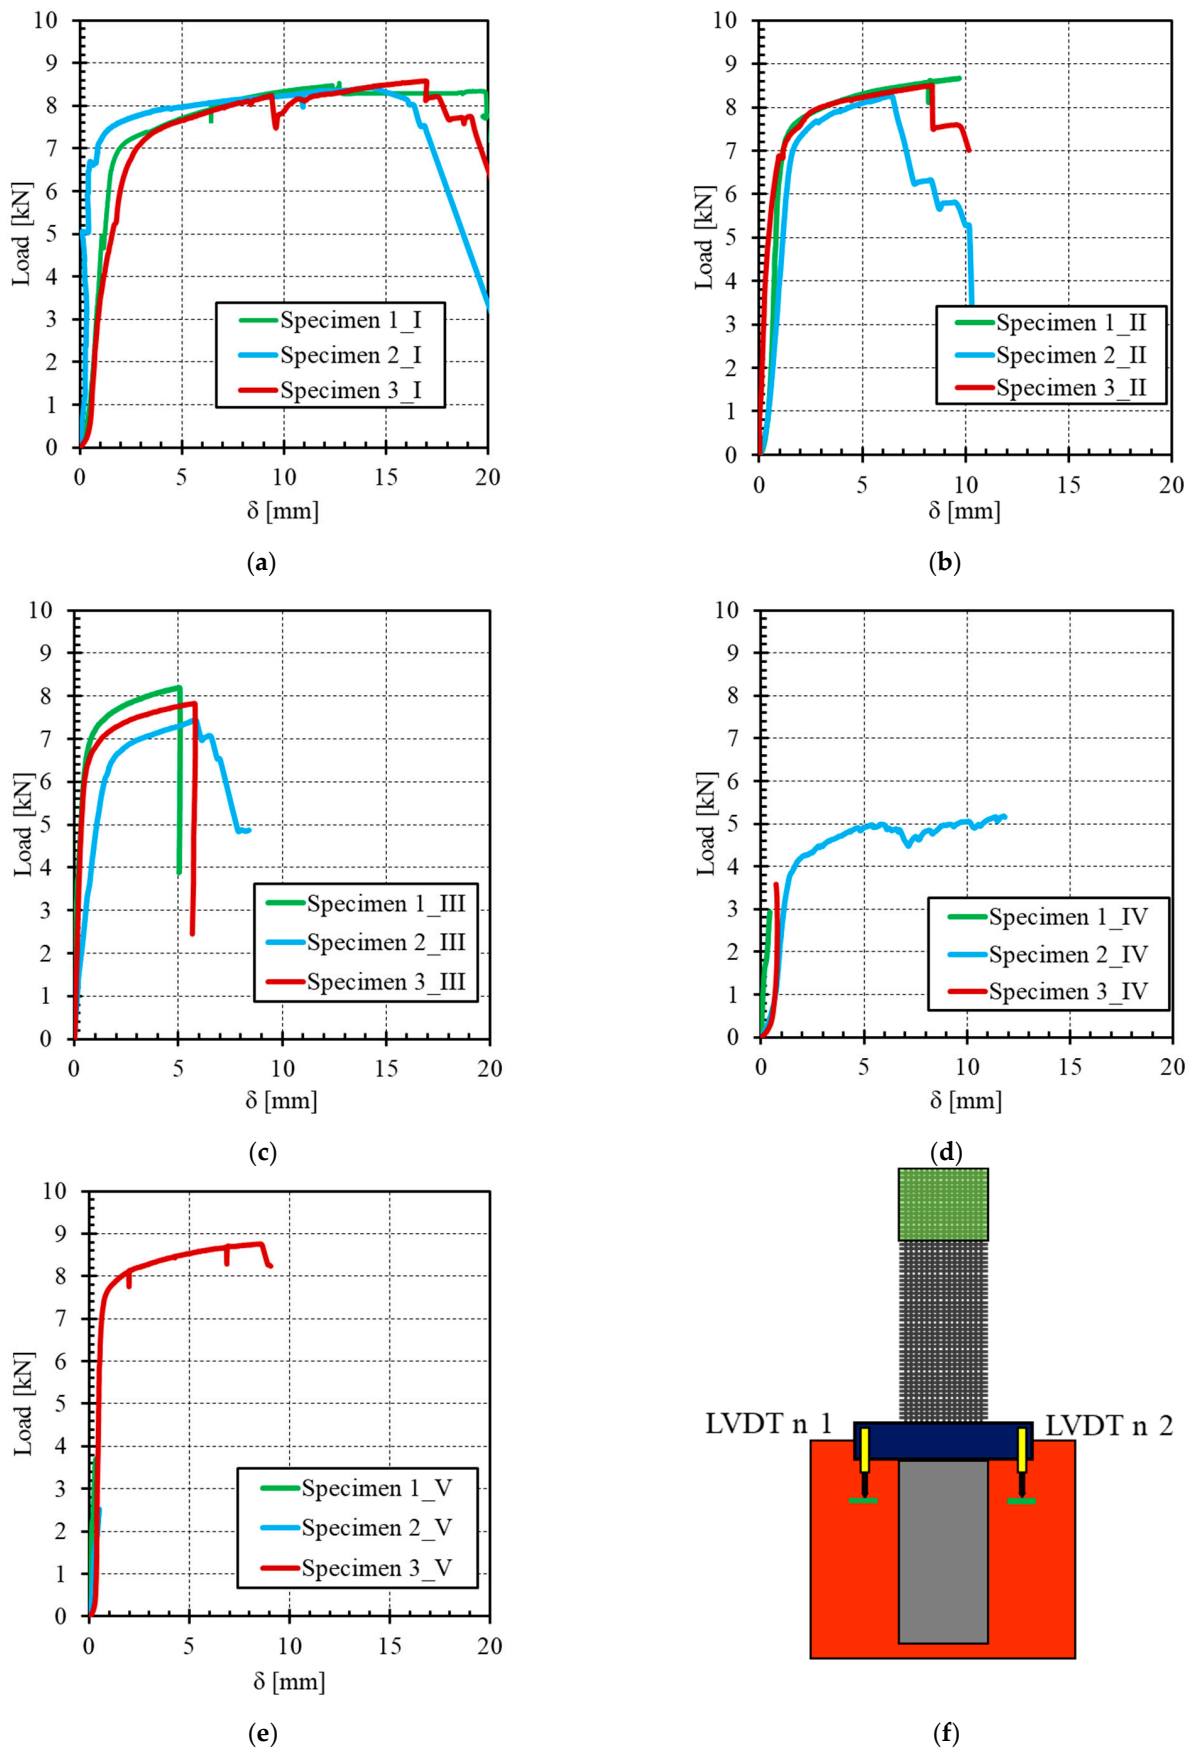
**Figure 11.** Load–relative displacement between SSG and clay brick for the different mortar formulations: (a) formulation MI, (b) formulation MII, (c) formulation MIII, (d) formulation IV, (e) Formulation MV, and (f) locations of the LVDTs.

The axial load–slip curves of the different mortar formulations are plotted in Figure 11, while Table 4 summarizes the results of the bond tests.

The stress transfer mechanisms (load-displacement curves) occurring between the SSG stainless steel grid (SSG) and clay brick are typically divided into two stages, as shown in Figure 11.

- Stage I–Elastic: the linear response signifies the perfect bond between the SSGRM composite and brick.
- Stage II–Non-linear: this stage depends on the failure mode.
  1. Failure mode 1: nonlinear behaviour of the SSG (ductility) followed by brutal rupture of the steel cords.
  2. Failure mode 2: partial debonding starts and spreads along the bonded length with successive debonding until entire embedded length is debonded. This behaviour stage was not observed because of the high stroke rate. The SSGRM was brutally separated from the clay brick.

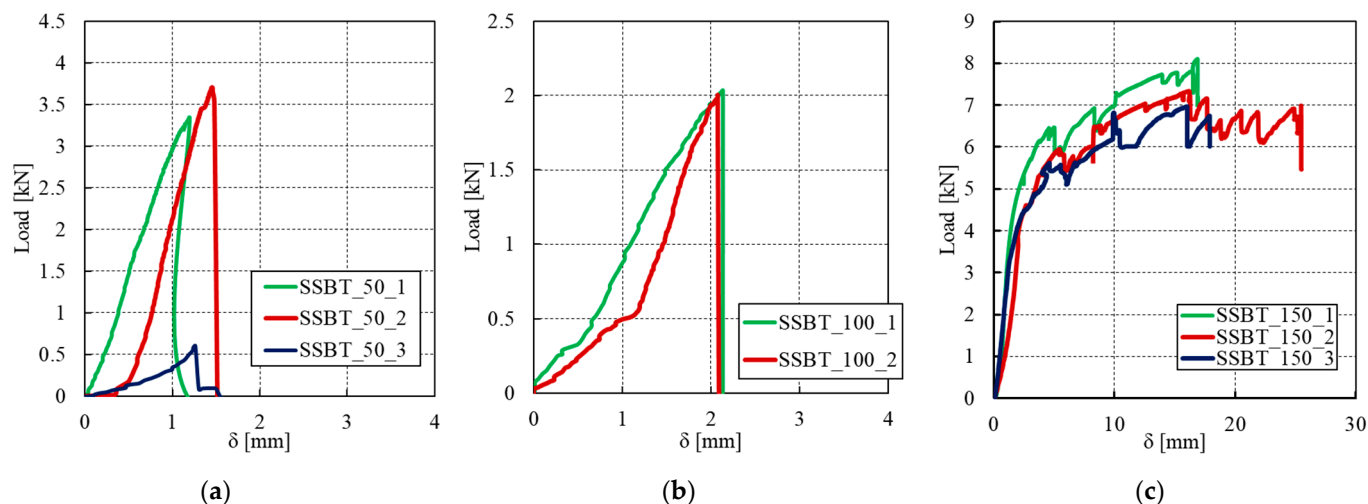
**Figure 12.** Load–relative displacement between SSG and clay brick of the different anchoring lengths: (a) 50 mm, (b) 100 mm, and (c) 150 mm.

The average results of all the tested specimens are presented in Figure 12. Here, “SSBT” denotes the shear bond test, “50, 100, and 150” denote the anchoring length in millimetres, while the last number denotes the sample number. The mean peak load, mean maximum relative displacement (slip) measured by the LVDT, exploitation ratio, and ultimate shear of each anchoring length are summarized in Table 5. The ultimate shear stress was calculated by dividing the ultimate load at failure by the bonded area.

All the specimens exhibited an initial uncracked behaviour, associated with a stiff response, as shown in Figure 12. The behaviour is almost brittle for the two smallest anchoring lengths of 50 mm and 100 mm. One sample of each anchoring length did not even reach a significant strength. For the 50 mm anchoring length, it broke directly by debonding at the substrate–matrix interface in only a few seconds after applying the load. The same observation was made at the very start of one test for the 100 mm anchoring length, so that only two samples could be considered for these anchoring lengths. For other two specimens with an anchoring length of 50 mm, a cohesive failure within the clay brick was observed. A chunk of the brick attached to the SSGRM was generally found after failure, as shown in Figure 13a. This mode of failure proves that the matrix has allowed for a full transmission of efforts between the two substrates, in other words, the matrix has provided a stronger adhesion bond than the shear strength of the brick. Regarding specimens with 100 mm anchoring length, Figure 13b shows that failure occurred at the brick/matrix interface with splitting of the clay–brick. This may be explained by the low adhesion between the matrix and the brick due to the geometrical imperfections or by several factors occurring during the preparation of the specimens, such as the presence of small air bubbles and surface preparation (humidification). This is confirmed by the low exploitation ratio obtained with this anchoring length (Table 5). By contrast, the

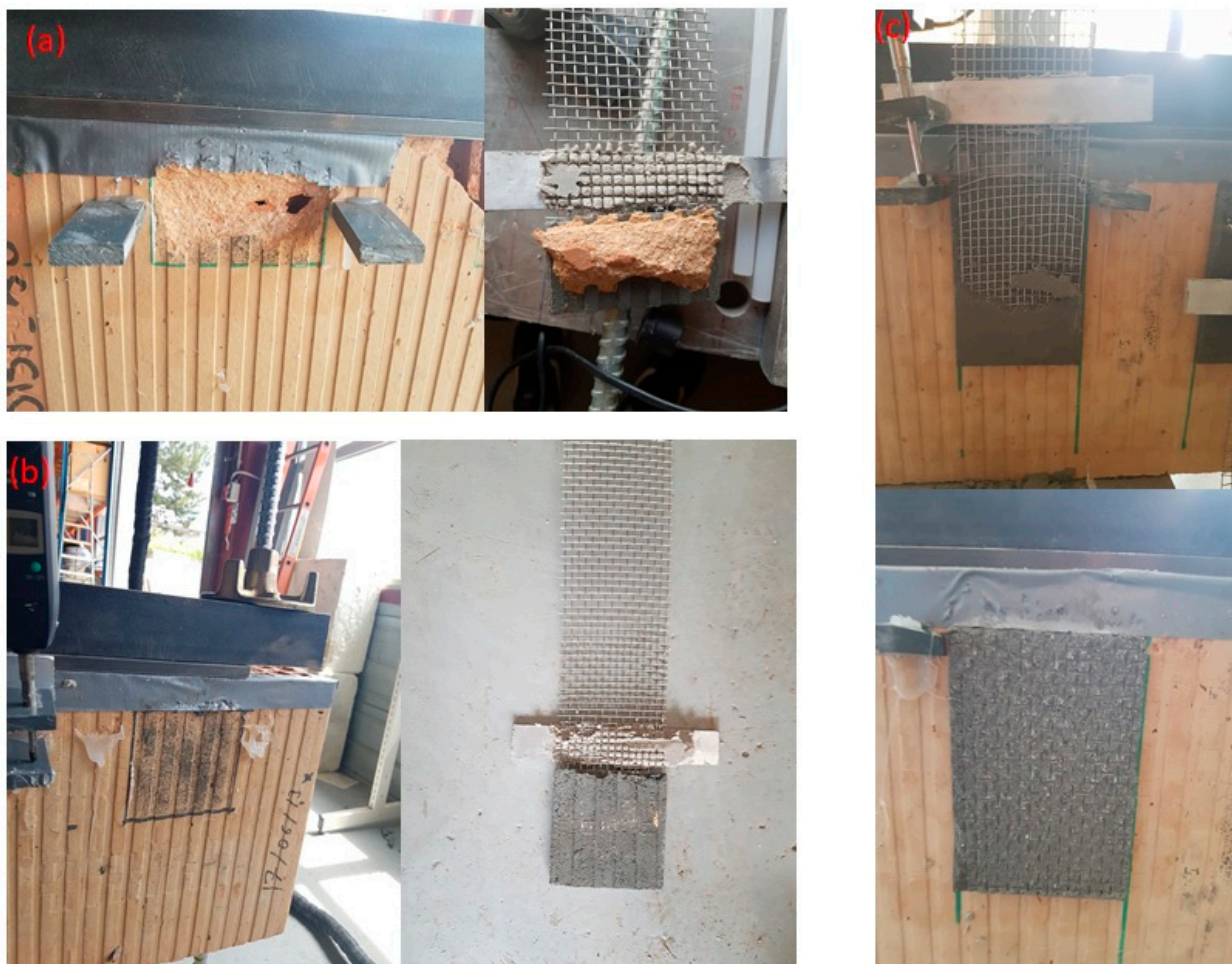
**Figure 13.** Failure modes of specimens with an anchorage length of (a) 50 mm, (b) 100 mm, and (c) 150 mm.

samples with the 150 mm anchoring length exhibited a non-linear behaviour with high ductility, corresponding to the generation of multiple cracks in the composite. The results from the different specimens with this anchorage length are almost repeatable and the exploitation ratio is close to 1.0, which is also quite close to the value obtained with the highest anchorage length of 250 mm. For all the specimens, the failure mode observed from the bond tests was cohesive by debonding at the textile-matrix interface, as shown in Figure 13c. The rupture of the specimens was by shearing in the matrix close to the textile-matrix interface. Indeed, a transversal crack in the matrix near the loaded end of composite was observed first. This crack led to detachment of the matrix from the textile and some matrix chunks fell from the composite. The matrix detachment continued expanding and ultimately became wide enough to lead to the separation of the textile and the matrix. A thick mortar layer was kept with the brick after specimen failure, indicating a high adhesion between the matrix and the brick. This observation is in agreement with the findings of previous experimental studies on SSGRM [15].

The results of the bond tests performed on SSGRM showed that the anchorage length may have a significant effect on the failure mode and the exploitation ratio of the composite. As a result, it was found that the anchoring length of 150 mm is sufficient to ensure the efficiency of the current TRM.
