Failure Analysis of Atmospheric Neutron-Induced Single Event Burnout of a Commercial SiC MOSFET

Keywords: power MOSFET, silicon carbide (SiC), neutrons, single event burnout (SEB), failure analysis

Abstract. Dealing with electronic devices for high reliability applications in terrestrial environments, neutron-induced Single Event Effects must be investigated. In this paper, the experimental observation of an atmospheric-like neutron-induced Single Event Burnout (SEB) on a packaged commercial SiC power MOSFET is presented after irradiation at ISIS-ChipIr. The effects of the SEB in the electrical properties of the MOSFET are established, and the SiC damaged zone is observed by scanning electron microscopy. Based on this failure analysis at the die level, the distinct stages during the SEB mechanism can be defined. The sensitive volume where the secondary particle deposited enough energy to trigger the SEB mechanism is identified and located inside the SiC n-drift epitaxial layer near the epitaxial layer/substrate junction.

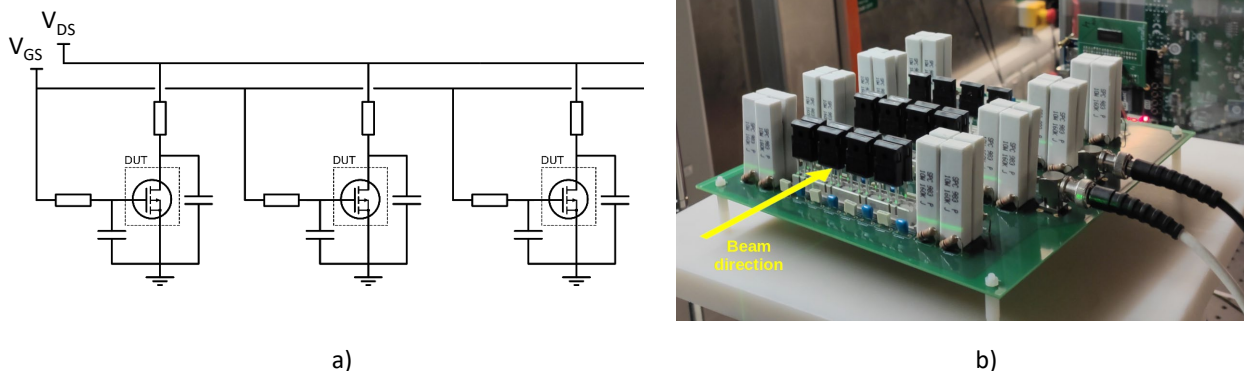
Figure 1: a) Schematic of the dedicated test board for irradiation (for 3 devices) and b) picture of the board with SiC MOSFETs.

To evaluate the irradiation effect, a dedicated test board following the MIL-STD-750E test standard has been designed and fabricated. The test board containing DUTs is placed under the radiation beam while drain and gate voltages are controlled. Source measurement units (SMUs) are used to supply voltages and to measure currents in the control room. The SMUs were controlled and data were collected via Ethernet and USB interfaces. The schematic diagram of the developed irradiation test setup is presented in Fig.1.a). The SiC devices were connected in parallel configuration. For each DUT, a series resistor at the drain was placed in order to limit the total current of the power supply to ensure bias voltage stability across the rest of the non-failed devices. On top of that, a capacitance was placed at the drain of each DUT providing sufficient energy for SEB. Fig.1.b) shows the test board in the irradiation room. During neutron irradiation, $V_{DS} = 675$ V (75% of the V_{DSmax}) and $V_{GS} = 0$ V were applied.

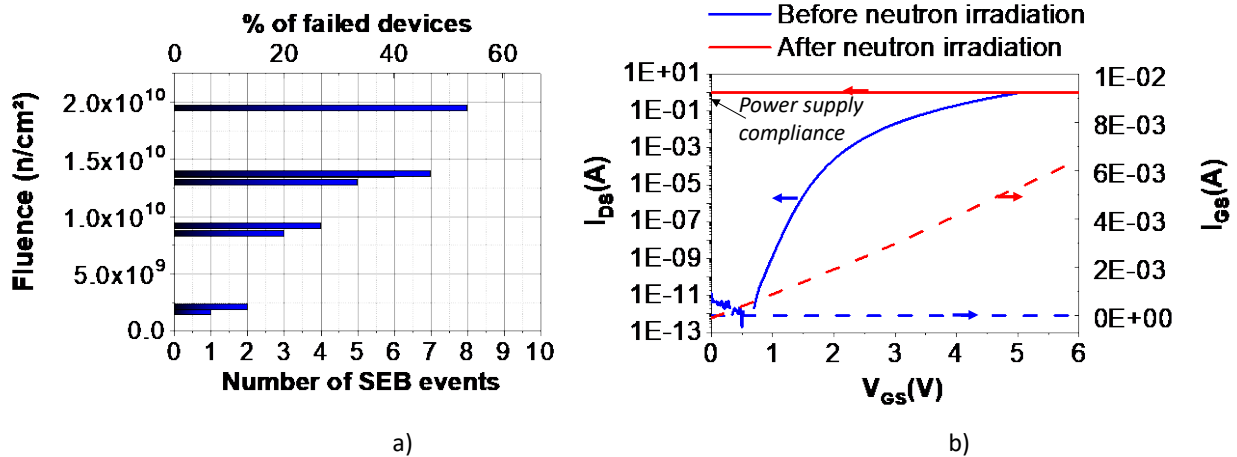
Figure 2: a) Fluences of SEB occurrence during neutrons irradiations, b) $I_{DS}-V_{GS}$ and $I_{GS}-V_{GS}$ before and after neutron irradiation for a device having suffered a SEB.

Experimental results are reported in Fig.2. Fifteen devices, with the same lot number, were irradiated by neutrons. A SEB event was detected by the increase of I_{DS} of the device. The cumulative SEB events is plotted versus the neutron fluence (Fig.2.a). Since the neutron-matter interaction is considered as a stochastic process, as expected, a constant rate increase with time is observed. Moreover, Weibull shape parameter of the neutron induced failure distribution is 0.93, close to 1,

which indicates random failures i.e. constant failure rate over time. After the total fluence of 2×10^{10} n/cm², 53 % of the irradiated devices were destroyed, thus eight devices of the initial lot. For a device having suffered a SEB, subthreshold $I_{DS}-V_{GS}$ and $I_{GS}-V_{GS}$ before and after irradiation are represented in Fig.2.b). Electrical characterizations after neutron irradiation show the occurrence of the short circuit between the drain and the source due to the SEB. After neutron irradiation, the I_{DS} exhibits an increase and reaches the compliance limit, implying the loss of voltage blocking capability of the SiC MOSFET structure. On top of that, from $I_{GS}-V_{GS}$ response, a low resistance current path from gate to source is measured.

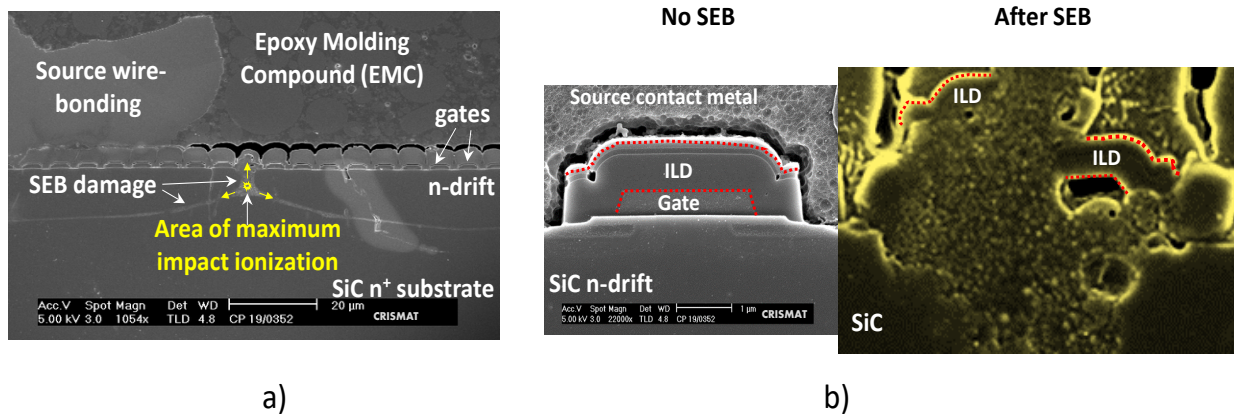
Figure 3: SEM views of the SiC MOSFET structure after SEB, a) large view where the location of the impact is determined and b) comparison of two gates regions without and after SEB.

Cross sectional Scanning Electron Microscopy (SEM) views indicate the residual trace induced by the SEB inside the SiC die from the top of the gate (in the metal contact source) to the SiC substrate (Fig.3.a)). Indeed, looking at the failure analysis results, residual deformations, cracks, appearance and shape of the materials allow to propose the following scenario for describing the different steps of the failure mechanism. If the root cause is known to be a nuclear neutron-atom interaction, the SEB can only be initiated by ionizing particles such as recoil ions or secondary atoms created through the primary neutron interaction. A bifurcation shape of the damage inside the SiC material suggests that the secondary particle has deposited enough energy in this sensitive volume (area located in Fig.3.a). Due to the high local electrical field, the impact ionization current is created, and generated electrons and holes respectively flow towards the drain (from the SiC epilayer to the substrate) and the source contacts, surrounding the gate contact. This bifurcation trace is clearly located at the point of maximum impact ionization inside the SiC, which corresponds to the hot spot during the SEB (the point of the highest temperature). Therefore, the starting point of the SEB is thus located in the n-drift epitaxial region below the channel. This experimental observation agrees with the location of the SEB sensitive volume determined by simulations in reference [12]. A zoom of the damage in the gate region is compared with a gate without impact (Fig.3.b)). In the SEM view, after the SEB the gate and interlayer dielectric (ILD) are completely blown up. Due to the SEB, the ILD is cut in two parts and one part is displaced, thrown up into the source metal. This is an evidence of a self-sustained

strongly localized overheating through the impact ionization process and/or the Kirk effect. Once the SEB has resulted in the high drain current state due to the short-circuit between drain and source and an electrical connection of the metal source contact to the drain is created. Like a fire blast, a collateral effect likely related to the thermal expansion of SiC material has been observed, leading to the total contact melting and metal inclusion. As a more global thermal consequence, we also observe the delamination of the epoxy resin of the metal layer.
