Failure Analysis of Atmospheric Neutron-Induced Single Event Burnout of a Commercial SiC MOSFET

Abstract. Dealing with electronic devices for high reliability applications in terrestrial environments, neutron-induced Single Event Effects must be investigated. In this paper, the experimental observation of an atmospheric-like neutron-induced Single Event Burnout (SEB) on a packaged commercial SiC power MOSFET is presented after irradiation at ISIS-ChipIr. The effects of the SEB in the electrical properties of the MOSFET are established, and the SiC damaged zone is observed by scanning electron microscopy. Based on this failure analysis at the die level, the distinct stages during the SEB mechanism can be defined. The sensitive volume where the secondary particle deposited enough energy to trigger the SEB mechanism is identified and located inside the SiC n-drift epitaxial layer near the epitaxial layer/substrate junction.

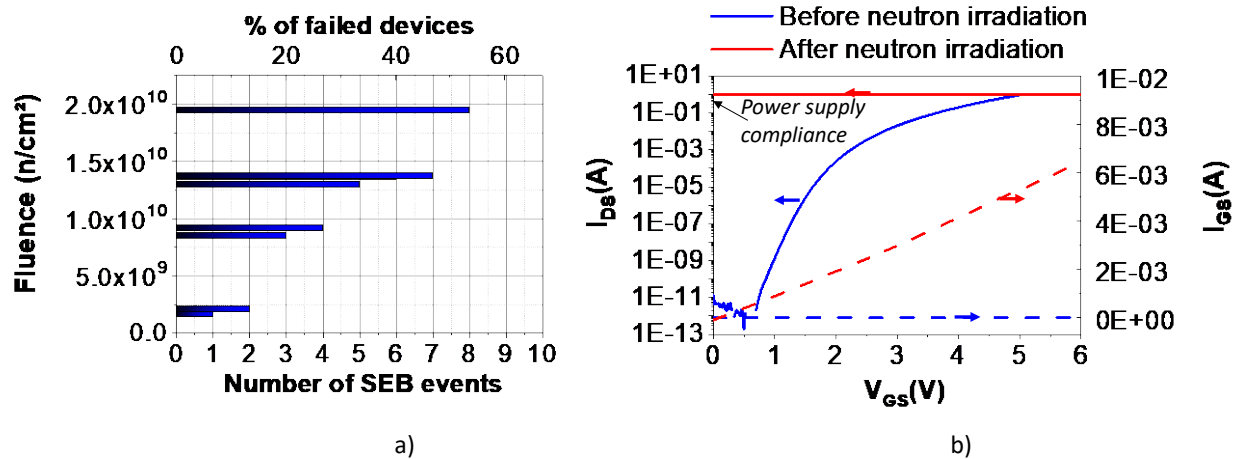
Figure 2: a) Fluences of SEB occurrence during neutrons irradiations, b) $I_{DS}-V_{GS}$ and $I_{GS}-V_{GS}$ before and after neutron irradiation for a device having suffered a SEB.

Experimental results are reported in Fig.2. Fifteen devices, with the same lot number, were irradiated by neutrons. A SEB event was detected by the increase of I_{DS} of the device. The cumulative SEB events is plotted versus the neutron fluence (Fig.2.a). Since the neutron-matter interaction is considered as a stochastic process, as expected, a constant rate increase with time is observed. Moreover, Weibull shape parameter of the neutron induced failure distribution is 0.93, close to 1,

which indicates random failures i.e. constant failure rate over time. After the total fluence of 2×10^{10} n/cm², 53 % of the irradiated devices were destroyed, thus eight devices of the initial lot. For a device having suffered a SEB, subthreshold $I_{DS}-V_{GS}$ and $I_{GS}-V_{GS}$ before and after irradiation are represented in Fig.2.b). Electrical characterizations after neutron irradiation show the occurrence of the short circuit between the drain and the source due to the SEB. After neutron irradiation, the I_{DS} exhibits an increase and reaches the compliance limit, implying the loss of voltage blocking capability of the SiC MOSFET structure. On top of that, from $I_{GS}-V_{GS}$ response, a low resistance current path from gate to source is measured.
