Imaging in Hip Arthroplasty Management Part 2: Postoperative Diagnostic Imaging Strategy

Charles Lombard, Pierre Gillet, Edouard Germain, Fatma Boubaker, Alain Blum, et al.. Imaging in Hip Arthroplasty Management Part 2: Postoperative Diagnostic Imaging Strategy. *Journal of Clinical Medicine*, 2022, 11 (15), pp.4416. 10.3390/jcm11154416 . hal-03749840

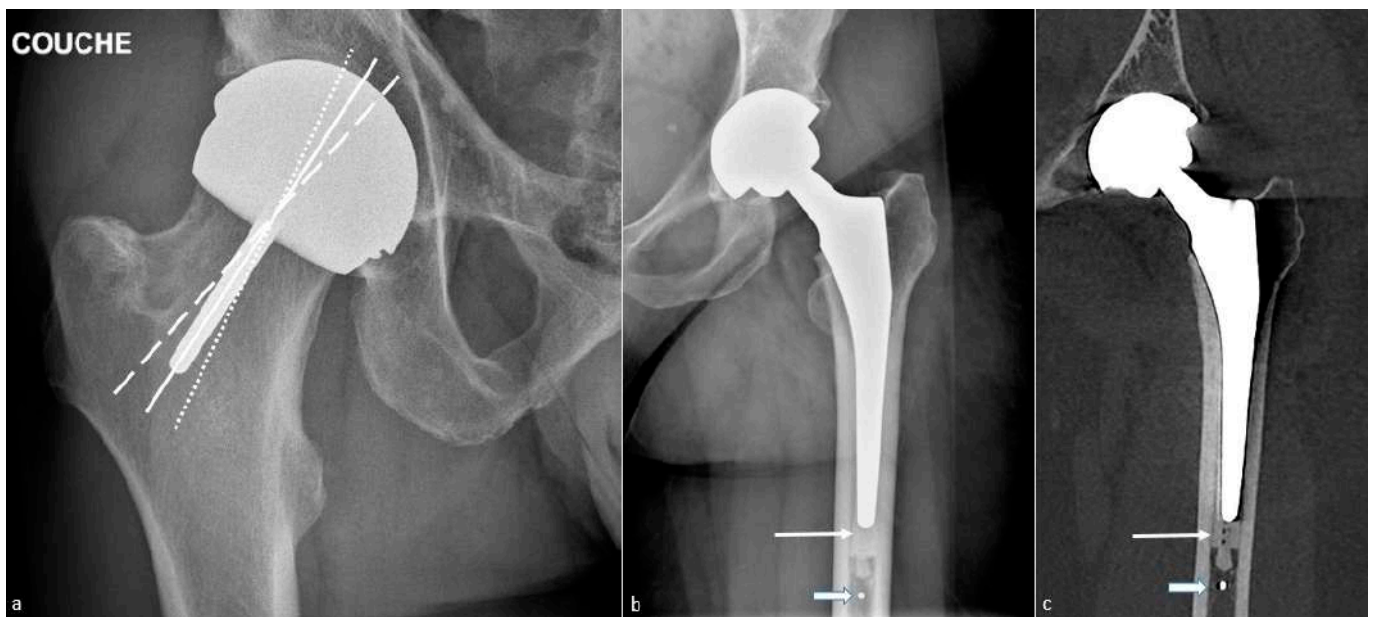
Figure 1. Total hip arthroplasties. A resurfacing arthroplasty is shown on (a) an antero-posterior hip radiograph and a conventional arthroplasty on (b) an antero-posterior hip radiograph and (c) a frontal CT-scan reformat. On (a), note the neutral position of the stem of the femoral component (white line). One should consider that slight valgus can be tolerated (little-dotted white line) and that varus positioning should not occur (large-dotted white line). On (b,c), also note the cement (thin arrow) and a metallic marker at the distal part of a cement restrictor (thick arrow).

THA can be conventional or resurfacing types and replaces both the femoral and acetabular sides of the hip. The component's analysis must include the acetabular cup, the femoral head, and the femoral stem. Acetabular and femoral components may themselves be modular (neck-head and/or neck-stem junctions) or nonmodular (one piece), the latter being currently uncommon [13]. Therefore, the femoral component might be composed of one, two, or three parts (stem, collar, head) and the acetabular component of one or two (metal-back and insert) pieces. Dual mobility works by containing a three-component system: a socket, a free polyethylene (PE) liner, and a head, allowing mobility between the femoral head and the liner and between the liner and the acetabular cup [41]. "Sandwich" liner refers to a PE insert outlined in its inner face by a ceramic or metallic layer to combine PE elasticity and metal or ceramic resistance, and in its outer surface by an acetabular metal back so that the PE finds itself in a "sandwich" position between two "hard" layers [42]. A resurfacing prosthesis only replaces the proximal femoral head, leaving the native femoral neck and a part of the femoral head intact. This kind of prosthesis is mostly used in younger patients as it preserves bone stock and allows for easier revision than conventional THA [14,32] (Figure 1).

Resurfacing arthroplasty responds to specific issues. Even though the acetabular component position does not differ from other types of prosthesis (lateral inclination of $30\text{--}50^\circ$ and anteversion of $5\text{--}25^\circ$), the femoral component must be placed in a relative valgus position of $5\text{--}10^\circ$ to avoid notching the neck (in case of excessive valgus) and to adequately cover the femoral neck [32] (Figure 1).

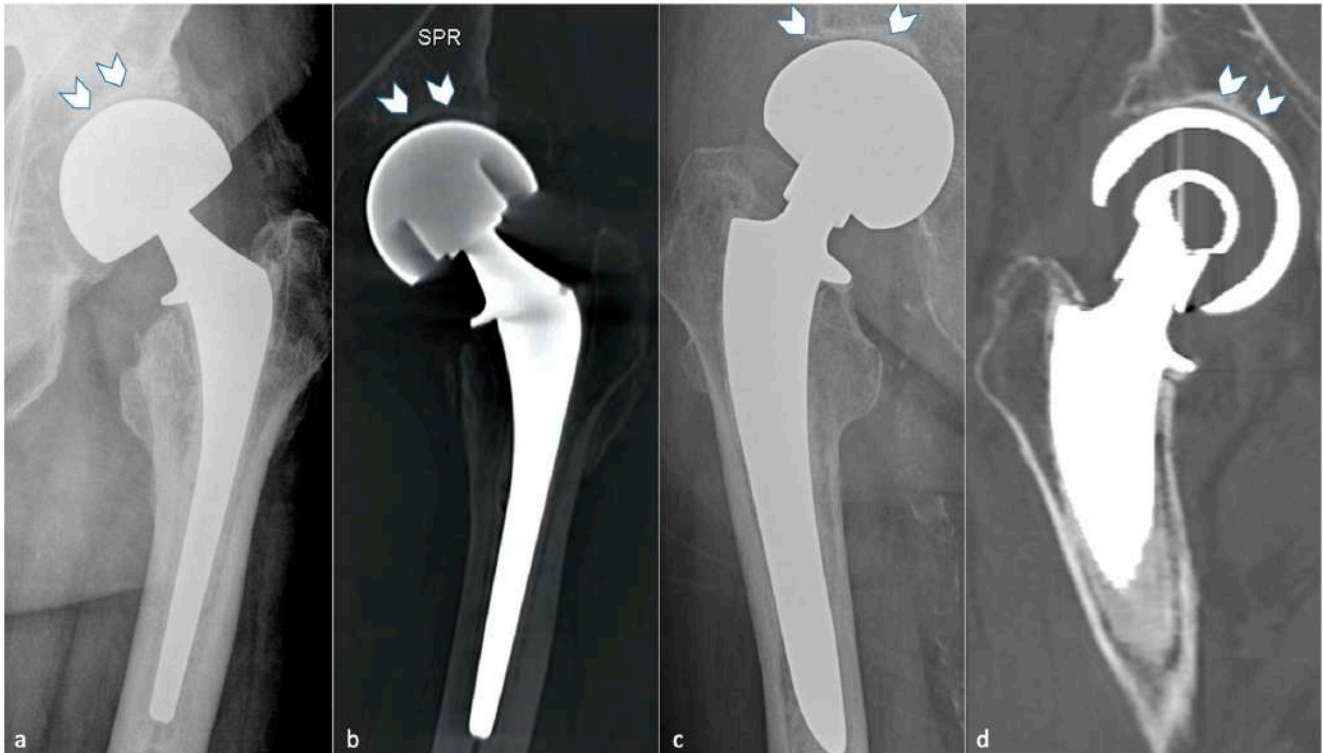
Figure 2. Hip hemi-arthroplasties. A unipolar arthroplasty is shown on (a) an antero-posterior hip radiograph and (b) a coronal slice of CT-MAR. A bipolar arthroplasty is shown on (c) an antero-posterior hip radiograph and on (d) a coronal slice of CT-MAR. Note that the native acetabulum can be seen on all imaging modalities in both cases (white arrowhead).

A hemi-prosthesis only replaces the femoral head and can be unipolar (femoral component articulating with the native acetabulum) or bipolar (femoral component articulating with a non-fixated acetabular cup) (Figure 2). Distinguishing a hemi-prosthesis from THA is crucial and can be completed by analyzing acetabular native cartilage and subchondral plate, both preserved in hemiarthroplasty. One must keep in mind that the acetabular cartilage might wear down, leading to a protrusion of the acetabular modular piece, which might be confused with an acetabular THA component. Additionally, a bipolar femoral head has a slightly greater than hemispheric shape, lacks screw holes, and has a smooth outer surface rather than a textured one in case of THA [37].

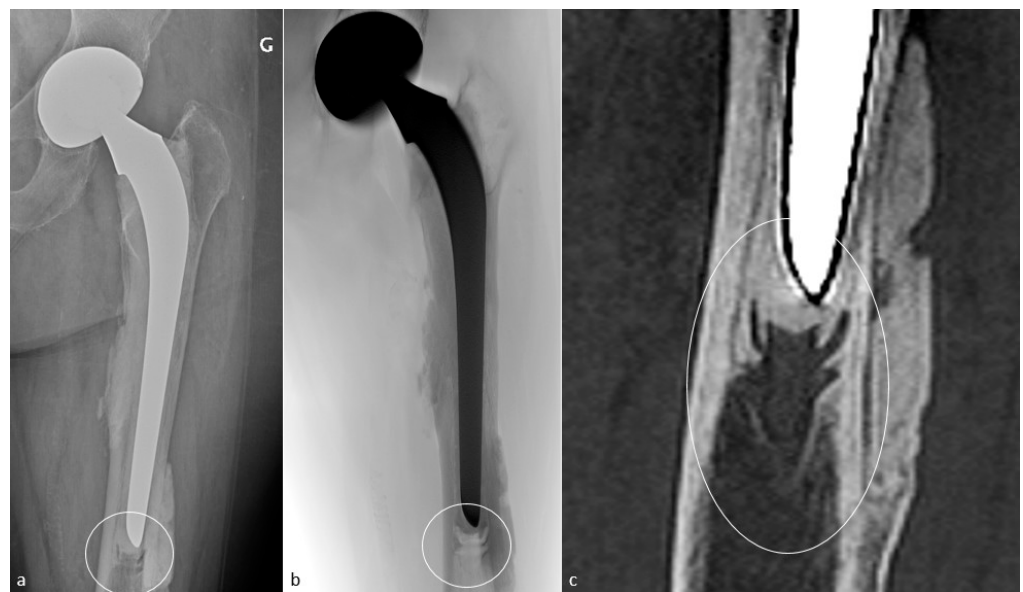
Figure 3. Distal centralizer in a cemented femoral stem. A centralizer is shown on an anteroposterior radiograph (a), a tomosynthesis (b), and a CT-scan reformat (c) (white circle). Note its radiolucent and hypodense aspect.

In cemented femoral components, intramedullary plugs are commonly used and are available in a wide variety of materials and shapes, both biodegradable and non-resorbable. Osteolytic changes around biodegradable models have even been described [46]. Some types of restrictors have a metallic marker that can appear at the tip of the stem (Figure 1). Additionally, a proximal and/or distal centralizer can be used to obtain a uniform cement mantle and neutral alignment of the femoral stem [47]. It is composed of polymethylmethacrylate [48] and can appear as a radiolucent zone not to be mistaken for osteolysis (Figure 3).

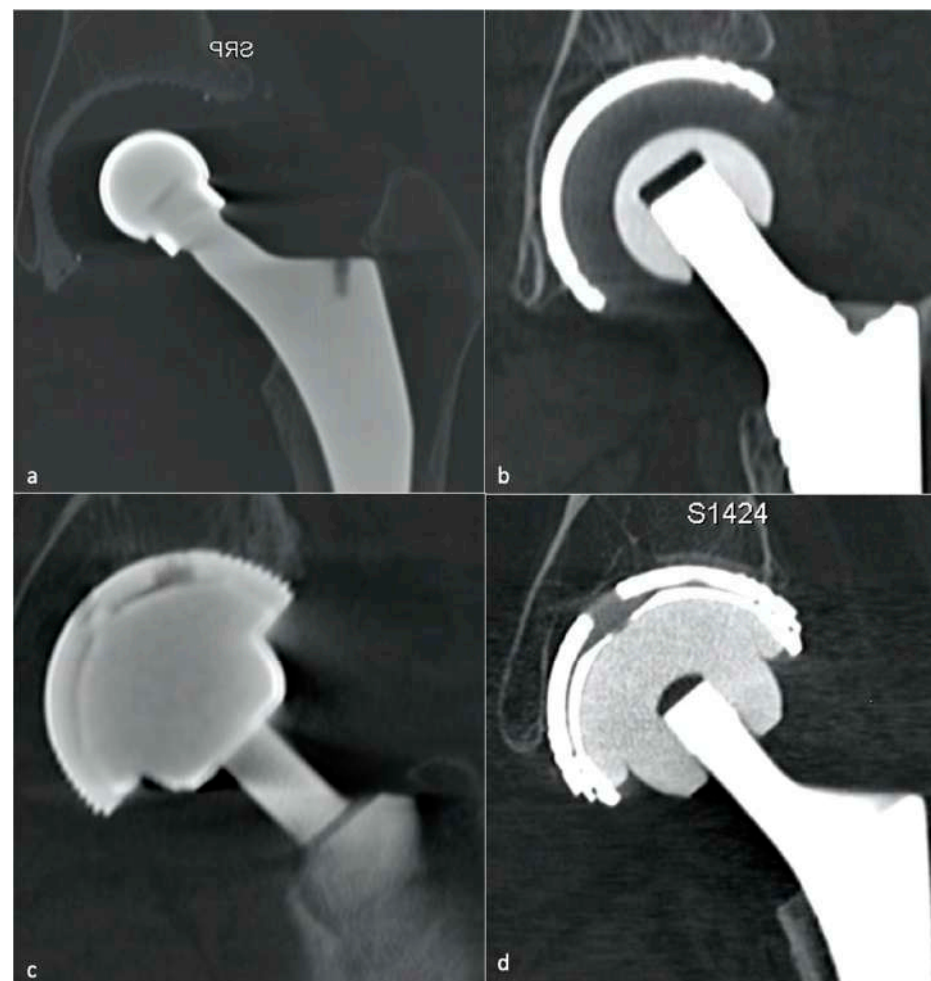
Figure 4. Bearing surfaces. Coronal slices of CT-scan showing on (a) a metal–polyethylene couple, (b) a ceramic–polyethylene couple, on (c) a metal–metal couple, and on (d) a ceramic–ceramic couple. The material can be recognized by its density with a «visual» scale as polyethylene is less dense than ceramic which is itself less dense than metal.

The four couples used are metal–PE (MoP), ceramic–PE (CoP), metal–metal (MoM), and ceramic–ceramic (CoC) (Figure 4). However, the optimal bearing surfaces are still under debate. PE liners are often used on the acetabular side, regardless of the artificial head [52]. MoM THA with large femoral head diameters have led to a high rate of adverse reactions to metal debris and pseudo-tumors, leading to an almost worldwide cessation of their use and reinforced surveillance [53]. MoP bearing was known to lead to particles disease secondary to contact pressure-induced wear, but recent data showed that the use of an acetabular ultra-high molecular weight PE cup in association with a titanium alloy femoral head could reduce the wear rate compared to cobalt chromium molybdenum and stainless steel so that it can extend the life of THA, in developing countries, especially for Indonesian and, more widely, Asian people [6]. Additionally, to decrease the amount of PE wear debris, alumina ceramics can be used with newer PE, with good long-term functional and radiologic outcomes, so that CoP is thought to be an excellent bearing couple and accounts for more than half of THA in the USA [52]. CoC bearings have been widely used in Korea for economic purposes but can lead to ceramic fractures and squeaking. Those specific complications rate might be dramatically decreased by the use of CoP bearing surfaces [52].

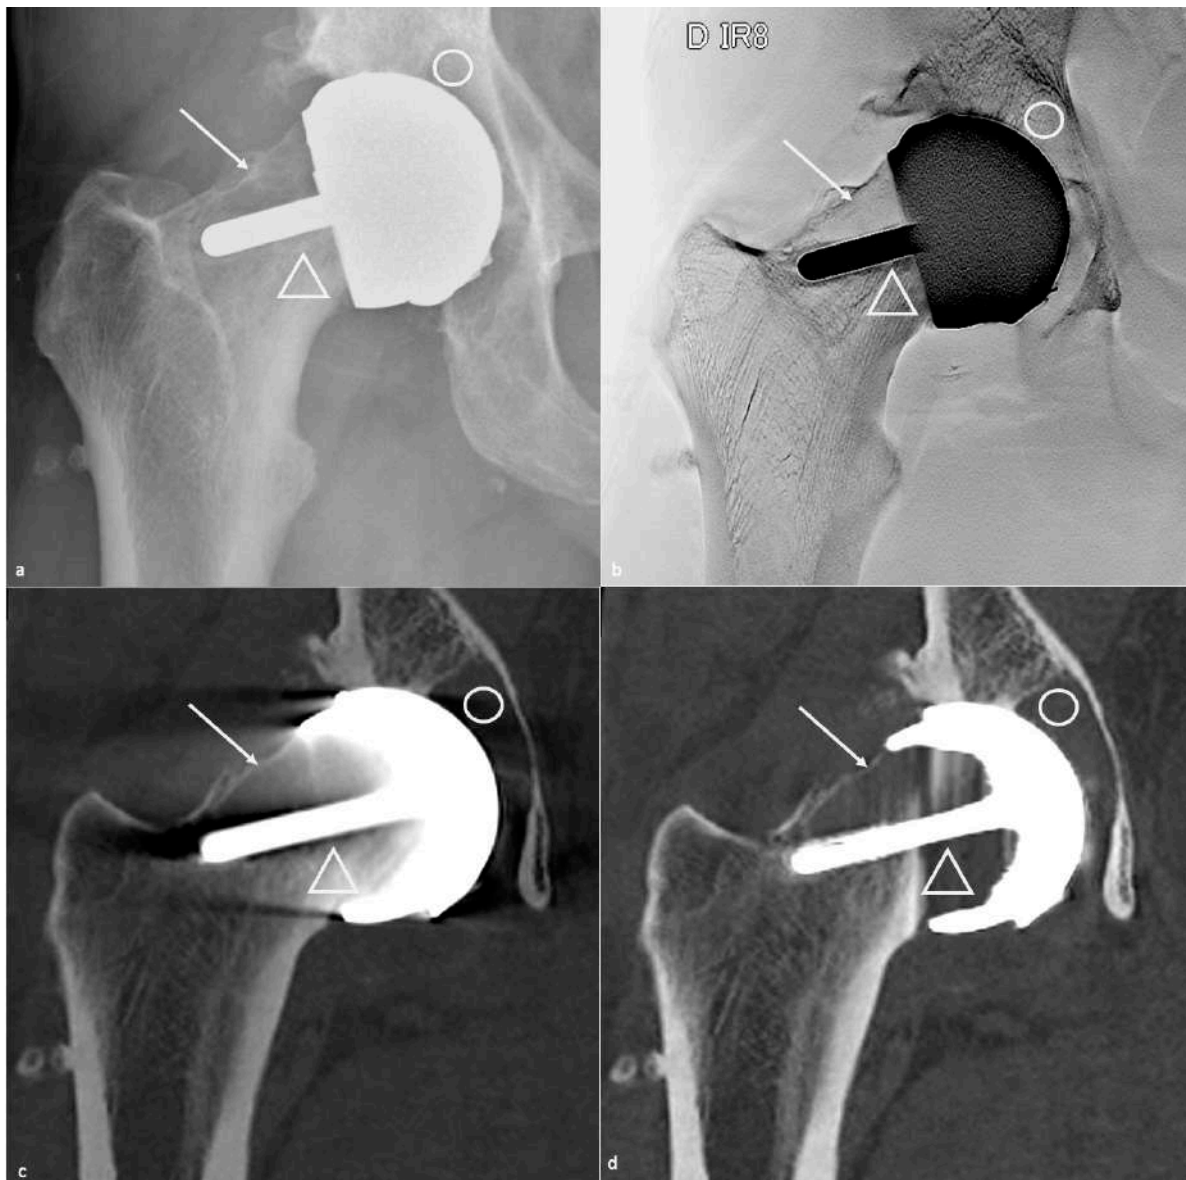
Figure 5. Peri-prosthetic osteolysis. Radiolucent zones are shown on (a) an anteroposterior hip radiograph, (b) an anteroposterior tomosynthesis view, (c) a coronal CT image, and (d) a coronal metal-artifact reduction CT image. All imaging modalities depict true osteolysis in the superomedial acetabulum (grey circle). Superior femoral neck osteolysis (grey arrow) is doubtful on (a,d) but is depicted on tomosynthesis (b) and CT with metal-artifact reduction (d). On the other hand, artefactual osteolysis is seen in (d) (grey triangle), underscoring the need for a combined interpretation of all imaging modalities.

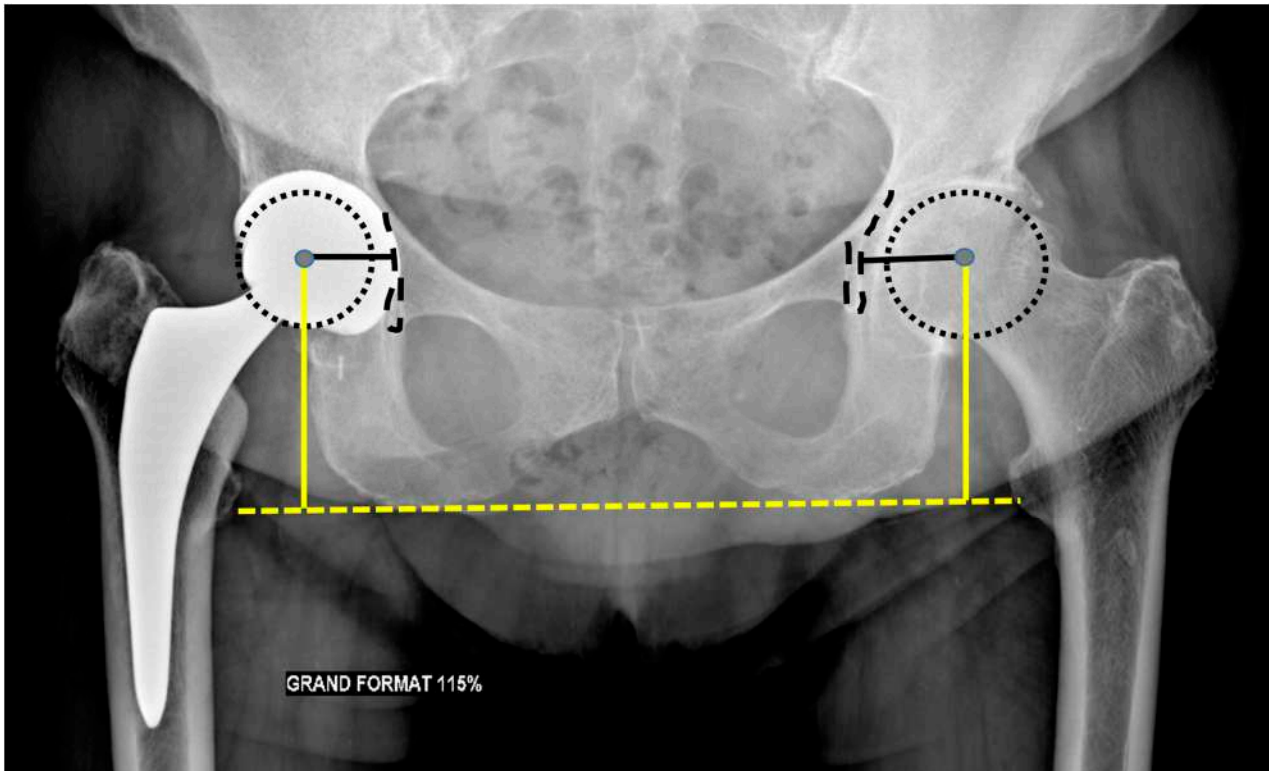
Figure 6. Acetabular centers of rotation. Pelvic anteroposterior radiograph. The horizontal center (black line) corresponds to the distance between the femoral head (dotted circle) center (grey point) and the teardrop (large black dotted curve) shadow, the vertical one (yellow line) to the distance between the center of the femoral head and the transischiatic line (dotted yellow line).

The acetabular vertical center of rotation corresponds to the vertical distance between the center of the femoral head and the trans-ischial tuberosity line, and the horizontal center of rotation to the distance between the center of the femoral head and the teardrop shadow (Figure 6). Those values should be similar to the contralateral hip [32], as a lateralized horizontal center might favor dislocation.

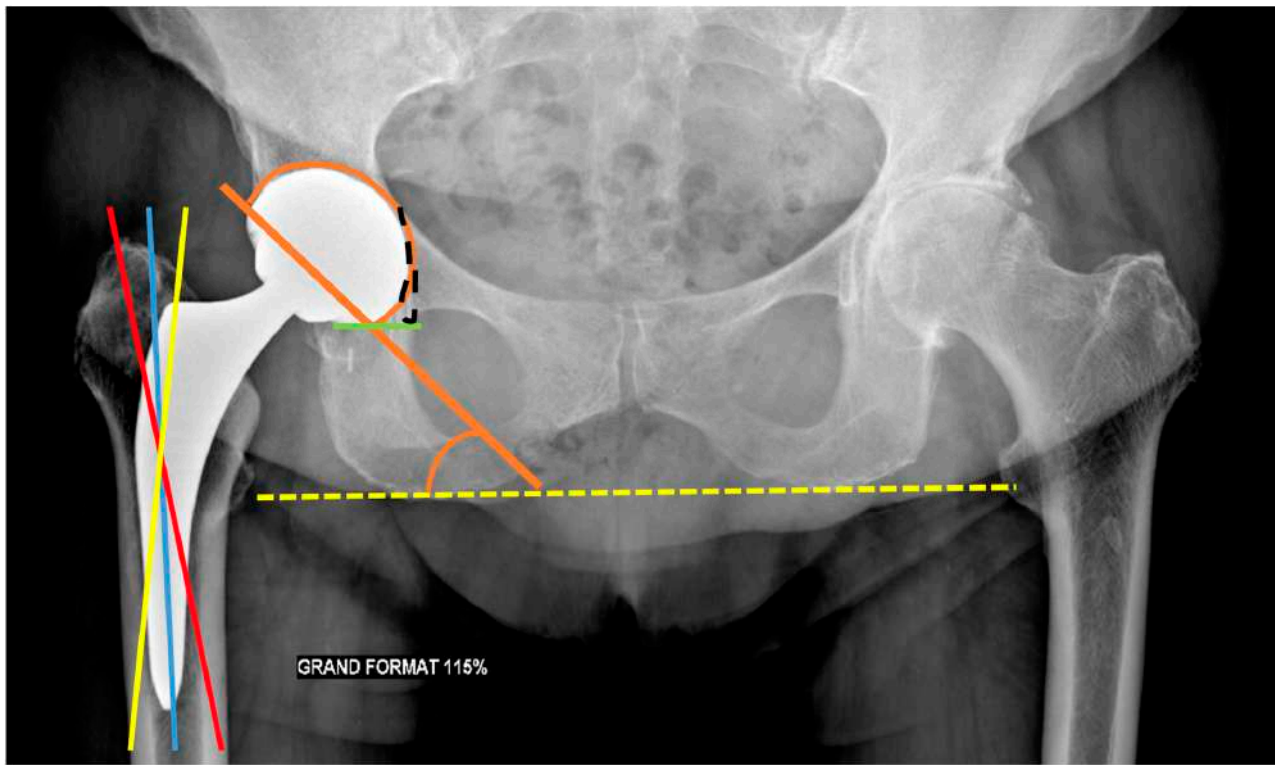
Figure 7. Acetabular frontal inclination and femoral stem position. Pelvic anteroposterior radiograph. The acetabular inclination corresponds to the orange angle between the acetabular piece contour (orange circle) and the transischial line (dotted yellow line). Additionally, note that the acetabular piece is aligned (green line) with the bottom of teardrop shadow (dotted black curve). The femoral stem should be placed in a neutral position (blue line). A slight valgus (red line) can be tolerated, but varus (yellow line) should not occur.

The frontal acetabular inclination is the angle between the lateral edge of the cup and a transischial tuberosity line in the frontal plane and should be of $40 \pm 15^\circ$, as a lesser angulation would limit hip abduction, whereas a greater one would increase the risk of dislocation [32] and premature wear. The inferomedial border of the acetabular component should be aligned with the bottom of the teardrop on an AP pelvic view (Figure 7).

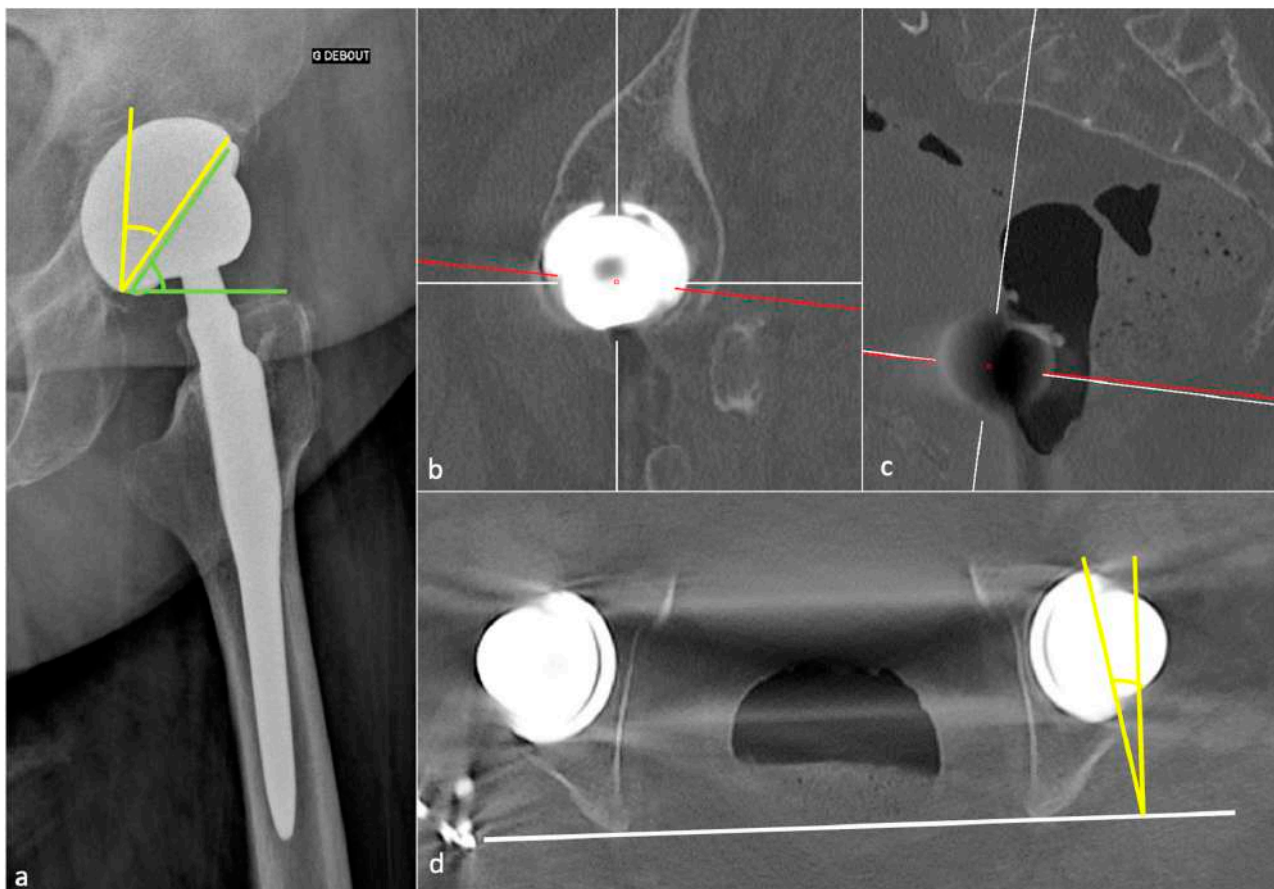
Figure 8. Acetabular cup anteversion and sagittal inclination. The radiographic angle of anteversion is shown on (a) a hip profile radiograph and corresponds to the angle between the vertical axis and the acetabular piece edges (yellow angle). The sagittal acetabular inclination is shown in (a) and corresponds to the angle between the horizontal axis and the acetabular piece edges (green angle). A CT method is then proposed to calculate anteversion: on (b) a sagittal CT slice, one should restore the femoral head center, then align it within the middle of S1 superior plate as shown on (c) in the sagittal plane. The anteversion can be measured in the so-created plane (red lines) on (d), as the yellow angle between the cup edges and the perpendicular line to the transischial line (white line).

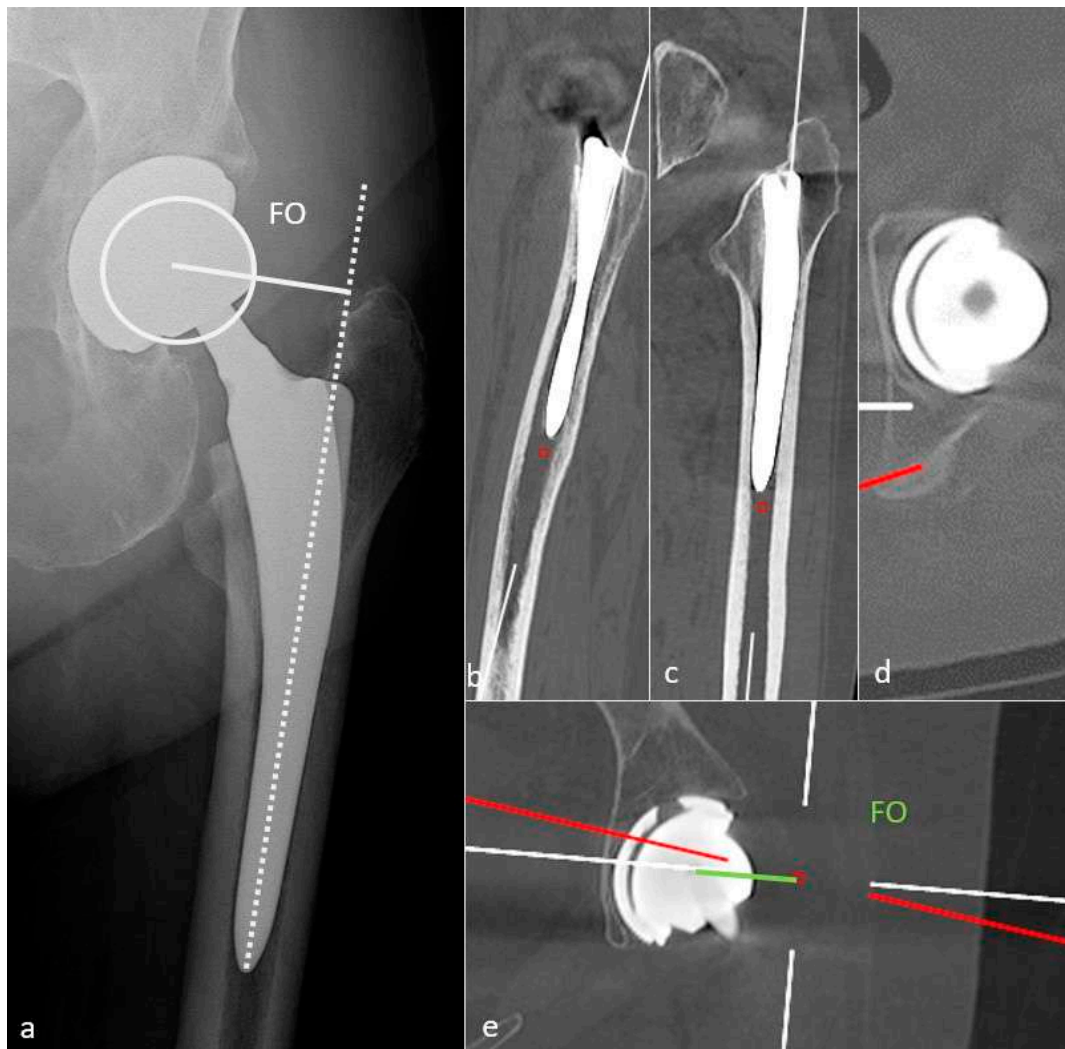
Figure 9. Femoral offset (FO). The radiographic method is shown on (a) an anteroposterior hip view and corresponds to the perpendicular distance (white line) between the femoral head (white circle) and the femoral axis (dotted white line). A CT method is also proposed. First, on (b), in the sagittal plane, the femoral inclination is considered, then on (c) in the frontal plane, and the level of the center of the femoral head is repaired in (d). Finally, in (e), the FO can be measured (green line) as the perpendicular distance between the resulting femoral axis (white vertical line) and the center of the femoral head.

The FO should be like the contralateral hip and measure 41–44 mm. This value must be measured on an anteroposterior hip view in neutral rotation, as rotation might induce significant measure variation. It can also be obtained with the EOS system or CT-scan (a method proposed in Figure 9) [54]. A low FO can lead to limping, mobility limitation, and dislocation by gluteal muscles weakness. A loss of FO negatively influences patients' satisfaction after THA [74]. A too high FO might induce gluteal muscle pain because of exacerbated tension and PE wear.

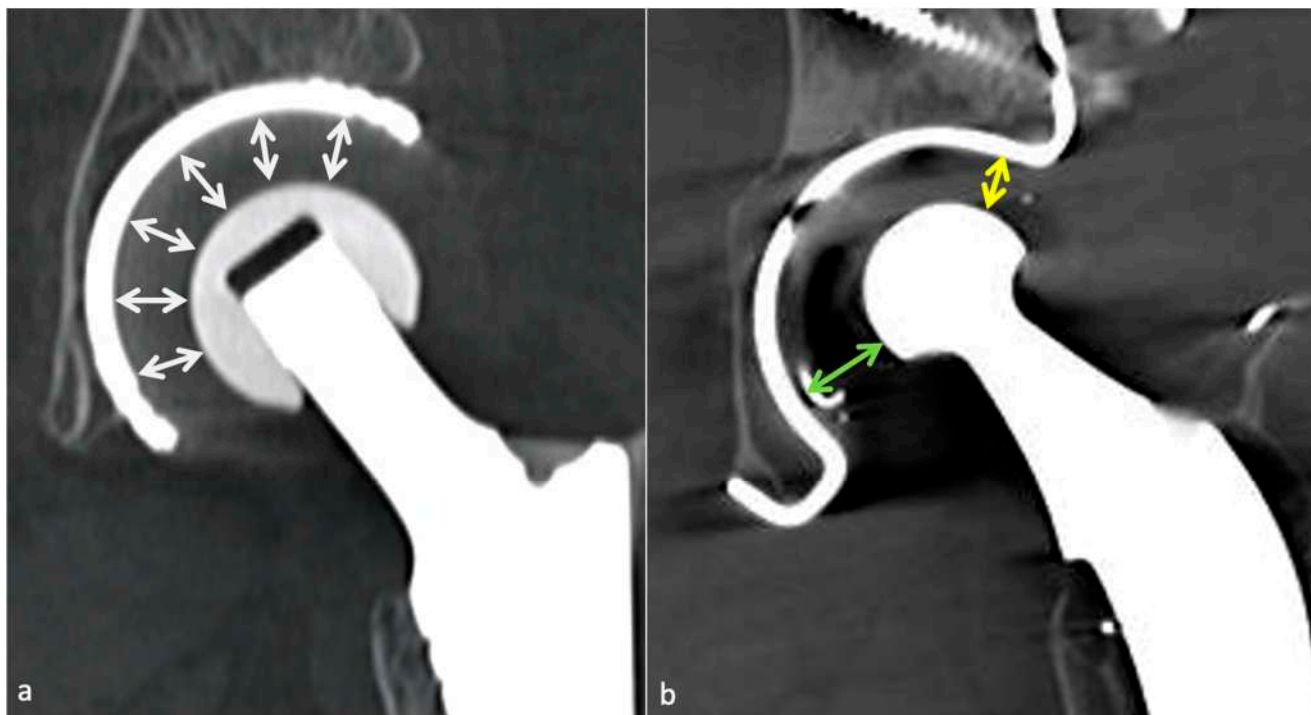
Figure 10. Polyethylene wear. Normal polyethylene appearance is shown in (a) a frontal CT-scan slice, with a regular thickness as all double arrows are equal, whereas wear is shown in (b) a similar frontal CT-scan slice, with asymmetric thickness as the superior yellow double arrow is smaller than the inferior green one.

The prosthetic femoral head should be centered within the acetabular cup or slightly inferiorly located as the PE liner has a thicker superior rim. In case of PE liner, wear of 0.1 mm/year is considered normal [54]. Therefore, if it is located upwards, it indicates PE wear and should raise suspicion for granulomatous osseous resorption (Figure 10).

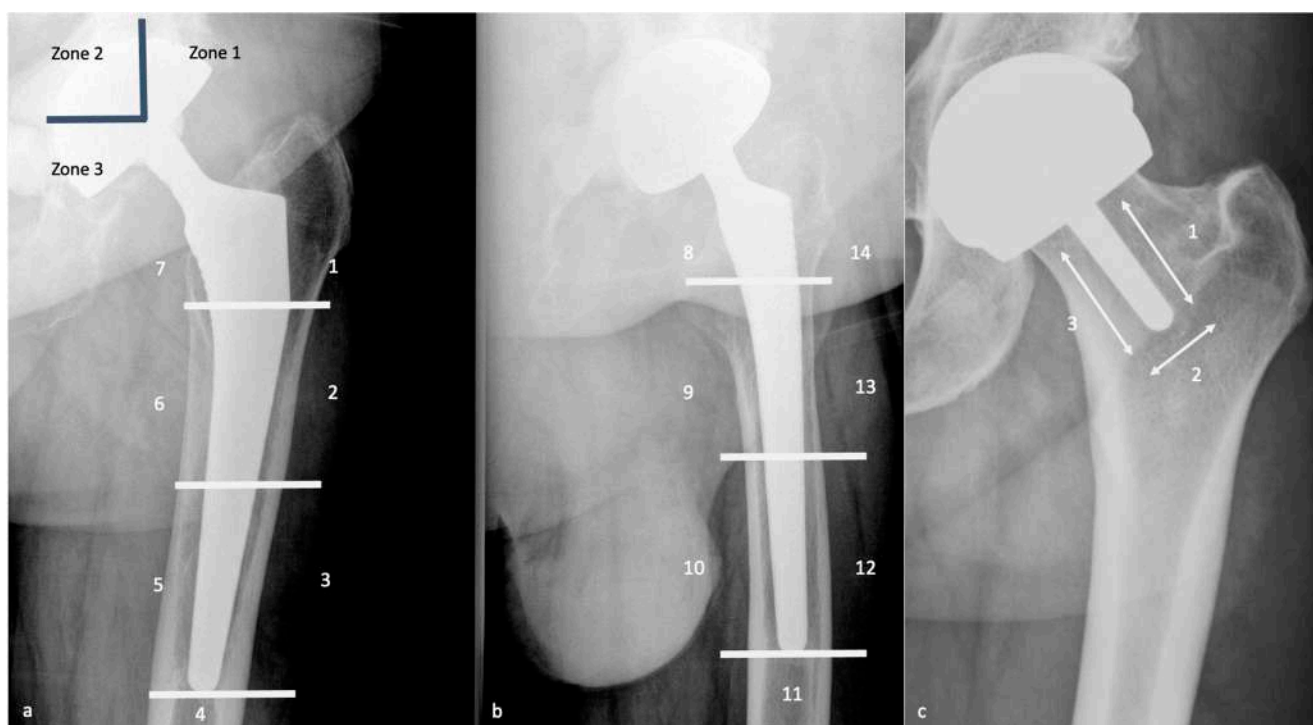
Figure 11. Acetabular and Femoral Zones to be described for osteolysis. The De Lee and Charnley acetabular zones and Gruen 1–7 femoral zones are shown on (a) an anteroposterior hip view, the Gruen 8–14 femoral zones on (b) a profile hip radiograph. The three zones to consider for femoral stem in resurfacing arthroplasties are shown on (c) an anteroposterior hip radiograph.

With radiographs or CT, the presence of periprosthetic radiolucent zones (RLZ) might be a normal finding if it meets strict criteria. Pathologic or regular, they should be described according to the classification of De Lee and Charnley for the acetabular component and with the Gruen zones for the femoral component (Figure 11). Concerning resurfacing arthroplasty, three zones are described around the peg [78] (Figure 11). RLZ around the metaphyseal stem of a resurfacing prosthesis are often asymptomatic, and a neck narrowing can be found without clinical significance [79].

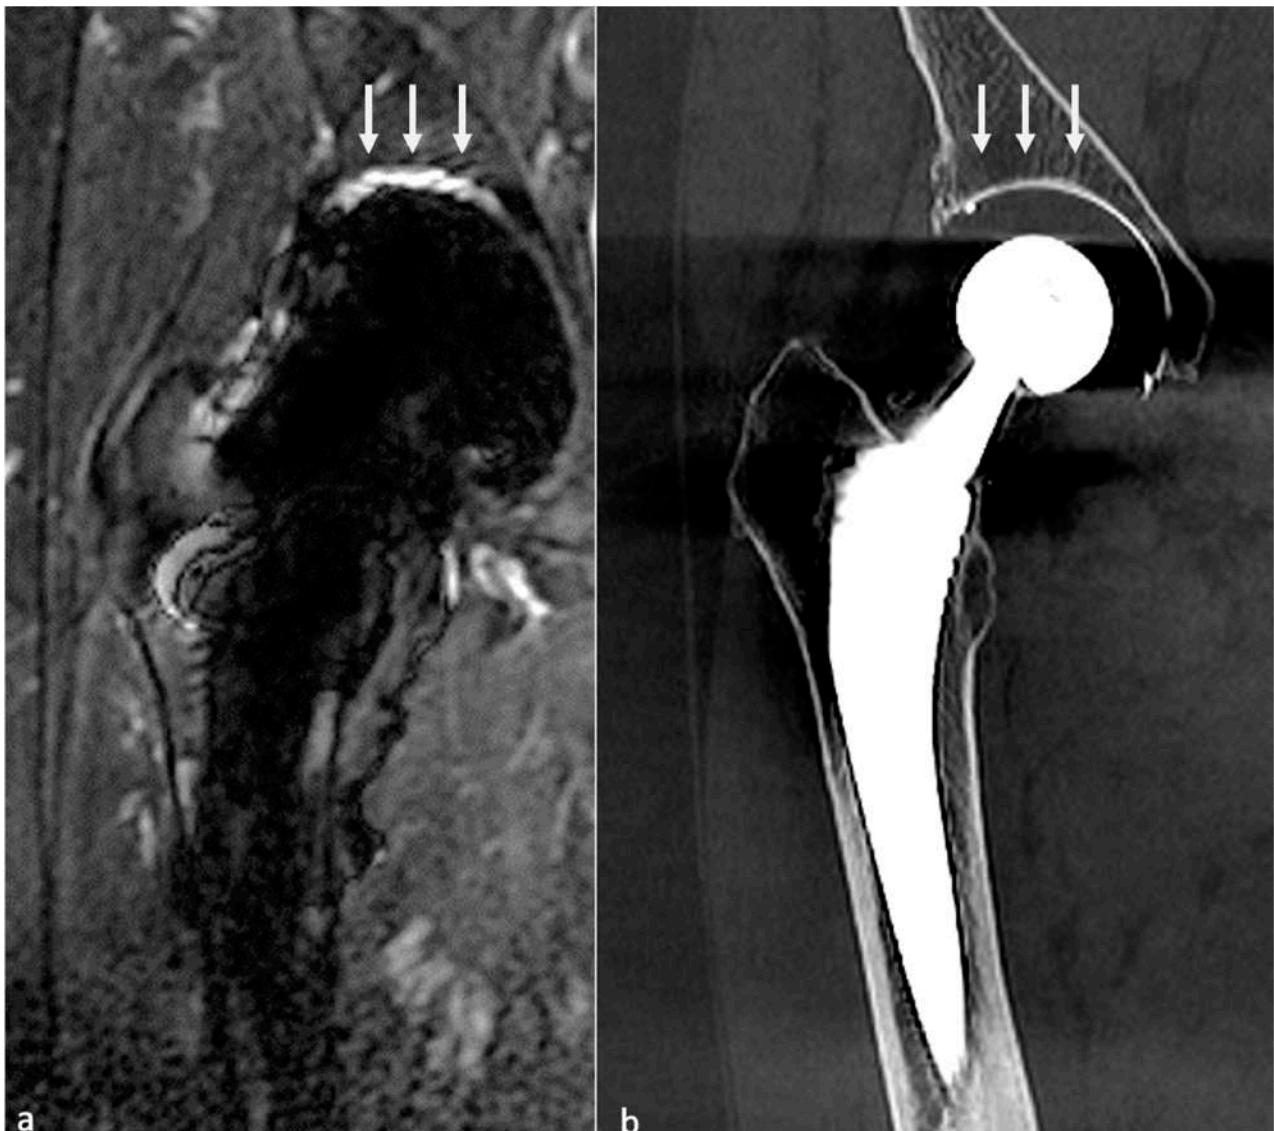
Figure 14. Acetabular fibrous membrane. A thin STIR hyperintense layer (white arrows) is shown close to the acetabular piece on (a) a frontal STIR image, without osteolysis in the corresponding zone on (b) a coronal CT-scan slice.

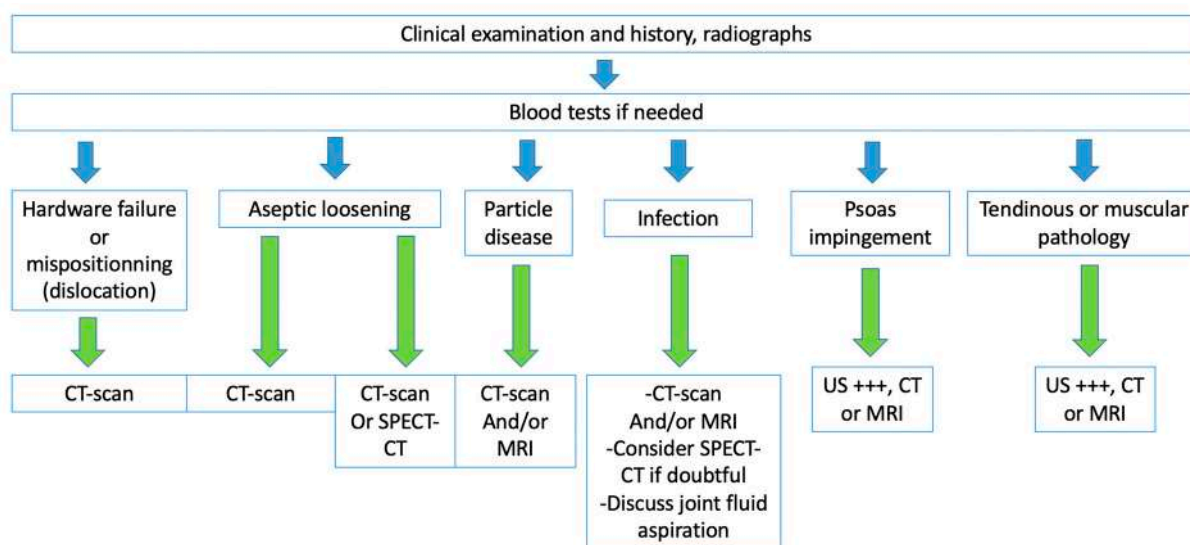
Figure 15. Imaging diagnostic algorithm proposition, adapted from Blum et al. [80,81].

Complications can be classified as common to all kinds of arthroplasties (loosening, dislocation, peri-prosthetic fractures, psoas impingement, heterotopic ossification, implant failure, neurovascular and muscle pathology), and specific to bearing surfaces (MoP: wear and osteolysis; MoM: metallosis, pseudo-tumor, and trunnionosis; CoC: squeaking and prosthetic fracture; CoP: ceramic fracture and wear). Resurfacing arthroplasty complications are developed in a separate section. An imaging-based algorithm is proposed in Figure 15 [80,81].

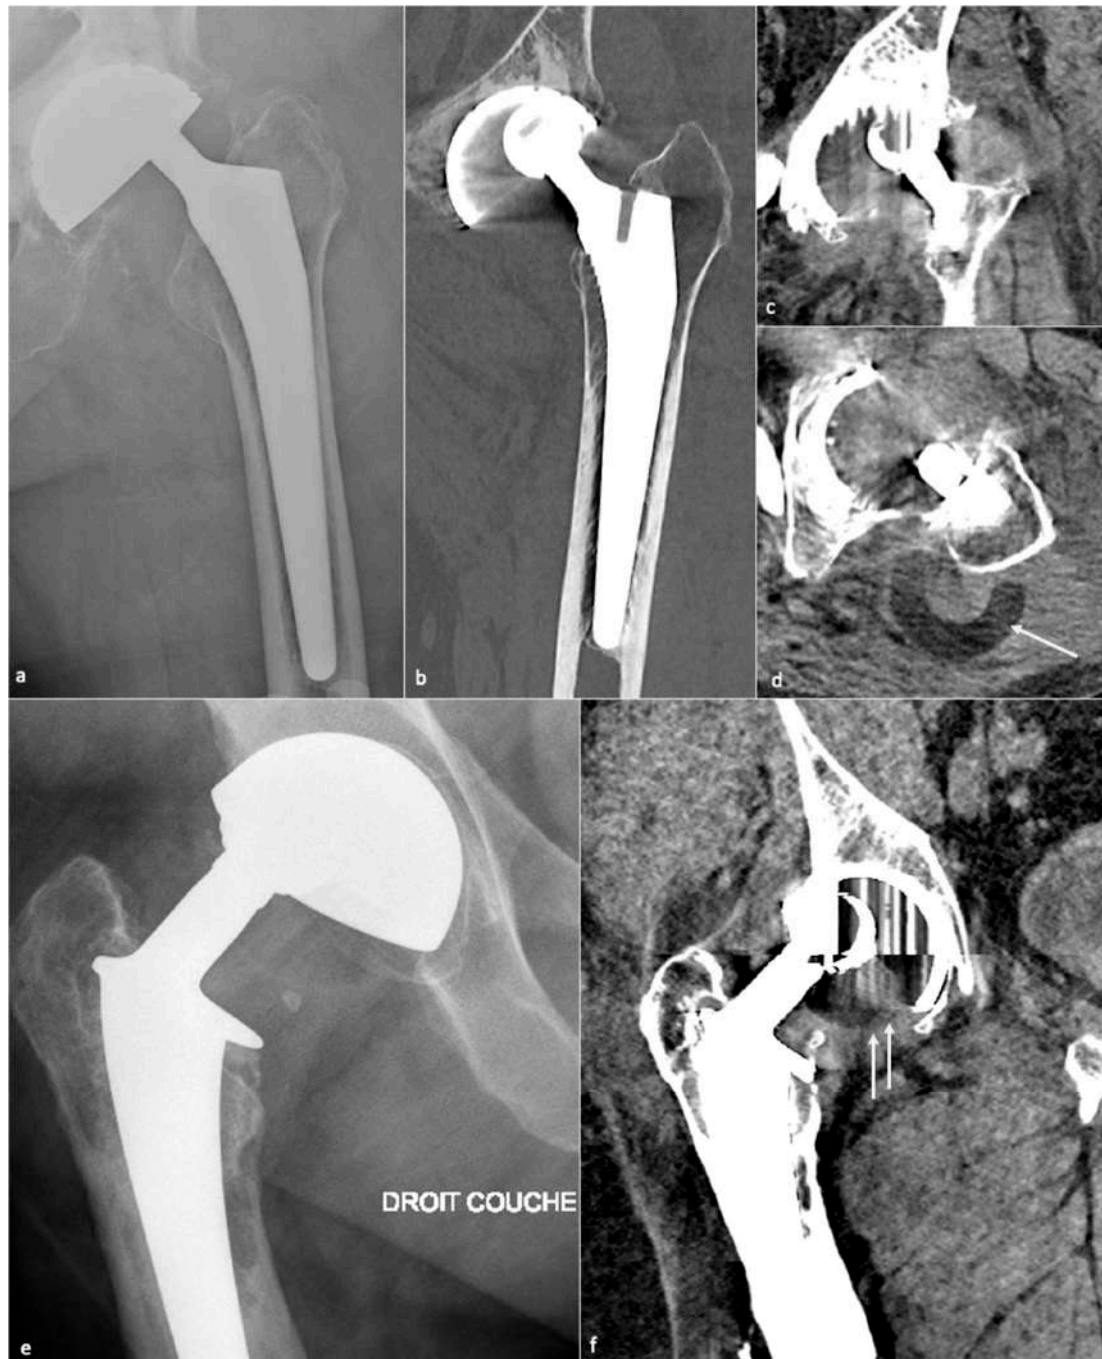
Figure 16. Polyethylene dislocations. An intra-prosthetic dislocation is shown on (a) an anteroposterior radiograph and (b) a coronal CT-scan with bone kernel where out-of-round of the femoral head is seen. Using soft tissue kernel in (c) frontal and (d) axial CT-scan slices, no polyethylene is seen in its usual position in (c) but is depicted behind the great trochanter in (d) (white arrow). In another patient, an intra-prosthetic dislocation is shown on (e) an anteroposterior hip radiograph where exenteration of the femoral head is seen, and on (f) a frontal CT-scan slice where the polyethylene (double white arrow) is located downwards.

prosthetic PE dislocation [84], defined as a loss of contact between the head and the PE. The latter can occur during the reduction of a classical dislocation in the early setting and lately secondary to wear [85] (Figure 16).

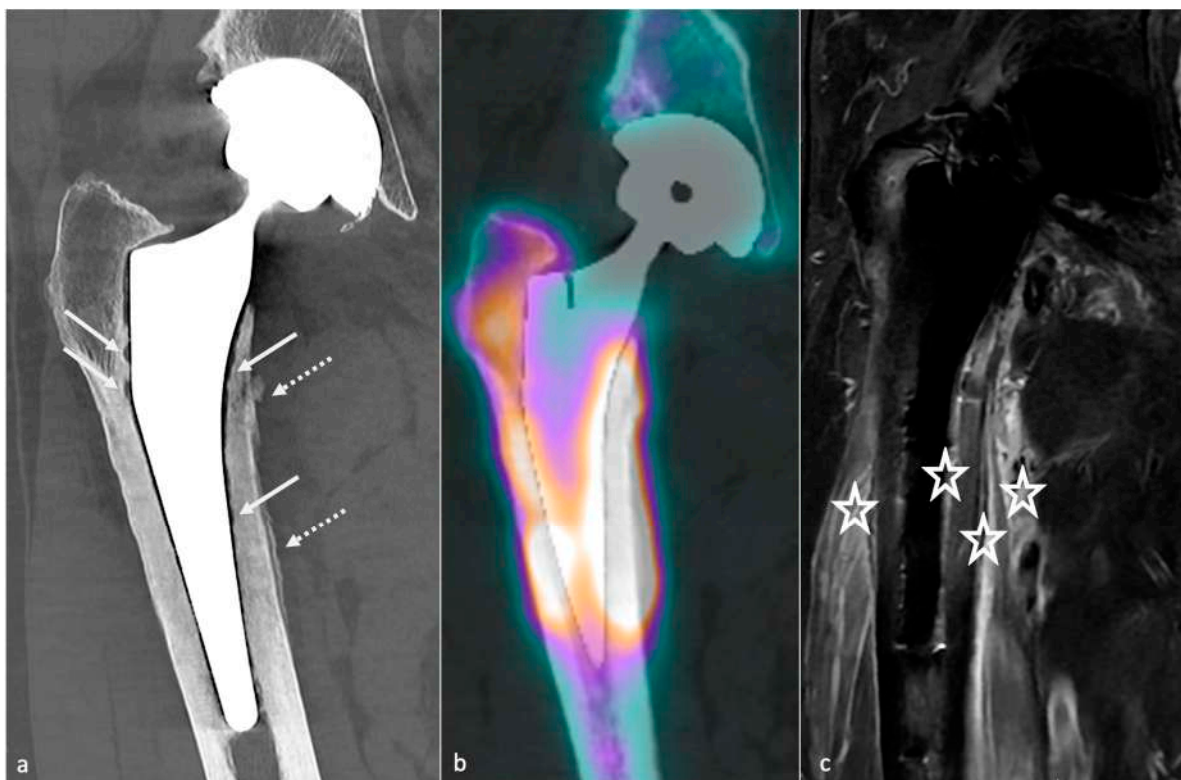
Figure 18. Infectious loosening (staphylococcus lugdunensis). An infectious loosening is shown on (a) a frontal CT-scan slice with irregular femoral endosteal osteolysis (white arrows) and periosteal reaction (dotted arrows), (b) a frontal SPECT-CT slice with diffuse hyperfixation, (c) a frontal T2 STIR image with a peri-prosthetic, cortical, and soft tissue hypersignal (white stars).

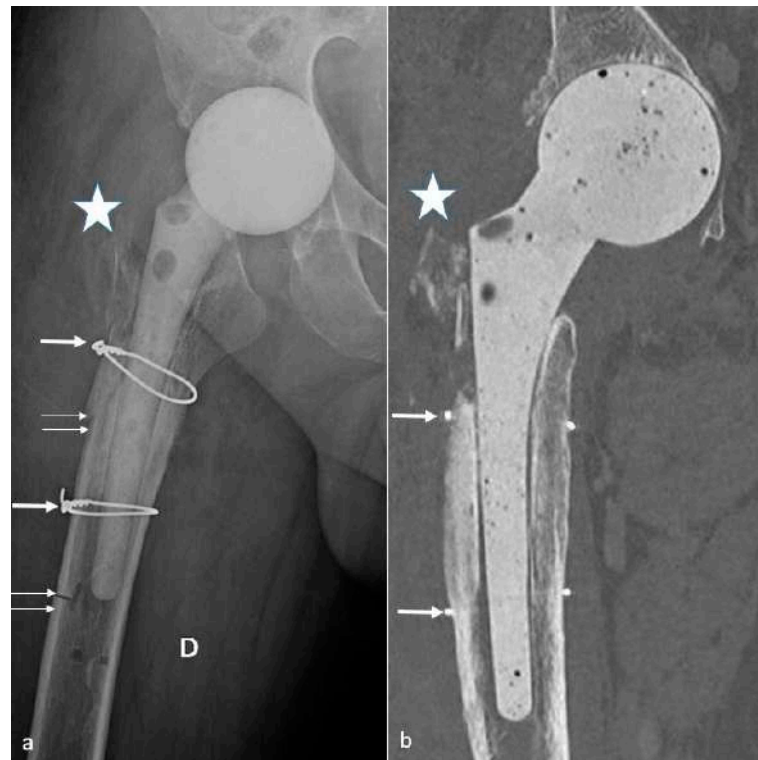
Figure 19. Spacer appearance. A spacer is shown on an AP radiograph (a) and a coronal CT-scan slice (b). Note the cerclage wires (thick arrows), the trochanteric lysis (white star), and the femorotomy sequelae (thin double arrows). NB: “D” in (a) means “droite” and is referred to the right side.

One should be aware of the aspect of temporary cement spacer, impregnated with antibiotics, temporarily used when revision surgery is performed to allow functional hip movement while locally treating an infection (Figure 19). Dislocation, periprosthetic fractures, and secondary infection can occur [100].

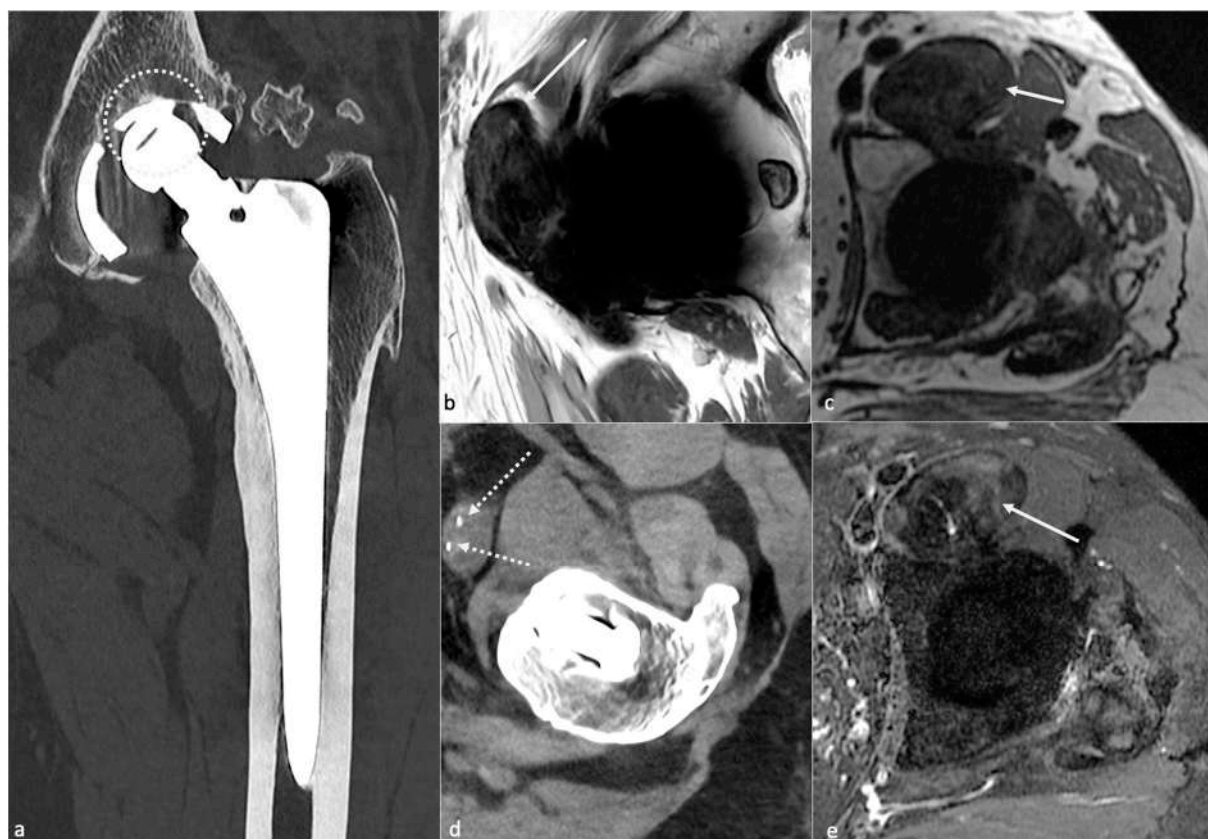
Figure 20. Metallosis. Contact between the acetabular metal-back and the femoral head (dotted white circle) is shown on (a) a frontal CT-scan slice, secondary to polyethylene wear. A pseudo-tumor extending into the iliopsoas bursae is shown on (b) a sagittal T2-weighted image, (c) an axial T1 MAVRIC and STIR (e) images as hypointense. Additionally, note on (d) an axial CT-scan slice the presence of metallic debris (dotted white arrows) into the pseudo-tumor.

- *Metallosis* results from the shedding of metallic debris (secondary to a MoM prosthesis with corrosion, a conflict between a metallic acetabular cup and the prosthetic neck, or a contact between a metallic head and an acetabular metal back in case of PE wear or dislocation) that induces synovitis and an indolent pattern of osteolysis, potentially leading to loosening (i.e., potentially looking similar to osteolysis and PE wear). Synovitis may contain low-signal intensity or metallic density debris, causing MRI artifacts and bone erosion, best depicted on CT-MAR (Figure 20). Such debris might also be located in periprosthetic soft tissue and lymph nodes [54,57]. Metallic debris presence might also accentuate PE wear (i.e., third fragment wear) [54]. Of note, high serum metal-ion levels can be found in symptomatic and asymptomatic patients and would be associated with pseudo-tumors, so that such a biological finding should lead to the prescription of an MRI to rule out a pseudo-tumor even in asymptomatic patients [6,103].

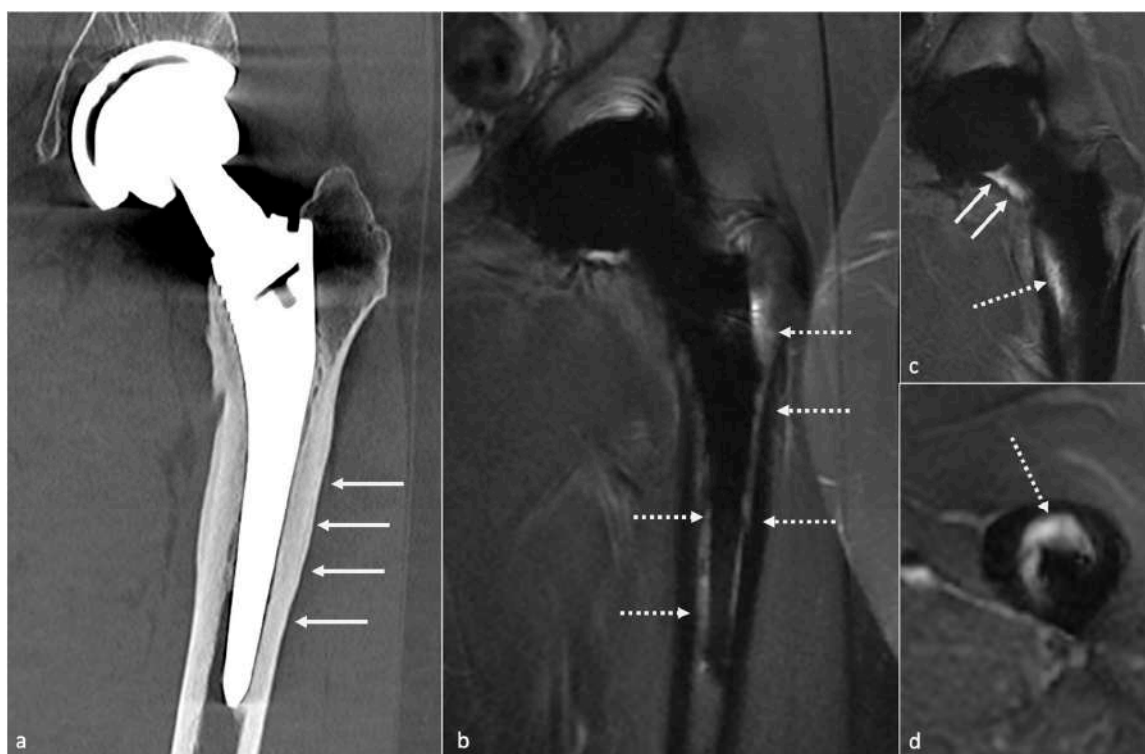
Figure 21. Stress reaction. A stress reaction is shown on (a) a coronal CT-scan slice with a varus stem position and asymmetric periosteal reaction (arrows). Periprosthetic bone marrow edema (dotted arrows) is doubtful on (b) a coronal STIR image but is depicted on another (c) coronal and (d) axial STIR image. Additionally, note the small amount of joint fluid (double arrow) on (c), considered nonspecific.
