Article

Using UAV and Structure-From-Motion Photogrammetry for the Detection of Boulder Movement by Storms on a Rocky Shore Platform in Laghdira, Northwest Morocco

Mouncef Sedrati ^{1,*}, Juan A. Morales ², Abdelmounim El M'rini ³, Edward J. Anthony ⁴, Glen Bulot ¹, Romain Le Gall ¹ and Abdelkarim Tadibaght ³

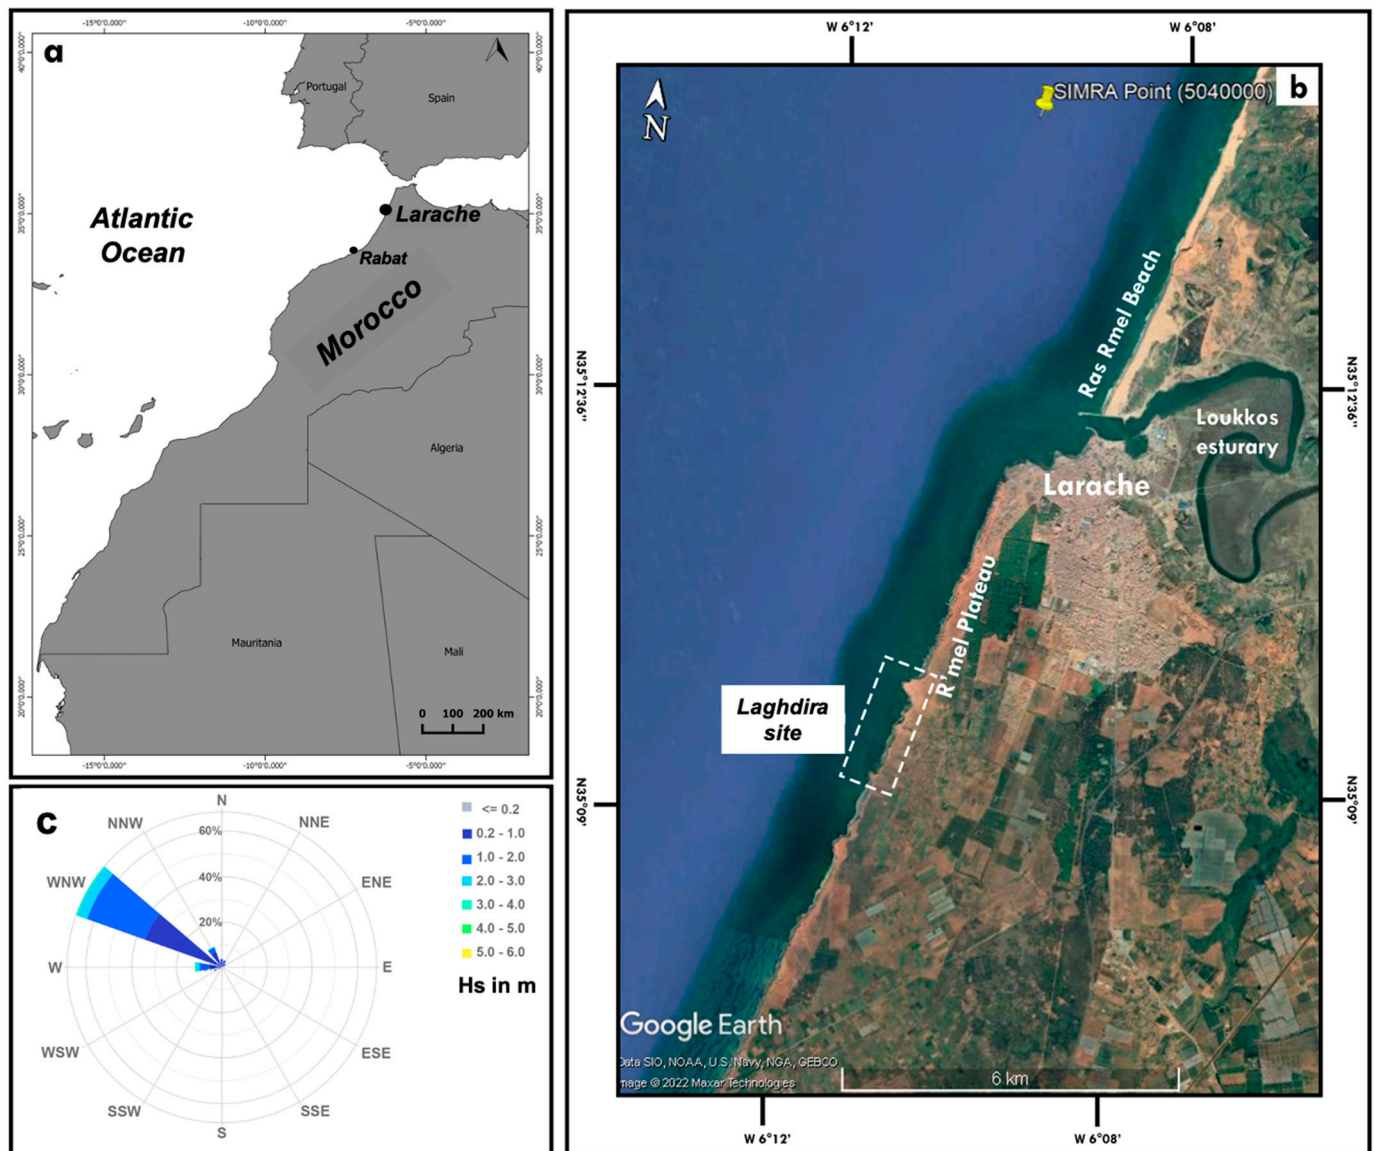
Figure 1. (a) Location of the study area; (b) Google Earth map of the Laghdira site with wave data source (SIMAR) location; (c) wave rose off the study area based on data from 2000 to 2020 for SIMAR spot 5040000.

The Laghdira site is part of a dominantly rocky shore south of the Loukkos River estuary and the city of Larache on the northwestern Atlantic coast of Morocco (Figure 1). The coast north of the estuary comprises a sandy beach, Ras Rmel, composed of fine and medium sand, either capped by dunes up to 10 m high or limited inland by a Quaternary sandstone cliff [45]. This sandstone formation also underlies the dunes, and is responsible for the constriction of the Loukkos estuary mouth [46]. The sector south of the estuary, comprising the study site, is composed of actively retreating cliffs that bound the Rmel Plateau, the elevation of which varies between 20 and 30 m asl [23,47]. Older inactive cliffs appear some 1–3 km inland [44]. The active cliffs form an almost rectilinear shoreline with a few promontories, including Punta Nador and Laghdira (the northern limit of our study area). The cliff outcrops consist of an alternation of poorly consolidated Quaternary aeolianites with large foreset beds, thin red sandy levels, continental gastropods, and thin beach deposits. The lowermost part of the cliffs is composed of 2 m thick, horizontally layered, more compacted red Quaternary sandstones with low porosity [23,47]. The retreat

2019) offshore of Larache show that waves from the west-northwest largely dominate in both winter and summer (Figure 1). Tides on the Larache coast are semi-diurnal and mesotidal, with a mean spring range of 3.1 m and a mean neap range of 1.3 m.

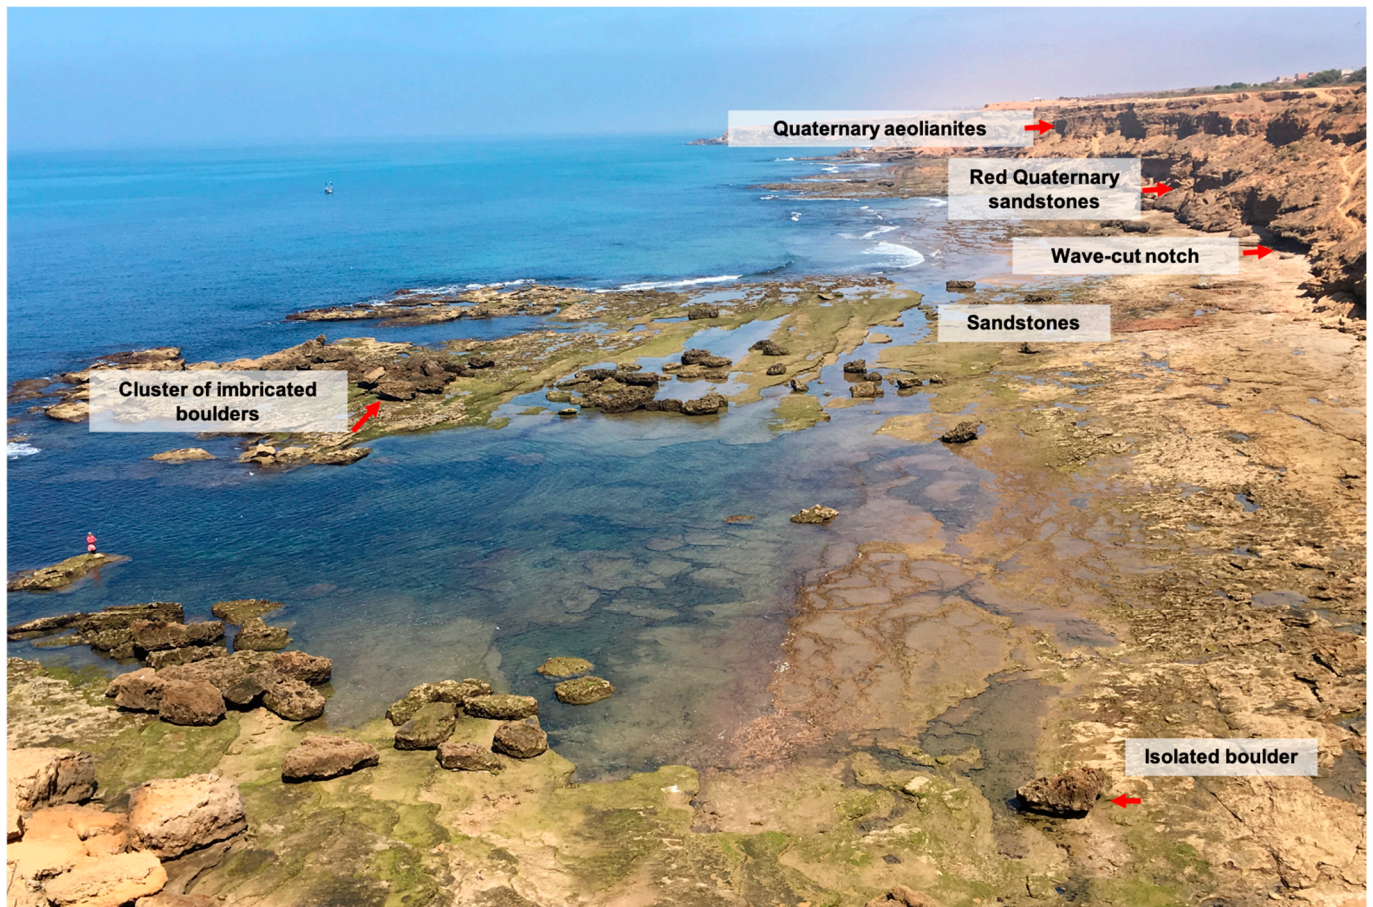
Figure 2. Oblique view of the shore platform at Laghdira, showing aspects of the lithology and geomorphology.

of these aeolianite cliffs has led to the cropping out of the sandstones that form the surface of the shore platform (Figure 2). The intertidal width of the platform at Laghdira at mean low tide varies from 20 m at the promontories to 100 m in the widest sectors, with a mean of 60 m. The surface dips gently seawards or landwards (Figure 2). The basal level shows a few wave-cut notches where the shore platform is narrowest. The boulders originate from wave dismantling of this shore platform, and are deposited as single clasts, clusters, or imbricated stacks (Figure 2). Medina et al. [23] and Adil [47] have provided detailed geological descriptions of two sections of the cliff wall and platform: 5.2 km north and 5.4 km south of Laghdira, respectively.

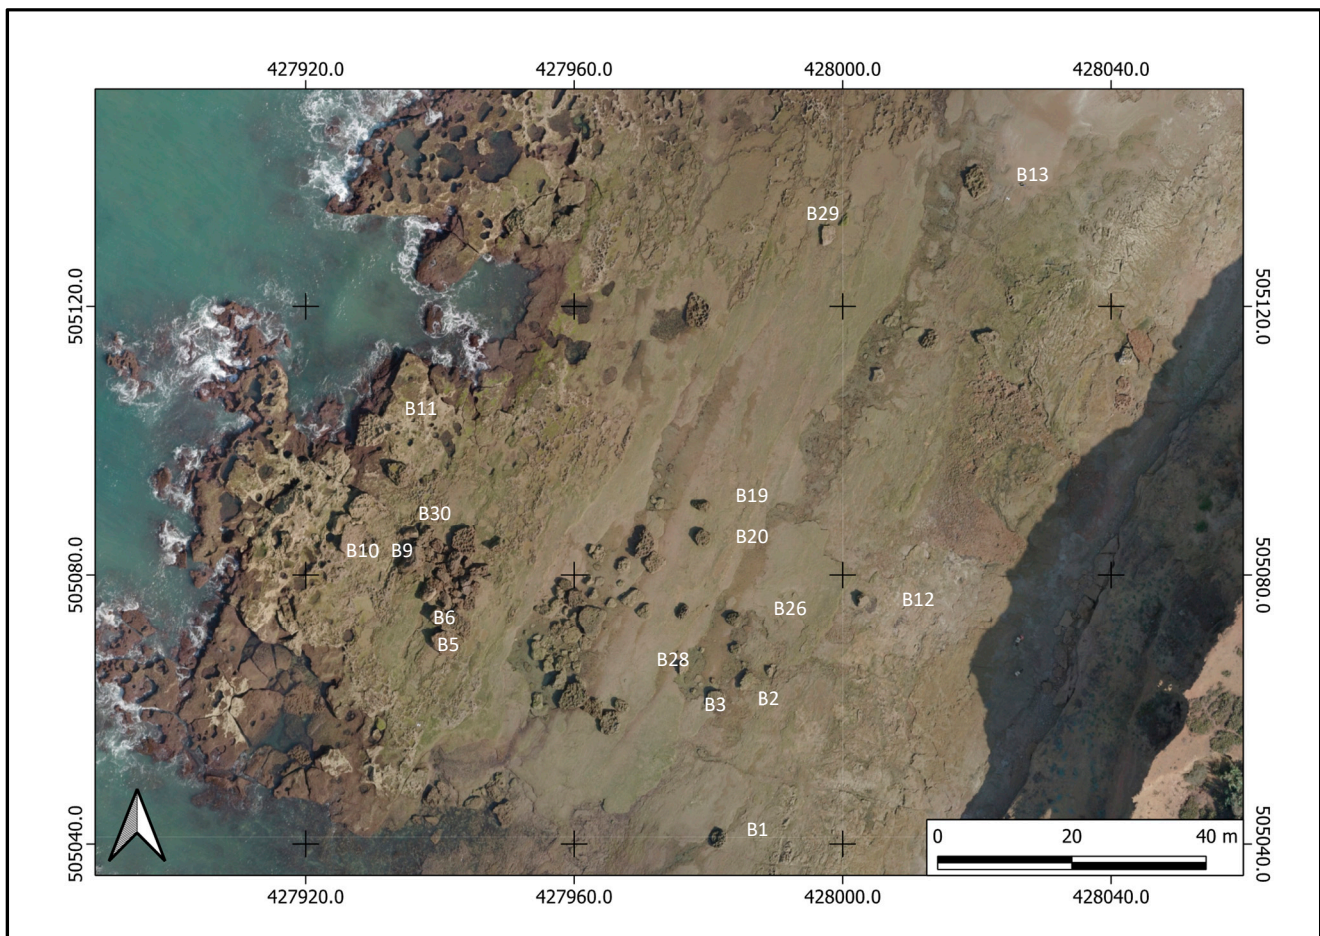
Figure 3. September 2019 orthophotograph showing the spatial distribution of some of the analyzed boulders.

In the course of the field surveys, geological and geomorphological observations of the coastal cliffs, shore platform, and boulders were carried out over an area of 980 m × 80 m. In addition to an inventory of the boulders, their locations, sizes, shapes, and lithology were determined. The distribution of these boulders is not homogeneous (Figure 2). We therefore chose to focus on the southern part of the site, which has a wide distribution of boulders with single clasts, clusters, and imbricated stacks (Figure 3).

The rocky platform of Laghdira consists mainly of a horizontally layered, well-compacted, porous sandstone [23,47]. Along this platform, the longitudinal distribution of boulders is not homogeneous. Some sectors of the platform are completely devoid of megaclasts. Boulders are mainly found on the southern part of the rocky shore platform, where we concentrated our investigations. In this sector, boulders are deposited as single clasts, clusters, or imbricated stacks. In total, 31 boulders of various sizes and shapes were selected and analyzed (Figure 3).

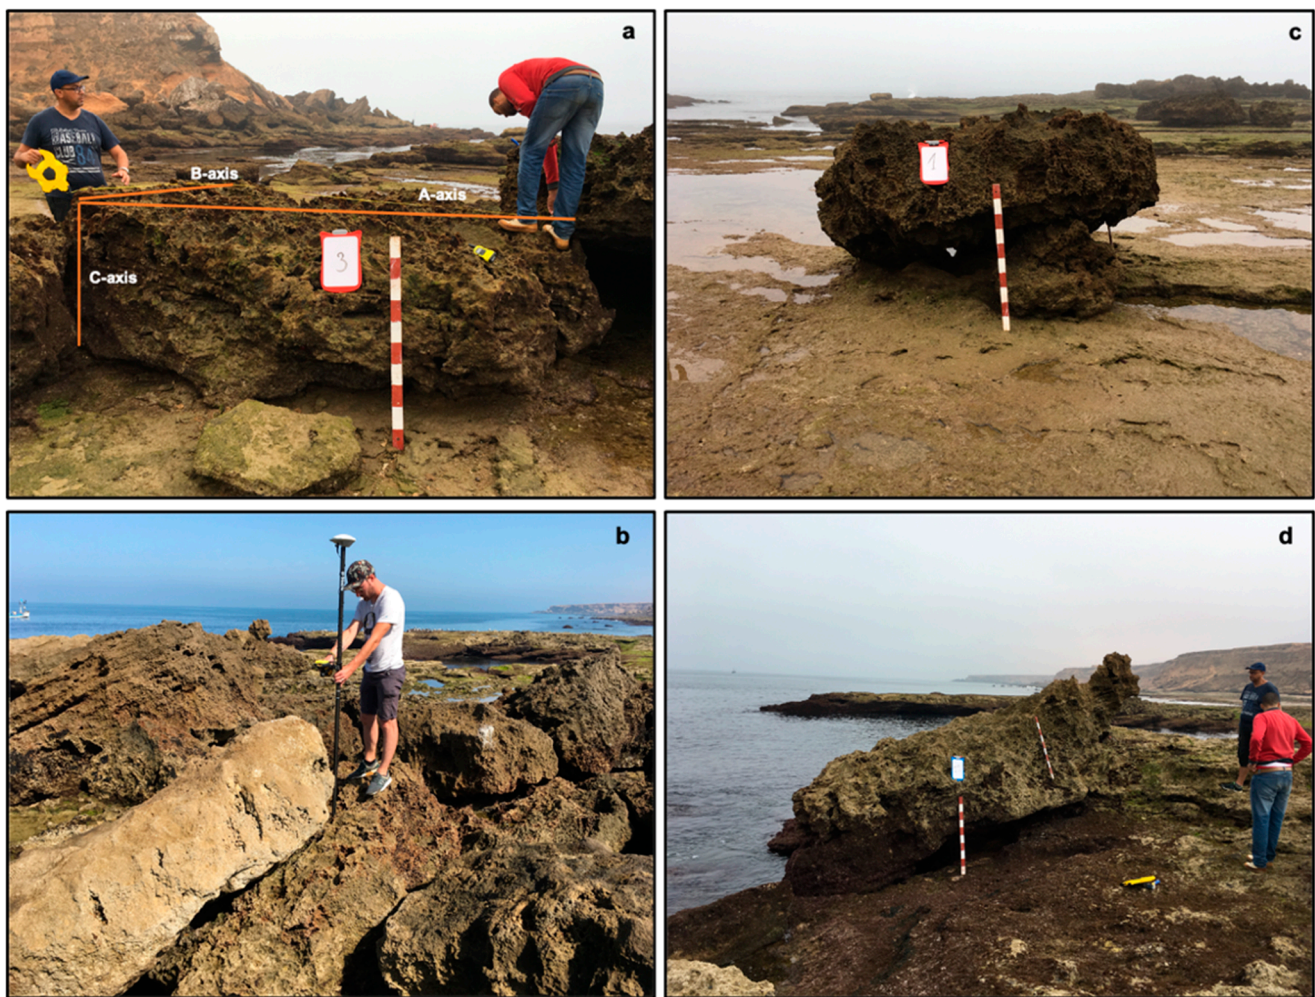
Figure 4. Examples of boulders at Laghdira: (a) measured boulder axes (A, B, and C); (b) DGPS topographic measurements of boulder positions; (c) imbricated boulders at the upper part of the rocky platform (B1); (d) joint-bounded boulder at the platform edge (B11).

Joint-defined blocks not yet detached from the shore platform and joint-defined sockets were observed at the edge of the shore platform (Figures 4 and 7). The largest boulders, which are also predominantly imbricated, with an onshore orientation (Figure 8), occur closest to the shoreline. The central area of the rocky platform has a wide range of boulder sizes and orientations. Most boulders display a normal polarity, and a few are turned upside-down or laterally (Figure 7). In the same area, small and very small clasts can sometimes be found imbricated below larger clasts. As we approach the top of the intertidal zone near the foot of the cliff, boulders are less present and more dispersed (Figure 2, Figure 3, and Figure 8). The surface of 90% of the boulders displays biogenic encrustations of vermetids (Figure 4), and several boulders show sharp edges and striae on their surfaces (Figure 4a).

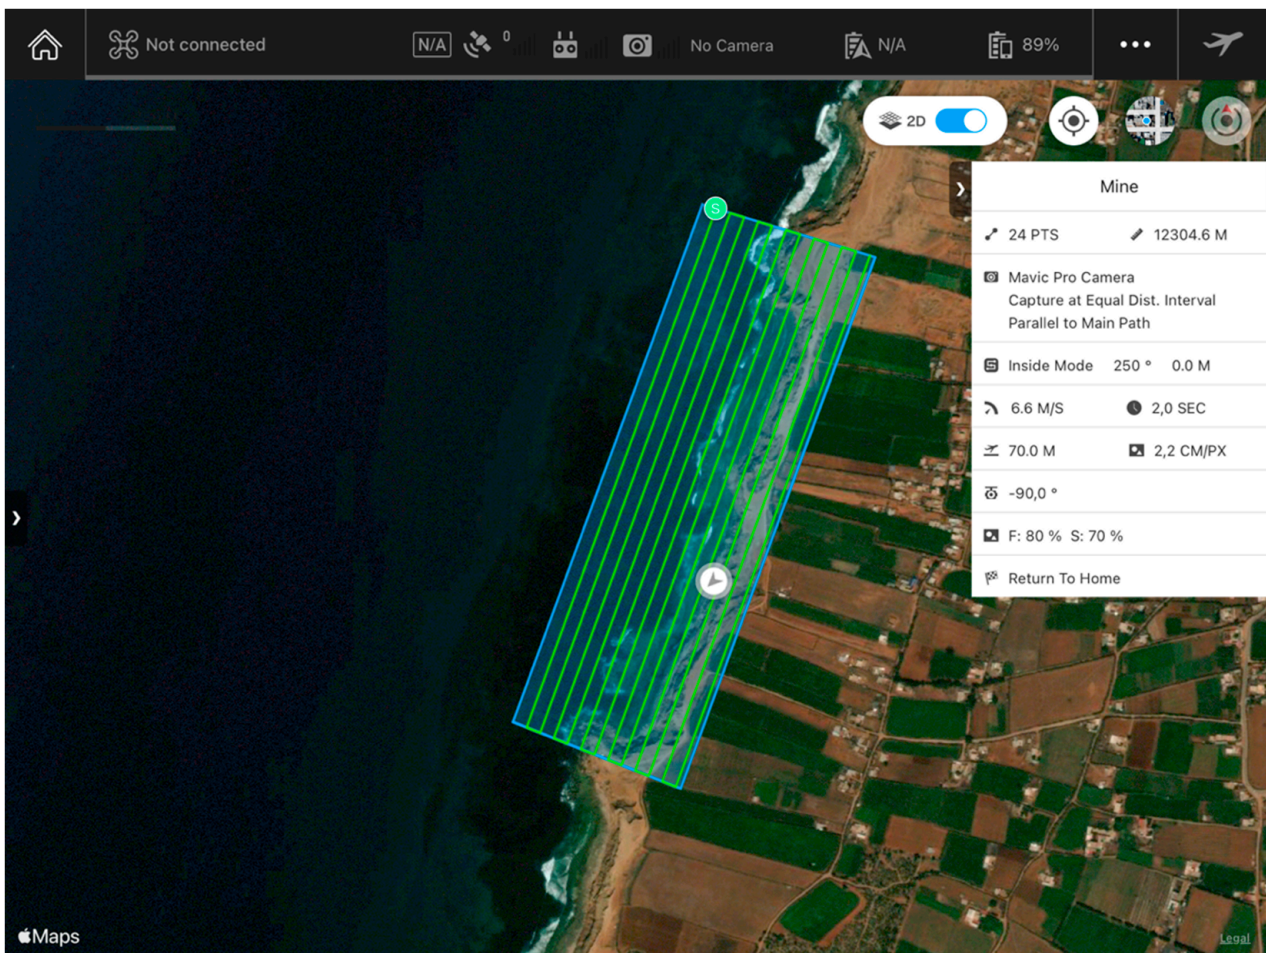
Figure 5. September 2019 flight path over the study area as seen in the screen capture from the DJI GO 4.

We carried out two UAV flights on 15 September and 26 December 2019 using a DJI MAVIC PRO PLATINUM quadcopter (DJI, Nanshan District, Shenzhen, China) equipped with a 12.35 MP camera. DJI GS Pro Flight Planner softwareTM was used for programming the automatically and autonomously executed flight plans (Figure 5). Images were collected at nadirs along calibrated flight paths parallel to the coast, at an elevation of 70 m (Table 2).

High-overlap image sets ensure sufficient target points in adjacent images; as the standard procedure, we planned the flight paths to provide 80% overlap between successive images and 70% sidelap between adjacent paths [35,55–59].

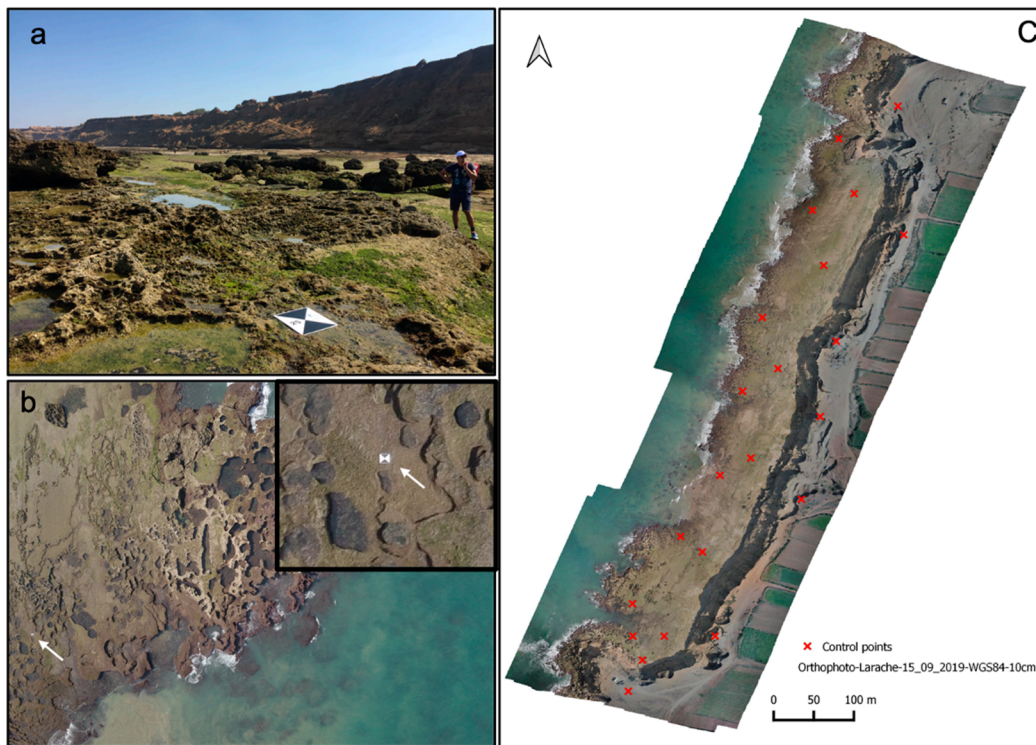
Figure 6. Ground control points (GCPs) deployed in the study area: (a) photograph of a GCP positioned on the rocky platform; (b) GCP (white arrow) visible on an image; (c) spatial distribution of GCPs in the study area.

In both surveys, 22 ground control points (GCPs) consisting of black-and-white checkered cardboard, essential for the production of georeferenced aerial images, were deployed—7 on the top of the cliff and 15 at different locations on the rocky platform (Figure 6)—to provide the widest possible coverage. Their positions were recorded using a Trimble differential GPS in real-time kinematics mode. The RMSE values of the September and December 2019 UAV surveys were 14 cm (xy of 13 cm and z of 5.4 cm) and 13 cm (xy of 12 cm and z of 5.2 cm), respectively.

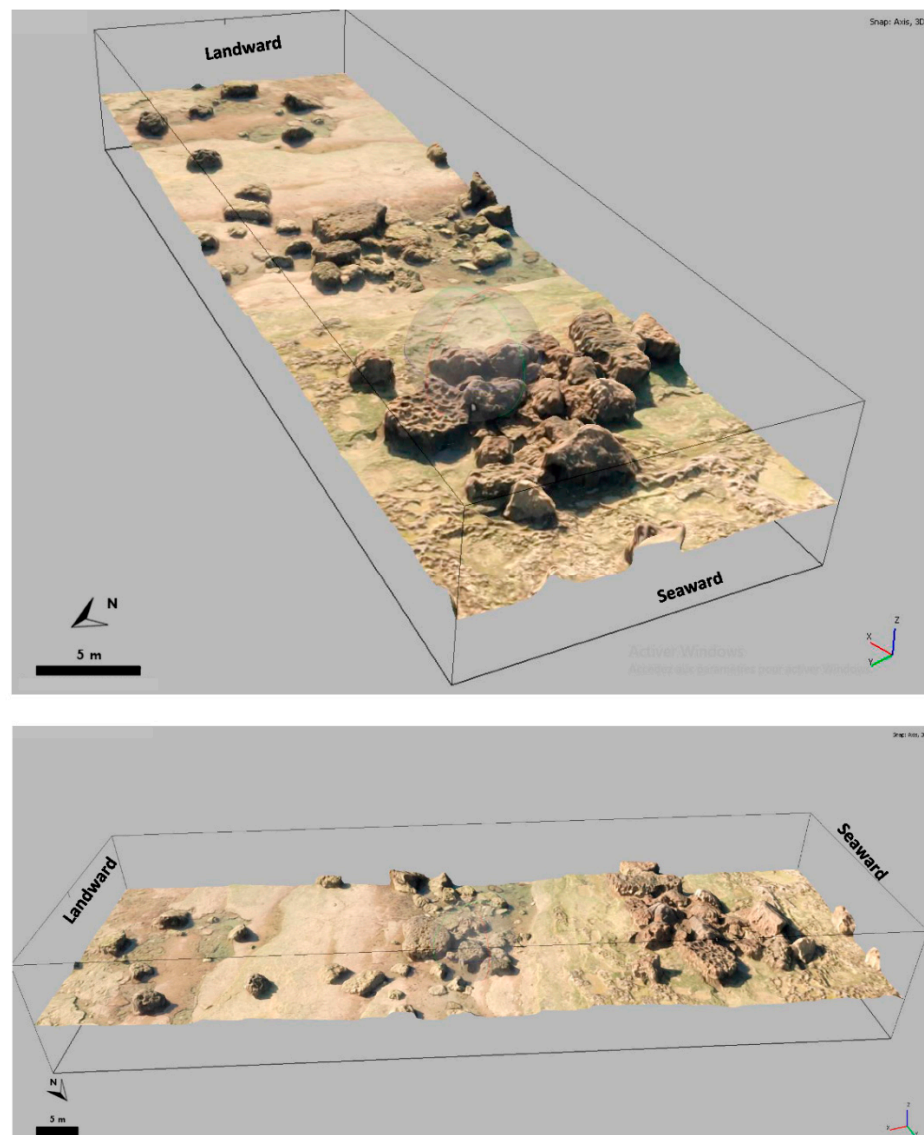
Figure 7. Plunging axial (top) and lateral oblique (bottom) views of the 3D model generated for the study area from the September 2019 UAV survey.

enced, it is possible to create a 3D mesh by forming a planar structure “connecting” the points: “processing” tab -> “build a mesh” [51]. It is then possible to specify the “source data” (this involves favoring the dense point cloud, as it is fairly precise and has little space between points), the “surface type” (choose “Arbitrary 3D” for fairly complex geometries), and the “number of faces”. However, the more faces there are, the more computational resources are required, and the finer the resolution of the output model. After this step, the texture can be built and plated on the 3D model. The “mapping mode” determines how the texture will be plated. It is desirable to choose the “generic” or “adjusted orthophoto” modes for arbitrary geometries in order to ensure a better visual quality in the output [51]. The “merge mode” allows one to choose how the pixels of the different images will be combined. At this stage, the “mosaic” mode is preferred, as it allows for selection of the pixels of the center of the image in order to improve the quality of the images, with no luminosity variation during the UAV tracking. Finally, the “size/number of textures” represents the resolution of the image. The greater the size/number, the better the resolution, but at the expense of computation time. The 3D models are generated and can then be processed to search for the evaluation of possible boulder rotation and translation transport.

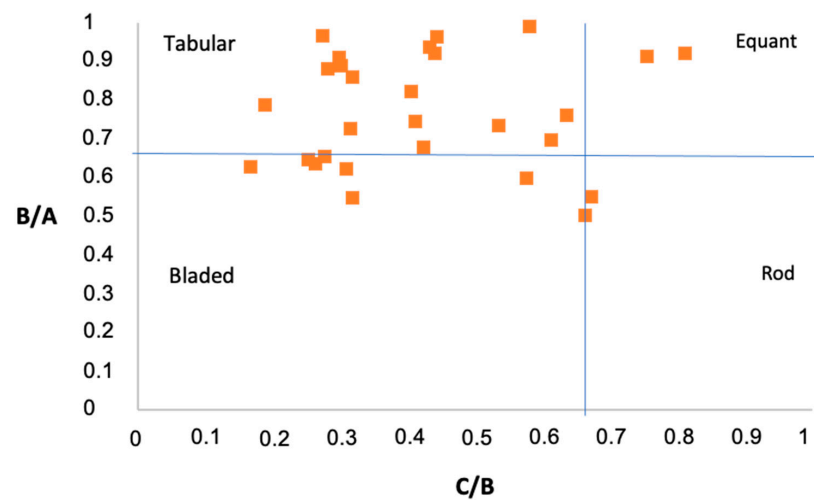
Figure 8. Zingg shape classification for the 31 selected boulders.

The values of the A, B, and C axes measured on the 31 boulders are shown in Table 2 and Figure 8. The axis values and the volume of the average boulder are $3.38 \times 2.51 \times 1.01$ m and 10.43 m^3 , respectively. The largest boulder (B11) is $6.27 \times 5.53 \times 1.56$ m, with a resulting volume and mass of 54 m^3 and 119 t, respectively.

About 96% of the boulders exhibit a tabular or bladed shape (Figure 8), and are characterized by slightly smoothed or sharp-cornered edges forming angles in the range between 55 and 80°. No common polarity or prevailing directions of the A and B axes between the different boulders—from the outer edge to the upper rocky platform at the foot of the cliff—could be detected. The lateral distribution of the boulders followed the same pattern. Boulders B1, B12, and B11, which are isolated along the upper rocky platform, have A, B, and C axis values ranging from even to double (Table 3).

The majority of the boulders have a tabular shape (Figure 8). However, the three boulders that were significantly displaced during this storm belong to three categories of clast shapes: B28 is tabular, B29 is bladed, and B30 is equant in shape. Furthermore, the lightest of the mobile boulders (B28 $\approx 2.82 \text{ m}^3$ and 6.21 t) presented a similar displacement distance to the heavier and larger boulder B30 (B30 $\approx 9.91 \text{ m}^3$ and 21.79 t). The mobile boulders were located at varying distances from the outer edge of the platform, with B30 being closest and B28 being farthest (Figure 10).

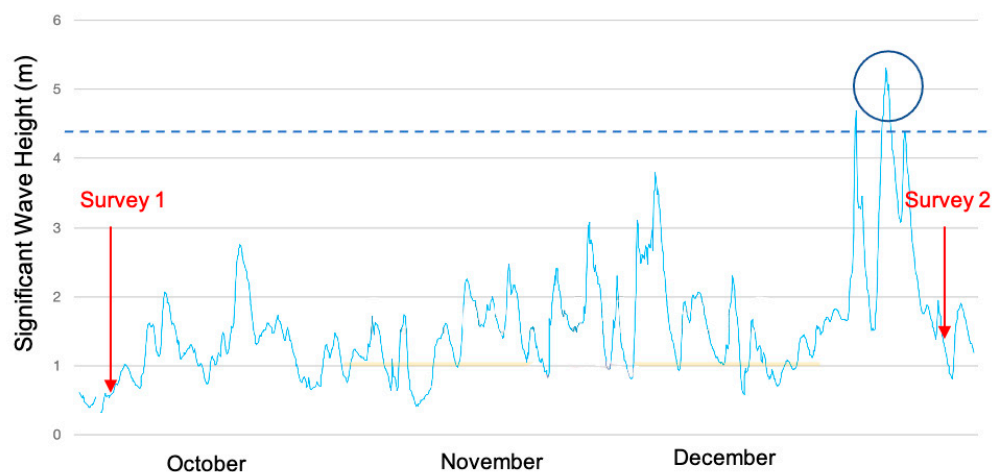
Figure 9. Significant wave height (m) conditions between the UAV surveys (red arrows), the wave storm threshold adopted for this study (blue dashed line), and the December storm conditions (blue circle). Wave data were obtained from the Port Authorities of Spain (<http://www.puertos.es> accessed on 1 October 2019).

A comparison between the UAV surveys of September and December 2019 was carried out in order to identify and quantify any boulder movements related to the December 2019 storms (Figure 9).

Between the survey of September 15th and December 26 (Figure 9), wave conditions were generally calm until mid-November, when a few episodes of strong agitation with H_s exceeding 3 m were recorded. This was followed by a relatively calm period until December 19, when wave conditions exceeded the 4.5 m storm wave threshold for a continuous period of 25 h. This storm occurred in a phase of transition from neap to spring tides, which probably significantly reduced its impact on wave propagation over the rocky platform, and, consequently, on boulder mobility.

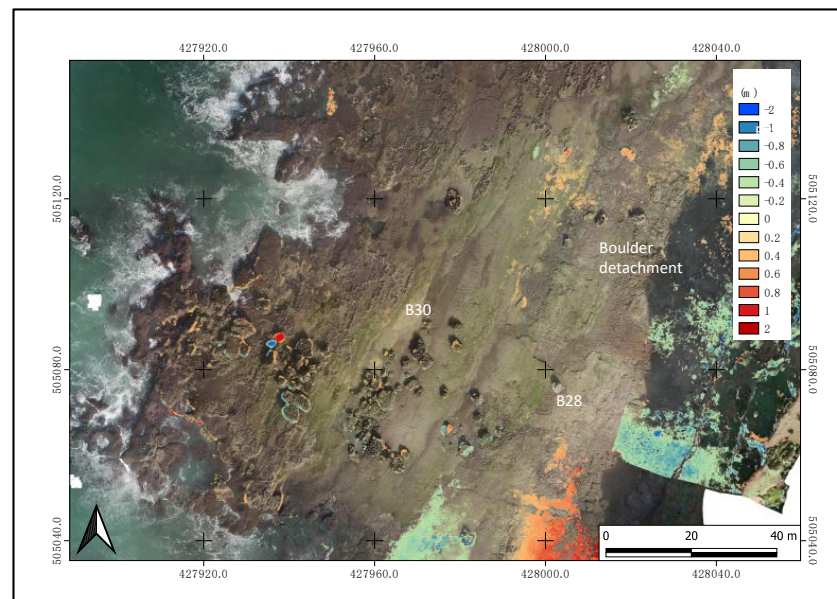
Figure 10. Orthophoto generated from the December 2019 UAV survey, showing the spatial distribution of three boulders affected by the December storm (B28, B29, and B30). An incipient boulder detachment is also visible in the central sector of the rock platform.

Comparison of the September and December models shows no erosion or accretion over much of the rocky platform, and unevenly distributed boulder movements (Figure 10). Areas with orange and green tints at the upper rocky platform are linked to an offset because of the presence of humans or animals (especially donkeys used to transport sand) during the drone flights.

Detailed analysis of the model output differentials indicates detectable boulder movements near the outer edge (B30) and the central areas of the rocky platform (B28 and B29) (Figure 10). A recently initiated detachment process of a new boulder in the central sector of the platform is also visible in the comparison of the UAV surveys (Figure 10).

UAV surveys and SfM model analysis captured the start and end points of boulders within a single storm event with measured waves at Laghdira, Morocco. This dataset could provide an excellent opportunity to apply empirical models of the energy flux and wave heights required for boulder mobility [64–66], and to test their effectiveness and adaptability, and even eventually calibrate them for the geomorphological specificities of Laghdira in order to project future boulder dynamics at this site. This study shows that with pre- and post-storm UAV surveys, we can confirm that wave erosion and wave-induced morphological changes are active at Laghdira. The appearance of a new detached boulder in the central zone of the rock platform attests to the continuity of landform change in this coastal setting. However, the location of mobile boulders at varying distances from the outer edge of the platform, as during the December storm (Figure 10), also shows that

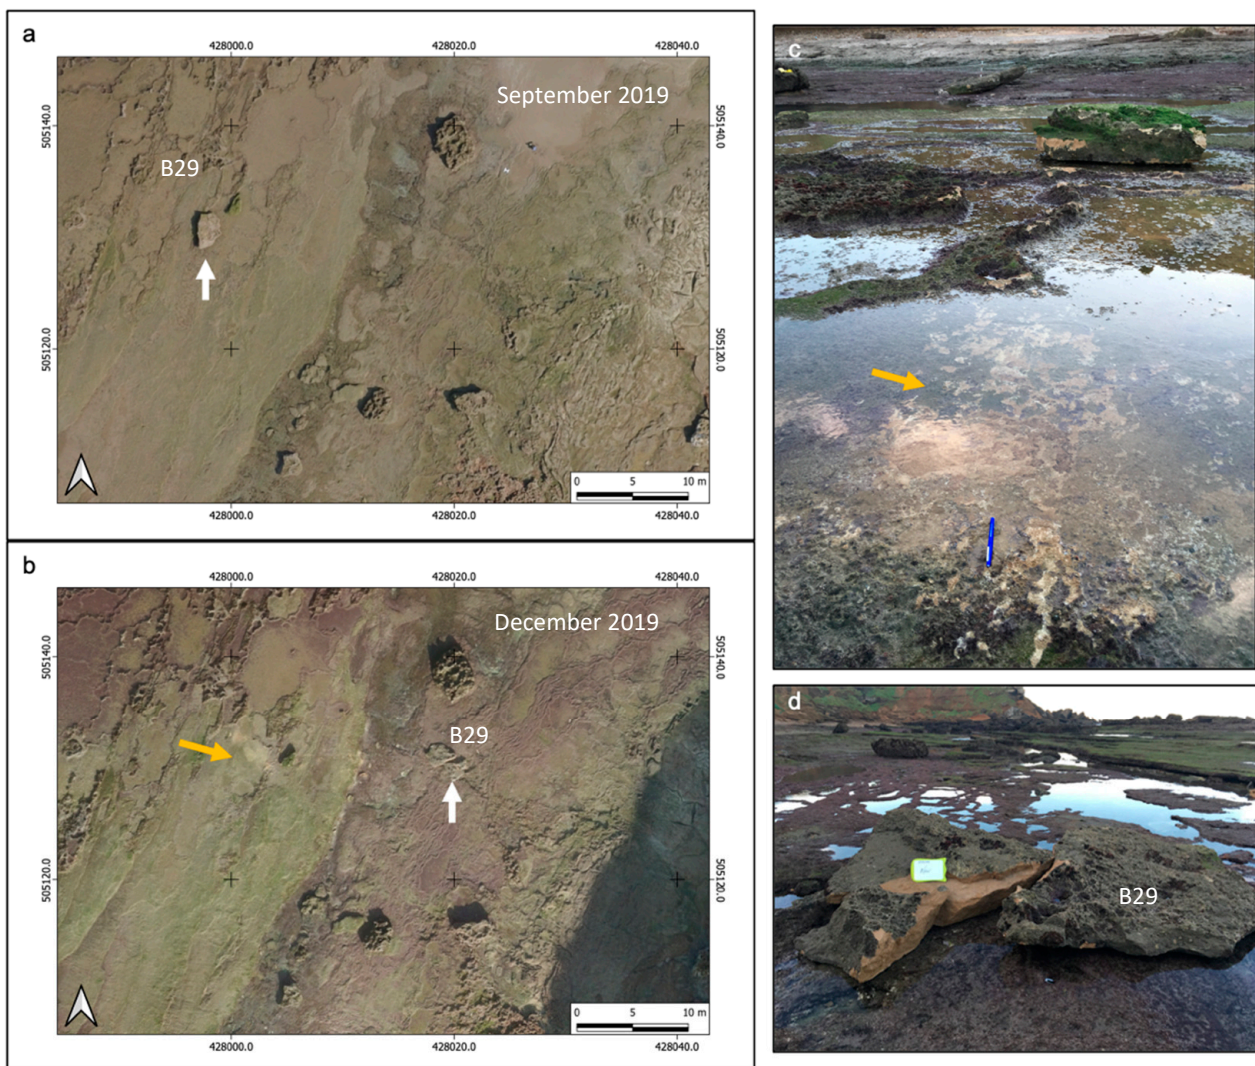
Figure 11. (a) Initial position and (b) displacement of boulder B29 (white arrows); the orange arrows (b,c) show the initial position and trace of the B29 pedestal; blue pen in (c) for scale (d) Post-storm position of B29.

The quadrangular boulder B29 ($\approx 3.38 \text{ m}^3$ and 7.44 t) was oriented with the longer axis parallel to the shoreline and the main axis in the wave direction. Following the December storm, this boulder was found 12 m further inshore and broken into two parts (Figure 10). The alignment of the main axis of the two fragments of this dislocated boulder has now become oriented in the main wave direction.

The September and December 2019 differential was of a resolution high enough to identify sliding as the mode of boulder transport for B29. The fresh traces of this boulder's movement are also detectable in the orthophoto and the model, and were confirmed by the field investigation (Figure 11).

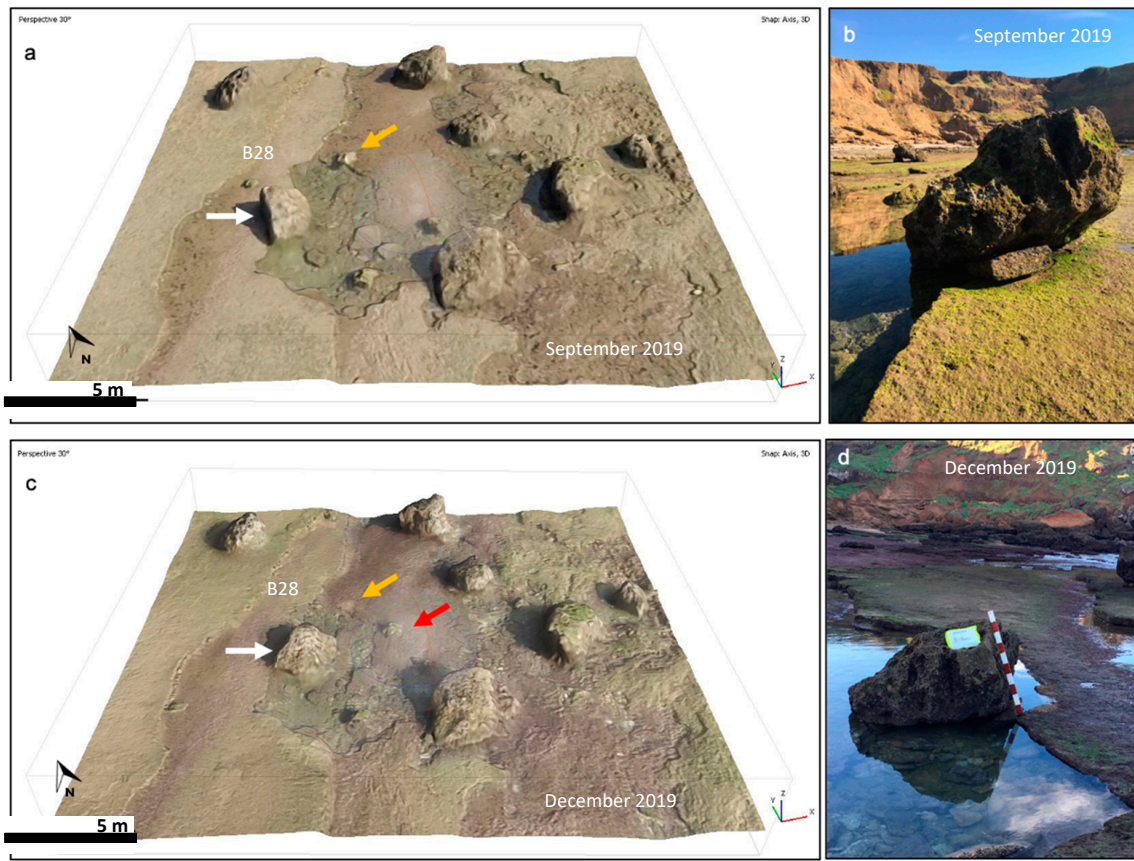
Figure 12. (a) Initial position of boulder B28 (white arrow); orange arrow shows the position of a small clast near B28; (b) photo of B28 in September 2019; (c) displacement of B28 (white arrow), initial position of small clast (orange arrow) and its new position (red arrow); (d) photo of B28 in December 2019, with bar scale.

Figure 12 displays a view of B28's position pre- and post-storm, and clearly shows that the boulder was overturned by the storm and not displaced. A view from the sea to the land enables clarification of the mode of movement of boulder B30 following the December 2019 storm (Figure 13). B30 moved laterally (eastwards) while positioning itself on the boulder just ahead (imbrication) and obscuring its sharp eastern edge. It also exposed a new face, but with no biogenic encrustations as yet (Figure 13). This confirms a rotation and saltation of boulder B30 in response to the storm.

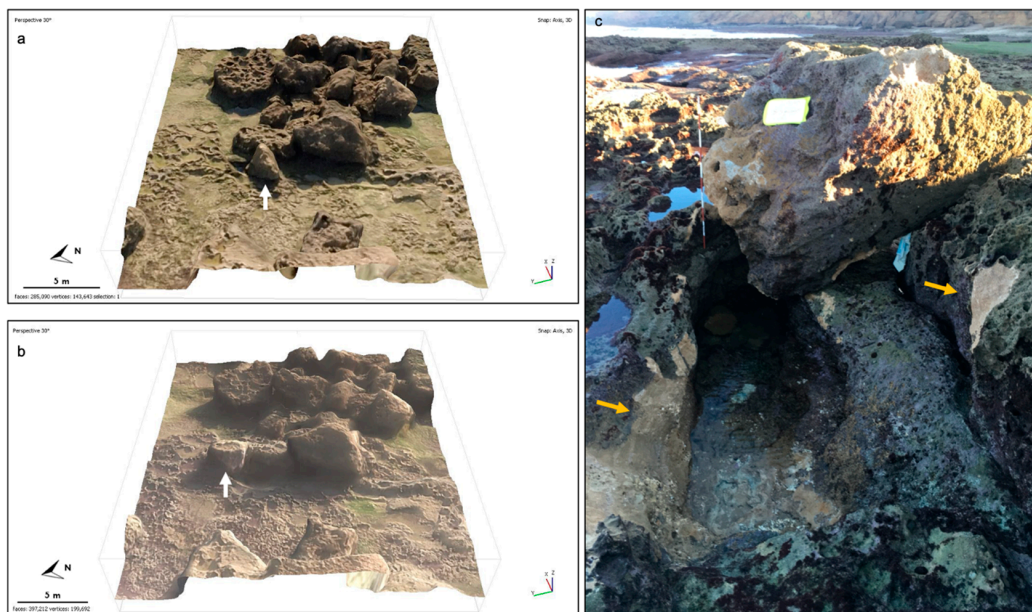
Figure 13. (a) Initial position of boulder B30 in September 2019 (white arrow) and (b) in December 2019; (c) field photo of B30 overturned; orange arrows show striae on the rock platform and adjacent boulder caused by B30's movement.

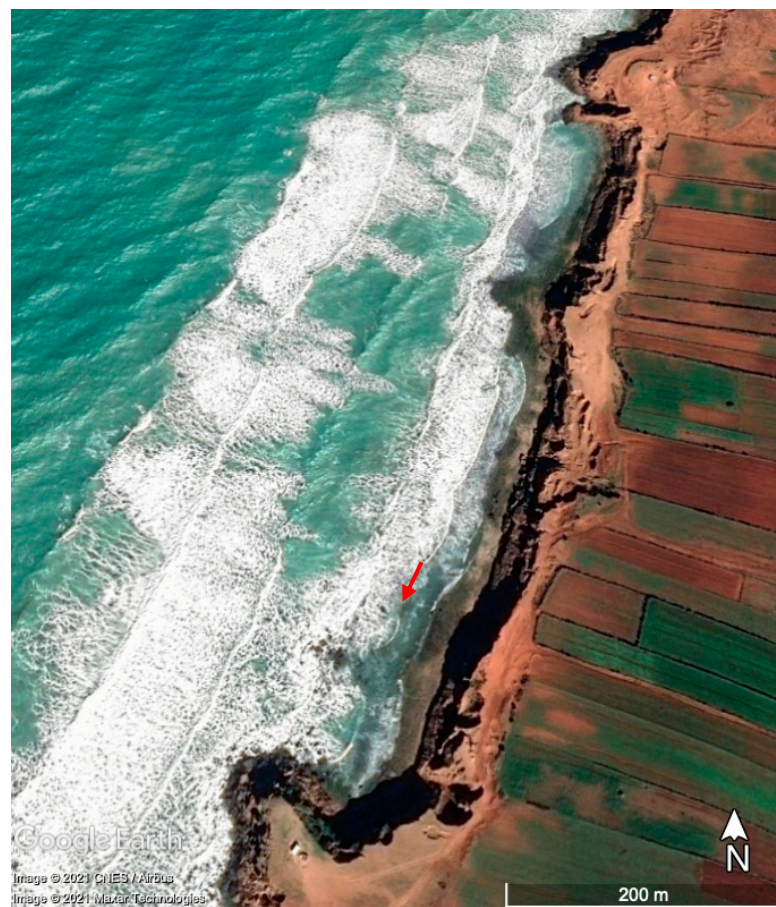
Figure 14. Satellite image (Google Earth) of Laghdira on 16 February 2016 showing northwesterly storm waves with a significant wave height of 4.5 m (almost the same storm conditions as in December 2019). Wave diffraction and energy damping by the cluster of imbricated boulders (red arrow) can be clearly seen.

When combined with close monitoring of storms, the employment of the UAV approach at multimonth-to-multiyear time steps allows for distinguishing boulder dynamics of tsunami origin from those of storm origin [63]. At Laghdira, our datasets provide evidence of the detachment and mobilization of three boulders during the December 2019 storm, as well as the emplacement of a new boulder following the storm. Three modes of boulder transport were detected from the analysis of orthophotographs in combination with 3D SfM models. The northern area, mainly characterized by isolated boulders, was subject to the longest boulder displacement (sliding) and the generation of a new boulder. The southern zone, characterized by a broad cross-sectional distribution of imbricated boulders and boulder clusters, showed a combination of saltation and boulder overturn with contrasting sizes and volumes. The presence of some joint-bounded boulders (Figure 4d), of sockets carved at the rocky platform edge, and the correspondence of morphometry between sockets and boulders, could confirm that the production of the blocks at the southern part of the study area occurred because of their detachment from the platform edge. The northern zone, without boulder clusters close to the rocky platform edge, was potentially more affected by the storm, resulting in the longest recorded boulder displacement, but also in the detachment of a new boulder in the central part of the platform. At the southern zone, the imbricated boulder cluster situated near the platform edge may have acted as a wave energy dissipation ramp, thus reducing the potential transport of adjacent boulders (Figure 14).

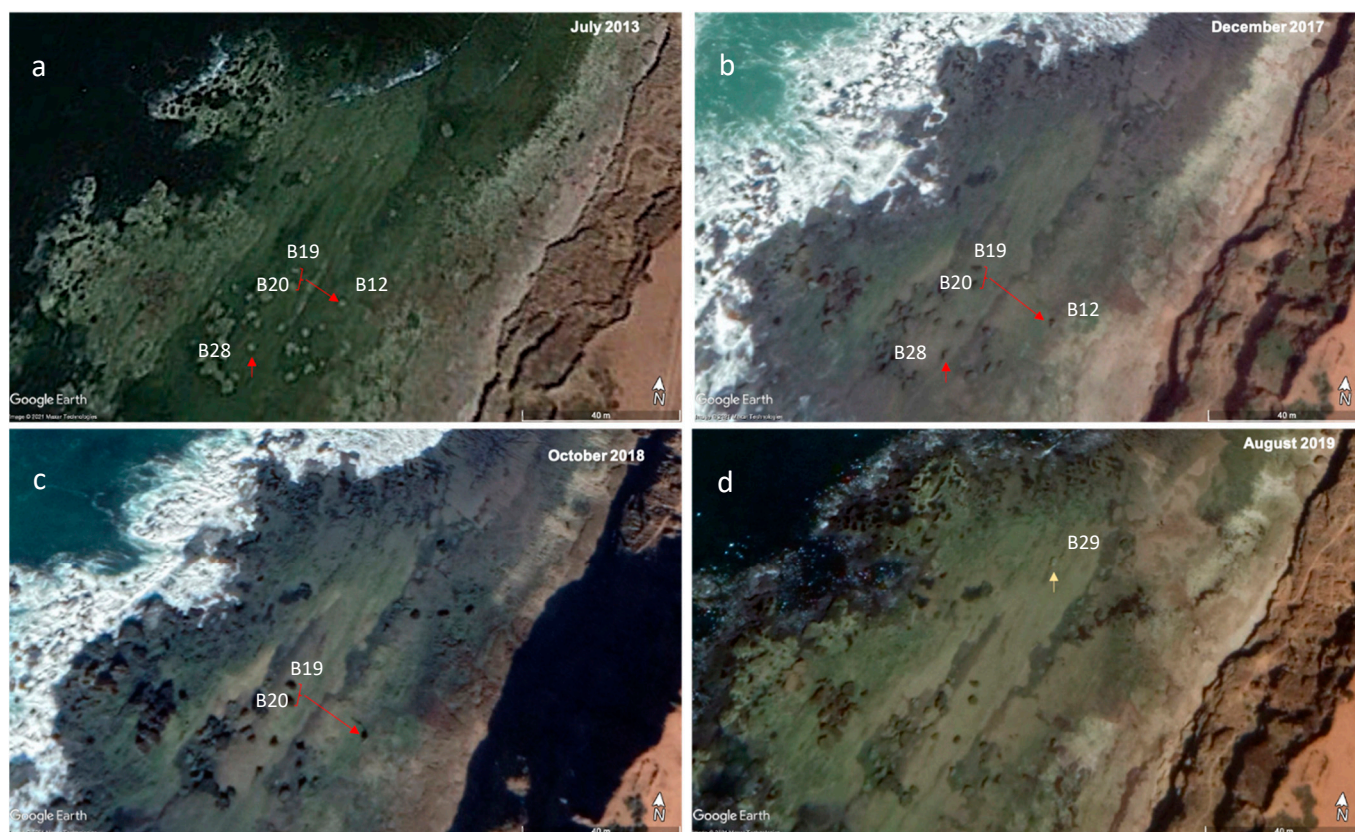
Figure 15. Satellite images (Google Earth Engine) of Laghdira in 2013, 2017, 2018, and 2019: (a) positions of boulders B12, B19, B20, and B28 in 2013; (b) displacement of boulders B12 and B28 between 2013 and 2017; (c) no significant and detectable changes in boulder locations in 2018; (d) appearance of boulder B29 on the rock platform of the study site in 2019.
