Assessment Of The Hygrothermal, Microstructural And Chemical Evolution Of A Hemp-Based Cementitious Mortar Under Etics Total Weathering Aging Protocol

D Kosiachevskiy, Kamilia Abahri, Anne Daubresse, Evelyne Prat, Mohend Chaouche

Keywords: Hemp mortar, ETICS, rain cycles, heat-cold cycles, microstructure, thermal conductivity, moisture buffer value, vapor permeability

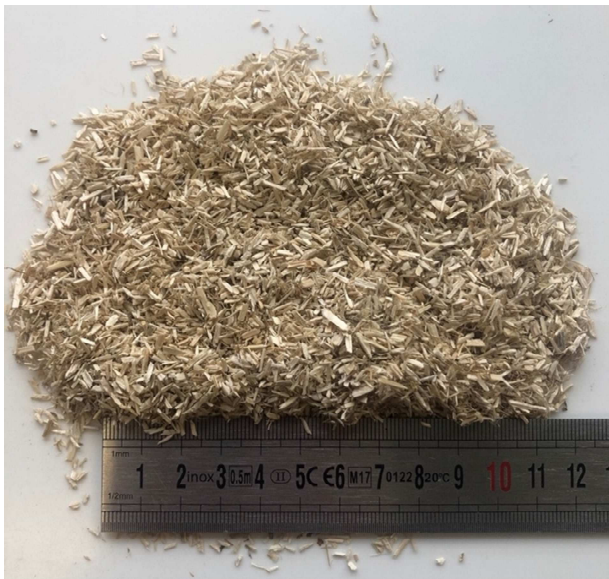
Figure 1. Hemp shives

The hemp shives of France origin were used for manufacturing the hemp mortar samples. Their visual aspect and granulometric curve are presented in Figures 1 and 2 respectively. The binder represents a commercial mix designed by ParexGroup SA. It is composed of hydrated lime, Portland cement and various additions to achieve the rheology suitable for spray application. Chemical composition of mineral binder is presented in Table 1. The hemp mortar proportion ratios are represented in the Table 2. This mix is suitable for material application by spraying. This requires special attention to the rheology that allows the industrial application of insulating hemp mortar. The studied samples were manufactured in laboratory using the laboratory mixer. The mixing was done in two stages: firstly, hemp shives were mixed with water during 1 minute at 140 rpm, secondly, the binder was added and it was mixed during 5 minutes at 140 rpm. After their laboratory manufacture, the specimens were dried for 28 days at laboratory conditions (23 ± 2 °C, $50 \pm 5\%$ RH) as shown in Figure 3. The adopted sample sizes depend on experimental procedure and are presented for every type of test in the paragraph 2.3.

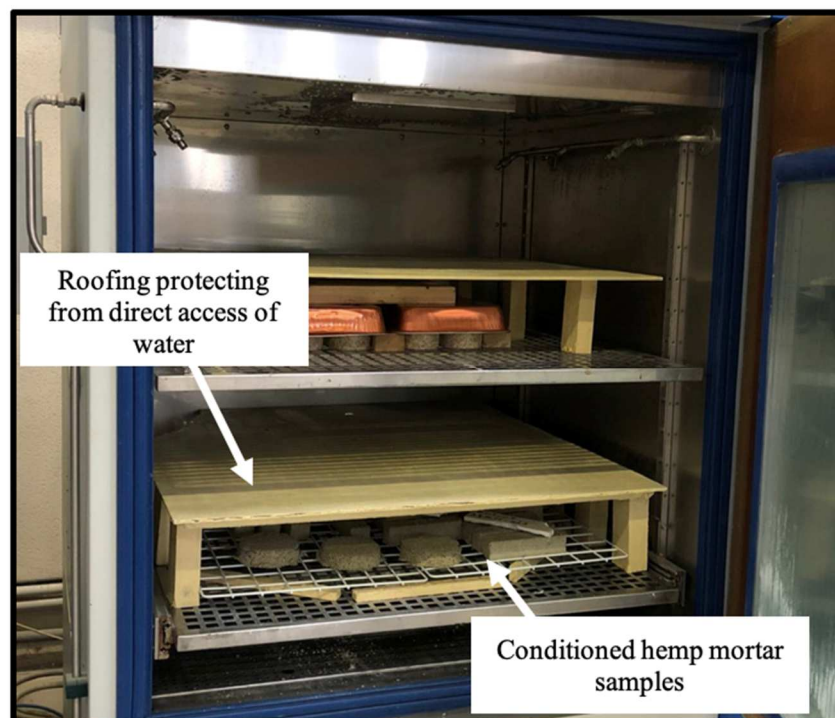
Figure 5. Disposition of the hemp mortar specimens in the climatic room before accelerated aging cycles

aging cycles. That is why in this study, we used a roofing to avoid direct spraying of water on the samples, as shown in Figure 5.

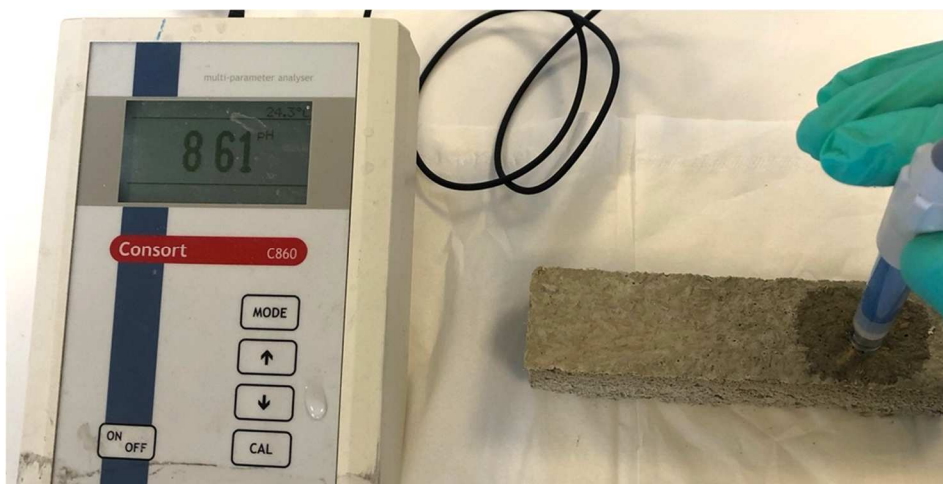
Figure 8. Measurement of the surface pH level using a WTW Sentix Sur electrode

of the solid phases but especially of dilution, moreover if talking about hygroscopic composite material. That is why in this work a surface electrode WTW Sentix Sur was used [21]. It allowed us to get a reliable result and especially on different parts of samples to evaluate a chemical degradation of the mineral matrix.

For this test the specimens of the same composition, made with the same raw materials, of the size $16 \times 4 \times 4 \text{ cm}^3$ were used. For each value three measures were performed at different positions on the specimen. As the pH level measurements are possible just in solution, the constant volume of demineralized water (0.2 ml) was deposited on the studied surfaces. Then, the electrode was kept on the sample surface, so that the electrode's membrane remains in contact with the hemp mortar (Figure 8). At equilibrium, the WTW Sentix Sur displays a constant value of PH which will be subsequently recorded. For the inner pH level measures the protocol is the same, but the measurements were conducted in the middle of the specimen.

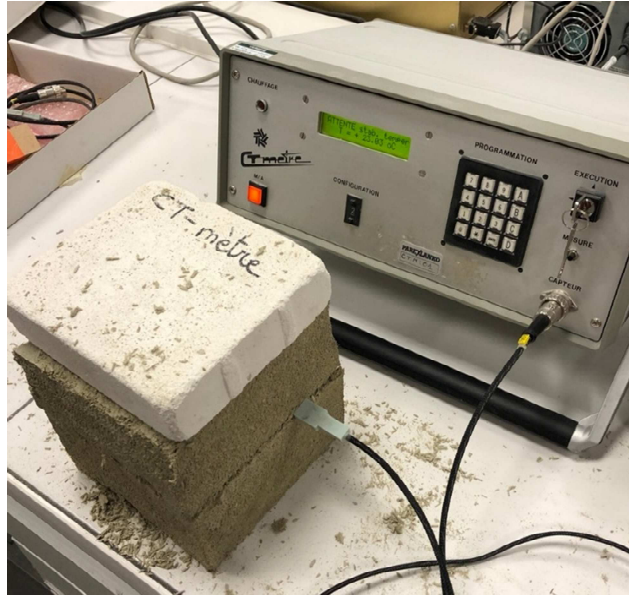
Figure 10. CT-Metre measurement device

Measurements were made according to the device precautions on the measurements. The used protocol consists of placing a probe between two samples keeping the maximal parallelism of the surfaces to avoid the distortion of results. The thermal conductivity values were calculated by the CT-Metre automatically, coefficients of correlation of presented results were 0.999.

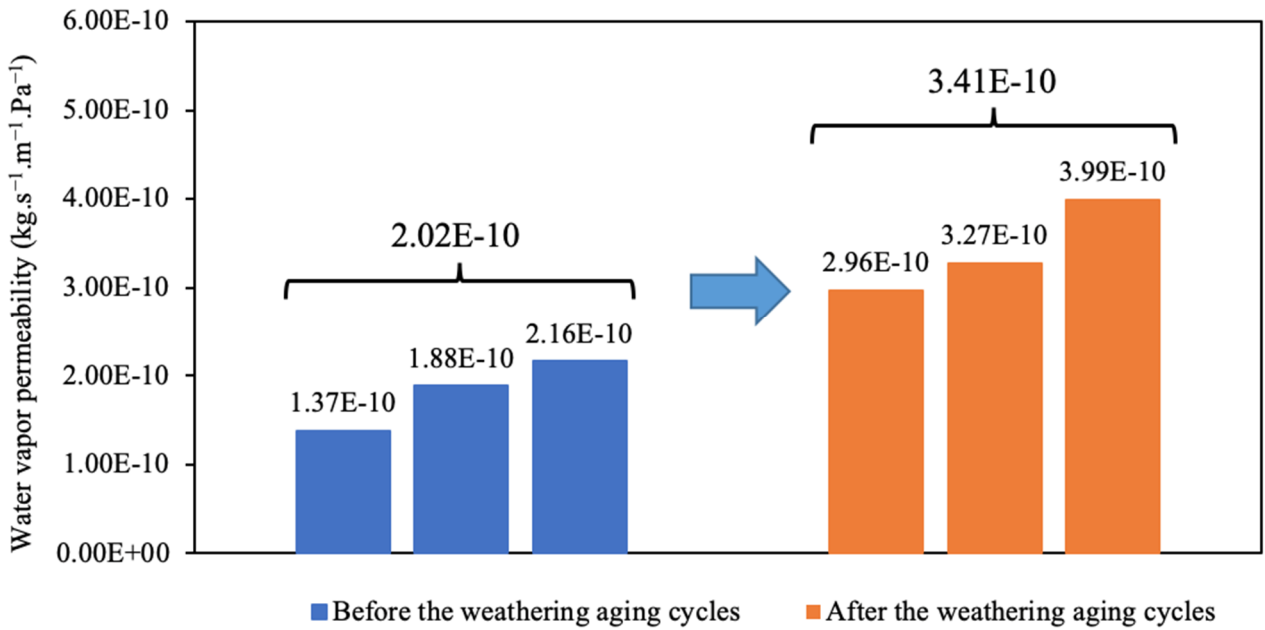
Figure 16. Water vapor permeability ($\text{kg}\cdot\text{s}^{-1}\cdot\text{m}^{-1}\cdot\text{Pa}^{-1}$) evolution of hemp mortar samples before and after the weathering aging cycles

First, the water vapor permeability evolution due weathering aging cycles was investigated. This parameter expresses the quantity of water vapor that passes through sample's porosity. Thus, the evolution of this parameter also gives information on the evolution of the porosity and cracking caused by the hygrothermal dimensional variations after aging. The results of water vapor permeability before and after the weathering aging cycles are present in Figure 16. Firstly, one can notice that the results obtained from this study are much higher than the values measured for other formulation of the hemp mortar in the literature [10]. The measured value at the age of 30 days for wet cup method was $2.02 \text{ E}^{-10} \text{ kg.s}^{-1}.\text{m}^{-1}.\text{Pa}^{-1}$. That is explained by the composition, the particle size of hemp particles, and different binder types that allow to produce more aerated hemp mortar in case of studied formulation. Also, we notice the increase of the average water vapor permeability after aging from 2.02E^{-10} to $3.41\text{E}^{-10} \text{ kg.s}^{-1}.\text{m}^{-1}.\text{Pa}^{-1}$, that justify the results of the increase of the porosity. This is explained also by the cracking of the hemp mortar, which increases its vapor diffusion capacity and thus its permeability.

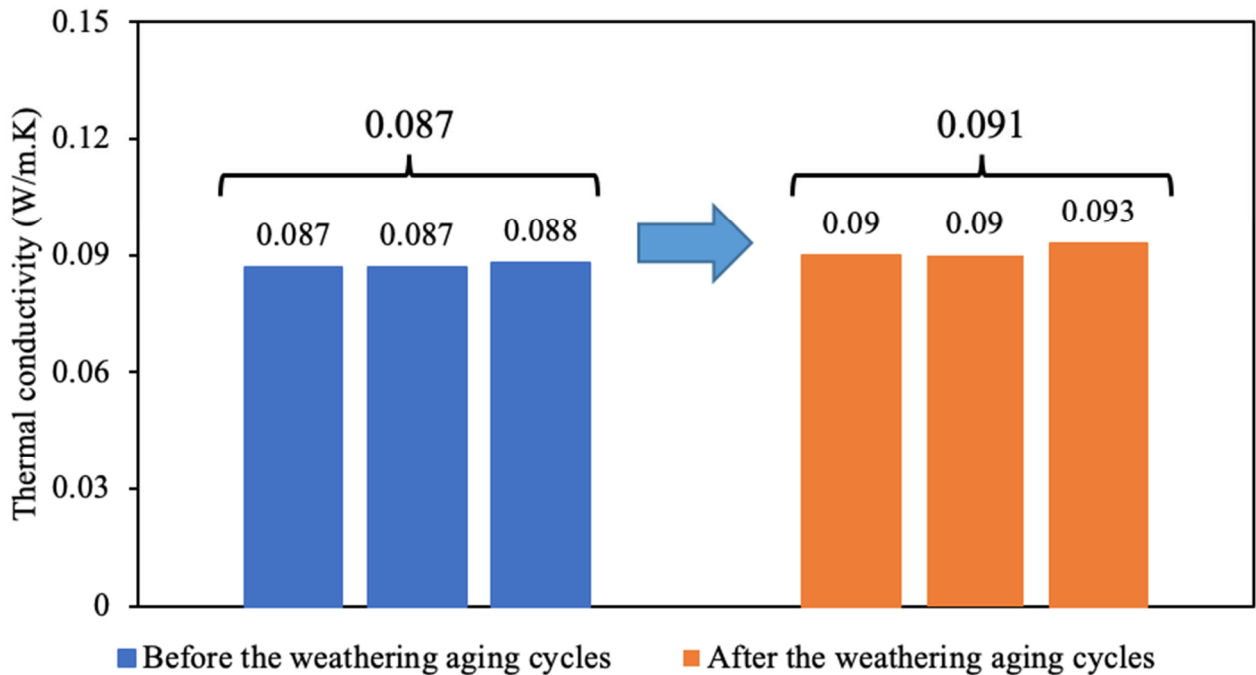
Figure 17. Thermal conductivity [$\text{W}/(\text{m}\cdot\text{K})$] evolution of hemp mortar samples before and after the accelerated aging cycles

The result of the evolution of the thermal conductivity before and after aging are presented in Figure 17. The thermal conductivity was slightly increased after aging from $0.087 \text{ W}/(\text{m}\cdot\text{K})$ to $0.091 \text{ W}/(\text{m}\cdot\text{K})$. In fact, this parameter is very dependent on the porosity. Thermal conductivity increased after aging because of the degradation of the plant fibers.
