## Typology of geometrical defects in Electron Beam Melting

Thanh Hoang Vo, Matthieu Museau, Frédéric Vignat, François Villeneuve,  
Yann Ledoux, Alex Ballu

# 15th CIRP Conference on Computer Aided Tolerancing – CIRP CAT 2018

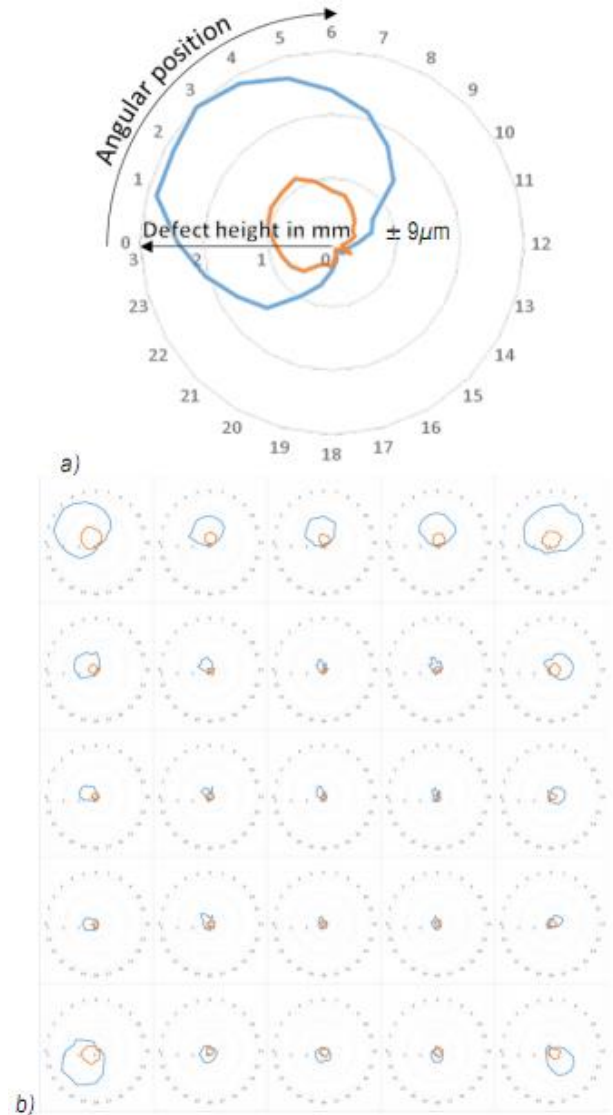
The different height variations of massive test specimens are presented in Fig. 9. An example of the height defect of one specimen is shown in Fig. 9a: the height defect is presented in function of the angular position of measured point. The defects cartography of 25 specimens is shown in Fig. 9b. It could be observed that the defect value is more important when the measured point on a specimen is close to the borders of the platform of the machine. The same conclusion was identified for the lattice structure.

Fig. 9 a) Example and b) defect cartography of the massive specimen (blue:  $\varnothing 30$  mm, orange:  $\varnothing 20$  mm)

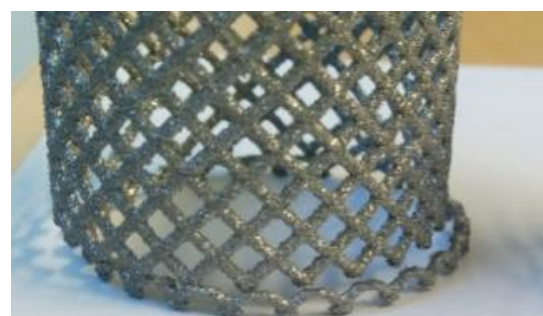
Fig. 10 Photography of the 2 mm mechanical shifting

Another interesting defect is the mechanical shifting of the first layers in the direction of the movement of the rake, see Fig. 10. This defect seems to be not repeatable from a sample to another one.

- The first hypothesis is related to the electron beam: the shape of the beam changes from a circle to an ellipse when the electron beam moves from the center to the border of the manufacturing platform. The surface of transmission becomes larger and leads to a decrease of the energy broadcast. Therefore, it results a decrease of the temperature that leads to limit the quality of the powder melting. This hypothesis may explain the type and location of the defect.
- The second hypothesis is related to the loss of temperature. At the borders of the manufacturing platform, the cold powder and metal enclosure might absorb the energy of the sintered powder.
- The third hypothesis involves the rake to explain the mechanical shifting in Fig. 10. When the rake spreads the powder out, a portion of specimen is moved in the rake direction and might cause deformations.

As a result, the hypothesis kept is a combination of the previous ones: the different contact area shape of the electron beam on the powder bed from the center to the border provides less energy to the powder. In addition, energy leaks near the border make the sintering of the powder weaker. Then, the rake passage might easily move the poorly sintered powder and the molten material. According to these investigations, the two main reasons of these defects are the loss of temperature and the contact of the rake with the specimen during the production.

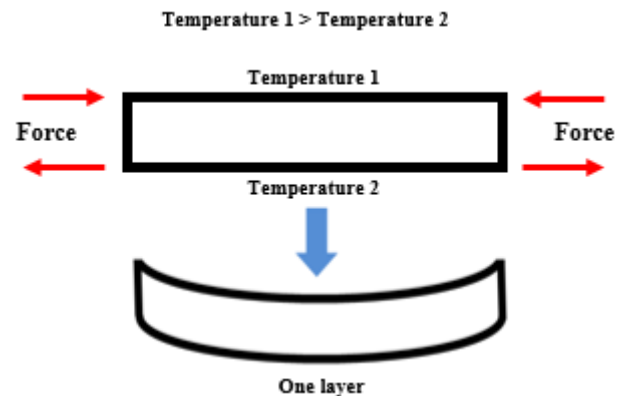
Fig. 13 Temperature gradient induced deformation [26]

The thermal stress can be explained from temperature gradients [26; 27]. Fig. 13 shows the temperature gradient inducing deformation of feature due to rapid heating of the upper surface caused by the fast moving of the electron beam and the relatively slow heat conduction. Since the temperature of the upper surface is higher, a temperature gradient is observed. Then the expansion of the heated top layer is restricted by the underlying material (having a lower temperature), and counter compressive strain phenomena are induced. During the cooling of the zone, the compressed upper layers start to shrink and leads to the warping of the overhang surfaces. Thus, the temperature gradient is the main physical phenomenon in the apparition of the warping defect.

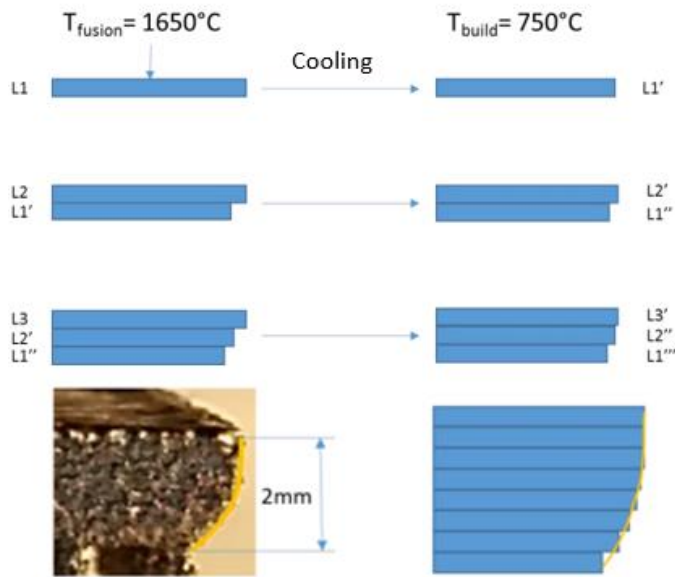
The loss of edge defect is a loss of side geometry at the end of the overhang portion, see Fig. 16. This geometric defect may be explained by the decrease of the layer length due to the cooling phenomenon from previous melted layer to the new one.

Fig. 16 Loss of edge defect and explanation

Once the first layer of a surface has cooled, it shrinks due to the temperature gradient (from 1650°C to 750°C). The powder of the next layer is distributed and melted. An offset is produced between successive layers. The offset between two layers would be caused by the shrinkage between 1650 and 750°C, as the upper layer is warmer, it is a little longer and it clings to the previous layer with a shift. The second layer also undergoes a narrowing that causes the first layer to shrink since the force exerted is greater than the elastic limit of the material. The first layer is plastically deformed. This phenomenon is repeated for each layer but the deformation

becomes smaller due to the opposite deformation of the previous layers and the increase of the part stiffness. The gap between the two layers becomes smaller each time.
