World heritage: inventory of earthen architecture

Inventory of **earthen** architecture

WORLD HERITAGE **EARTHEN** ARCHITECTURE PROGRAMME

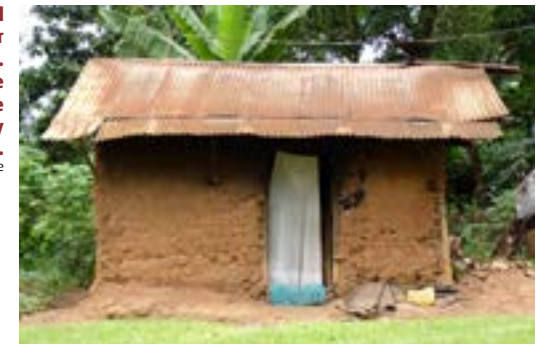
House of one of the traditional guardians who watches over the spirits of deceased kings. This is the last earthen house within the property, as all the others have been replaced by burnt brick structures.
 © Sébastien Moriset, CRATERre

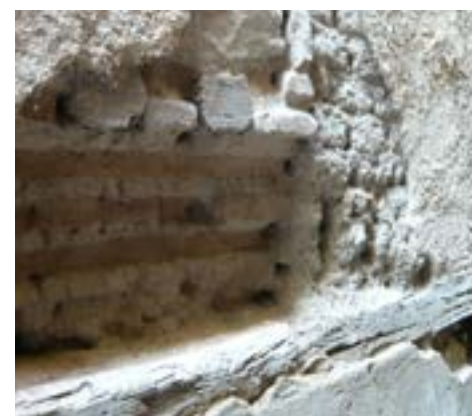
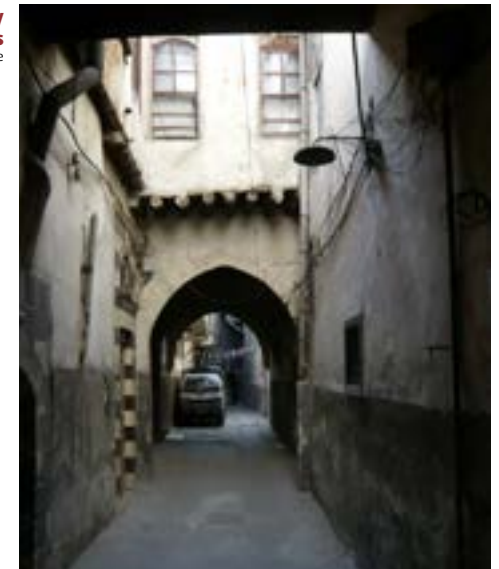
Detail of degraded plaster and of the earth bricks showing underneath

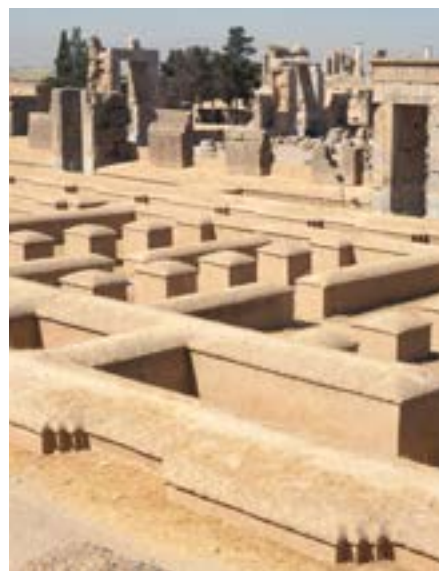
Detail, restored earth walls
© David Gandreau, CRAterre

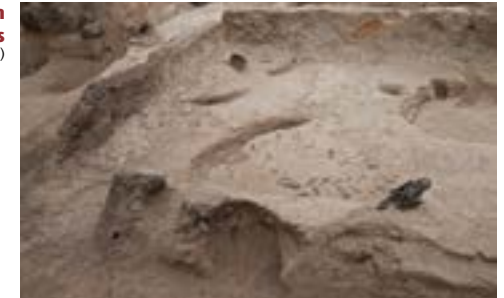
Repaired patches of mortar with
finger impressions
© Çatalhöyük (Flickr, creative commons)

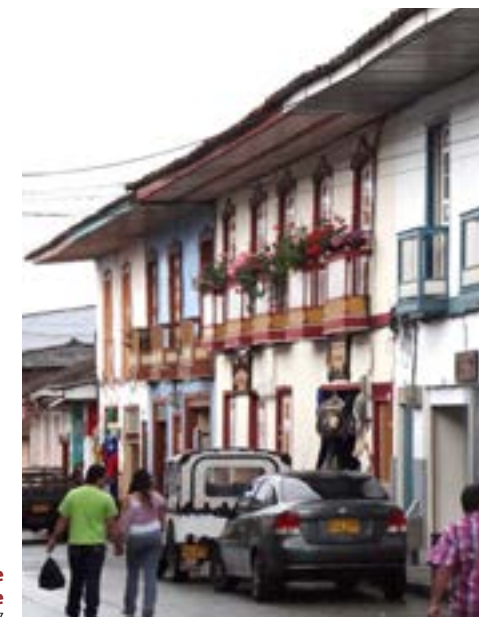
Constructions en terre faites de pisé à la base et de torchis (bahareque) à l'étage
© Beatriz Helena Ramirez Gonzalez
