# Preservation of the Greater Kyz Kala at Ancient Merv

### Preservation of the Greater Kyz Kala at Ancient Merv

### Progress report 2015

David Gandreau and Chamsia Sadozai, CRAterre, France

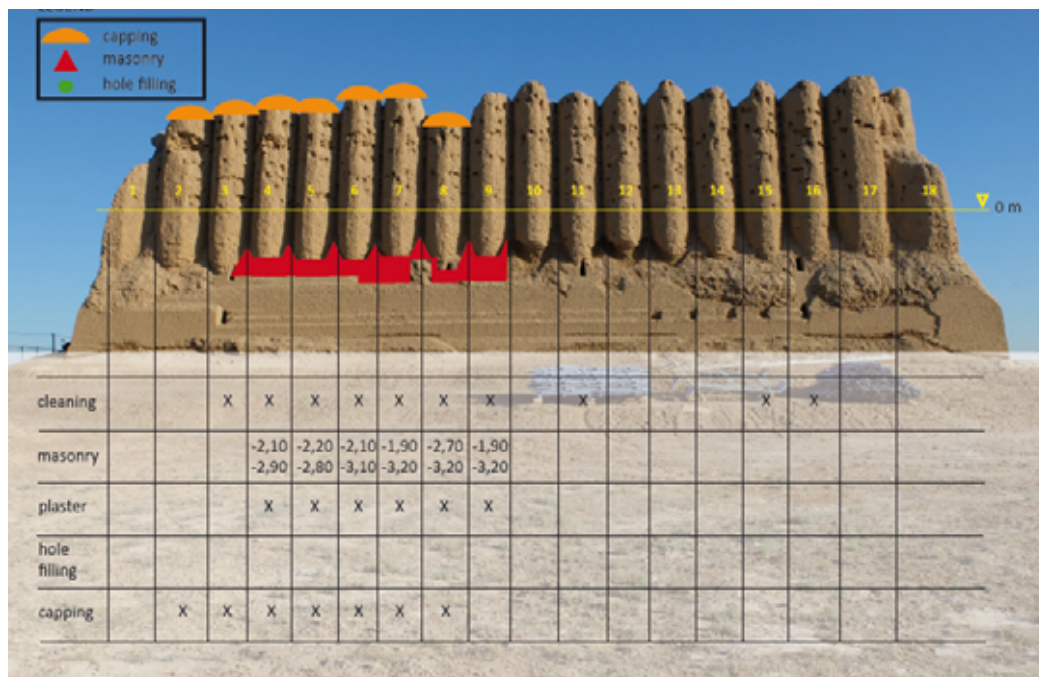
Synthetic presentation of the conservation work implemented on the south facade of the Greater Kyz Kala in, May 2015

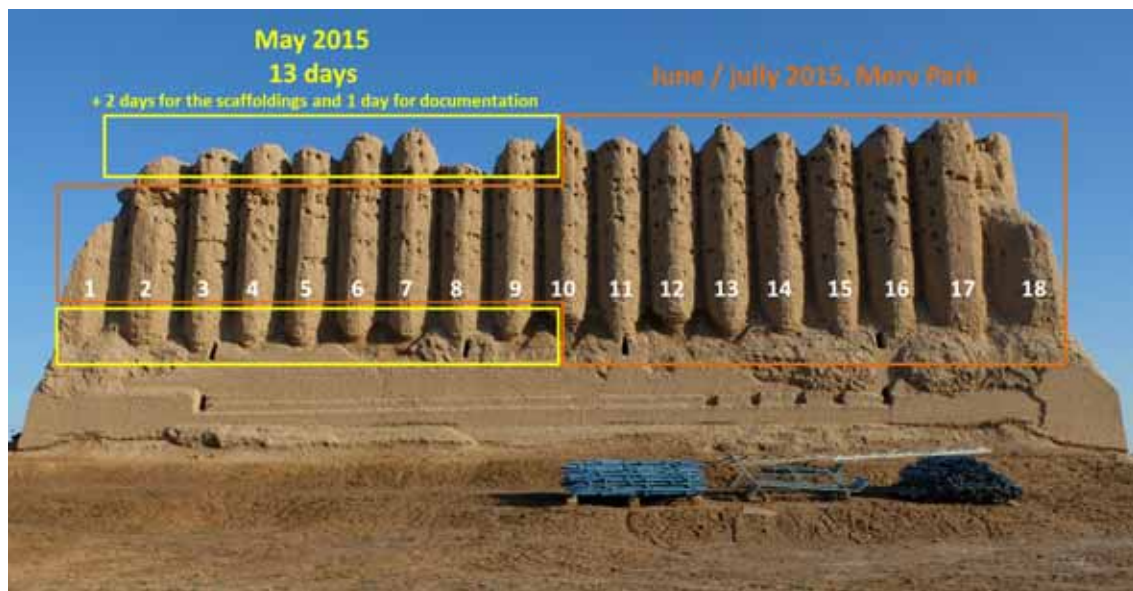
Recommended work plan for the south facade, from May to September 2015

- Continue to restore with mud bricks the eroded parts of the wall, according to the method developed in May (see chapter 2.3 and 3);
- Apply this method to the holes created by the bird nests after the breeding season;
- Ensure preventive conservation by finishing the capping on the top of the wall and improving the drainage at the base;
- Document all step of the works;
- Assess the restoration/preventive conservation work in fall and adjust if necessary;
- Assess the technical and aesthetical (patina) results after two rainy seasons.

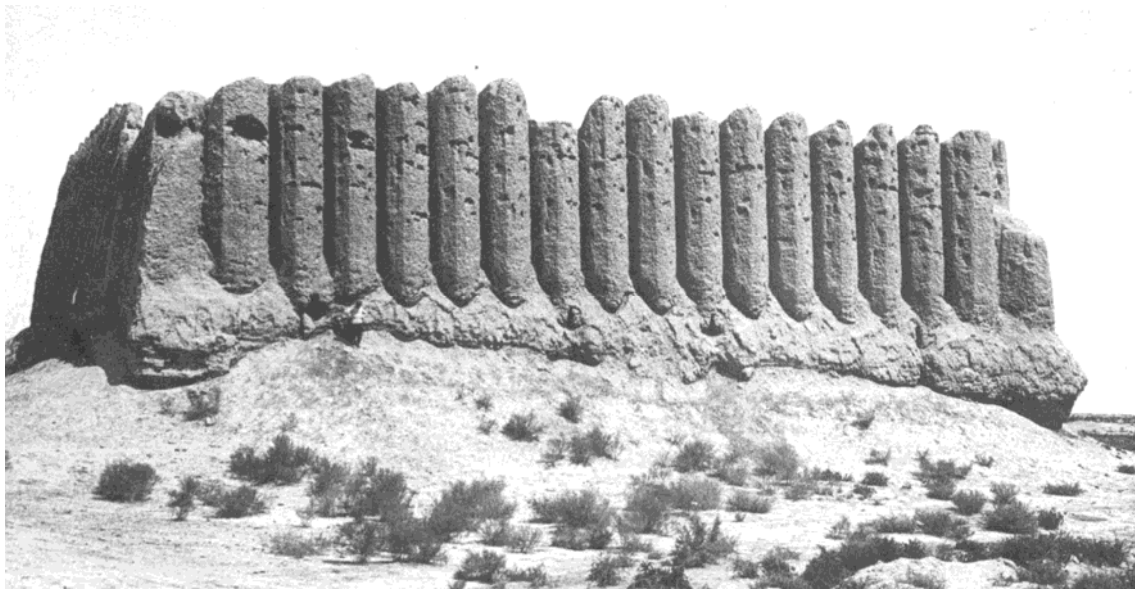
**1890.** Ref. ZHUKOVSKY

- No conservation undertaken
- Corners are the most eroded (bases and tops)
- Many holes on the corrugations
- Massive debris deposit along the wall bases

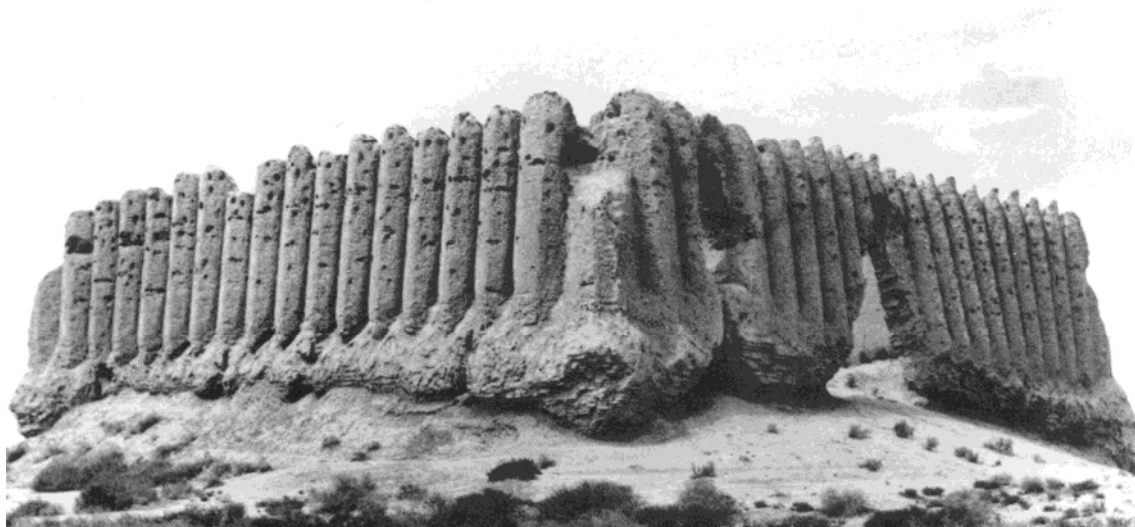
**1971.** Ref: PILYAVSKY

- Same situation of the south facade (view from the S/E angle)

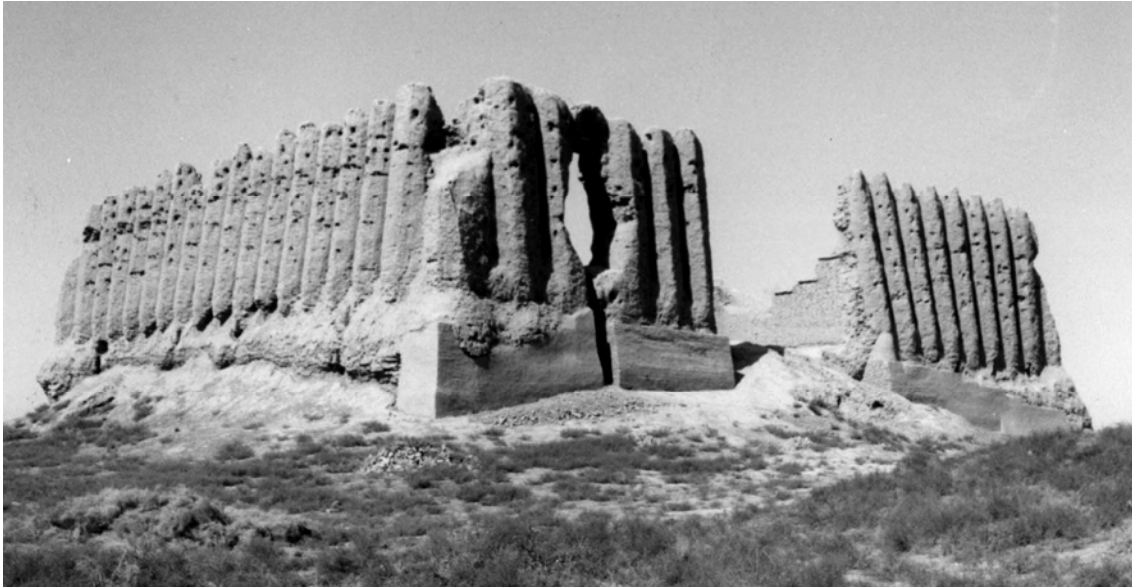
**1999.** Ref: J. ROCK

- Huge collapse of the East Facade (6 columns in the middle have collapsed since 1971)
- East facade is restored at the base (see S/E corner)

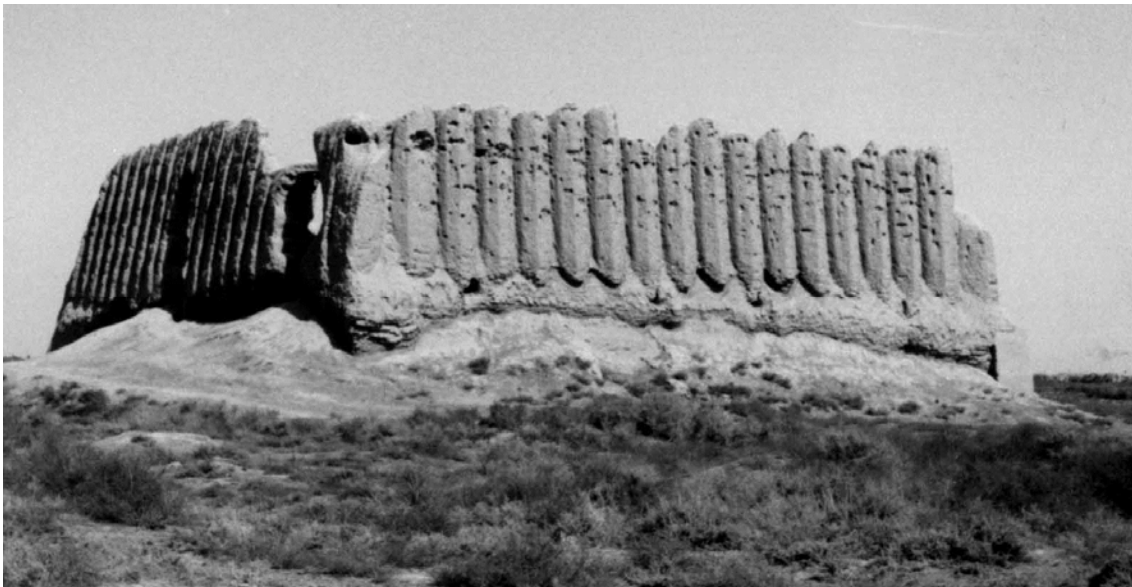
**1999.** Ref : J. ROCK

- View from the S/W angle.
- Only the S/E corner is restored
- Traces of the trench excavated by Khodjaniasov (1989 - report available in Russian, YuTAKE)

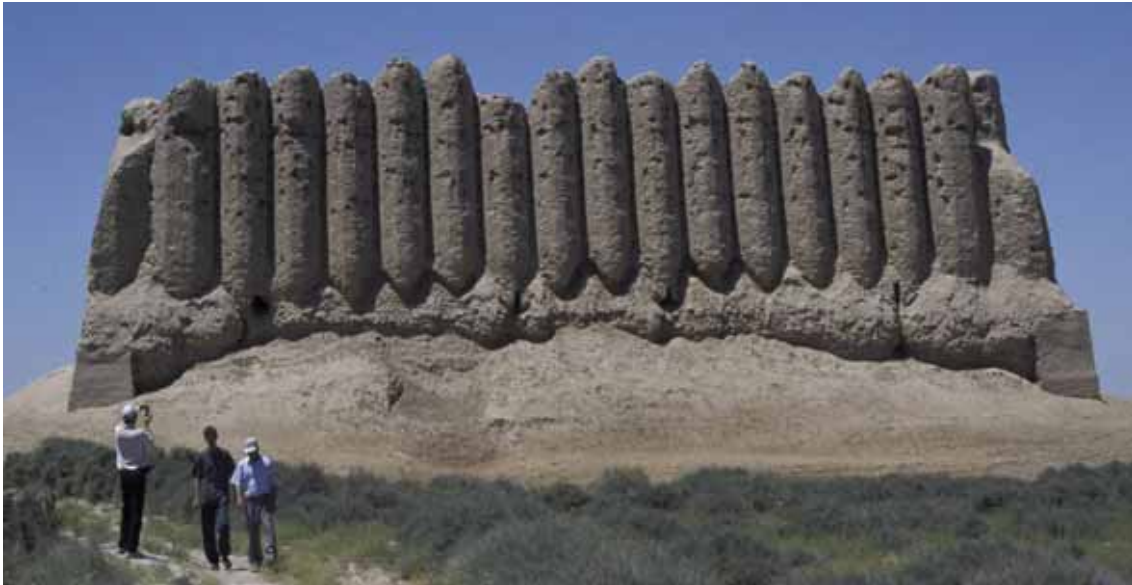
**2001.** Ref: CRAterre, Sébastien MORISET

- The bases of the West facade have been restored
- Beginning of CRAterre cooperation to the project

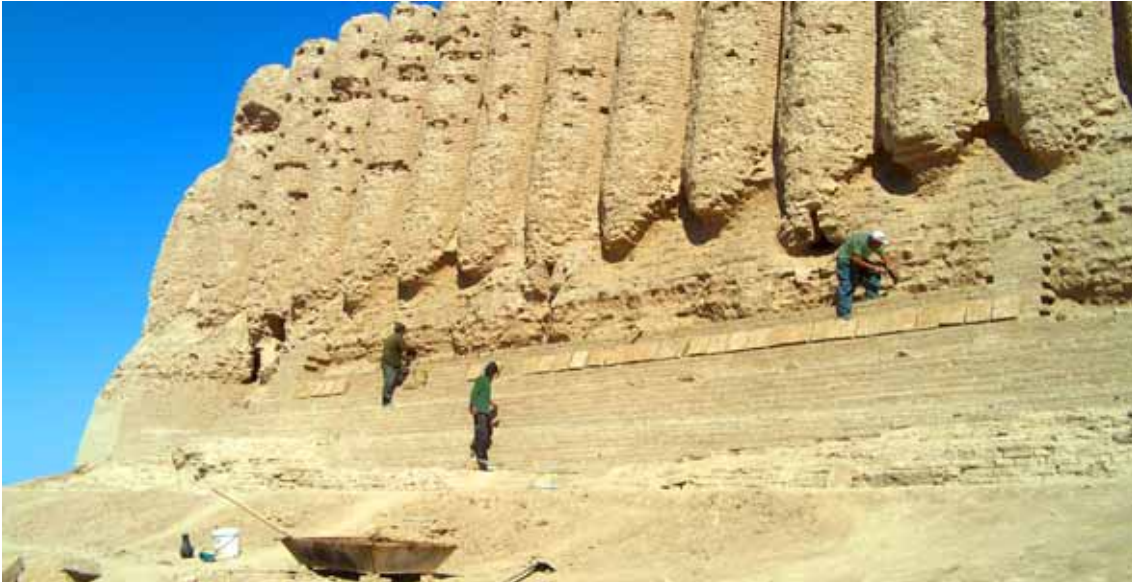
**November 2012.** Ref: Merv Park, Redjep DJEPAROV

- Several conservation phases between 1999 and 2012
- A preventive conservation approach rather than restoration
- Preventive conservation of the wall bases masonries by “steps” to permit access without scaffolding
- Original parts are left visible in “first plan”.
- The only facade without render covering the conserved areas

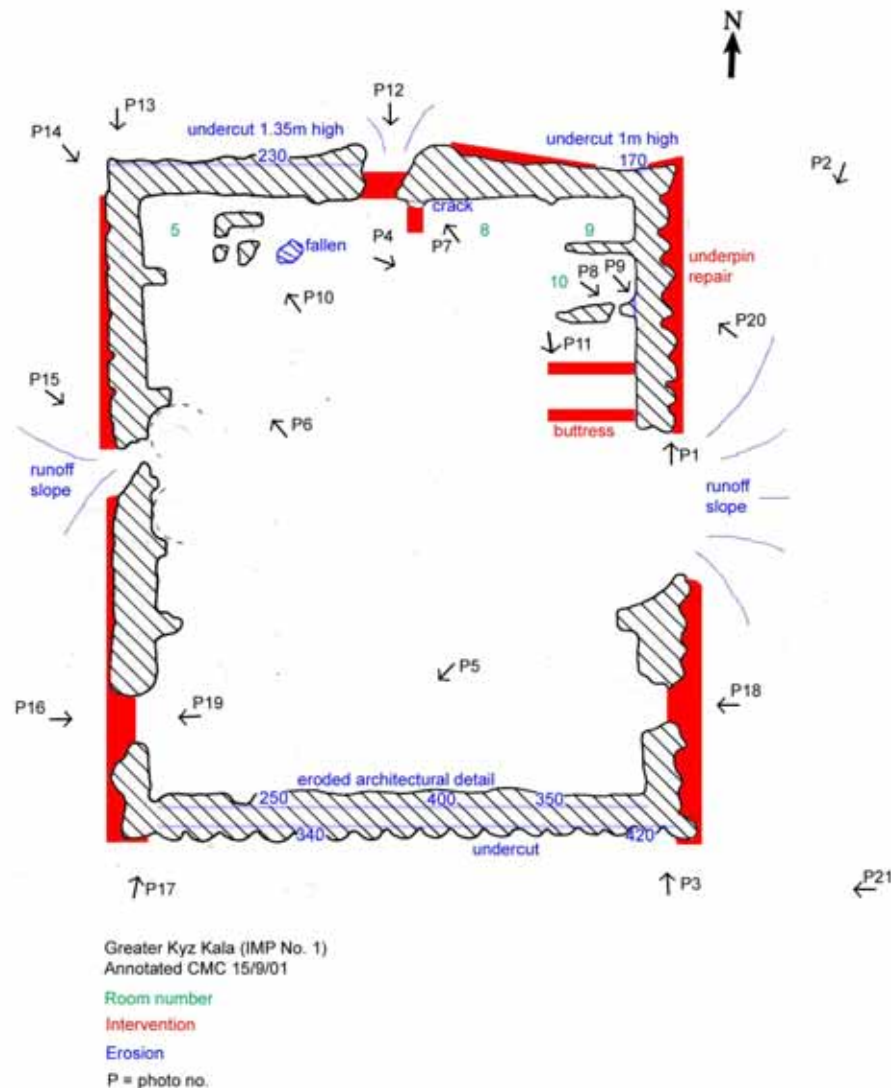
This survey conducted in 2001, point out that the condition of the building was not alarmous but the decay process speed was increasing, mainly because of water pathologies (moisture). A brief history of the conservation actions is done with a plan and an analysis of their visual impact.

“Plan of monument indicating existing interventions, erosional problems and position of photographs”  
(UCL, 2001, p.5)

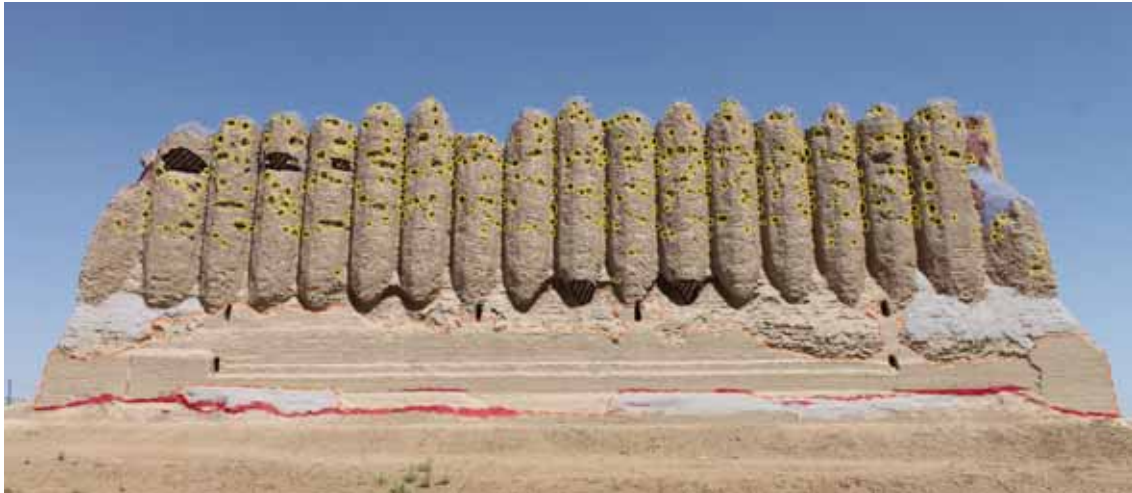
“Wall 4. South-east face (external)” (UCL, Alshisani, F., Katrakazis, T. 2013, p.6)

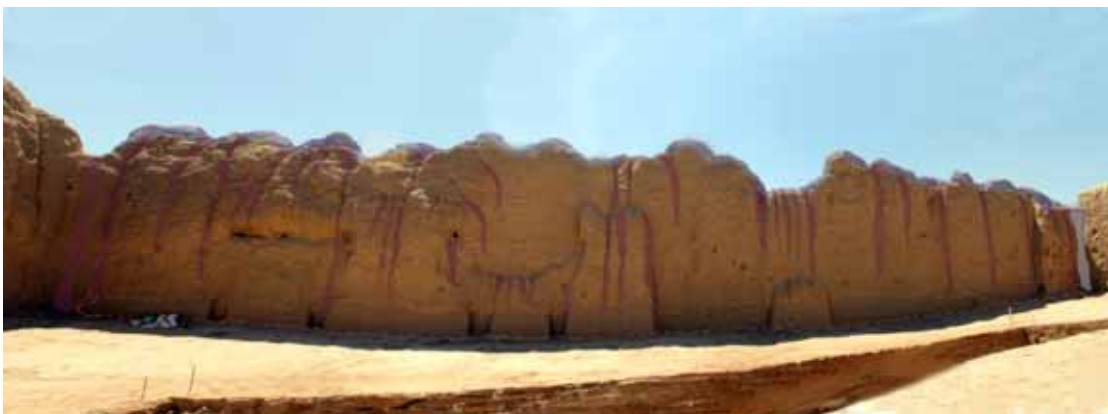
“Wall 4. North- west face (internal)” (UCL, Alshisani, F., Katrakazis, T. 2013, p.6)

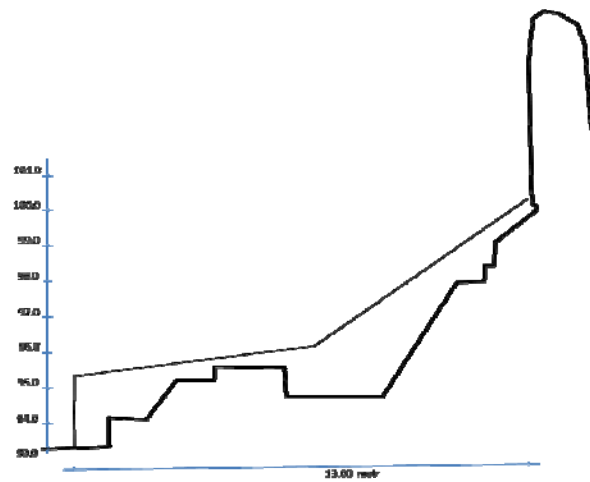
The first excavation was conducted by Khodjaniasov in 1989. A trench situated perpendicularly to the southern facade, near the corrugation #6. The archaeologist made a 4 pages report in Russian with one drawing of the trench section.

Section drawn from Khodjianasov report. Provided by Redzhep Djeparov

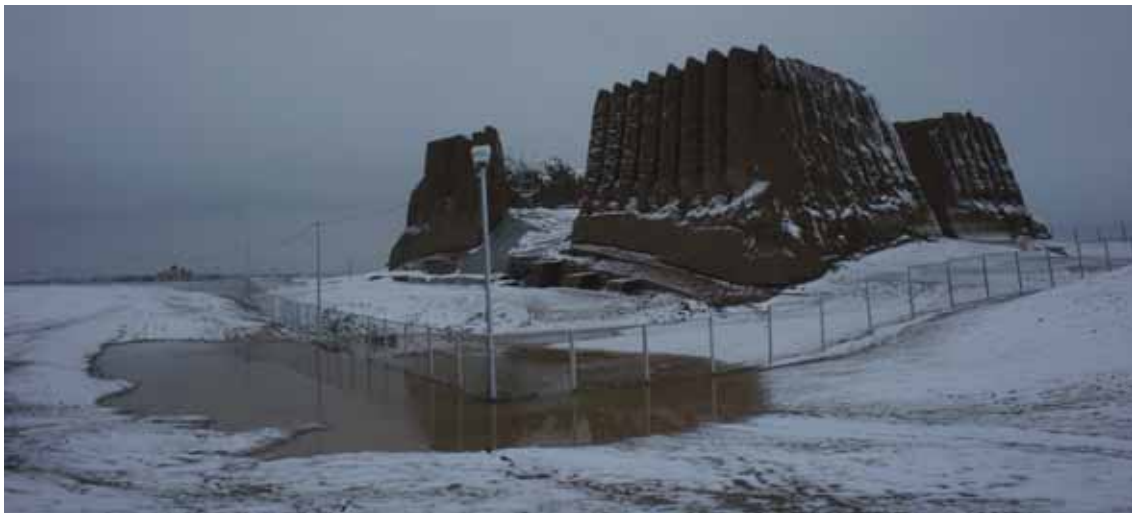
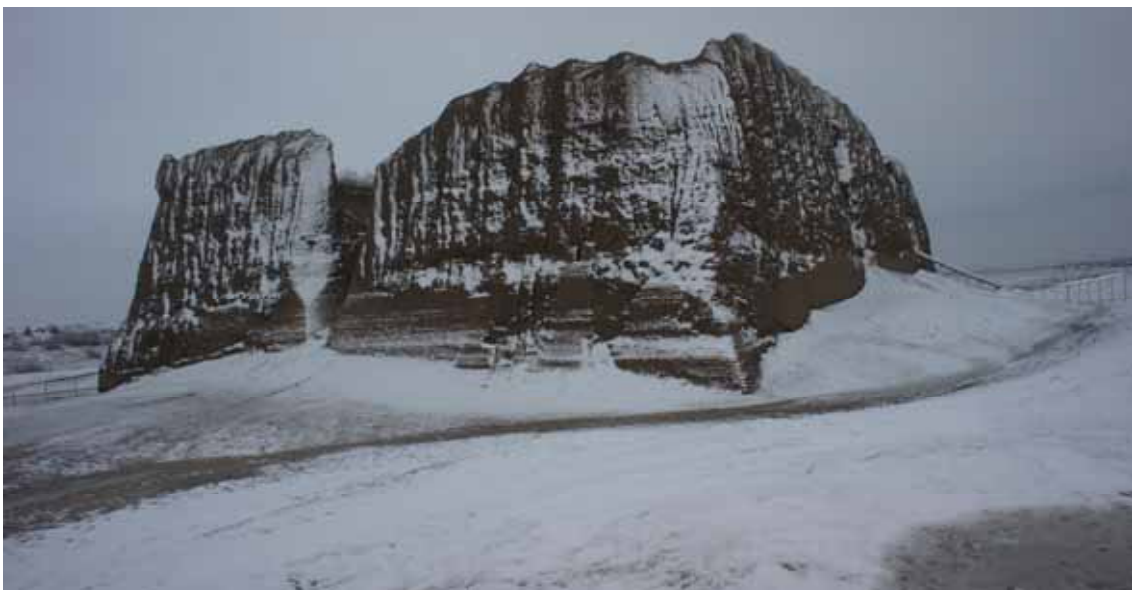
The January 2015 mission has allow to assess the situation of the site after a heavy rain and snowfall (about 10 hours at night), combined with frost. These extreme climatic conditions are not usual in Merv, but it happens more often, according to the Park Director.

Many zones of water stagnation have been observed, inside the monument and on its direct surroundings. The entire monument was soaked in depth, revealing the poor drainage of certain zones of the site. Due to the capillary nature of the earthen material and its weakness against wet conditions, it is necessary to improve the drainage of the overall site, with a particular attention regarding the excavation areas.

The greater Kyz Kala under snow. 01/02/22015

During the May mission, a drainage sketch has been produced, giving recommendation to create additional water run-off. (See chap. 1.6.)

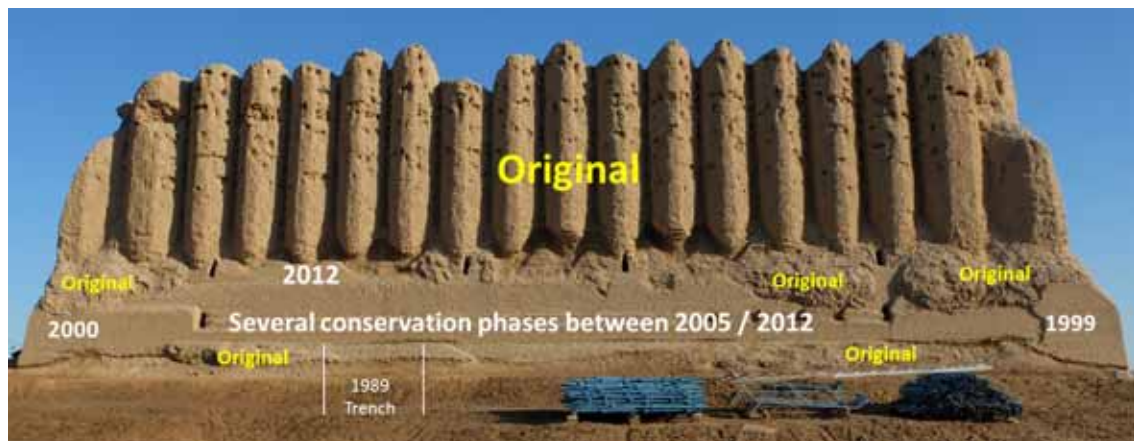
This documentation also allow to clearly distinguish the original and the restored parts of the south facade. The integrity of the building is respected. But the “stairs shaped” in the basis (probably to avoid the use of a scaffolding) may be confusing for the public.

Original / Restored parts of the south facade

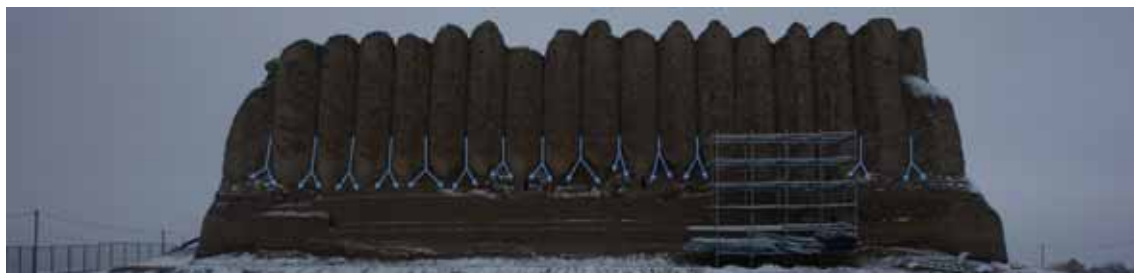
Another observation was made specifically on the bases of the corrugations, at the junction between the platform and the columns. The erosion, particularly important in the middle of the wall (from #5 to #13), is probably due to the fact that the rainwater from all the upper parts of the facade are channeled on this building detail, making it relatively weak. Rainwater is leaking along the wall between the corrugations and creates a cone shaped hole, comparable to the alluvial fan at the mouth of a river.

Erosion process at the bases of the corrugatuions

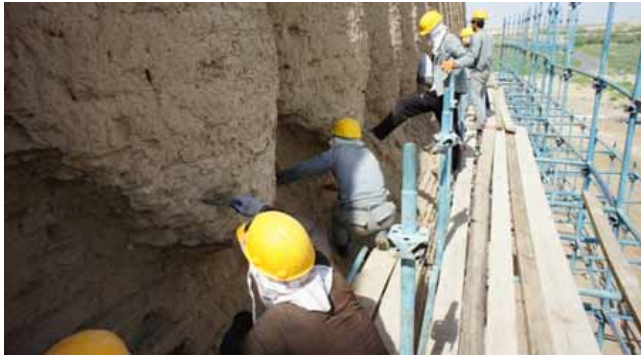
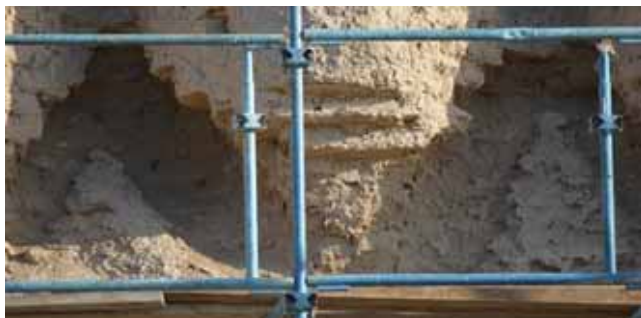
It is difficult to reconstitute with full certitude the original shape of the corrugated wall at its base, where it is too eroded. Therefore, our restoration work is based on the observation made on the columns 1 / 2 / 3 / 4 / 11 / 15 / 16 / 17 / 18, which are less eroded.

Detail of the erosion (column 10)

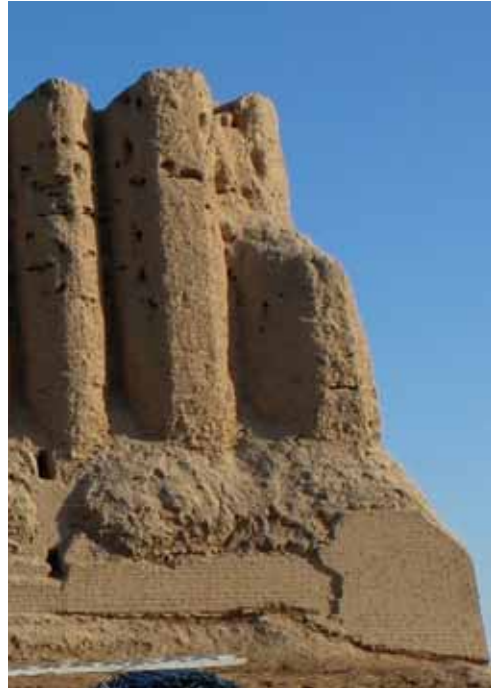
Columns 16;17;18, less eroded

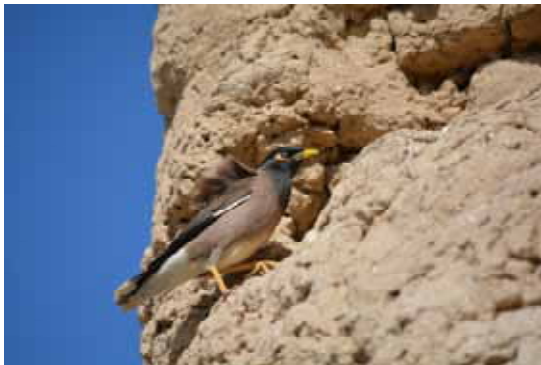
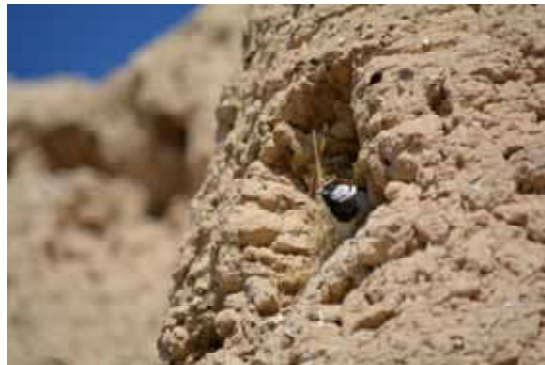
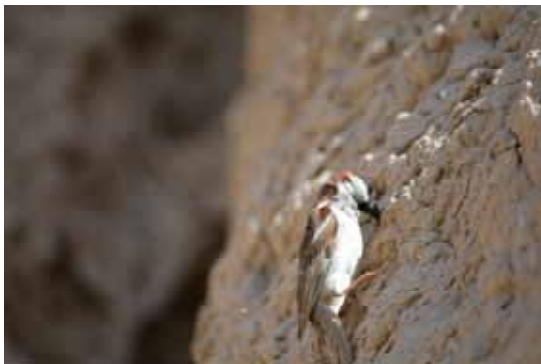
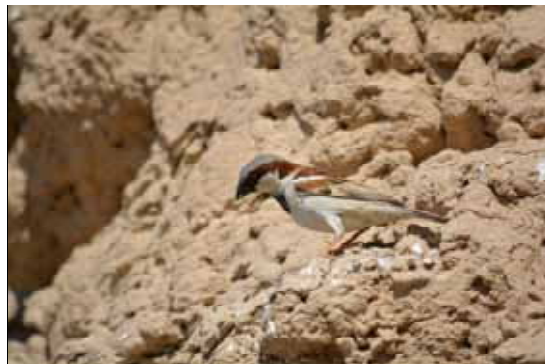
Bird nests are also a real threat. Although the holes they make are visible since the first images known, the return of the colony every spring for breeding seems to enlarge the holes and weaken the bricks.

Bird nests

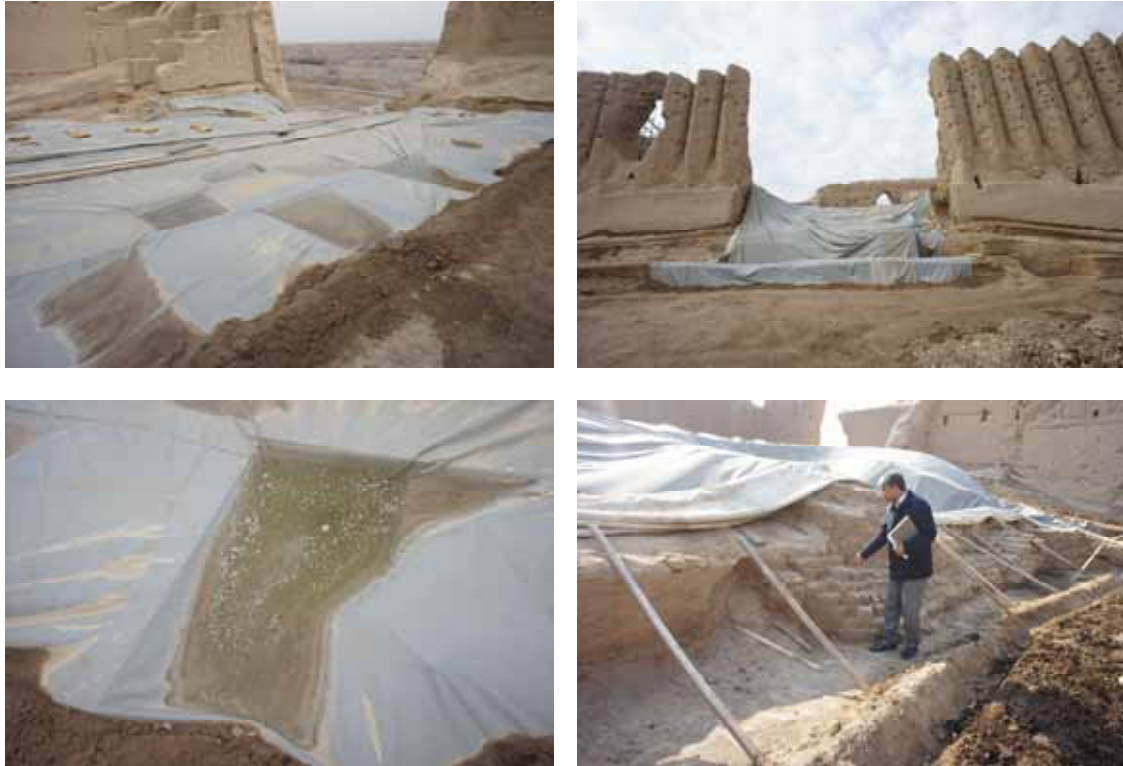
In January 2015, the areas excavated were entirely covered with a thick textile laid by the staff of 'Ancient Merv' Reserve in November 2013. It was not possible to assess the situation of the structures underneath. Our observation mainly concerned the numerous "pools" on the textile, where water was trapped after the rain. In some places, the rainwater was frozen.

Observation of the protective textile laid on the excavated areas. January 2015

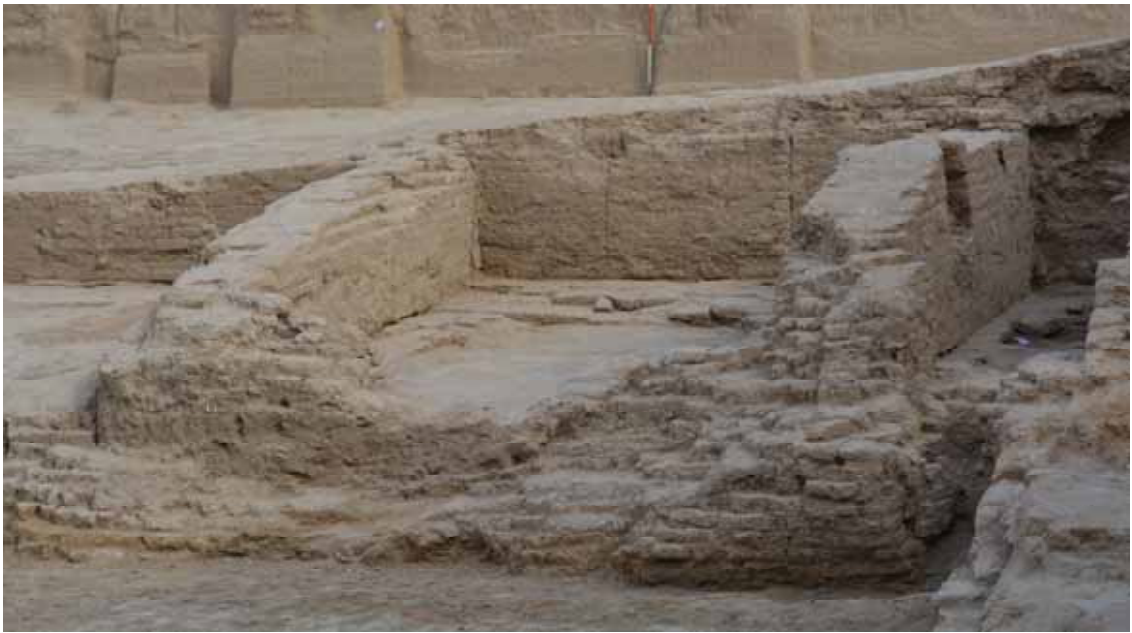
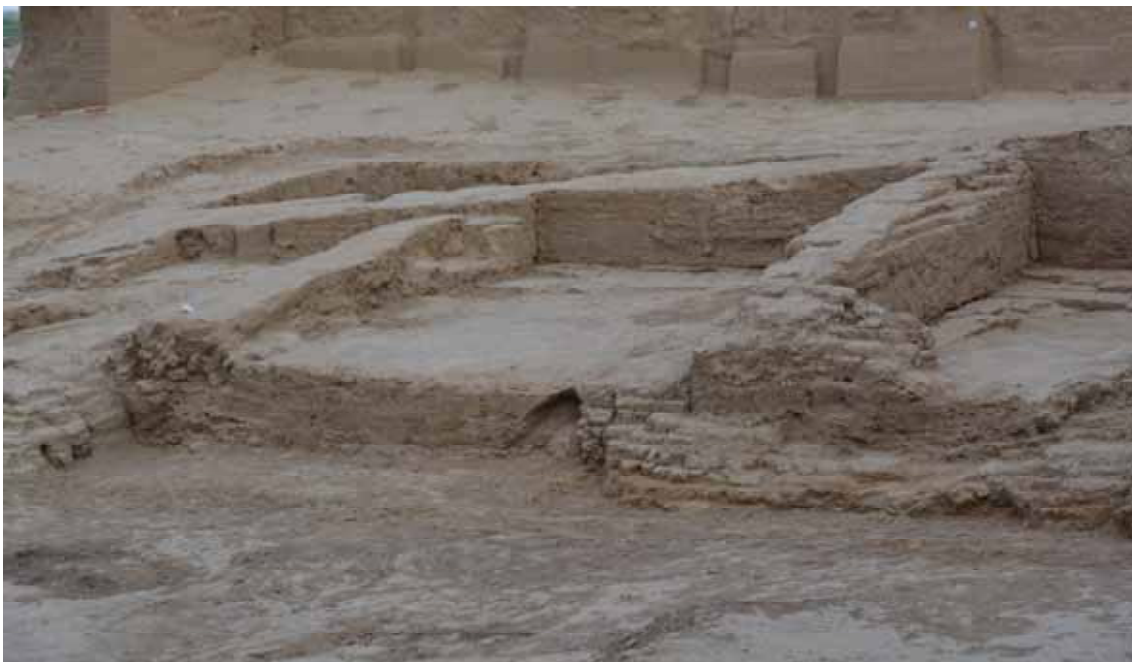
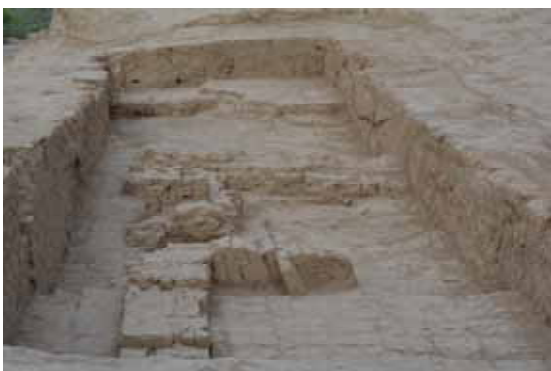
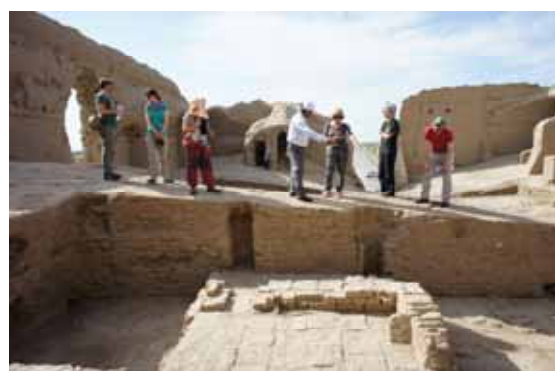
In May 2015, the textile was removed when we arrived on site and the assessment of the condition of the ruins was made possible. Based on a comparison with pictures taken after the 2013 excavation season, it seems that the erosion of the massive walls and structures discovered is rather low. In contrast, we can observe a more significant erosion of the building details such as the floors or niches. Our first conclusions are that the erosion processes are still occurring despite the protective textile, but probably at a rather slow pace. A monitoring system should be set up to record more in detail the speed of erosion of the excavated areas.

Excavated areas inside the Greater Kyz Kala. Photographed by David Gandreau, May 2015

- At this stage, leave a perimeter of minimum 4 meters along the wall (interior) without excavation to ensure structural stability of the corrugated walls. Focus on the central area;
- Ensure simultaneity of excavation and conservation;
- Be cautious and take justified decision step by step.
