## Ayaz Kala, Uzbekistan. Practical training workshop on conservation of earthen structures in Central Asia and Afghanistan. Preventive conservation work

Mahmoud Bendakir, David Gandreau

Practical training workshop on conservation of earthen structures in Central Asia and Afghanistan

Preventive conservation work

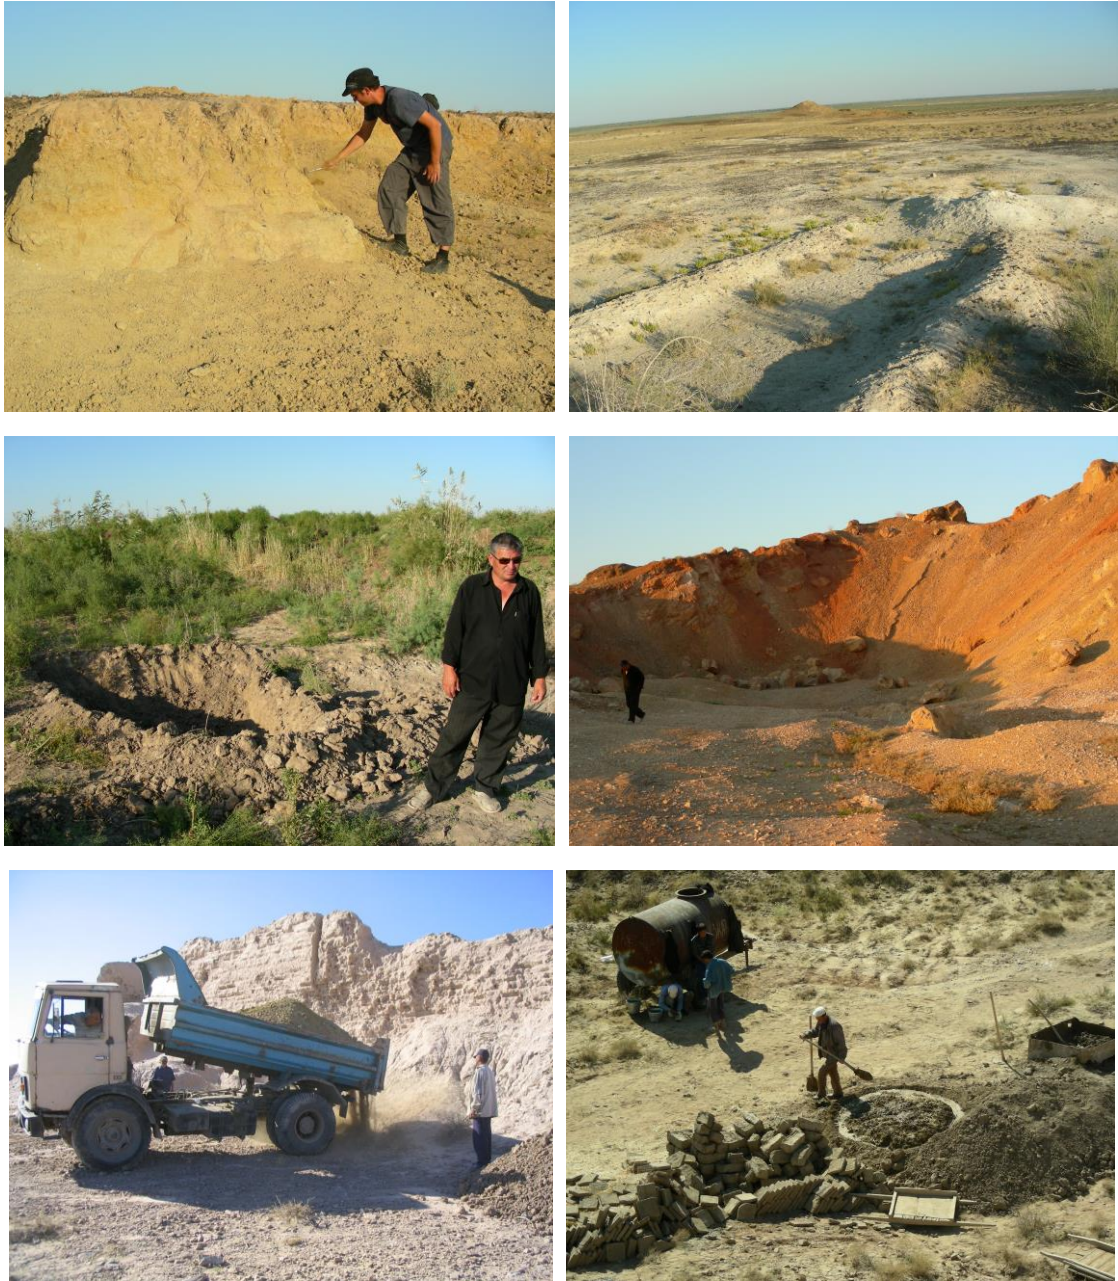
*31 trucks of soil have been delivered to repair the access road and allow the circulation to the main gate of Ayaz Kala 1. 6 trucks of brown soil and 6 others of green soil, 10 water tanks, about 2000 mud-bricks of different sizes, gravel, straw and all the equipment and tools were then brought directly the conservation site.*

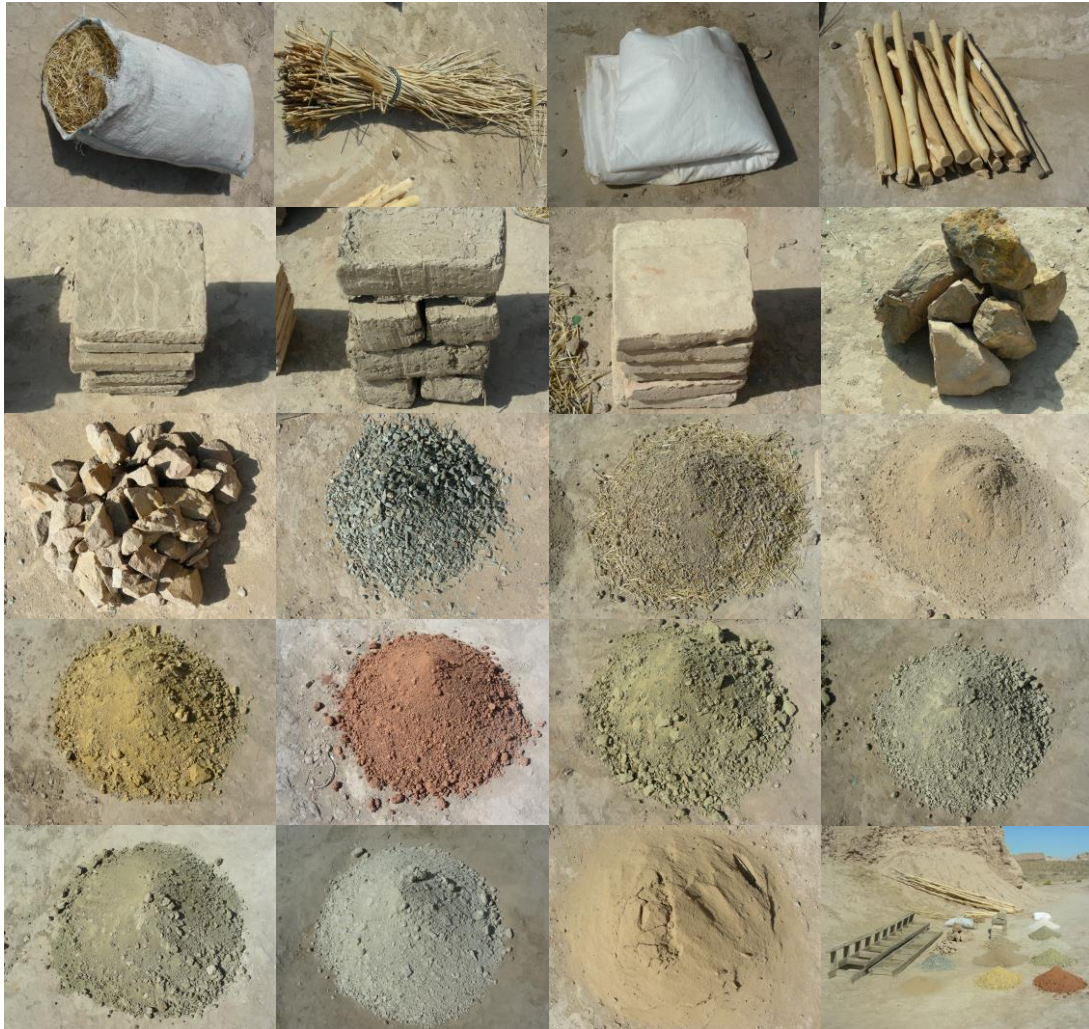
*Samples of soils and material exhibited at Ayaz Kala to show to the local workers, the national authorities and the participants of the workshop the variety of resources available in the close surrounding of Ayaz Kala*

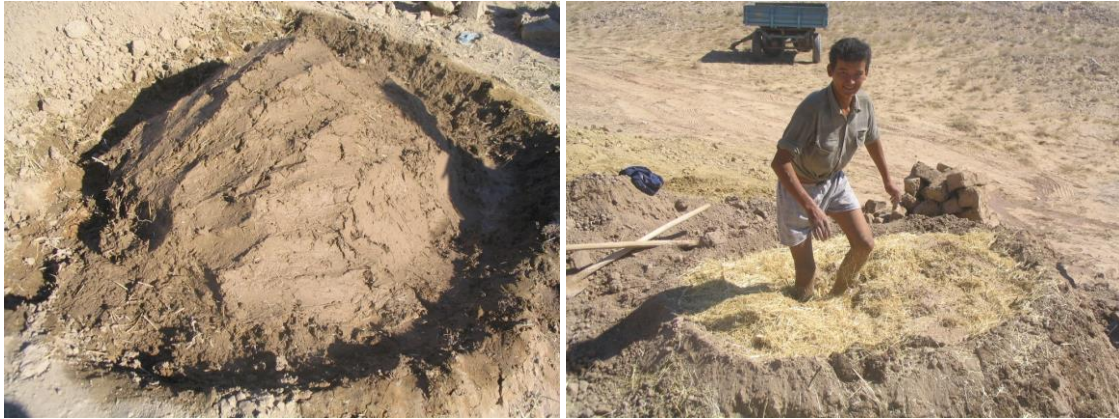
Cob: first experiments showed lot of cracks and problems of adherence with the support. This has been improved by adding sand (1 for 8 in volume) and more straw in the mud mixture.

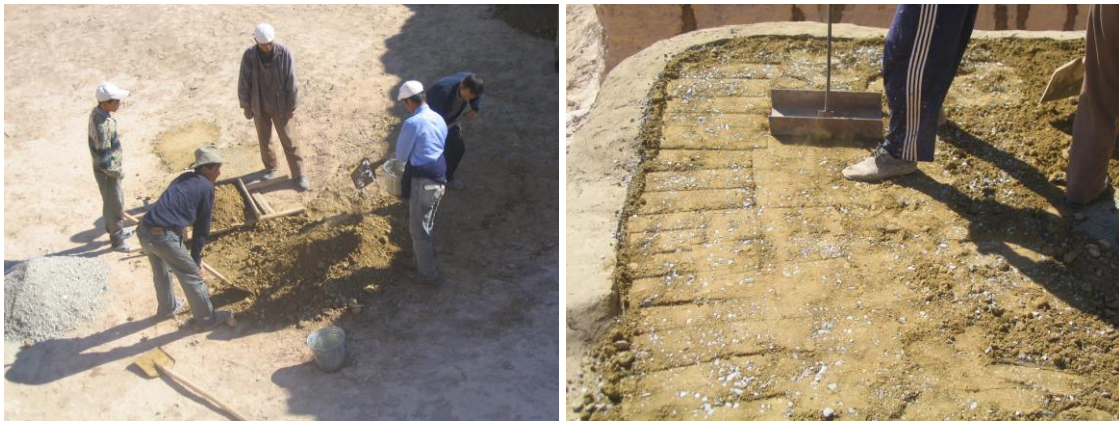
Rammed earth: Tests have been developed with a soil green in colour found 3 km at the east of Ayaz Kala which appeared to be gravelly. The results are quite efficient after ramming. Gravels have been added on the surface to reduce the speed of erosion due to rain waters.

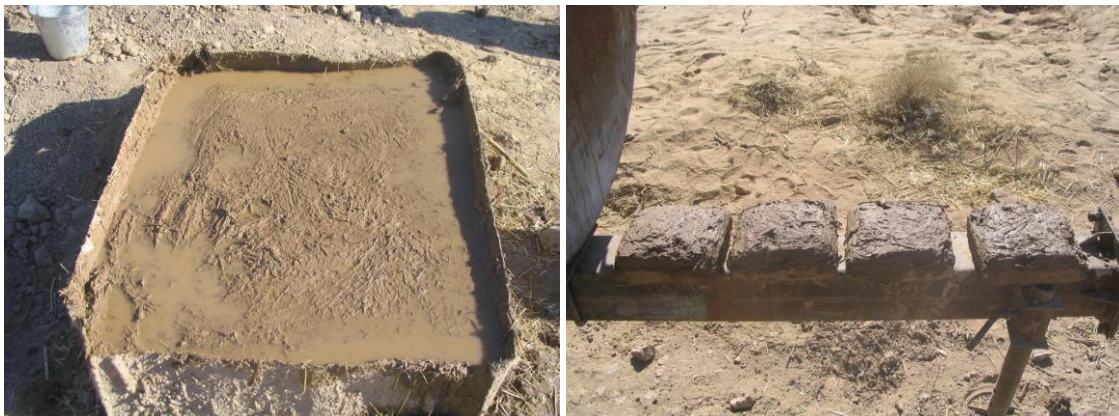
Plastering for Ayaz Kala (outside): After one week, the soil mixed with water and straw starts to smell moisture. This attention given to the soaking period has permitted to avoid the apparition of cracks which occurred with the first tests done with soil mixed with water for only one or two days.

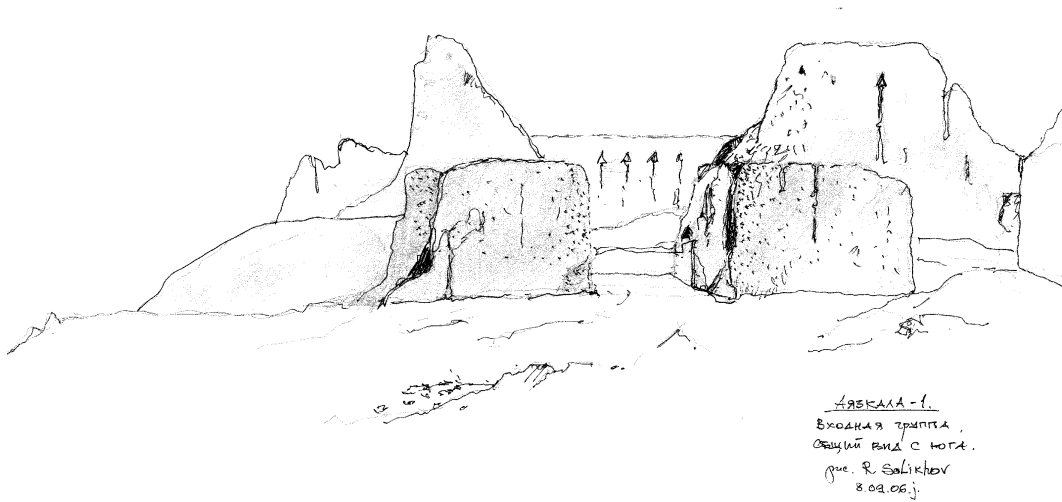
All the rain water collected in this first courtyard of the citadel were evacuating by this depression which goes inside the southern wall of the gate, causing important degradations. The zone has been cleaned with archaeological care and the surface modified to allow a proper drainage through the gate

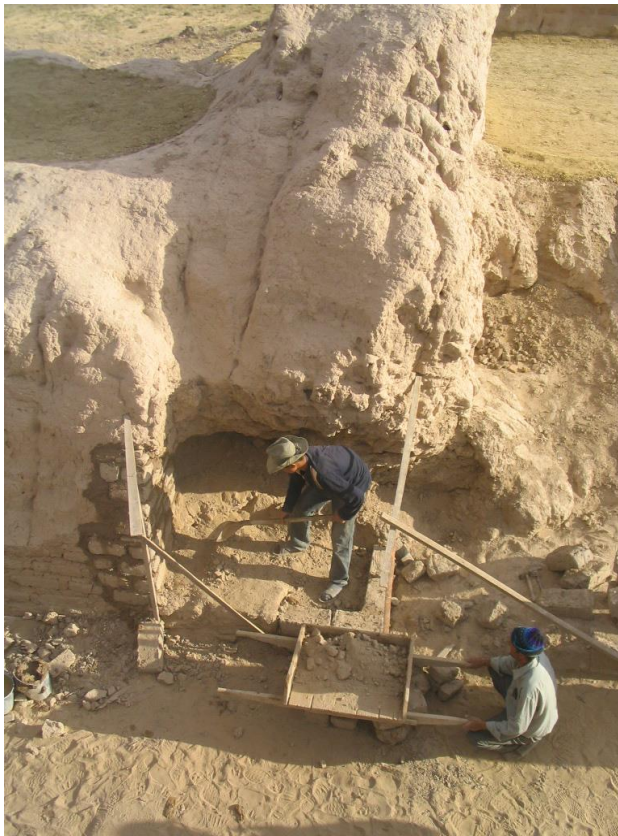
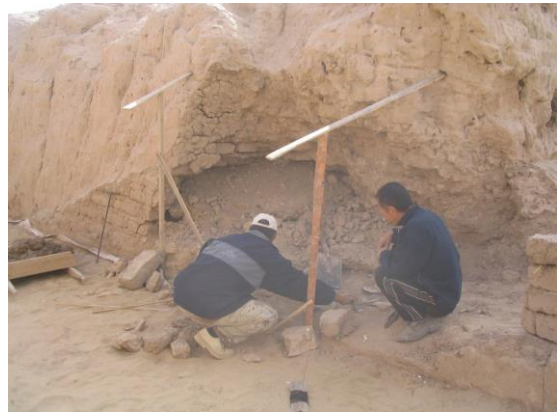
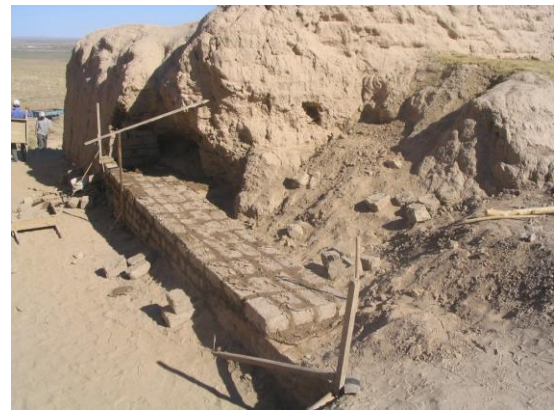
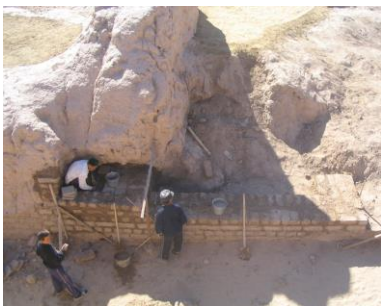
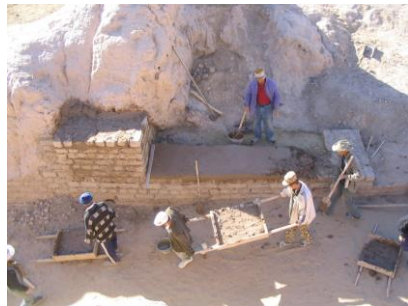
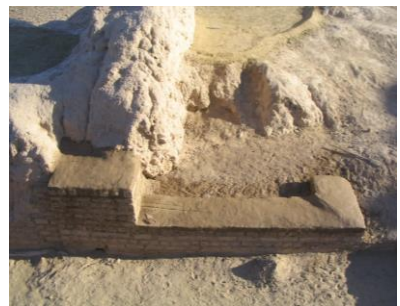
*Restoration and partial restitution of the south western wall of the main gate, heavily affected by erosion. The new masonry will avoid further degradation of the original wall by channelling the water flows away from it*

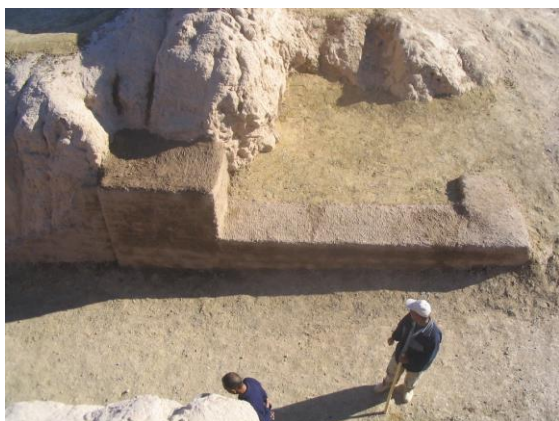
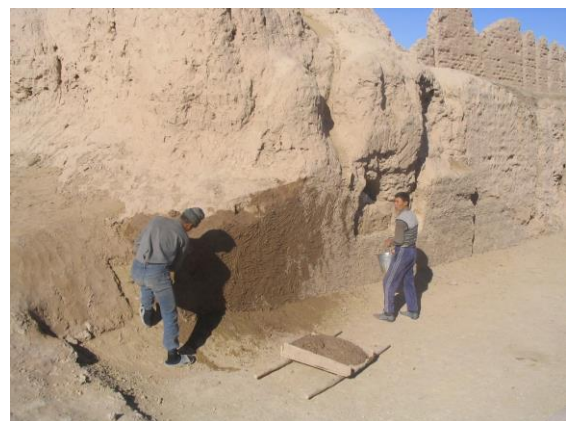
*Protective plastering of the walls on both sides of the main gate*

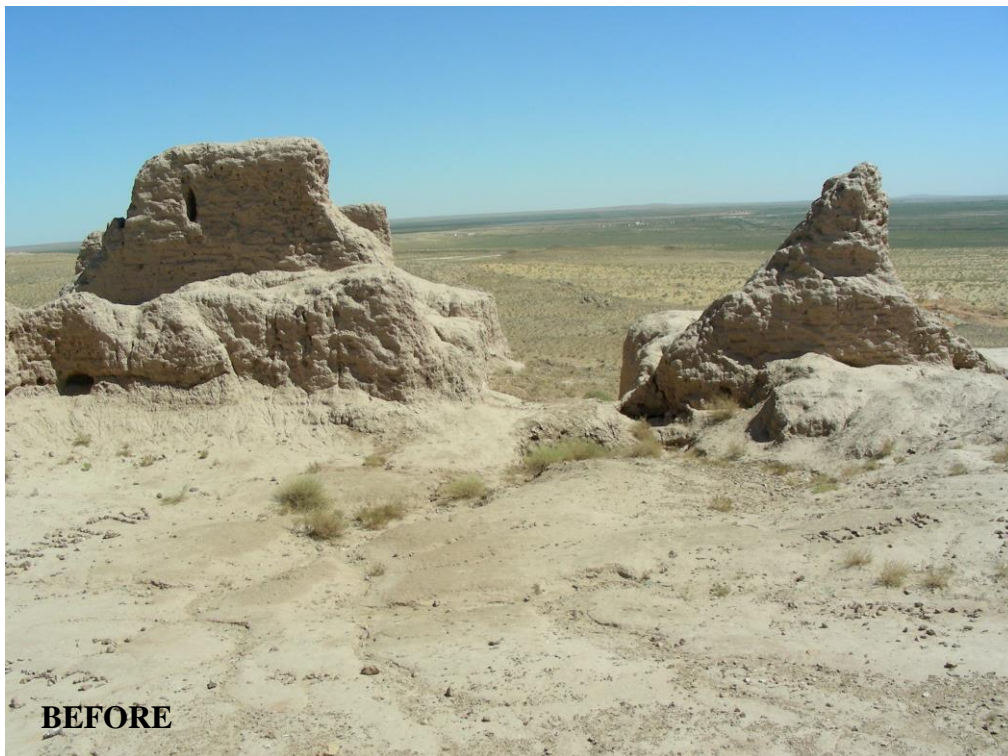
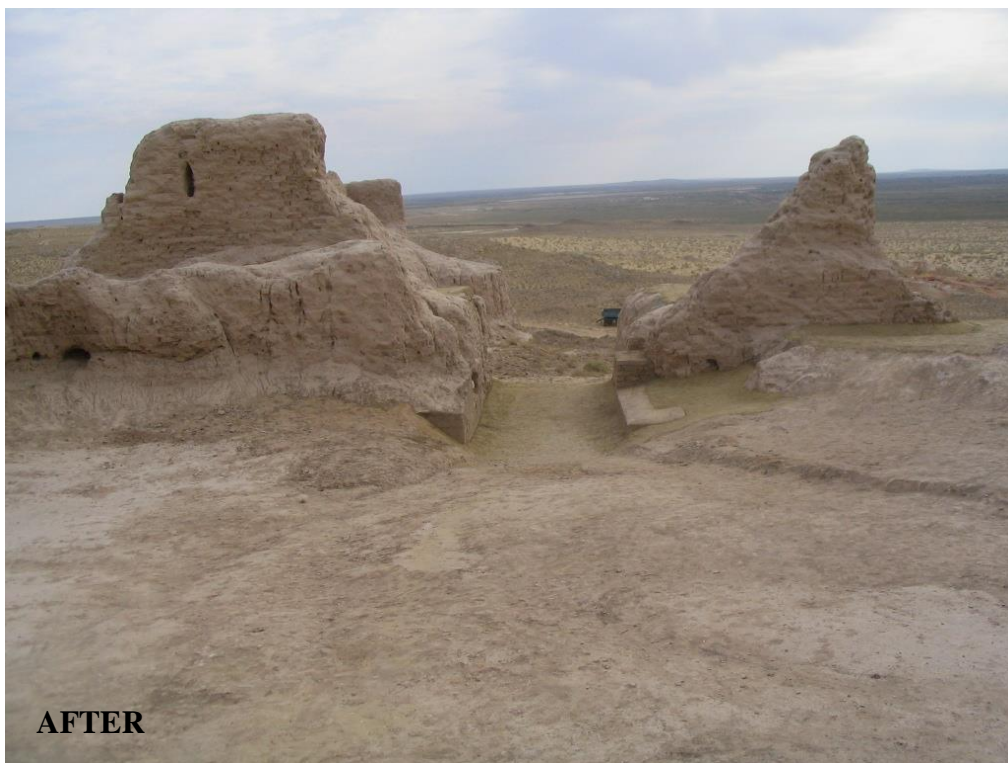
*Views of the gateway at Ayaz Kala 1,  
Before / after archaeological cleaning and preventive conservation interventions*

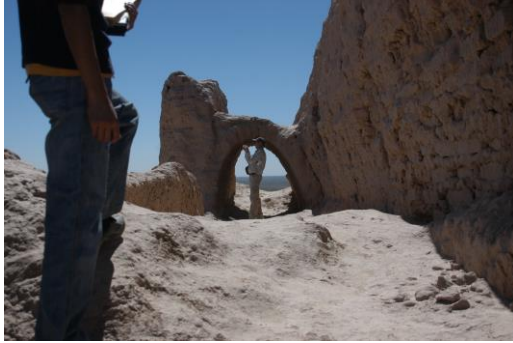
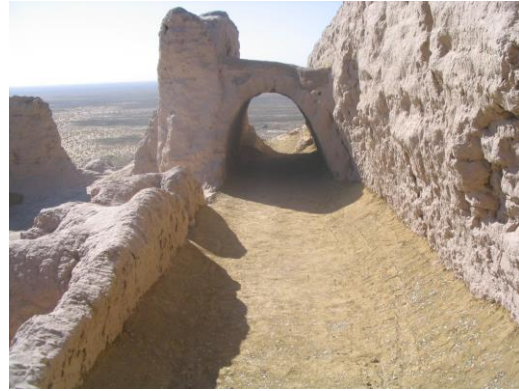
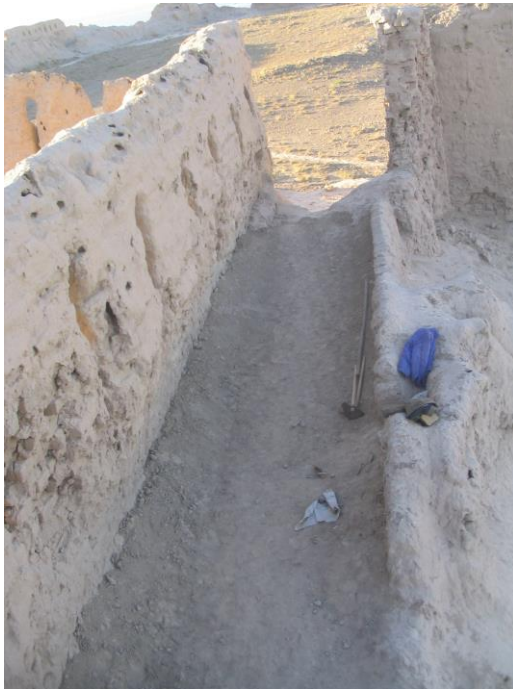
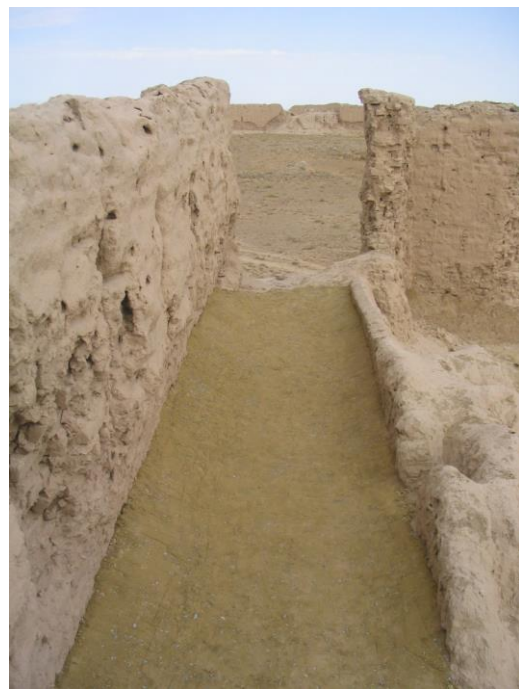
*Drainage of the corridor*

The majority of the vaulted corridors which surround Ayaz Kala have collapsed, but some remain and they must be conserved in priority as they are the last visible evidences of this particular system. The work accomplished on the vault situated on the western side of the main gate consisted on repairing part of it (filling the void which was the starting point of punctual erosion) and to ensure a proper drainage on top of it.
