Susceptibility to Pitting and Environmentally Assisted Cracking of 17-4PH Martensitic Stainless Steel Produced by Laser Beam Melting

Article

Keywords: martensitic stainless steel; austenite; environmentally assisted cracking; pitting; pit initiation; pit propagation; chloride

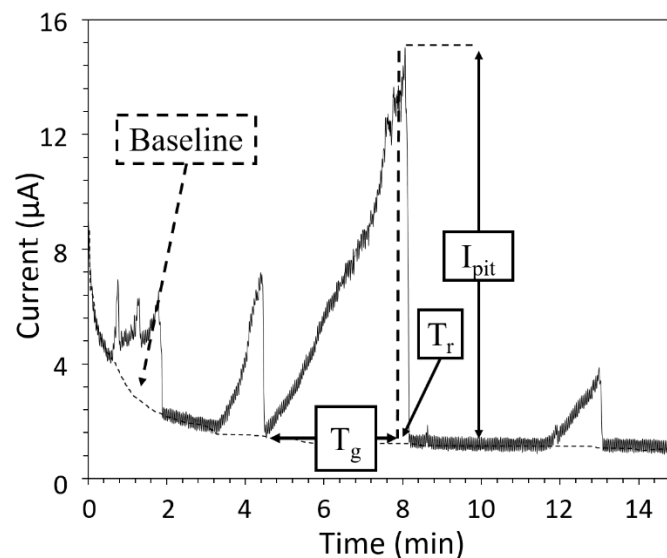
Figure 2. Example of a current transient measured during the potentiostatic experiments (samples maintained at a constant potential of 250 mV versus E_{corr} for 1 h). Identification of the values characteristic of the metastable pits, i.e., E_{pit} , T_g , and T_r .

The current transients were counted and characterised by identifying the relevant characteristic parameters, as shown in Figure 2. By using average values of I_{pit} and T_g , the growth kinetics of the current transients were also calculated through the ratio I_{pit}/T_g . The average values of these parameters are presented in Table 2. The statistical analysis of the current transients first confirmed that the current transients were more intense for the AM samples than for the CM samples, as suggested in Figure 4. However, these transients were more numerous (by a factor of 4) for the CM samples than for the AM samples. In addition, the T_g values were larger for the AM samples than for the CM samples, and the growth rate of metastable pits was significantly higher for the AM samples than for the CM samples (by a factor of 2.4). These results, therefore, showed that the susceptibility to metastable pitting could not be assessed on the basis of the number of current transients alone. Considering the other parameters, MSS produced by AM seemed to be more susceptible to metastable pitting than MSS obtained using CM.

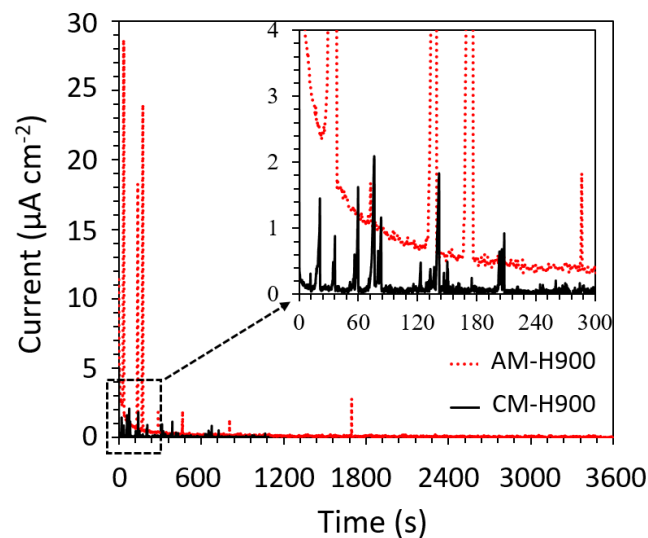
Figure 4. Current transients recorded during chronoamperometry tests performed in 0.5 M NaCl solution for the AM and CM samples at a fixed potential of +250 mV versus E_{corr} .

To further evaluate the susceptibility to metastable pitting of the two MSSs, chronoamperometry tests were performed. Considering the width of the passivity plateau, the samples were polarised at a fixed potential equal to $+250 \text{ mV}$ relative to E_{corr} . The $I = f(t)$ curves representative of the AM and CM samples of MSS during chronoamperometry tests are presented in Figure 4. This figure shows current transients for both MSSs, but the transients seemed to be of lower intensity for the CM samples than for the AM samples, as observed in Figure 3, and in agreement with the work of Barroux et al. [32].

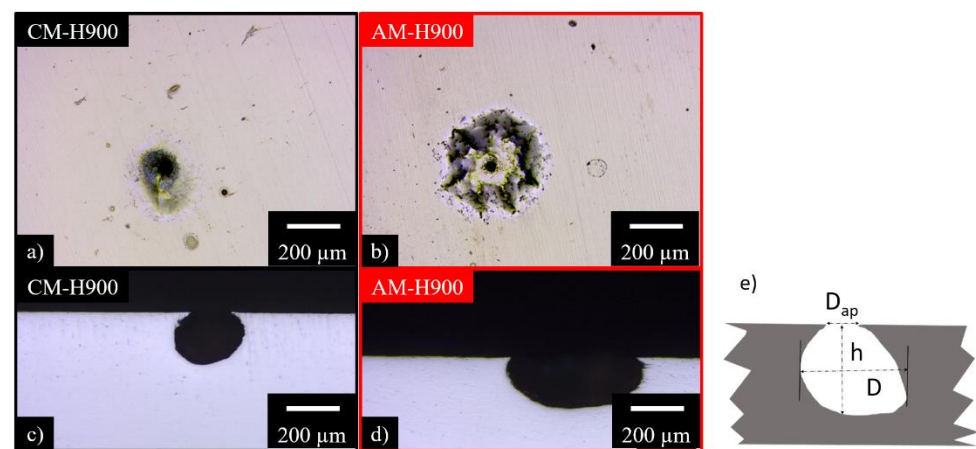
Figure 5. Optical microscope observations of the stable pits formed after chronoamperometry tests performed in 0.5 M NaCl solution at a fixed potential of +500 mV versus E_{corr} for: (a,c) CM samples; (b,d) AM samples; (e) scheme of a pit with the parameters used for the analysis.

A statistical analysis of the stable pits formed as a result of the tests was carried out to verify these observations. A confocal microscope was used to determine the pit depth, h , and cross-sections were studied to measure the pit diameters D and D_{ap} , where D is the maximal pit diameter on the cross section view, and D_{ap} is the aperture diameter measured at the sample surface (Figure 5e). Finally, with these parameters, an average pit shape factor, f , given by the D/h ratio, was also estimated. The results of this statistical analysis are presented in Table 3. The quantitative analysis showed that the average number of stable pits per unit area was similar for the AM and CM samples of MSS, in agreement with the work of Barroux et al. [32]. However, contrary to what was shown by the latter authors, differences were observed in the present work with regard to the morphology of the pits, with notably larger pits, and even deeper, for the AM samples as compared with the CM samples. The result was consistent with the higher measured anodic current densities for the AM than for the CM samples. As mentioned earlier, pitting propagation seemed to be faster for the AM than for the CM samples. In view of the microstructural differences observed between the two MSSs, it was interesting to assess the role of reversed austenite. Thus, combining these results with those presented by Barroux et al. [32,34], in particular concerning the lower Cr amount of the passive film above the reversed austenite, the results showed that it was more difficult to initiate stable pits for MSS produced by AM because
