Susceptibility to Pitting and Environmentally Assisted Cracking of 17-4PH Martensitic Stainless Steel Produced by Laser Beam Melting

Article

Keywords: martensitic stainless steel; austenite; environmentally assisted cracking; pitting; pit initiation; pit propagation; chloride

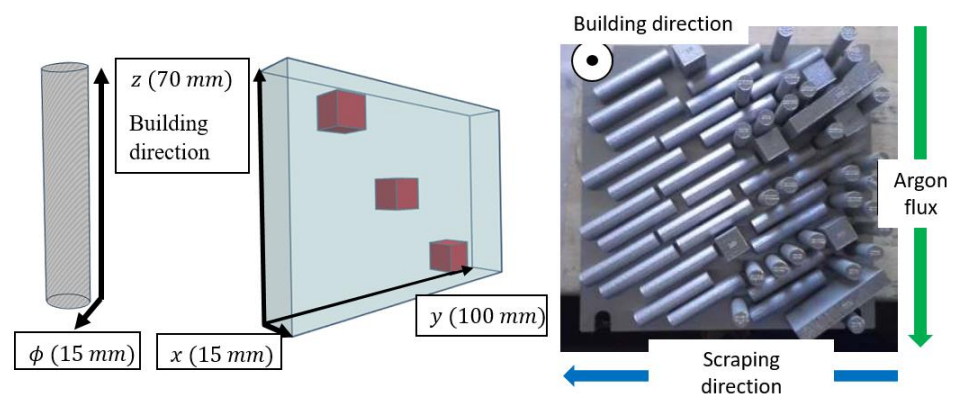
Figure 1. 3D representation of the AM specimens and a photograph of the building plate with the built parts. Cylinders and parallelepipeds were built. Cubic samples were machined from the parallelepipeds after building.

The parts of 17-4PH MSS manufactured using L-PBF, here, referred to as AM, were built using an EOS DMLS M290 machine (400 W laser) under Ar, with the building plate maintained at 200 °C, a 40 µm layer thickness, and a 67° rotation between each layer. To select the process parameters, we performed a comparison with 5 manufacturers with their own parameters. On this basis, one manufacturer was selected for its metallurgical quality (few defects) of built parts and its traceability. In particular, the porosity rate was only 0.04%. Parallelepipeds (100 mm × 15 mm × 70 mm) and cylinders (15 mm in diameter and 70 mm in height) were built; the direction relative to the 70 mm side of the parallelepipeds and the cylinder axis was parallel to the building direction (Figure 1). Cubic samples were extracted from the parallelepipeds for the corrosion tests, while samples for EAC tests were machined using the cylindrical parts. For the conventional 17-4PH MSS, cubic samples and cylindrical samples (15 mm diameter) were extracted from a 50 mm diameter wrought cylinder for the corrosion and EAC tests, respectively, and were referred to as the CM samples. The chemical compositions of both the AM and the CM samples are presented in Table 1. The AM and CM samples were both studied in the H900 metallurgical state, as previously defined. As indicated in the Introduction section, this post-building heat treatment released the residual stresses due to the building process for the AM samples.

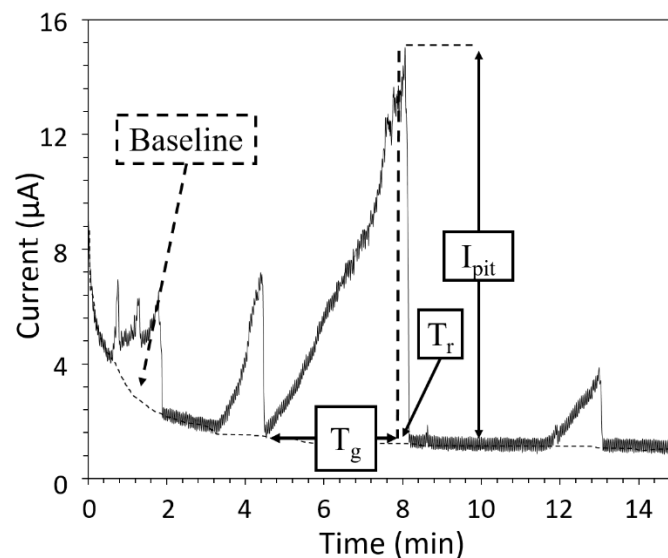
Figure 2. Example of a current transient measured during the potentiostatic experiments (samples maintained at a constant potential of 250 mV versus E_{corr} for 1 h). Identification of the values characteristic of the metastable pits, i.e., E_{pit} , T_g , and T_r .

The current transients were counted and characterised by identifying the relevant characteristic parameters, as shown in Figure 2. By using average values of I_{pit} and T_g , the growth kinetics of the current transients were also calculated through the ratio I_{pit}/T_g . The average values of these parameters are presented in Table 2. The statistical analysis of the current transients first confirmed that the current transients were more intense for the AM samples than for the CM samples, as suggested in Figure 4. However, these transients were more numerous (by a factor of 4) for the CM samples than for the AM samples. In addition, the T_g values were larger for the AM samples than for the CM samples, and the growth rate of metastable pits was significantly higher for the AM samples than for the CM samples (by a factor of 2.4). These results, therefore, showed that the susceptibility to metastable pitting could not be assessed on the basis of the number of current transients alone. Considering the other parameters, MSS produced by AM seemed to be more susceptible to metastable pitting than MSS obtained using CM.

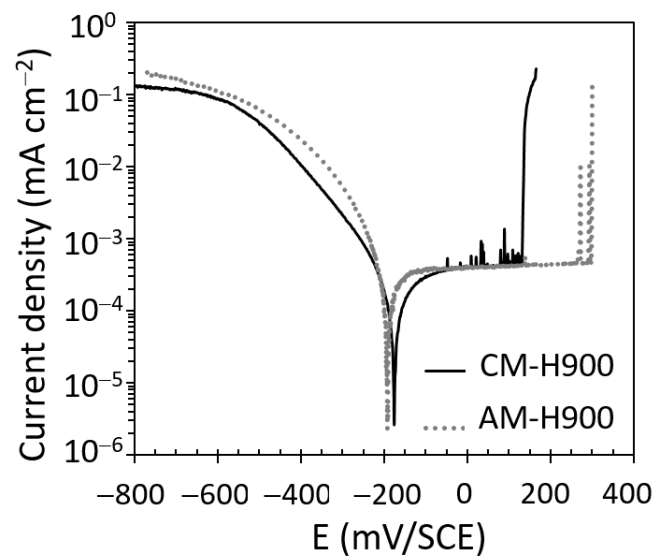
Figure 3. Polarisation curves plotted in 0.5 M NaCl solution for the AM and CM samples. Scan rate = 500 mV h⁻¹.

The polarisation curves plotted for the AM and CM samples are shown in Figure 3. The cathodic branch corresponded to the oxygen reduction and showed similar current densities for both the AM and CM samples of MSS. Similar E_{corr} values were also obtained for the AM ($-183 \pm 4 \text{ mV}_{\text{SCE}}$) and CM ($-179 \pm 1 \text{ mV}_{\text{SCE}}$) samples of MSS. The anodic branch was first characterised by a very well-marked passivity plateau, as commonly observed for SS. The corrosion kinetics was, therefore, primarily controlled by the resistance of the passive film, so that the passive current density (i_{pass}) was equal to the corrosion current density (i_{corr}), with very similar values of i_{pass} , and thus i_{corr} , for both MSSs (0.33 ± 0.01 and $0.39 \pm 0.02 \mu\text{A cm}^{-2}$ for the AM and CM samples of MSSs, respectively). Then, a breakdown potential was observed corresponding to an abrupt increase in the anodic current. The optical and SEM observations of the samples after the polarisation tests showed the formation of pits, and therefore, this breakdown potential was identified as the pitting potential E_{pit} . The E_{pit} values were more positive for the AM samples ($291 \pm 9 \text{ mV}_{\text{SCE}}$) than those for the CM samples ($123 \pm 11 \text{ mV}_{\text{SCE}}$). This could be explained by referring to the distribution of NbC carbides (fewer and finer for the AM samples as compared with the CM samples), which constitute preferential sites for pit initiation [32,34]. Therefore, the results showed that MSS produced by AM had better resistance to pit initiation than MSS obtained by CM, in agreement with Barroux's work [32,34]. Furthermore, current transients characteristic of metastable pits were observed for both MSSs; they were more numerous, but with a lower intensity, for the CM samples of MSS as compared with the AM samples of MSS.

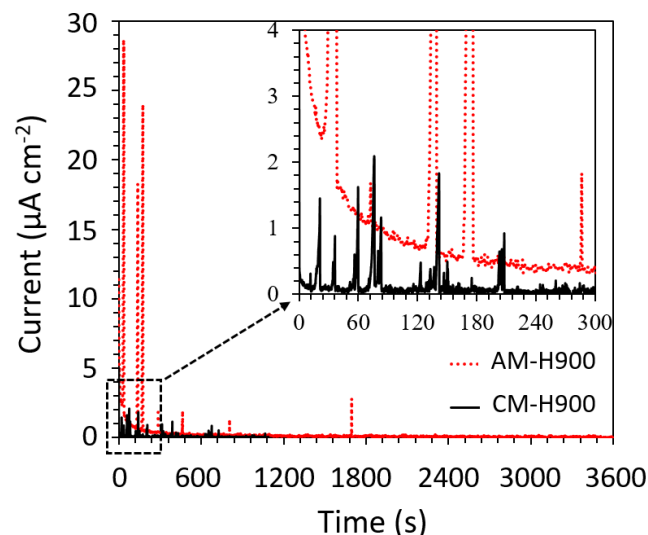
Figure 4. Current transients recorded during chronoamperometry tests performed in 0.5 M NaCl solution for the AM and CM samples at a fixed potential of +250 mV versus E_{corr} .

To further evaluate the susceptibility to metastable pitting of the two MSSs, chronoamperometry tests were performed. Considering the width of the passivity plateau, the samples were polarised at a fixed potential equal to $+250 \text{ mV}$ relative to E_{corr} . The $I = f(t)$ curves representative of the AM and CM samples of MSS during chronoamperometry tests are presented in Figure 4. This figure shows current transients for both MSSs, but the transients seemed to be of lower intensity for the CM samples than for the AM samples, as observed in Figure 3, and in agreement with the work of Barroux et al. [32].

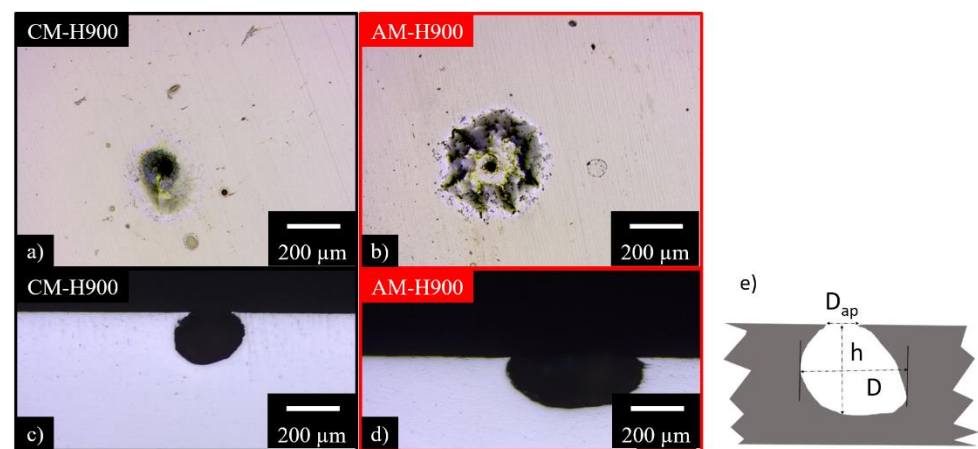
Figure 5. Optical microscope observations of the stable pits formed after chronoamperometry tests performed in 0.5 M NaCl solution at a fixed potential of +500 mV versus E_{corr} for: (a,c) CM samples; (b,d) AM samples; (e) scheme of a pit with the parameters used for the analysis.

A statistical analysis of the stable pits formed as a result of the tests was carried out to verify these observations. A confocal microscope was used to determine the pit depth, h , and cross-sections were studied to measure the pit diameters D and D_{ap} , where D is the maximal pit diameter on the cross section view, and D_{ap} is the aperture diameter measured at the sample surface (Figure 5e). Finally, with these parameters, an average pit shape factor, f , given by the D/h ratio, was also estimated. The results of this statistical analysis are presented in Table 3. The quantitative analysis showed that the average number of stable pits per unit area was similar for the AM and CM samples of MSS, in agreement with the work of Barroux et al. [32]. However, contrary to what was shown by the latter authors, differences were observed in the present work with regard to the morphology of the pits, with notably larger pits, and even deeper, for the AM samples as compared with the CM samples. The result was consistent with the higher measured anodic current densities for the AM than for the CM samples. As mentioned earlier, pitting propagation seemed to be faster for the AM than for the CM samples. In view of the microstructural differences observed between the two MSSs, it was interesting to assess the role of reversed austenite. Thus, combining these results with those presented by Barroux et al. [32,34], in particular concerning the lower Cr amount of the passive film above the reversed austenite, the results showed that it was more difficult to initiate stable pits for MSS produced by AM because

it contained fewer NbC particles, and the particles were smaller in size. However, once pitting had started, pits extended more rapidly in MSS produced by AM, particularly due to the lower Cr amount in the passive film, which made MSS produced by AM less able to repassivate. In addition, pits constituted a confined environment where acidification could occur rapidly due to corrosion reactions followed by hydrolysis of cations, and then the production of protons; this led to the absorption of hydrogen by the metal. The influence of hydrogen on MSS dissolution was not the focus of this paper, even though authors have shown a significant effect of hydrogen on the anodic processes [44]. Finally, it was interesting to note that the f values were very different between the AM and CM samples of MSS, due to the fact that the diameter (D) of the pits, on average, was twice as large as the depth (h) for MSS produced by AM. This suggested that the distribution of mechanical stresses should be different around the pits for the two MSSs under mechanical loading, which should influence their abilities to initiate cracks at the bottom of the pits during the EAC tests.

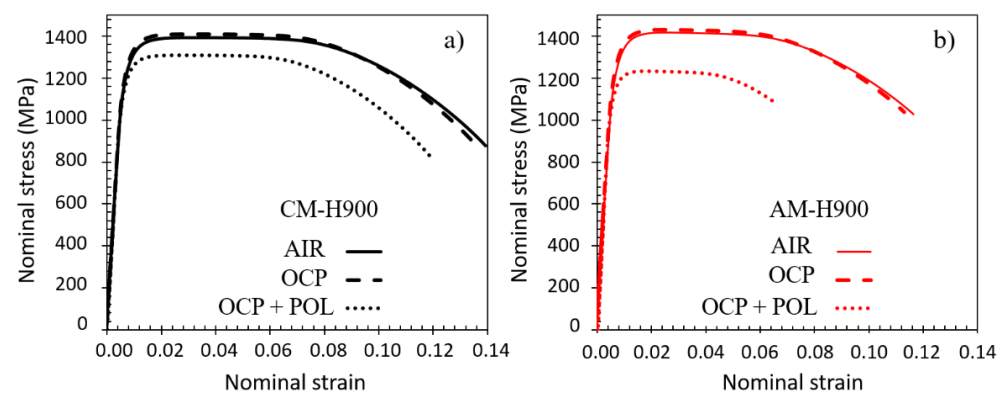
Figure 6. Nominal stress vs. nominal strain curves (10^{-3} s^{-1}) obtained during the EAC tests for (a) CM and (b) AM samples for two experimental conditions: samples maintained at OCP and tests with a polarisation period (OCP + POL). For both MSSs, curves representative of their mechanical behaviours in air, without any exposure to NaCl solution, were reported (AIR) for comparison.

The nominal stress versus nominal strain curves plotted in NaCl solution for both AM and CM samples after the EAC tests are shown in Figure 6. The results obtained for samples left at the OCP and for those left at the OCP, and then polarised during the tests, are given. The curves plotted in air for the samples non-exposed to NaCl solution are also reported for comparison. During all tensile tests, necking was observed for both MSSs. The parameters that are characteristic of the mechanical properties were extracted from these curves, i.e., Young modulus E , yield strength $YS_{0.2}$, and ultimate tensile strength (UTS), and are reported in Table 4. Concerning the strain to fracture, ϵ_f , the classical assumption of volume conservation during plastic deformation was made to take necking into consideration, i.e., to consider the heterogeneity in strain distribution all along the gauge length of the tensile specimens: $\epsilon_f = 2 \ln(\phi_0/\phi_f)$, with ϕ_0 the initial diameter of the tensile specimen and ϕ_f the minimum diameter of the tensile specimen measured close to

the fracture surface. This explained the differences between the strain to fracture values in Table 4 as compared with the curves from Figure 6. First, the results showed that the E , $YS_{0.2}$, and UTS values were similar for the non-exposed AM and CM samples [13,16]; lower values of ϵ_f were measured for the AM samples as compared with the CM samples, which could be due to the pores in the AM samples, even though the porosity rate was very low [13]. Then, after exposure to NaCl solution at the OCP, the mechanical responses of both MSSs were not significantly changed. On the contrary, for the samples polarised during 20 min, sharp decreases in $YS_{0.2}$, UTS, and ϵ_f values were observed, which were much more marked for the AM samples than for the CM samples, with a decrease of 10% versus 4% in $YS_{0.2}$ values and 12% versus 5% in UTS values, for the AM and CM samples, respectively. The decreases in ϵ_f values were similar for the two MSSs, i.e., 16% versus 14%, for the AM and CM samples, respectively. It was of interest to note that similar results were obtained when the tensile tests were performed in air after the exposure to NaCl solution under mechanical loading. This led us to assume that the period during which the samples were maintained under a constant strain in NaCl solution played a major role in modifying the mechanical behaviour of these MSSs.

Table 4. Parameters that are characteristic of the mechanical properties and extracted from the tensile curves plotted during the EAC tests (Figure 6). Errors on E , $YS_{0.2}$, and UTS are indicated in the table (\pm).

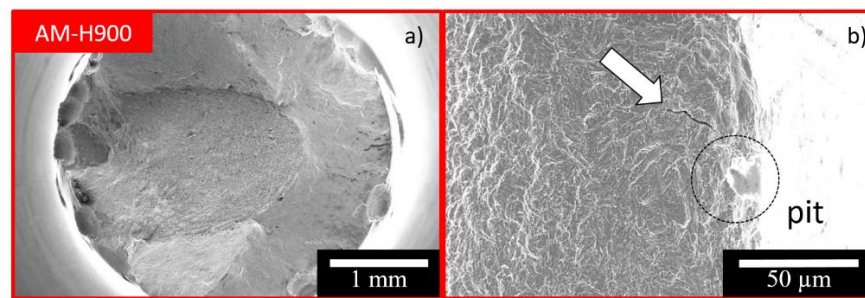
Figure 7. SEM observation of the fracture surface of an AM sample after an EAC test (sample maintained at the OCP and then polarised): (a) General view; (b) focus on a small crack initiated on pits (white arrow).

For both MSSs, and for all the EAC tests, the fracture surfaces were globally ductile (Figure 7). For some specimens, which had been polarised during the EAC tests, pits were observed on the gauge length (Figure 8) even though the samples had been polarised at a potential which was situated in the passivity domain determined for the specimens which were not submitted to mechanical loading (Figure 3). Furthermore, small cracks were observed in a direction perpendicular to the mechanical loading axis (white arrow in Figure 7b)). Cracks were initiated at pits, which was in agreement with the commonly accepted hypothesis that pits act as preferential crack initiation sites [37–42,49].

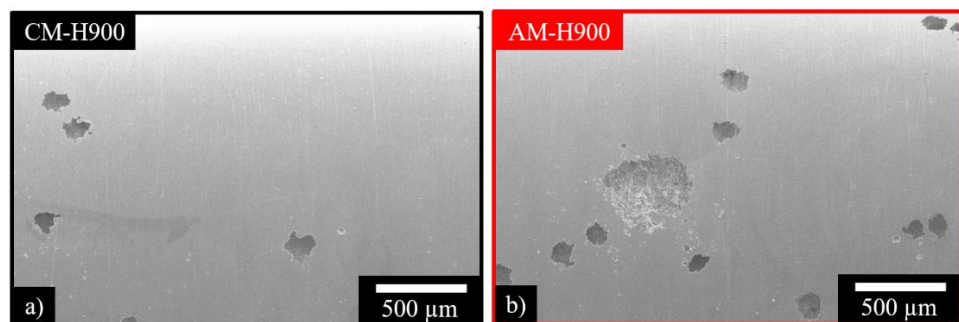
Figure 8. SEM observation of pits for: (a) CM; (b) AM samples. Pits were observed on the gauge length for samples polarised during the EAC tests.

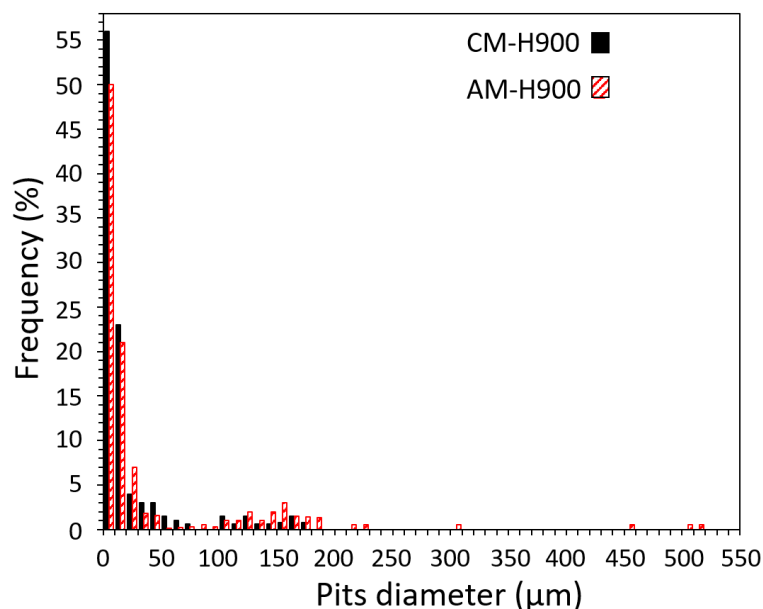
Figure 9. Statistical analysis performed on the stable pits observed for the AM and CM samples after some EAC tests in which the samples were polarised for 20 min during exposure to NaCl solution (total population of pits analysed: 420 and 480 for the AM and CM samples, respectively).

After some EAC tests, in which the samples were polarised at a potential corresponding to the passivity range of the MSSs when no mechanical loading was applied, a sharp and monotonic increase in current was recorded during the chronoamperometry measurements. This was associated with the formation of stable pits during the exposure to NaCl solution under mechanical loading, as observed previously (Figure 8). A statistical analysis of pit size was carried out by considering all the pits observed on the EAC samples in which pitting occurred. Approximately, 420 pits were observed for the AM samples and 480 pits were observed for the CM samples. For both MSSs, three populations of pits were identified depending on their sizes, but larger pits were globally observed for the AM samples as compared with the CM samples, as shown by the distribution of pit sizes (Figure 9).

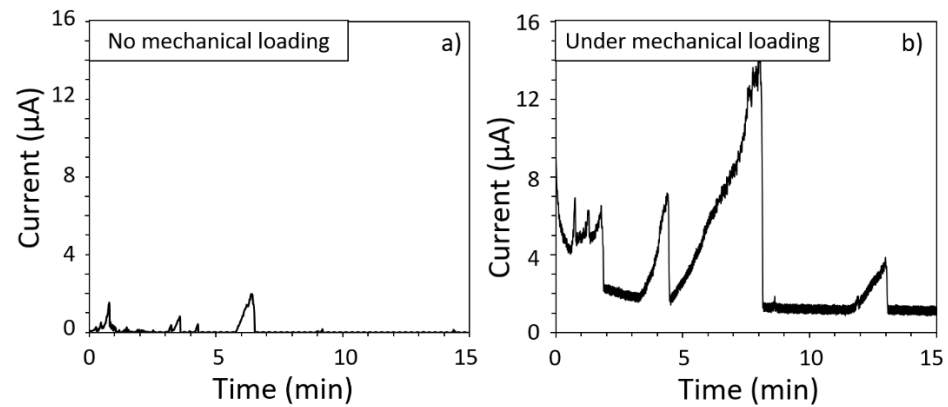
Figure 10. Current transients observed on samples exposed to 0.5 M NaCl solution: (a) Without mechanical loading; (b) with mechanical loading (EAC tests with an imposed strain corresponding to an initial stress of 80% of the $YS_{0.2}$ value). Results are given for the AM MSS samples.

Considering the results, attention was also given to the effect of mechanical loading on the susceptibility to metastable pitting of the MSSs. Indeed, during the EAC tests performed under polarisation, two sets of results were obtained. For some tests, stable pitting was observed during the chronoamperometry measurements, as previously discussed in Section 3.2.2. However, for some other tests, only metastable pitting was recorded, with similar current transients as those shown in Figure 2. In Figure 10, the current versus time measured on specimens exposed to 0.5 M NaCl solution in the EAC cell without mechanical loading (Figure 10a) is compared with mechanical loading, i.e., during the EAC tests (Figure 10b). The results are given for AM samples, but the conclusions were similar for the CM samples. Moreover, it was of interest to note that the results obtained without mechanical loading in the EAC cell were globally similar to those obtained with the cubic samples (Section 3.1.2). That said, Figure 10 clearly shows that the current transients were different for a test with mechanical loading as compared with a test without mechanical loading, with much more intense current transients under mechanical loading.

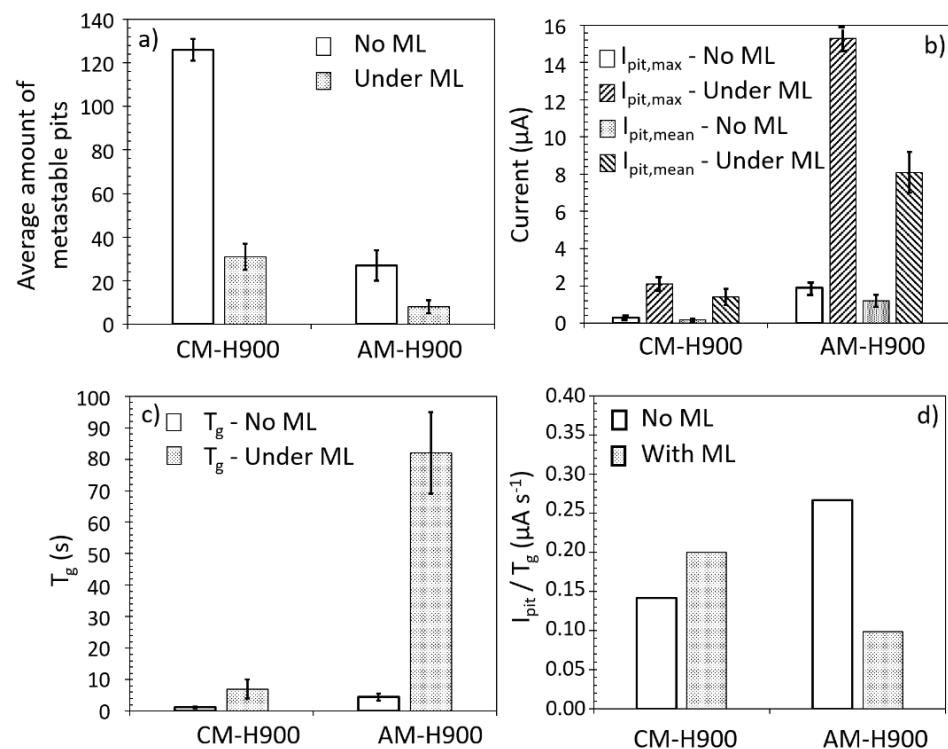
Figure 11. Results of the statistical analysis of the current transients observed for the samples exposed to 0.5 M NaCl solution, without mechanical loading (ML), and with mechanical loading (EAC tests with an imposed strain corresponding to an initial stress of 80% of the $YS_{0.2}$ value). The results are given for the AM and CM samples of MSS: (a) Average amount of metastable pits; (b) I_{pit} (max and mean values); (c) T_g ; (d) I_{pit}/T_g .

The results from the statistical analysis of these current transients are given in Figure 11 for both the AM and the CM samples of MSS. The number of current transients decreased sharply from 126 to 31 for the CM samples, and from 27 to 8 for the AM samples, when mechanical loading was applied (Figure 11a). However, the T_g values (Figure 11c), and also the T_r values (not shown), increased for both MSSs when mechanical loading was applied, which was more marked for the AM samples than for the CM samples. The results, therefore, showed that mechanical loading resulted in an increase in the average lifetime of the current transients, which was likely to be associated with an increase in the probability of stabilising these metastable pits. This was consistent with the observation of stable pits for some EAC tests. Furthermore, the highest influence of mechanical loading on metastable pits for the AM samples compared with the CM samples was in good agreement with the

larger stable pits observed for the AM samples after the EAC tests. The increase in I_{pit} values (Figure 11b) with mechanical loading, which was also much more significant for the AM samples than for the CM samples, confirmed the conclusions. The very high increase in T_g values with mechanical loading as compared with the tests without mechanical loading led to a I_{pit}/T_g ratio lower when mechanical loading was applied for the AM samples (Figure 11d).
