# Digital image correlation analyses of masonry infilled frame: Uncertainty-based mesh refinement and damage quantification

Vinicius Fiocco Sciuti, Rafael Vargas, Nestor Guerrero, María Eugenia Marante, François Hild

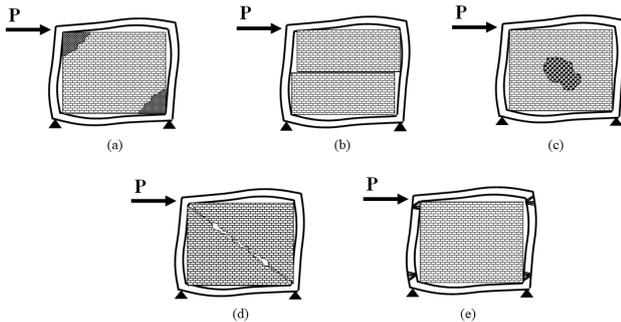
**Figure 1.** Different failure modes of masonry-infilled frames subjected to simple shear. (a) Corner crushing mode; (b) sliding shear mode; (c) diagonal compression mode; (d) diagonal cracking mode; (e) frame failure mode (adapted from Ref.<sup>12</sup>).

limits,<sup>5–10</sup> considering various failure modes. However, these criteria remain an active research topic in order to improve the reliability of such structures. The current literature offers extensive information on experiments geared toward the identification of failure modes, strength, stiffness, and other structural parameters to calibrate models to run numerical simulations for the analysis and design of buildings with this type of structural systems. Asteris et al.<sup>11</sup> classified the failure modes observed experimentally in simple shear into the five categories schematically shown in Figure 1.

Guerrero et al.<sup>12</sup> used DIC for evaluations of simplified models of infilled framed structures. Two different deformation mechanisms were found, namely, diagonal cracking (Figure 1(d)) during hardening phases and sliding shear during softening stages (Figure 1(b)). The inclination of the bands depended on the brick dimensions and arrangement. Didier et al.<sup>33</sup> quantified two proposed damage scores using DIC. Korswagen et al.<sup>34</sup> used DIC to detect crack formation and the evolution of the crack pattern, to calibrate and validate nonlinear finite element models. The authors defined a damage parameter as a function of the number, length and width of cracks in masonry walls. In the following analyses, two other damage indicators will be introduced.

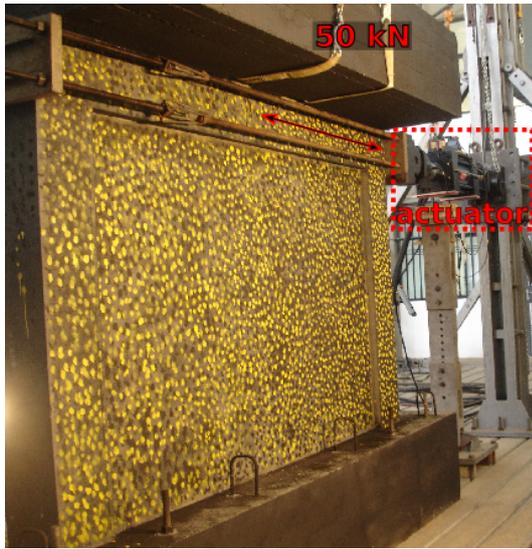
**Figure 3.** Masonry infilled frame before the experiment. The hydraulic actuator is shown in the dashed red box. The 50 kN dead load is visible above the frame.

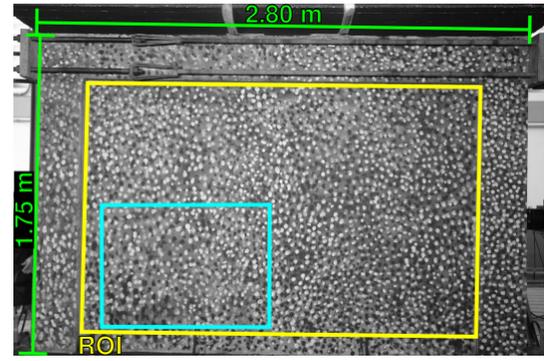
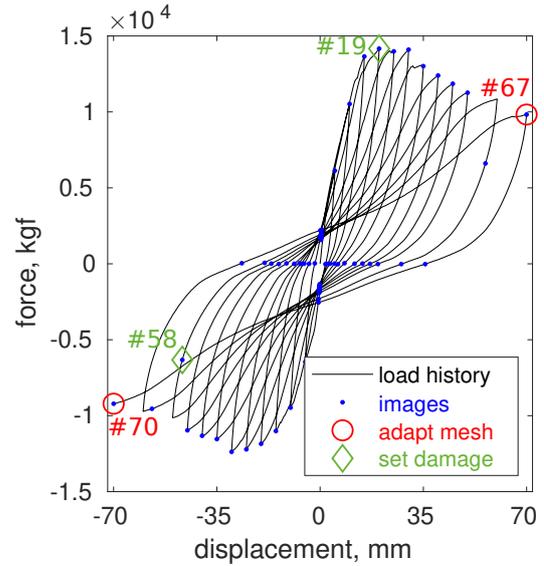
**Figure 4.** (a) Reference image of the unloaded configuration with the ROI highlighted in the yellow box. The smaller cyan box is discussed in Figure 14. (b) Loading history in which the blue dots depict image acquisitions. The red circles highlight the images used for adapting the meshes and the green diamonds those utilized for setting the damage parameter.

Figure 4(a) shows the acquired image of the reference configuration with the Region Of Interest (ROI) for DIC purposes depicted as a yellow box. To achieve good contrast for DIC purposes, the speckle pattern (Figure 3) was made first with a thin layer of black paint to emphasize the texture of the cladding. Black dots were then painted, and last yellow dots over the former. The hardware parameters are gathered in Table 1.

The applied displacement and resulting force are shown in Figure 4(b). One reference image was acquired prior to loading and 70 at the peak load of each cycle and when force or displacement were canceling out.

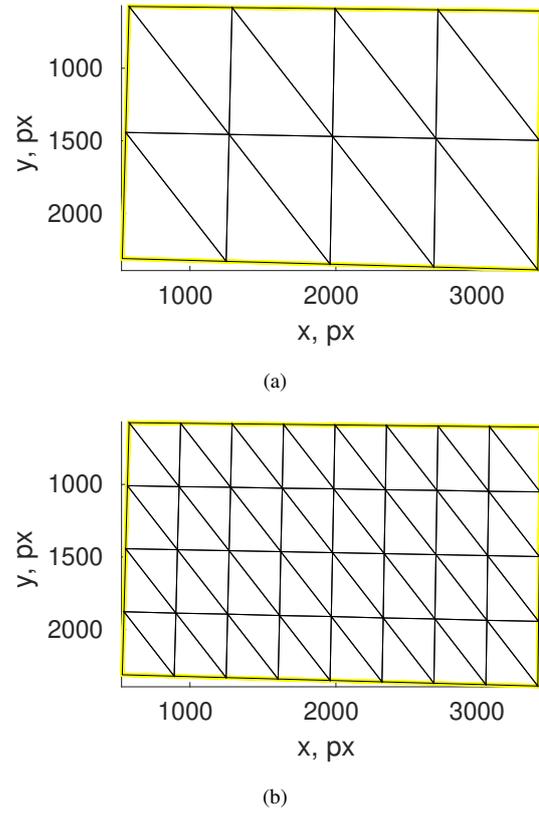
**Figure 5.** Uniform meshes with element lengths of 560 px (a) and 280 px (b). Each triangular element is divided into four new triangles. The physical size of one pixel is 790  $\mu\text{m}$ .

First, uniform meshes were considered, starting with an element size  $\ell = 560$  px, which was divided by two each time as shown in Figure 5. This analysis allows the thresholds to be set for adapting the mesh to better capture the crack pattern.

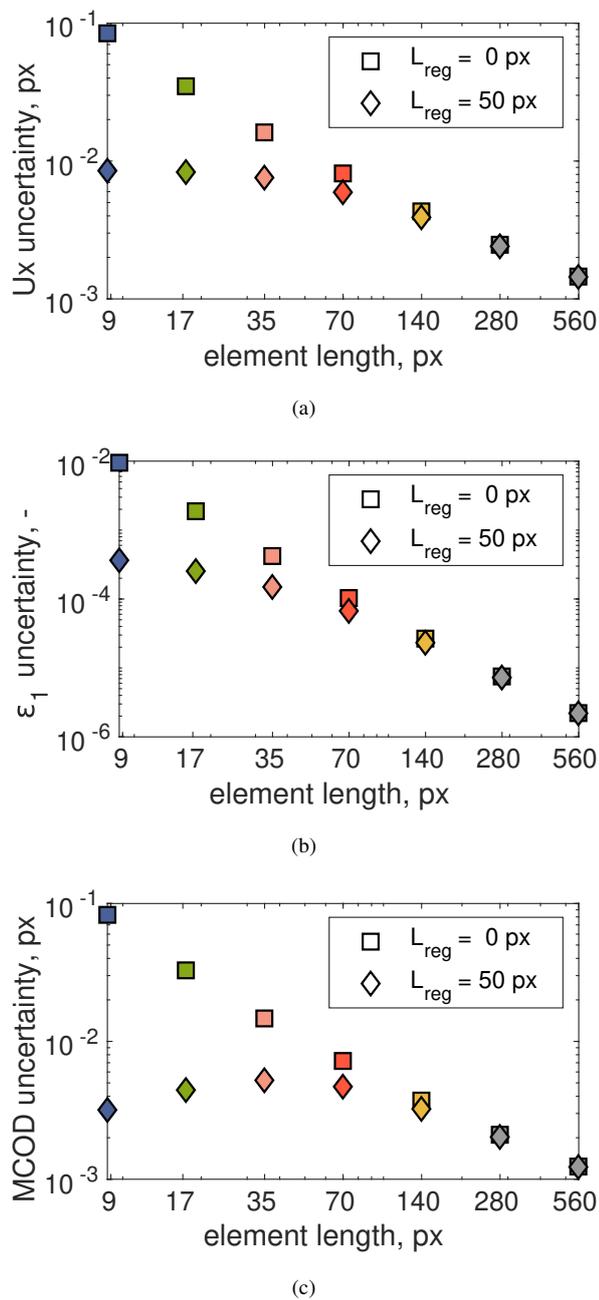
**Figure 6.** Standard uncertainties in terms of horizontal displacement (a), major eigen strain (b), and MCOd (c) for uniform meshes and two regularization lengths. The physical size of one pixel is 790  $\mu\text{m}$ .

The standard uncertainties are shown in Figure 6 for the horizontal nodal displacements (Figure 6(a)), the major eigen strains (Figure 6(b)) and the MCOD (Figure 6(c)) as functions of the element size. When no mechanical regularization was used (*i.e.*,  $L_{reg} = 0$ ), the uncertainties decreased with an increase in element length. This trend is the well-known compromise between measurement uncertainty and spatial resolution. <sup>42</sup> Conversely, when mechanical regularization was used (*i.e.*,  $L_{reg} = 50$  px) the standard displacement uncertainties decreased for elements whose size was greater than the regularization length. For small elements, the displacement uncertainty was controlled by the regularization length and no longer by the element size.

The standard strain uncertainty had a dual decrease depending on the element size. This trend was due to the fact that the standard strain uncertainty was proportional to the standard displacement uncertainty divided by the element size. For MCODs, which again considered the element length in its calculation, the uncertainty was smaller than for small elements, further highlighting the interest of using such regularization scheme.

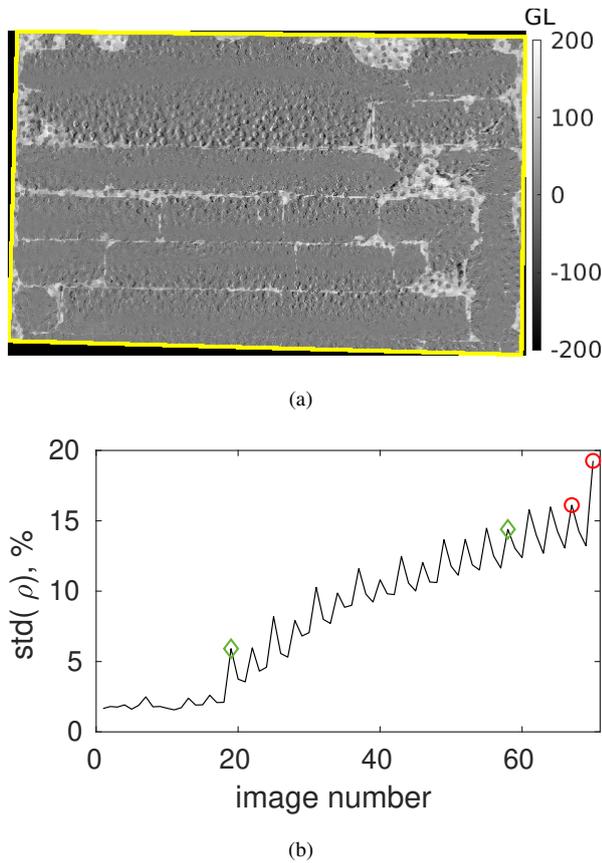
**Figure 7.** (a) Gray level residual for the initial DIC analysis using a coarse mesh (image #67). (b) Normalized standard deviation of gray level residuals (see Equation (5)). The green diamonds and red circles highlight images #19, 58, 67, and 70 further discussed in the text.

To illustrate the result of this first analysis and to compare with the following ones, the final gray level residual for the most loaded state (with positive horizontal displacement) is shown in Figure 7(a). Although convergence was achieved, interpolation errors are visible, which call for more degrees of freedom to properly describe the complex kinematics near damaged regions. The standard deviation of all residual images is shown in Figure 7(b) normalized by the dynamic range (*i.e.*, 255 gray levels). For the first 18 images, a value of about 2% is seen, which is classical for DIC.<sup>56</sup> However, from image #19 onward, it increased very significantly; reaching almost 20%, due to damage of the wall and its cladding. Such levels illustrate the challenges faced in the analysis of the test.

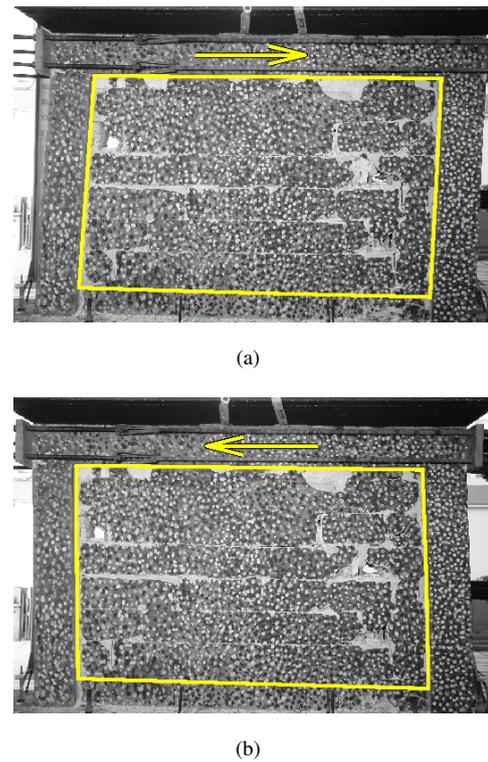
**Figure 8.** Images #67 and #70 of two deformed states that were used in the mesh adaption scheme (Figure 4(b)), respectively for the most loaded state with positive (a) or negative (b) displacements in the  $x$ -direction.

The gray level residual image using the adapted mesh is shown in Figure 11 (to be compared with the results displayed in Figure 7). The areas with higher residuals are more localized in the cracked region. Far from them, the residual was considerably lower with no special pattern (*i.e.*, signature of noise). In some specific regions, it is possible to read the initial pattern in the residual since part of the wall cladding fell off and the background became white (see Figure 8).

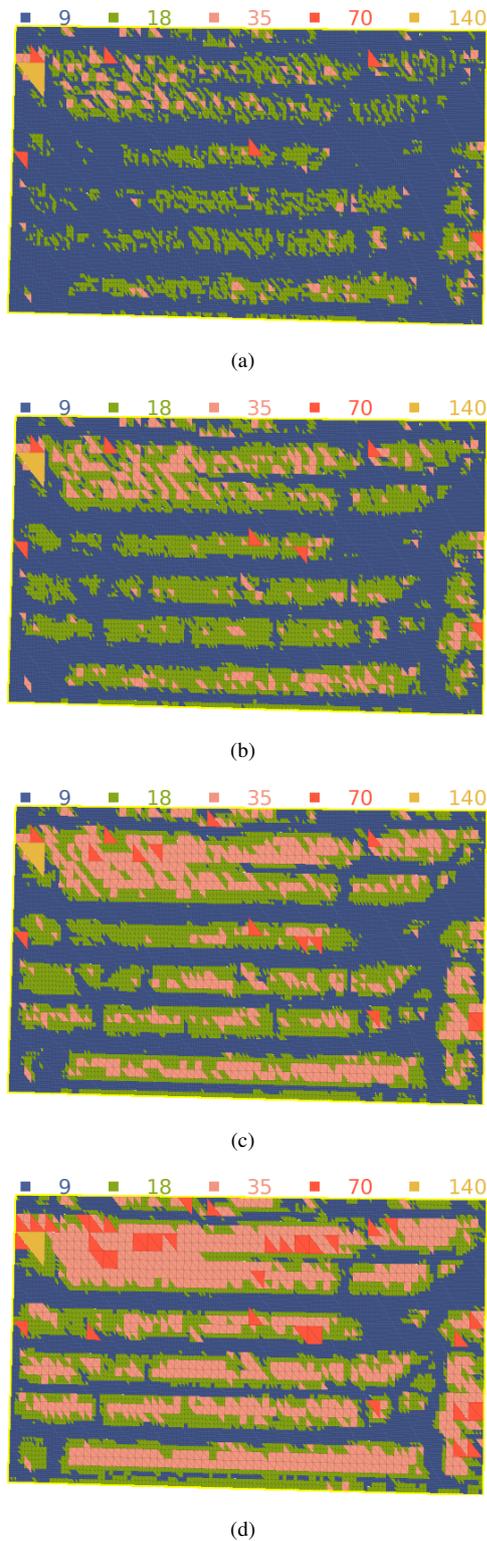
**Figure 9.** Adapted meshes using MCOD thresholds with  $k = 1.5$  (a),  $k = 3$  (b),  $k = 6$  (c), and  $k = 12$  (d). The colors depict the length of the elements expressed in px. The physical size of one pixel is  $790 \mu\text{m}$ .

Different values of  $k$  were tested (*i.e.*,  $k = 1.5, 3, 6, 12$ ) and the resulting meshes are shown in Figure 9 with the colors depicting the size of the elements. Although the starting mesh had 560 px elements, the biggest element in the final mesh was 140 px in length (see top left corner in Figure 9) because all elements reached the MCOD threshold during the two initial adaption steps. Using the present methodology, a suitable mesh size was obtained with no need of user intervention. When selecting  $k = 1.5$  (Figure 9(a)), the results are too much affected by noise, with some very fine elements scattered throughout regions where no damage happened. Conversely,  $k = 12$  (Figure 9(d)) provided a coarser mesh that was not refined for many vertical cracks. Even if  $k = 6$  (Figure 9(c)) provided a suitable mesh for the following analyzes,  $k = 3$  (Figure 9(b)) was kept since it is suggested in Ref.<sup>41</sup> and showed the best compromise to refine the mesh closer to where damage occurred (*i.e.*, connected regions with high MCODs) while not being affected much by noise. It is worth noting that gray level residual per element could also have been used instead of the

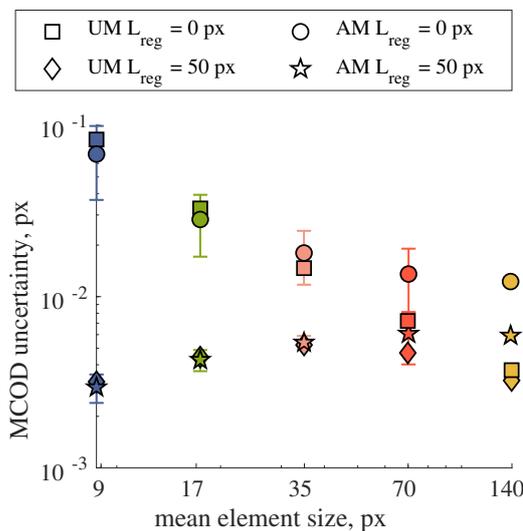
**Figure 10.** Standard MCOD uncertainties for the adapted mesh (AM, with  $k = 3$ , see Figure 9(b)) by groups of element size with no mechanical regularization or with  $L_{reg} = 50 \text{ px}$ . The mean standard uncertainties of each group are compared to the uncertainty of the uniform mesh (UM) with same element size. The error bar length depicts the standard deviations associated with the adapted meshes. The physical size of one pixel is  $790 \mu\text{m}$ .

Uncertainty analyses were then run using the adapted mesh shown in Figure 9(b) with the same set of 100 reference images as for the uniform meshes. Elements with same sizes were grouped to evaluate the corresponding uncertainties (Figure 10). The results are given for unregularized and regularized ( $L_{reg} = 50 \text{ px}$ ) DIC. For small element sizes with unregularized DIC, the MCOD uncertainties were close (*i.e.*, fell within error bars depicting the standard deviations of the standard uncertainties for the adapted mesh). The adapted mesh led to lower uncertainties as some small elements may have larger neighboring elements for which the uncertainty was lower. Conversely, for large element sizes, the trend was reversed due to the fact that large elements may have shared nodes with smaller adjacent elements.

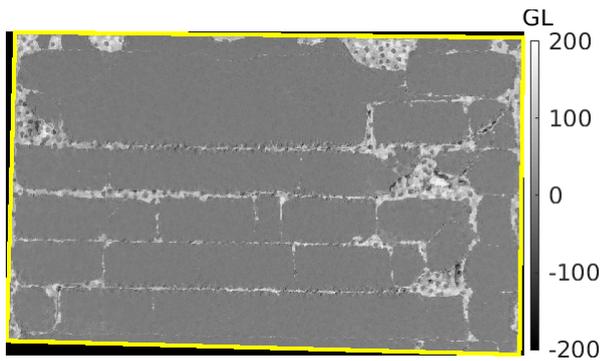
**Figure 11.** Gray level residual for the DIC analysis using the adaptive mesh (with  $k = 3$ , see Figure 9(b))

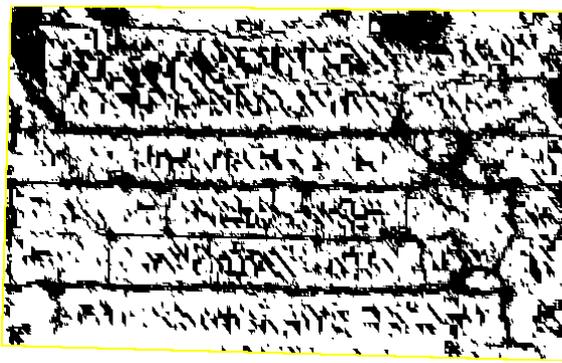
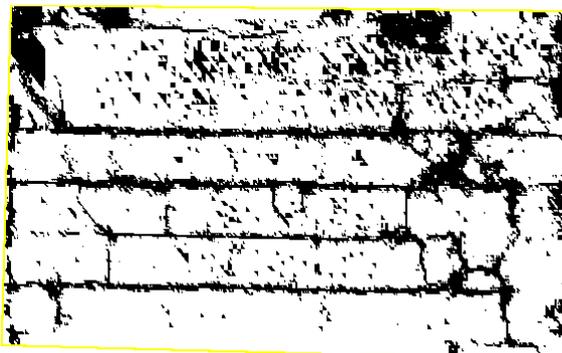
**Figure 12.** Damaged elements for deformed image #58 using as detection criterion only MCODs (a), gray level residuals (b), or both of them (c), all with  $K = 3$

For the sake of simplicity, the first choice was to keep  $K = k = 3$  from the mesh adaption procedure. In the gray level residuals, the three approaches (*i.e.*, MCOD, gray level or coupled criterion) were indistinguishable. However, the damage fields were studied very carefully for deformed image #58 (Figure 4(b)). As shown in Figure 12 with  $K = 3$ , if only MCODs are used for the detection threshold (Figure 12(a)), some regions where no crack occurred were labeled as damaged. Further, if only the gray level residuals are used (Figure 12(b)), damage became affected by brightness and contrast changes during image acquisition. When both quantities are coupled (Figure 12(c)), the aforementioned effects were reduced and damage concentrated essentially on cracked regions. However, for all these three results, there were damaged elements at the very beginning of the analysis showing that  $K = 3$  was too low for such thresholds.

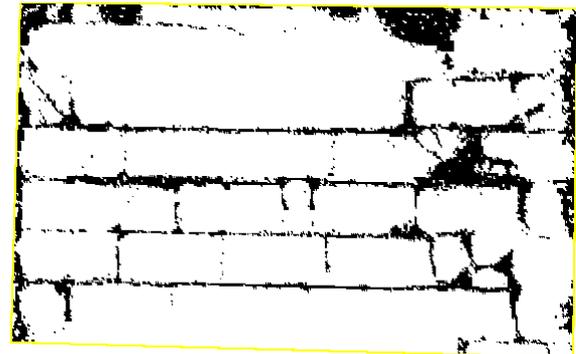
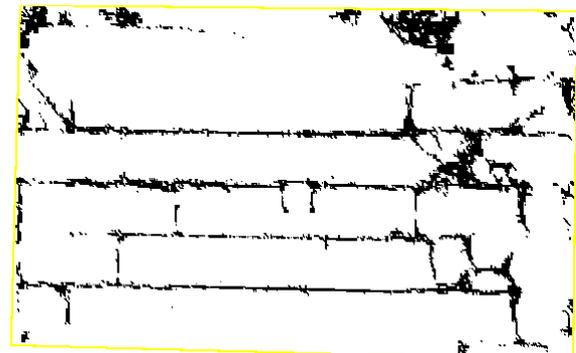
**Figure 13.** Damaged elements for deformed image #58 using as detection criterion only MCODs (a), gray level residuals (b), or both (c), all with  $K = 6$

When testing  $K = 6$  for the same image #58, using MCODs for the detection criterion, undamaged areas were detected (Figure 13(a)). If only the gray level residuals were considered, a fine description of the cracked state was observed in the damage field (Figure 13(b)). Contrary to the cases with  $K = 3$ , the coupled criterion now seems to erase some small aspects of the cracked network seen in the gray level residuals, when comparing Figures 13(b, c), yet both led to very similar damage fields.

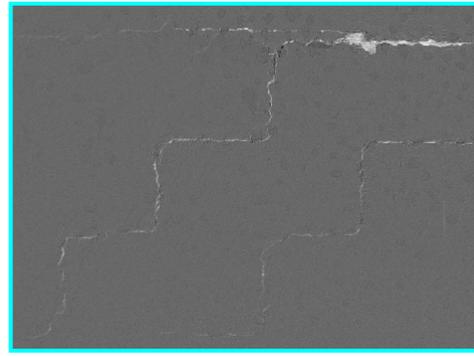
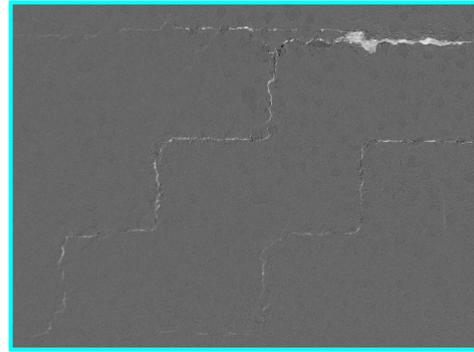
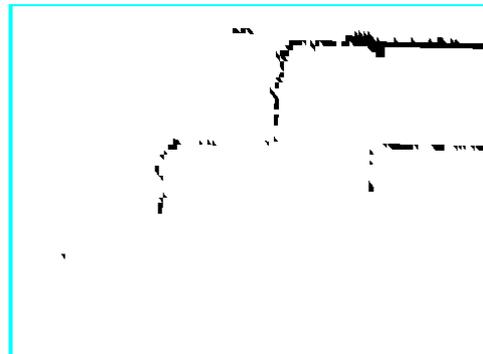
**Figure 14.** Detail (see Figure 4(a)) of the gray level residual for the DIC analysis of image #19 using  $K = 6$  and only the gray level residual as criterion (a) or the coupled criterion (b). (c, d) Corresponding damage fields.

A zoomed region (bottom left of the ROI, see Figure 4(a)) of image #19 was selected to distinguish the previous results. This image was the first one for which the global gray level residual increased beyond its baseline (or noise floor level, see Figure 7(b)), namely, where higher gray levels (*i.e.*, cracks) occurred. Figure 14(a, b) displays the residuals when  $K = 6$  and using only the gray level (Figure 14(a)) or the coupled criterion (Figure 14(b)). In both cases, the crack network is visible, and matches better the damage pattern when only gray level residuals are used as detection quantity (Figure 14(c)). Part of the damage was not detected by the coupled criterion (Figure 14(d)). Therefore, the choice

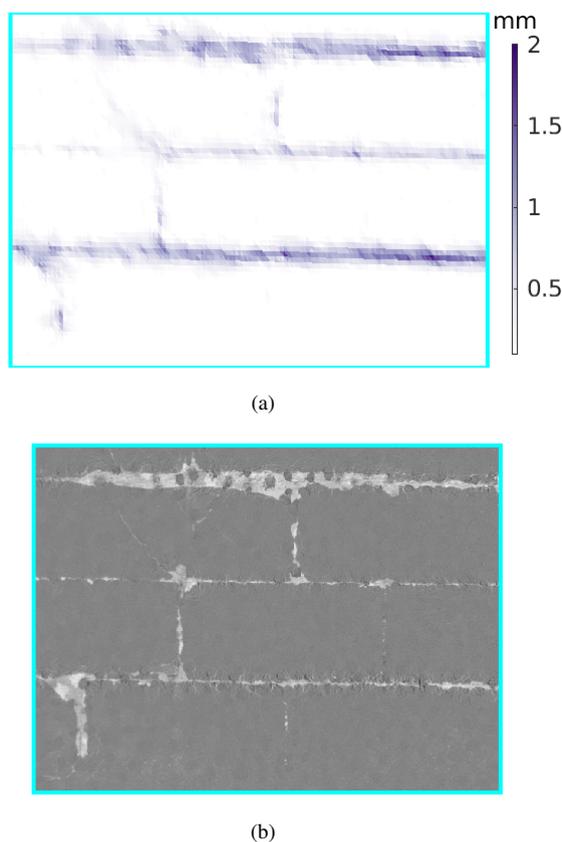
**Figure 15.** Details (see Figure 4(a)) of (a) MCOd and (b) gray level residual fields for image #58 using a fine uniform mesh.

If no adaptive mesh or damage was considered, an analysis with a very fine mesh with mechanical regularization would provide the best description of the displacement field in such challenging case. The results obtained with a uniform mesh with an element size of 9 px, which was the smallest in the adapted mesh, are first discussed. This mesh was created using the same element subdivision routine, but choosing all elements to be subdivided at each step. The MCOd field for image #58 is shown in Figure 15(a) for a zoomed area. The field was blurred due to the mechanical regularization, which spread the strains over few elements. Its corresponding gray level residual map is shown in Figure 15(b). Although a proper description of the crack network is observed, there are interpolation errors close to the horizontal cracks, which were created by enforcing the continuity and mechanical admissibility of displacements.

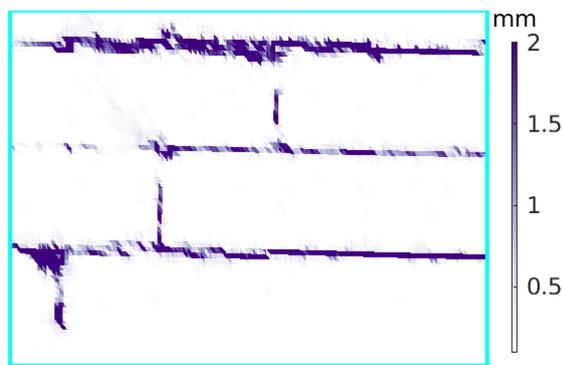
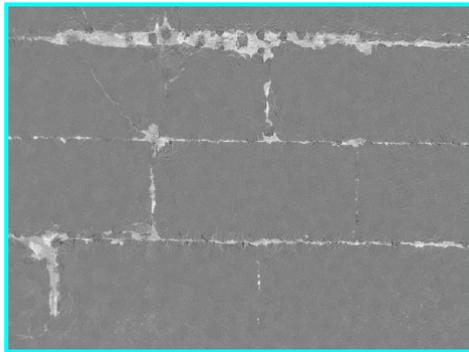
**Figure 16.** Details (see Figure 4(a)) of (a) MCOD and (b) gray level residual maps for image #58 using the adapted mesh.

Similar results are reported in Figure 16 with the adapted mesh (with  $k = 3$ ). The DIC analyses were conducted with damage based on the gray level residual (with  $K = 6$ ). In the MCOd field (Figure 16(a)), the localization of the cracks is visible in single elements. Even though the dynamic range of the color map was saturated at openings greater than 2 mm (for comparison purposes with the uniform mesh), local openings of up to 10 mm were captured for some elements. This better description is also perceptible in the gray level residuals (Figure 16(b)) in which, for smaller openings, they are concentrated in a single pixel line. It is worth noting that for this small ROI, the adapted mesh had about 30% fewer elements than the uniform mesh, while still yielding a better description of the underlying phenomenon.

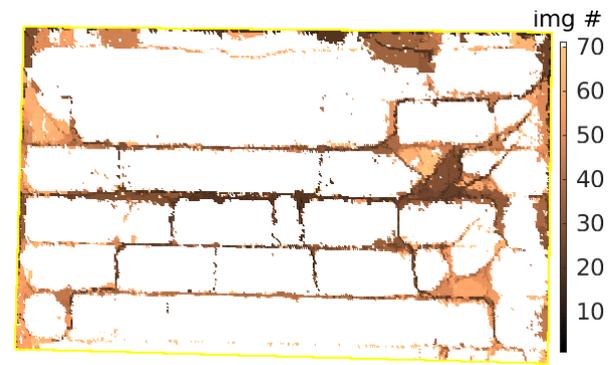
**Figure 17.** Map of first image for which elements were damaged. If damage never occurred, the element remains white.

The following procedure aims to have a spatial and temporal description of damage development, which is summarized in Figure 17. The color rendering of each element represents the image when damage initiated (*i.e.*, when the threshold was surpassed). If the element is white, it means that it remained undamaged for the whole analysis. Many undamaged regions are observed between cracked regions. Damage initiated in the central horizontal region and along the main diagonals up to image #19. By reaching the maximum load, more horizontal cracked regions were formed, and damage grew toward the outside frame. The bigger damaged regions were related to a sudden fall of the cladding.

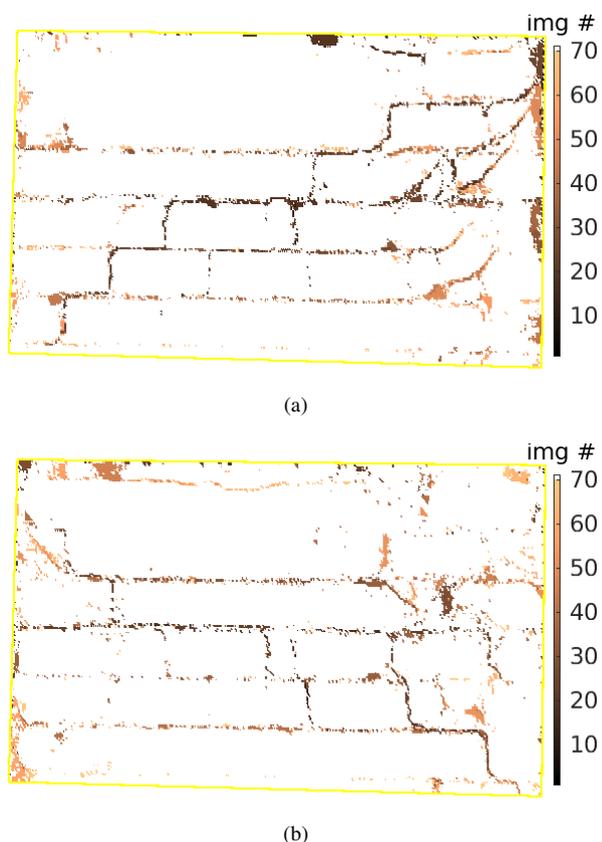
**Figure 18.** Map of first image for which elements were damaged in the peak loads for positive (a) and negative (b) applied displacements (see Figure 4(b)). If damage never occurred, the element remains white.

The same type of map was drawn using only the elements that were damaged at the peak loads for positive (Figure 18(a)) or negative (Figure 18(b)) applied displacements. Apart from the previous conclusion pointing out that damage started in the center and grew outward, a first diagonal band is seen in both cases, which was aligned along the loading direction applied at the top part of the wall. Then, beyond the maximum force, other horizontal bands appeared, some for the very last images (*e.g.*, see top of Figure 18(b)). These maps provide interesting data to validate damage models.

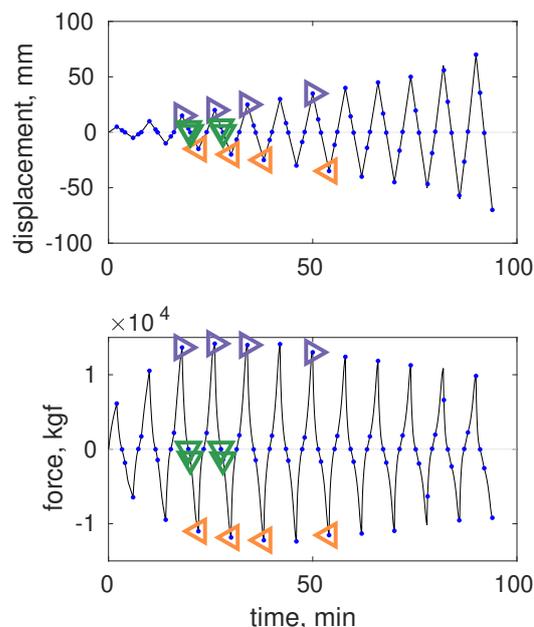
**Figure 19.** Stroke and force histories. The blue dots depict image acquisitions, and the triangles the series of images studied for crack initiation for positive (in purple, images #13, 19, 25, and 37) or negative (in orange, images #16, 22, 28, and 40) prescribed displacements. To analyze the activation / deactivation of crack systems, additional frames were considered (in green, images #14, 15, 20, and 21).

For a finer description of crack initiation, it is proposed to further investigate both series of images highlighted in the loading history displayed in Figure 19, for maximum positive or negative strokes where softening occurred. The range for the color map was set small in order to highlight the damage pattern (*i.e.*, MCOB levels less than 1 px or 0.8 mm).

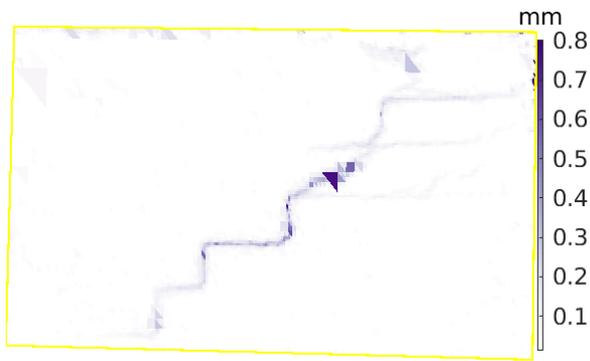
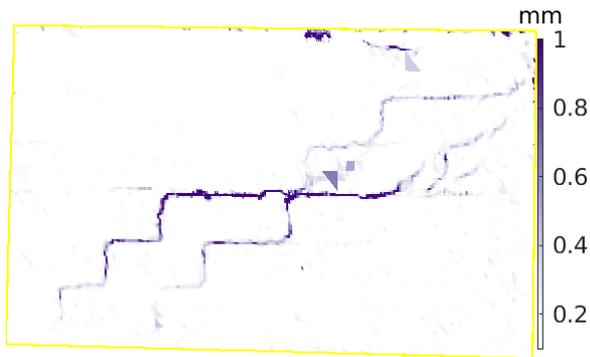
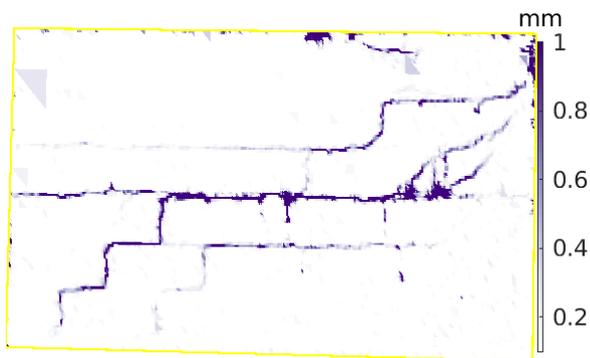
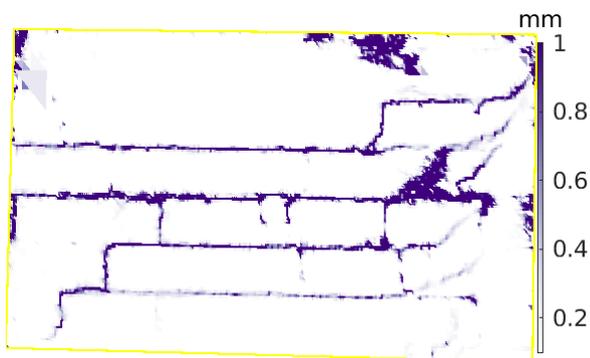
**Figure 20.** MCOD fields for images #13 (a), 19 (b), 25 (c), and 37 (d), at peak loads of positive displacement (Figure 19)

MCOB fields are displayed in Figure 20 for the time steps related to damage initiation for positive strokes. The results are first shown for image #13 (Figure 20(a)), which was the first one where cracks appeared in the gray level residual map even though not yet perceptible in the global residual (Figure 7(b)). A first zigzagged diagonal pattern is observed with very small openings in the top right part. On the following cycle (image #19), two diagonal bands are observed (Figure 20(b)). For image #25, three horizontal bands became more prominent (Figure 20(c)), and a fourth one developed two cycles after (at image #37, see Figure 20(d)). The large damaged zones are due to cladding loss.

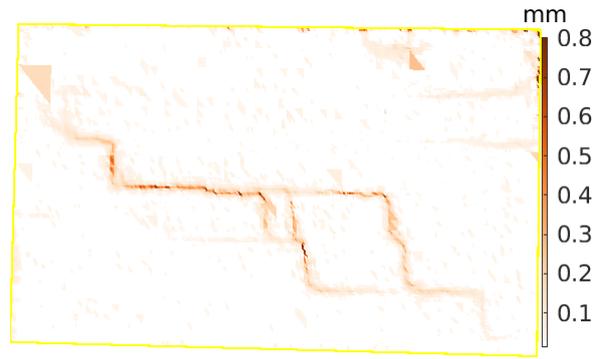
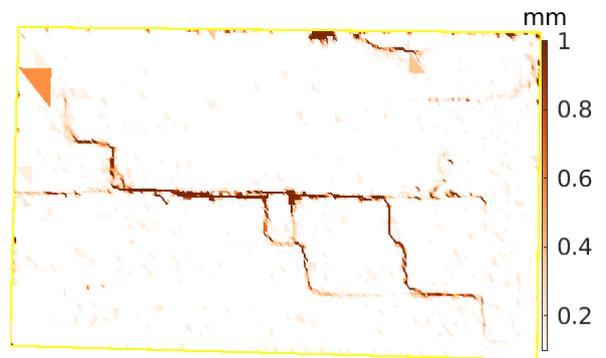
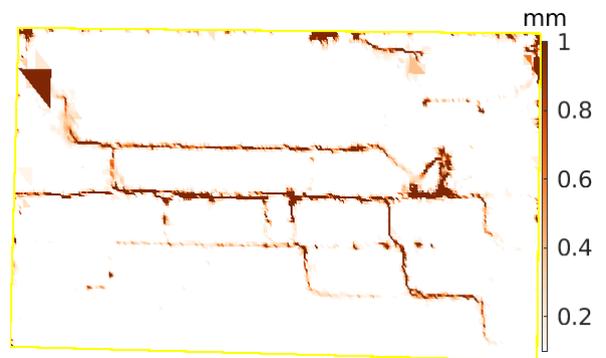
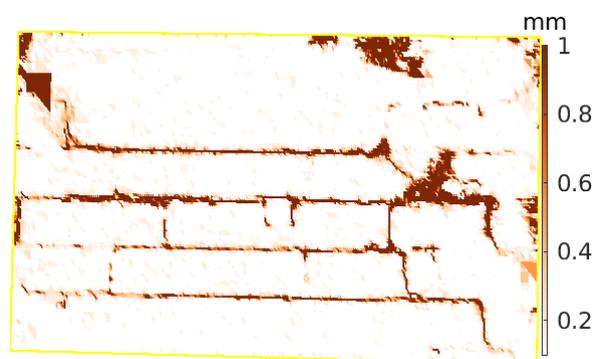
Similar trends are observed for MCOD fields associated with negative displacement peaks (Figure 21). One main

diagonal band first formed at image #16 (Figure 21(a)) with some bifurcation at the bottom right.

Part of the openings seen at the top right for image #13 (Figure 20(a)) remained, which indicated that the cracks did not fully close upon load reversal. On the next cycle (image #22), the development of a big horizontal crack occurred at mid-height (Figure 21(b)). For image #28, an additional diagonal band appeared on the right side and two more horizontal ones (Figure 21(c)). A fourth horizontal crack was then created two cycles later (image #40, see Figure 21(d)).

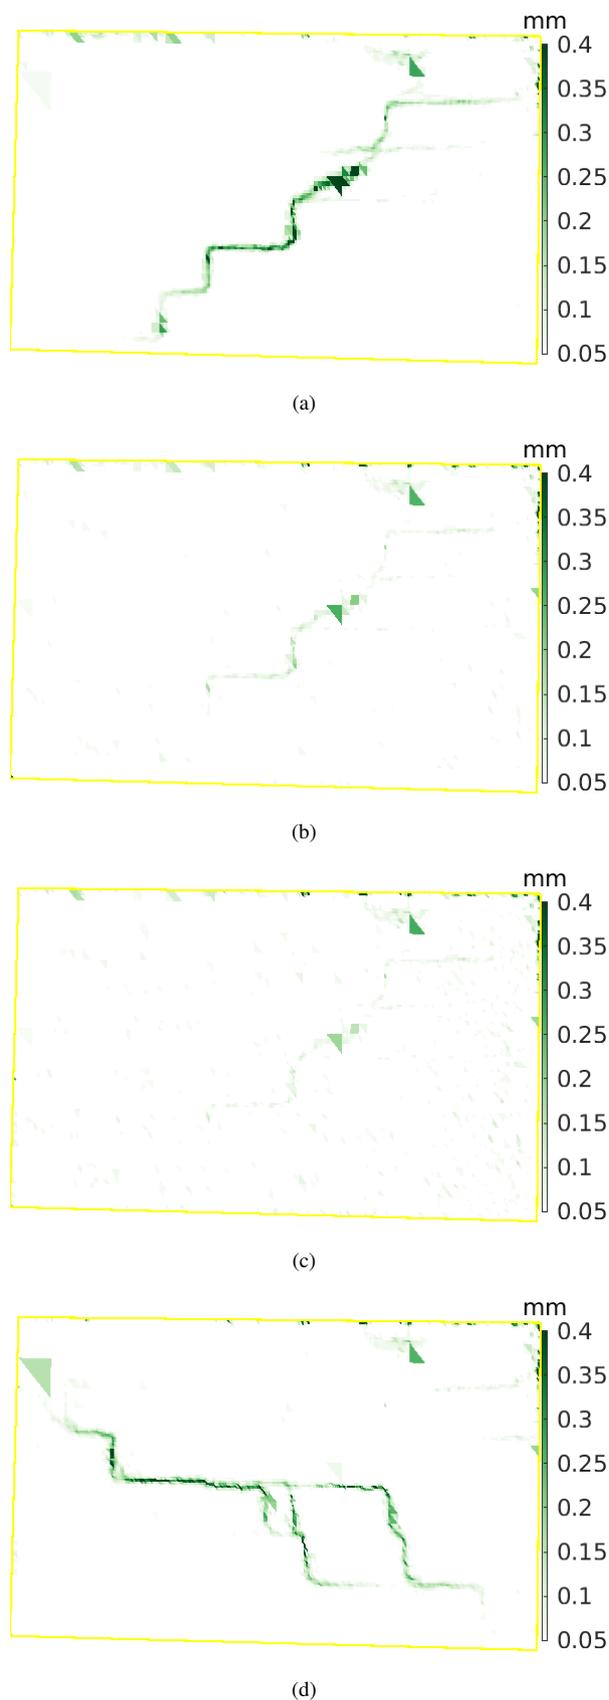
To further investigate the crack system development upon load reversals, two intermediate MCOD fields are also shown in Figure 22 (*i.e.*, images #14 and 15, see green triangles in Figure 19) in addition to images #13 and 16 for comparison purposes. The result of the first image (Figure 22(a)) was already reported (Figure 20(a)) but with a higher dynamic range compared to the present one (*i.e.*, 0.4 mm or  $\approx 0.5$  px for the latter). The highest MCOD levels occurred in the central part of the wall. Figure 22(b) corresponds to the unloading stage with zero applied force. The zigzagged crack had essentially closed with very limited residual opening. It further closed when the applied displacement was equal to zero (Figure 19(c)). The second system of zigzagged cracks was formed for image #16 (Figure 22(d)). The highest MCOD levels again took place in the central part of the wall. In this first regime, cracking that was induced by the first loading direction was deactivated as soon as the second one was activated and vice-versa. For the sake of conciseness, the next cycle is not reported. However, all the trends shown Figure 22 were identical, except the MCOD levels that increased because of higher stroke.

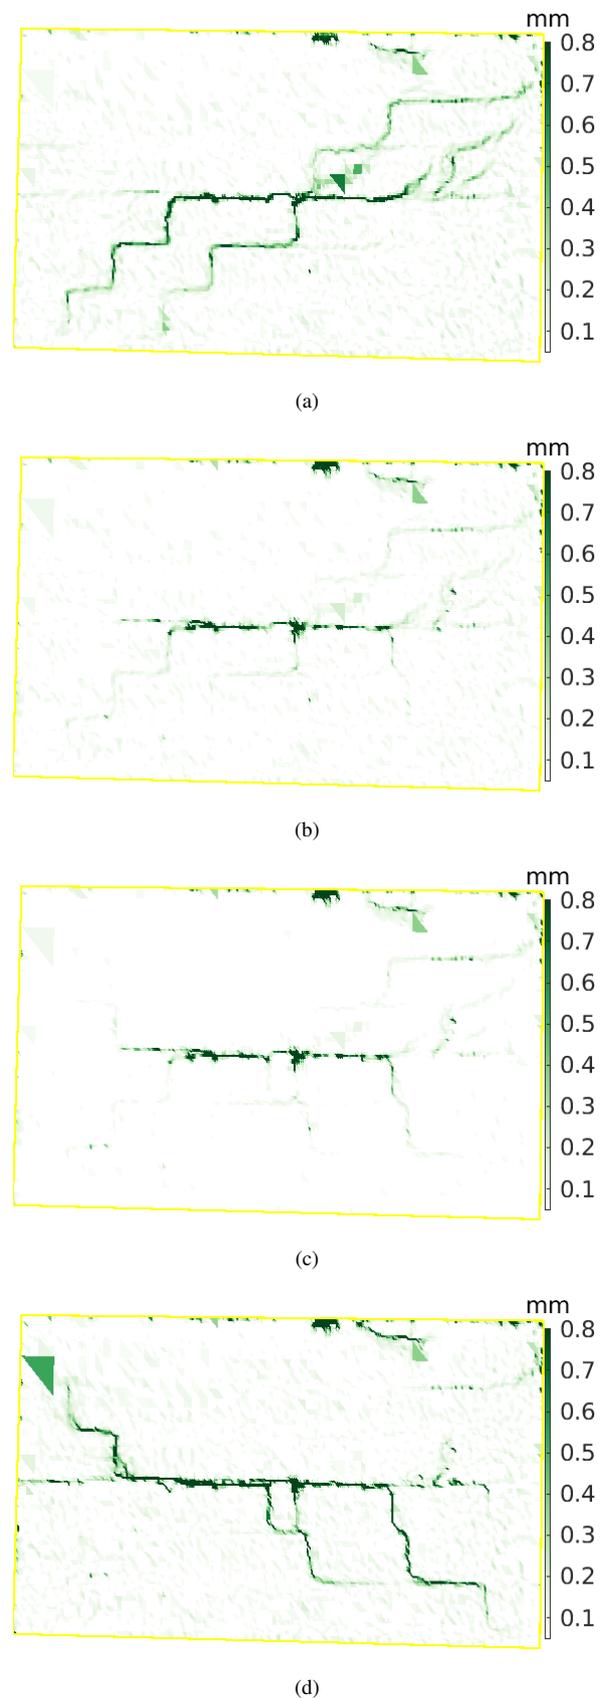
**Figure 23.** MCOD fields for images #19 (a), 20 (b), 21 (c), and 22 (d). Sub-figures (a) and (d) were already reported with different dynamic ranges in Figures 20(b) and 21(b), respectively.

The same analysis was performed for the fourth cycle. Two intermediate MCOD fields are also shown in Figure 23 (*i.e.*, images #20 and 21, see green triangles in Figure 19) in addition to images #19 and 22 for comparison purposes. The result of the first image (Figure 23(a)) was already reported (Figure 20(b)) but with a different dynamic range. The highest MCOD levels were significantly higher in the central part of the wall. Figure 23(b) corresponds to the unloading stage with zero applied force. Many of the zigzagged cracks had essentially closed (as in the previous case, see Figure 22). However, the horizontal crack remained open, presumably due to friction. The zigzagged cracks further closed when the applied displacement was equal to zero (Figure 19(c)) and the horizontal crack was still substantially open. Conversely, the second system of zigzagged cracks that was fully open for image #22 (Figure 23(c)) was still mostly closed. The second system of zigzagged cracks opened again for image #22 (Figure 23(d)) but most of the MCOD took place in the central part of the wall and for the horizontal crack. Contrary to the previous results (Figure 22), the horizontal crack experienced much higher MCOD levels.

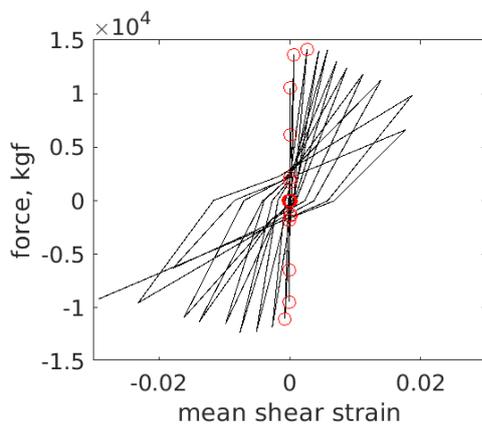
**Figure 24.** Measured force as a function of mean shear strain calculated over the whole ROI. The red circles depicts all the images up to the peak load (image #19).

One first quantification of macroscopic damage is shown in Figure 24, by considering the mean shear strain of the whole ROI and comparing to its evolution with the applied forces. The mean shear strain was very low for the first images, and as it increased, the force started to decay (in absolute value). The red circles depict the first 19 images (up to the peak load), which are the same highlighted inside the red box in Figure 25. It is interesting to note that from the previous results, it was concluded that damage had already initiated before reaching the ultimate force.

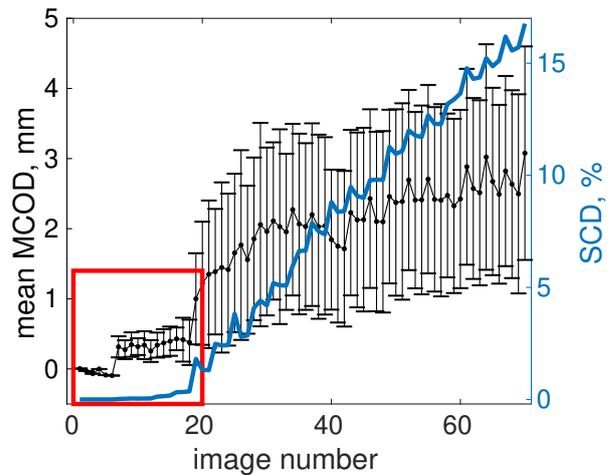
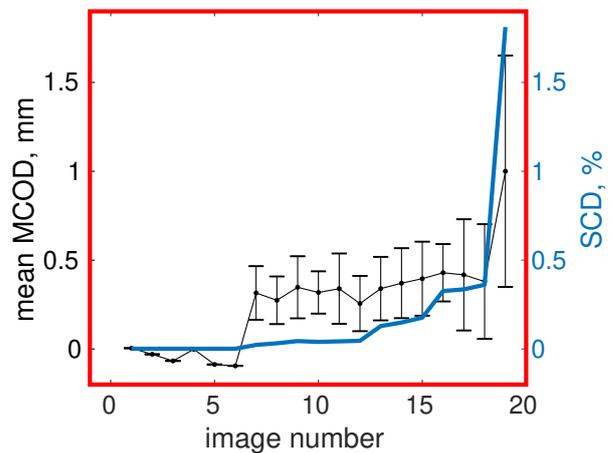
**Figure 25.** (a) Average MCODs of damaged elements and Surface Crack Density as functions of image number, and (b) zoom for the first 19 images (red box of sub-figure (a)). The length of the error bars corresponds to the standard deviation of MCODs.

Even if the previous discussions already gave a lot of insight into crack initiation and propagation in the infill, the selected ranges did not allow the crack openings to be fully quantified. Such type of information was obtained from the mean MCOD in damaged elements and the Surface Crack Density (SCD), calculated as the damaged area divided by the ROI area. Both quantities are displayed in Figure 25. Prior to image #19, very few elements were damaged, and the damaged ones had a very low MCOD (*i.e.*, on average less than 0.4 mm or 0.5 px). A sudden increase in mean MCOD (from 0.4 mm to 1 mm) is observed after image #19, which then continues to grow stably but at a slower rate up to the end of the test. Once the SCD started to grow (at image #19), it increased linearly up to the end. This trend corresponds to the existence of two different mechanisms (Figures 20 and 21). First, from images #7 to #18, damage developed as diagonal bands with essentially constant mean MCOD of  $\approx 0.4$  mm and gradual increase of the number of damaged elements (Figure 25(b)). Second, horizontal bands were formed with the SCD gradually increasing with

fluctuations associated with the cyclic nature of the applied load (Figure 4(b)). It was accompanied by an initially fast increase of mean MCOD, which then slowed down.

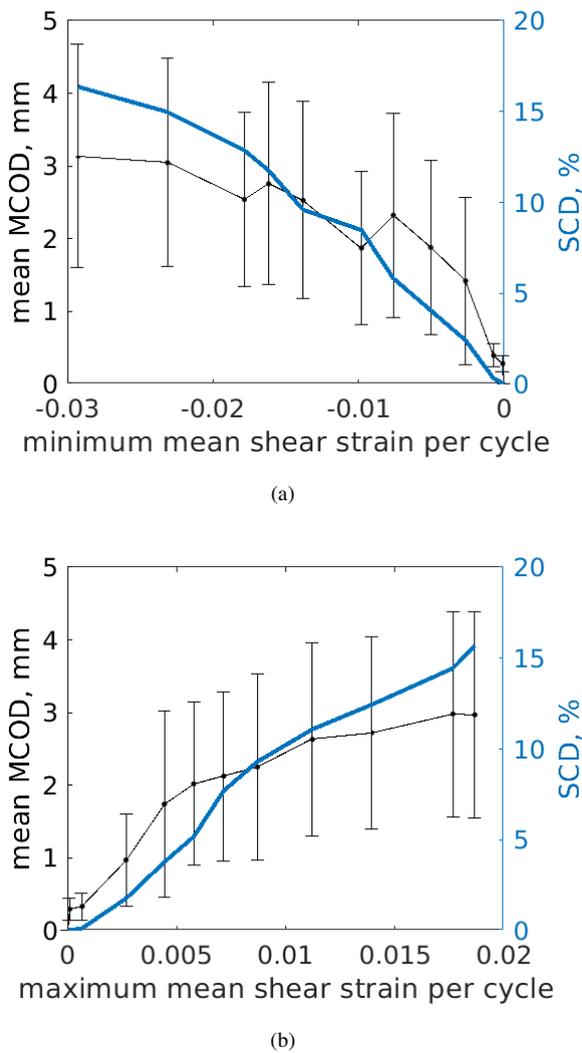
**Figure 26.** Average MCODs of damaged elements and Surface Crack Density as functions of minimum (a) and maximum (b) mean shear strain for each cycle of the experiment, depending whether the prescribed displacement was negative or positive. The length of the error bars corresponds to the standard deviation of MCODs

To further investigate the oscillations observed in Figure 25, both mean MCOD and SCD are shown as functions of the minimum (Figure 26(a)) or maximum (Figure 26(b)) shear strain per cycle, depending whether the prescribed displacement was negative or positive. The increasing trend in both cases highlights the fact that damage mostly developed on the envelope of the loading history, while the intermediate points on loading reversal were related to closure of one crack system and opening of the other one.
