Digital image correlation analyses of masonry infilled frame: Uncertainty-based mesh refinement and damage quantification

Vinicius Fiocco Sciuti, Rafael Vargas, Nestor Guerrero, María Eugenia Marante, François Hild

Vinicius Fiocco Sciuti, Rafael Vargas, Nestor Guerrero, María Eugenia Marante, François Hild. Digital image correlation analyses of masonry infilled frame: Uncertainty-based mesh refinement and damage quantification. Mathematics and Mechanics of Solids, 2023, 10.1177/10812865231174840 . hal-04079689

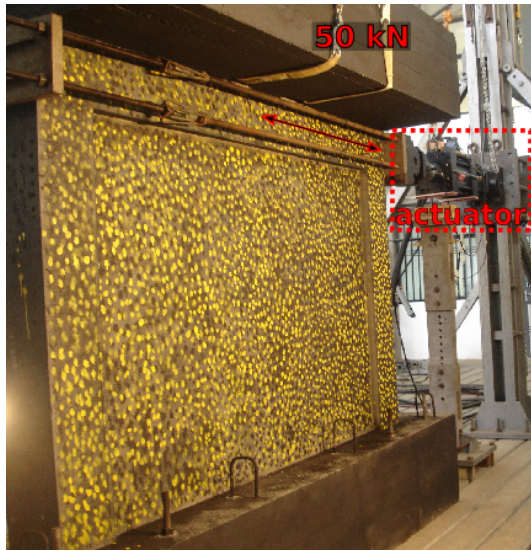
Figure 3. Masonry infilled frame before the experiment. The hydraulic actuator is shown in the dashed red box. The 50 kN dead load is visible above the frame.

A servo-controlled hydraulic actuator with a capacity of 500 kN was used to apply the desired displacement history and to measure the corresponding applied force. The actuator was mounted on a reaction frame and connected to the specimen through a steel device (Figure 3). In order to apply a uniform vertical load to the frame, an additional structure was built on top of it, in which blocks and steel plates were placed until reaching a total weight of 50 kN. A cyclic horizontal displacement was applied on the top part by a hydraulic actuator to mimic seismic motions.

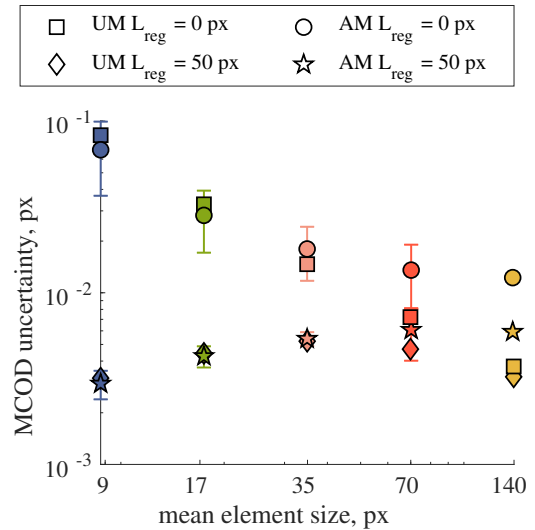
Figure 10. Standard MCO uncertainties for the adapted mesh (AM, with $k = 3$, see Figure 9(b)) by groups of element size with no mechanical regularization or with $L_{reg} = 50$ px. The mean standard uncertainties of each group are compared to the uncertainty of the uniform mesh (UM) with same element size. The error bar length depicts the standard deviations associated with the adapted meshes. The physical size of one pixel is $790 \mu\text{m}$.

Uncertainty analyses were then run using the adapted mesh shown in Figure 9(b) with the same set of 100 reference images as for the uniform meshes. Elements with same sizes were grouped to evaluate the corresponding uncertainties (Figure 10). The results are given for unregularized and regularized ($L_{reg} = 50$ px) DIC. For small element sizes with unregularized DIC, the MCO uncertainties were close (*i.e.*, fell within error bars depicting the standard deviations of the standard uncertainties for the adapted mesh). The adapted mesh led to lower uncertainties as some small elements may have larger neighboring elements for which the uncertainty was lower. Conversely, for large element sizes, the trend was reversed due to the fact that large elements may have shared nodes with smaller adjacent elements.

Regarding mechanical regularization, the very same conclusions applied for the same reasons. However, the uncertainties were more dominated by the regularization length for smaller elements, which led to significantly lower levels in comparison with unregularized DIC. When $L = 50$ px, standard displacement and MCO uncertainties less than 5×10^{-3} px (or less than $4 \mu\text{m}$) were again achieved irrespective of the element size.
