# Combined GPR and visible image databases of concrete structures

Foucher P.<sup>1</sup>, Dérobert X.<sup>2</sup>, Fauchard C.<sup>3</sup>

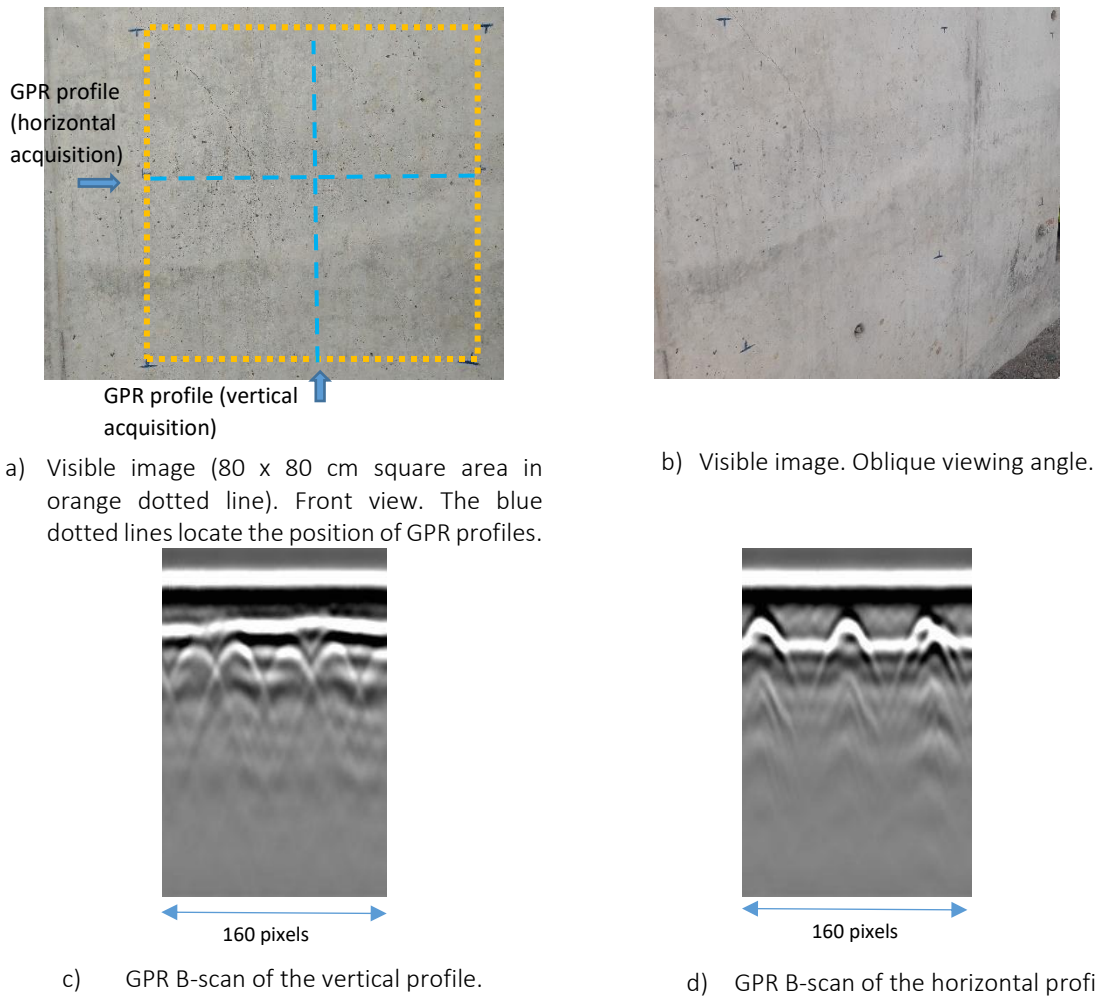
The visible and GPR images of concrete structures are acquired as follows. Each concrete area is delimited according to a 80 x 80 cm square, whose corners are drawn with chalk on the wall surface (see fig. 1.a). Two high-resolution visible colour images (usually 3000 x 4000 pixels) of the area are acquired, the first one is a front view of the square at a distance of about 2 meters and the second one is a view with an oblique angle of about 45°. A standard smartphone is used for the acquisitions.

On the same concrete area, two GPR profiles located at the center of each side of the 80 x 80 square are surveyed, one in the horizontal direction of the surface and the other in the vertical direction (see the blue dotted lines showing the profile directions in fig 1.a and the resulting B-scans in fig 1.c and 1.d).

Figure 1: Examples of the 4 images acquired on an elementary area of a concrete wall.

Note that the Radar signals (A-scan) are acquired at a rate of 1 acquisition every 1.25 mm. For a length of 80 cm, 641 A-scans lead to one B-scan (GPR time section). The time ranges during the acquisition have been fixed to 8 ns for the two concrete beams and 6 ns for a post-tensioned concrete bridge (structures presented in next section), in both cases sampling signals to 256 pixels. GPR processing consisted of several steps, an acquisition sampling limited to 5mm, a [520 MHz – 5200 MHz] pass-band filter and a time gain fixed at -15 dB. As results, leading to GPR B-scans of 161x256 pixels (Fig.1).

Each zone of the structure is therefore associated with four images (see Figure 1). With the help of a specialist in engineering structures, we have visually classified these zones into two categories: healthy area or damaged area with cracks. The four images of the same area have the same label.
