Investigation of the Protection Efficiency of Repair Mortar Against Chloride Corrosion in Repaired Zones of Reinforced Concrete

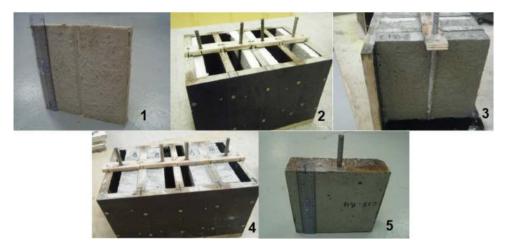
Fig. 2 Manufacturing process of reinforced concrete sample repaired with a mortar

diameter and 24 cm in length were cleaned using electric brushing. A silicone part with a rough surface was used to obtain an equivalent rough surface for proper bonding between concrete and mortar. The manufacturing process of the system is described as follows (Fig. 2):

Stage 1: Manufacturing of silicon borrowing. The silicone was cast in a mould which contained a test piece of sandblasted prismatic concrete on which reinforcement was glued to obtain a silicone piece with the impression of reinforcement and sandblasted concrete.

Stage 2: Placement of borrow pits and reinforcement before casting the concrete into three layers by vibration and conservation of the mould in a wet chamber for 24 h. The reinforcement steel was kept straight using a wooden cleat attached to the mould. The apparent part of the steel reinforcement was galvanised in stage 5.

Stage 3: Casting concrete, curing for 24 h in a conditioned chamber (20 °C and 95%RH), and releasing borrows from the mould.

Stage 4: Mortar casting in three layers using vibration in a mould containing half concrete and reinforcement.

Stage 5: Release samples from the mould, galvanisation of the apparent part of the steel reinforcement, and conservation in a conditioned chamber for 28 days (d) (20 °C and 95%RH). A schematic of the manufactured sample is shown in Fig. 3.
