Post-Disaster Reconstruction of Residential Buildings: Evolution of Structural Vulnerability on Caribbean Island of Saint Martin after Hurricane Irma

Article

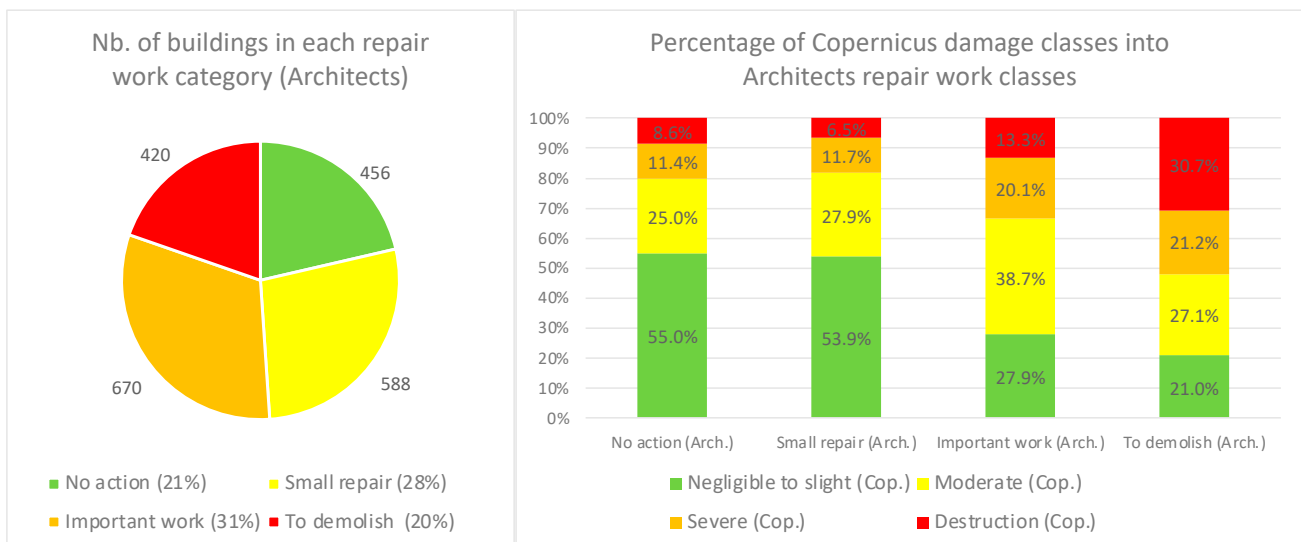
Figure 2. Synthesis of damage assessed by Moulin’s fieldwork (2018) [54] and comparison with that estimated by the satellite approach (Copernicus) [56].

A brief comparison of the average global damage calculated from the exhaustive Copernicus approach (13,163 structures) and that of the architects (2134 structures) shows a tendency for the satellite approach to underestimate damage (−20% approximately), confirmed by the more rigorous comparison of the 2134 common structures between the two approaches. A similar comparison, limited to 148 common structures, shows an underestimation of the average damage of around 27% for the drone approach and 36% for the satellite approach.

More in detail, while the most significant damage (destruction/to demolish) is more or less identical, it is the major damage (severe or moderate) that is underestimated by the satellite approach, in association with an overestimation of minor damage. An explanation for the overestimation of damage by architects is that damage is not assessed solely at the roof level. The expert’s assessment also considers damage to the lower parts of the building (openings, interior). A bias is therefore possible, due to the existence on Saint Martin of habitats that are sometimes very precarious and the absence of an inventory before Irma.

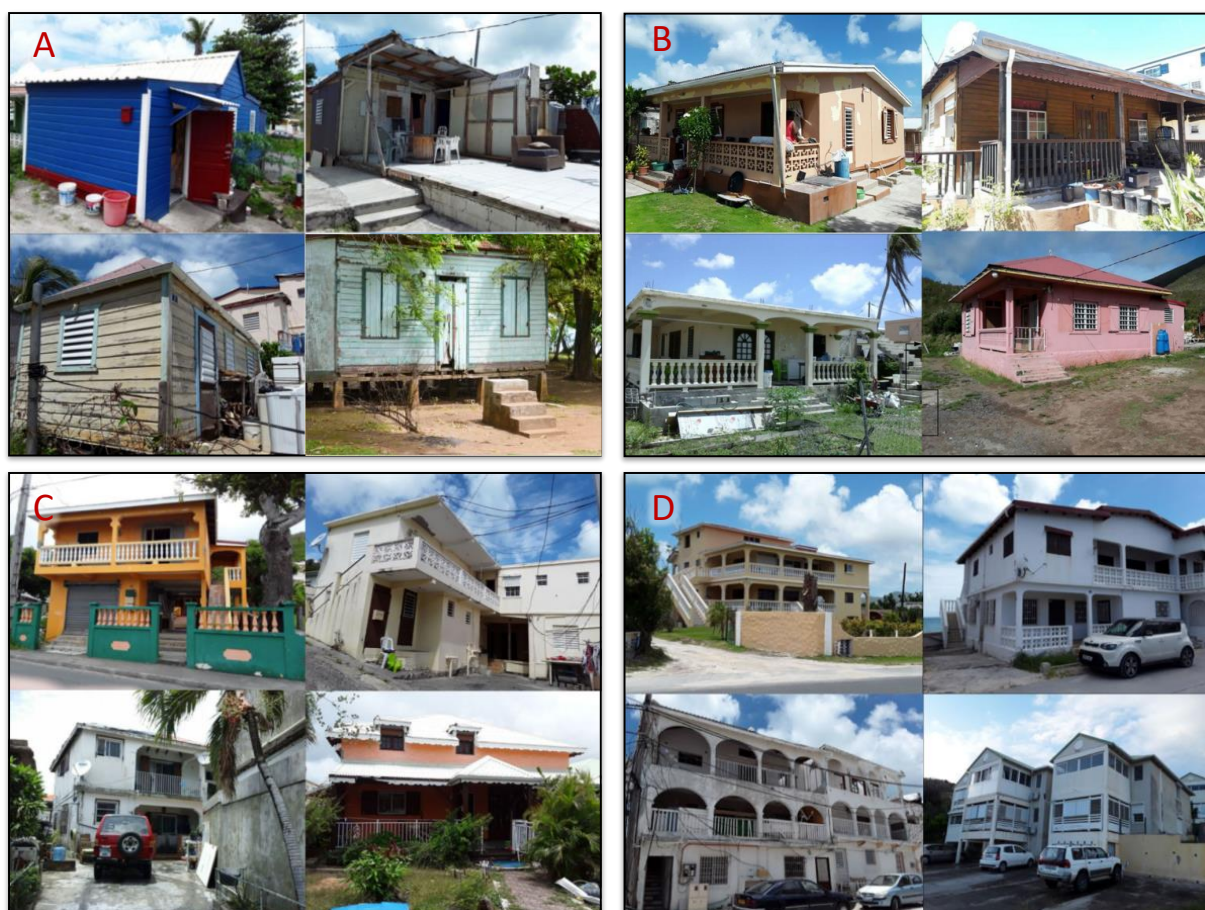
Figure 3. Different building types in St-Martin. (A): Individual dwelling without story, without masonry, in wood or sheet metal. (B): Detached single-story dwelling in masonry, stone, or reinforced concrete. (C): Individual dwelling with story(s) in masonry, stone, or reinforced concrete. (D): Collective housing in masonry, stone, or reinforced concrete.

different districts, different types of buildings, or between different building elements (roof, openings, structure, etc.). The four identified building types are presented in Figure 3.

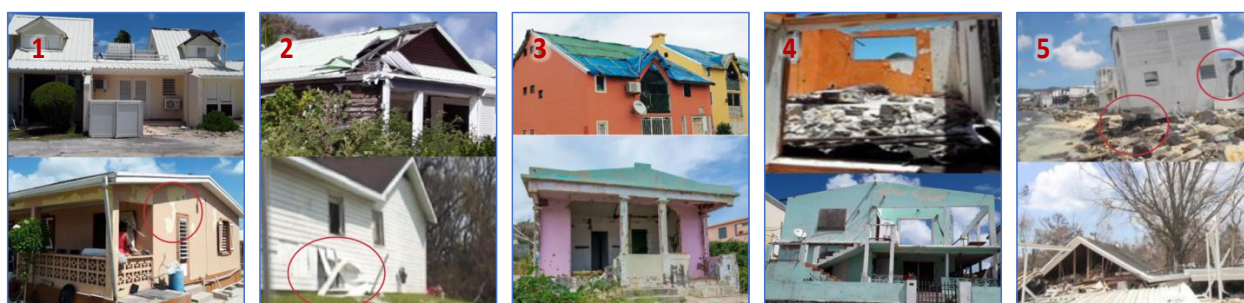
Figure 4. Different damage classes of residential buildings in St. Martin. **Classe 1.** No or limited damage (hardly visible from the outside/superficial damage to roof, windows, doors, or walls). **Classe 2.** Minor damage (roof affected in a few places, a few windows or doors broken/exterior walls partly in need of repair). **Classe 3.** Moderate damage (roof affected in many places, almost all windows or doors broken/cracks in walls are repairable). **Classe 4.** Severe damage (+50% of roof ripped off and structural damage/windows or doors completely broken/load-bearing walls severely damaged but not destroyed). **Classe 5.** Destroyed (foundations destroyed/roof structure and load-bearing walls totally destroyed).
