In situ ageing of a lime/cement-treated expansive clayey soil

Nicolas Chabrat^{1,2#}, Olivier Cuisinier¹, and Farimah Masrouri¹

ABSTRACT

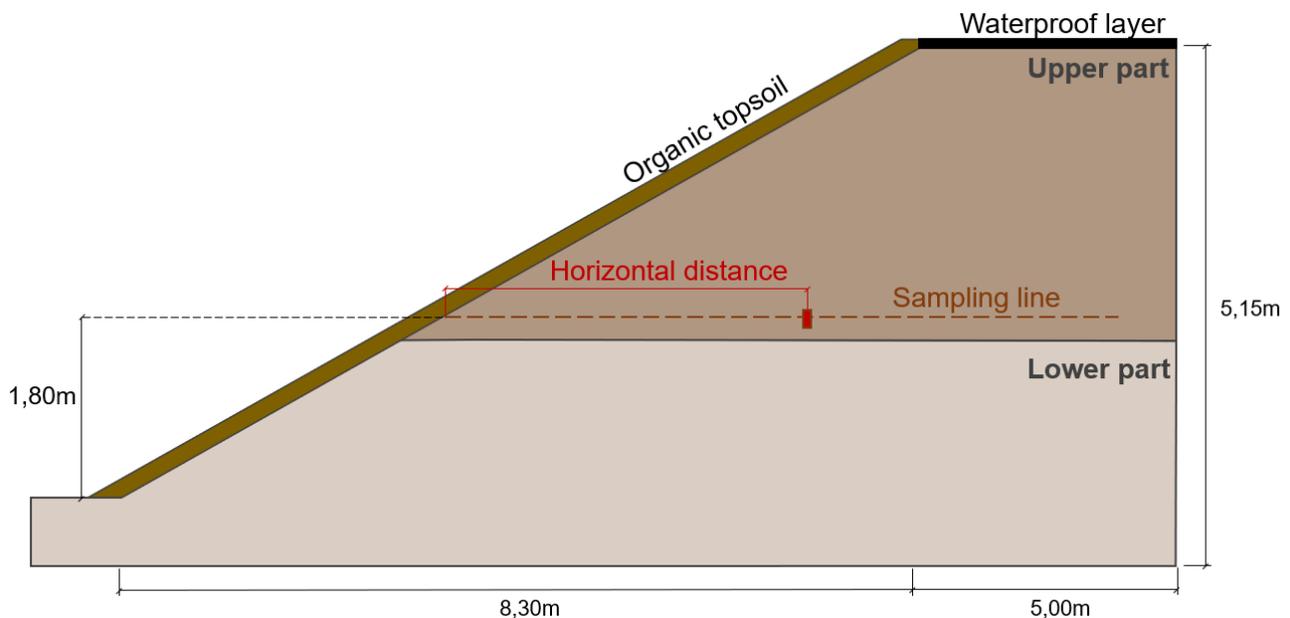
Figure 2. Core drilled zone in the upper and lower part of the embankment.

The embankment was constructed with the clayey soil presented before and is divided into 3 sections (Figure 1). For each section, the lower part (from 0.40 to 2.50 m of height) and the upper part (from 2.50 to 3.70 m of height) were built with different treatment mixes (Table 3). The base (from 0 to 0.40 m of height) and the top (from 3.70 to 5.15 m of height) of the embankment were erected with different treatments and are not considered in this article. The design method is presented in Froumentin's (2012) report. At the end of the construction, a waterproof layer made of asphalt emulsion was applied on the top of the structure. A layer of topsoil of approximately 0.10 m was also added to the edge of the earth structure. Finally, the embankment was constructed with an excess width of 1 m to the horizontal slope of the finished structure. This excess width has been removed at the end of the construction. This method limits potential compaction issues at the edge of the embankment.

The sampling campaign was carried out in November 2020. Figure 1 summarizes the different samples

collected during the operation. Horizontal coring was carried out in the upper part of the three sections, approximately 1.80 m above the natural ground level. Vertical coring was also performed in the three sections at the top of the embankment, allowing the sampling from the lower part of the embankment. Rotational coring with water as the drilling fluid was chosen to guarantee the quality of the samples. A mean recovery rate of 97% was achieved for the horizontal cores.

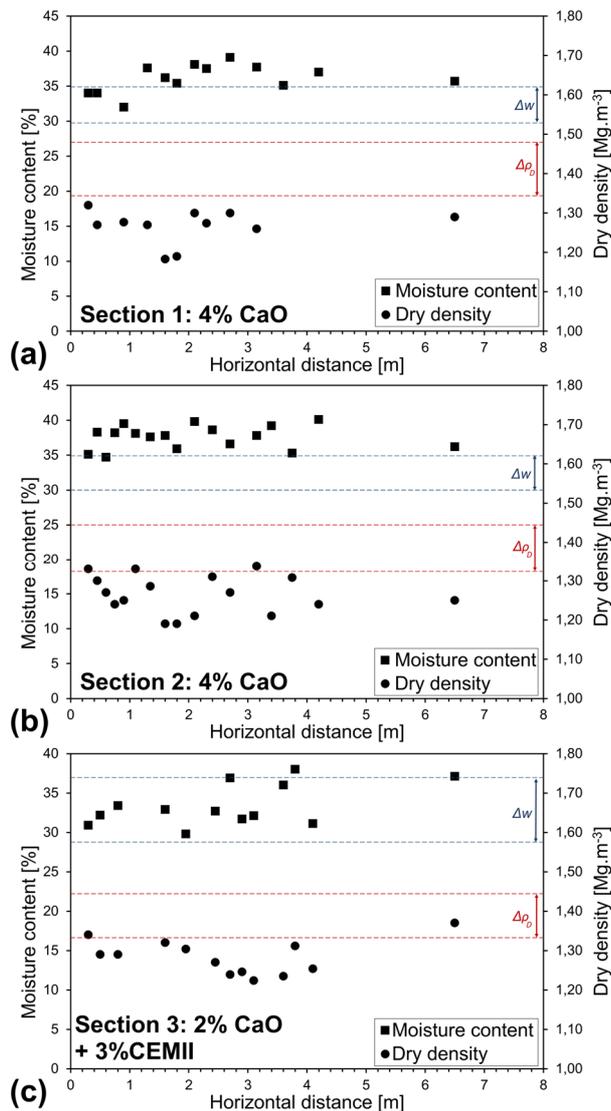
Figure 2. Moisture content and dry density evolution along the horizontal cores for section 1 treated with 4% lime (a), section 2 treated with 4% lime (b), and section 3 treated with 2% lime and 3% cement (c).

For section 1, the moisture content was comprised between 34% and 39% with a mean value of 36.1%. The lowest values of water content were found at low horizontal distances. The average dry density was found equal to 1.26 Mg.m⁻³. In section 2, the average dry density was also 1.26 Mg.m⁻³ while the average moisture content was 37.5%. Moisture contents and dry densities along the sampling line were also measured for the third section treated with 2% of lime and 3% of cement. The mean value of the moisture content was 33.4%, while the average dry density was found at 1.29 Mg.m⁻³. The density and moisture content found in section 3 were slightly different from the other sections, as the optimum moisture content depends on the treatment dosage.

Identification tests were first carried out along the horizontal axis at 1.80 m height (Figure 1) to assess the current state of the embankment. For each section of the backfill, the moisture content and the dry density of the soil are plotted in Figure 2.

Moisture content presented in Figure 2 can be compared to the one measured at construction time (Table 4). Moisture content values from all sections slightly increased since construction time: from 33.0% to 36.1% for section 1, from 35.0% to 37.5% for section 2

and from 32.8% to 33.4% for section 3. The edge of the backfill was however slightly drier than the inner part of the backfill (Figure 2). These results tend to indicate that the moisture content of the backfill has not significantly changed since the time of construction. Besides, moisture content values suggest that the soil was not impacted by the water used for drilling. These results are in line with the data collected by the in-situ sensors and presented by Bicalho et al. (2015). Continuous monitoring over a year indicated that the volumetric water content measured at 0.50 m of horizontal distance could vary from 0 to 1.5%. On the other hand, moisture sensors installed in the core of the embankment (at 4.50 m of horizontal distance) did not detect relevant variations of volumetric water content. Thus, the compaction parameters of the soil remained nearly unchanged over the years, except for the edge of the embankment where the soil is most exposed to atmosphere interactions. This confirms that the impact of climatic conditions on moisture content is limited to the first tens of centimeters of the embankment.

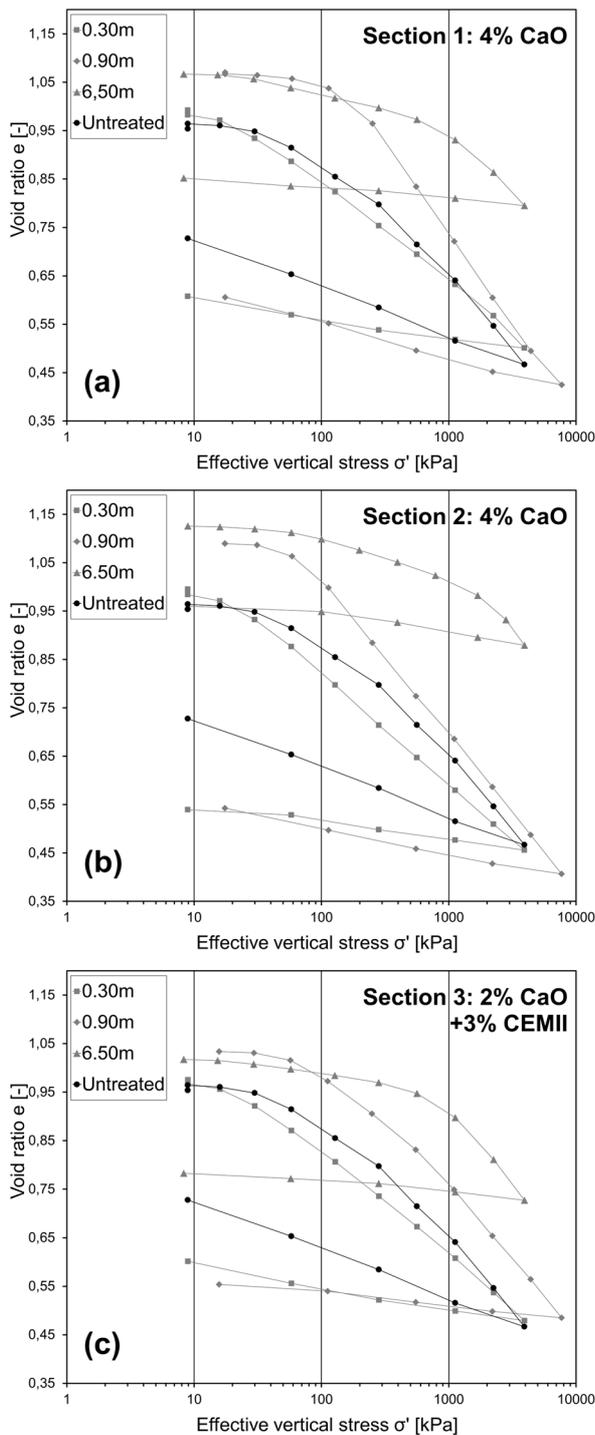
Up to 17 oedometer tests were performed in each section. Examples of the compressibility curves obtained from each section are plotted in Figure 3. The yield stresses determined in each oedometer test are shown in Figure 4. The results of these tests were compared to the curve obtained from the specimen taken from the untreated part of the backfill (lower part of section 1). The yield stress determined at the edge of the backfill in section 1 was equal to about 20 kPa. The compression curve of this specimen is very close to the one obtained with the untreated sample (Figure 3); the yield stress determined from both curves is of the same order of magnitude. The swelling index C_s of the two specimens were also very close. The results showed that the yield stress of the sample taken at the center of the backfill exhibited a yield stress of about 1000 kPa, significantly larger than the one determined on the sample taken at the edge. Figure 4a shows that there is a progressive increase of the yield stress from the surface up to about 2.70 m, the yield stress remaining stable between 2.70 m and the inner part of the backfill.

The analysis of the oedometer tests carried out in section 2, also treated with 4% lime, are plotted in Figure 3b and Figure 4b. At 0.30 m from the surface, the yield stress was slightly lower than the yield stress of the untreated specimen compacted at the optimum moisture content. This might be related to the initial void ratio of the treated sample that was lower than the one of the untreated sample. The yield stress progressively increased up to about 1200 kPa at 2.40 m from the surface. Between 2.40 and 6.50 m from the surface, the yield stress remained almost constant and higher than 1000 kPa.

A similar trend was observed in section 3. On the edge, the yield stress of the specimen was equivalent to the one of the untreated soil and equal to 20 kPa (Figure 3c). The yield stress gradually increased until a distance of 2.00 m from the surface. After that, it remained significantly higher than the yield stress of the untreated soil, even if the scattering of the data is greater compared to the results obtained in the first two sections.

Figure 3. Compression curves of specimens taken from various horizontal distances for section 1 treated with 4% lime (a), section 2 treated with 4% lime (b), and section 3 treated with 2% lime and 3% cement (c).

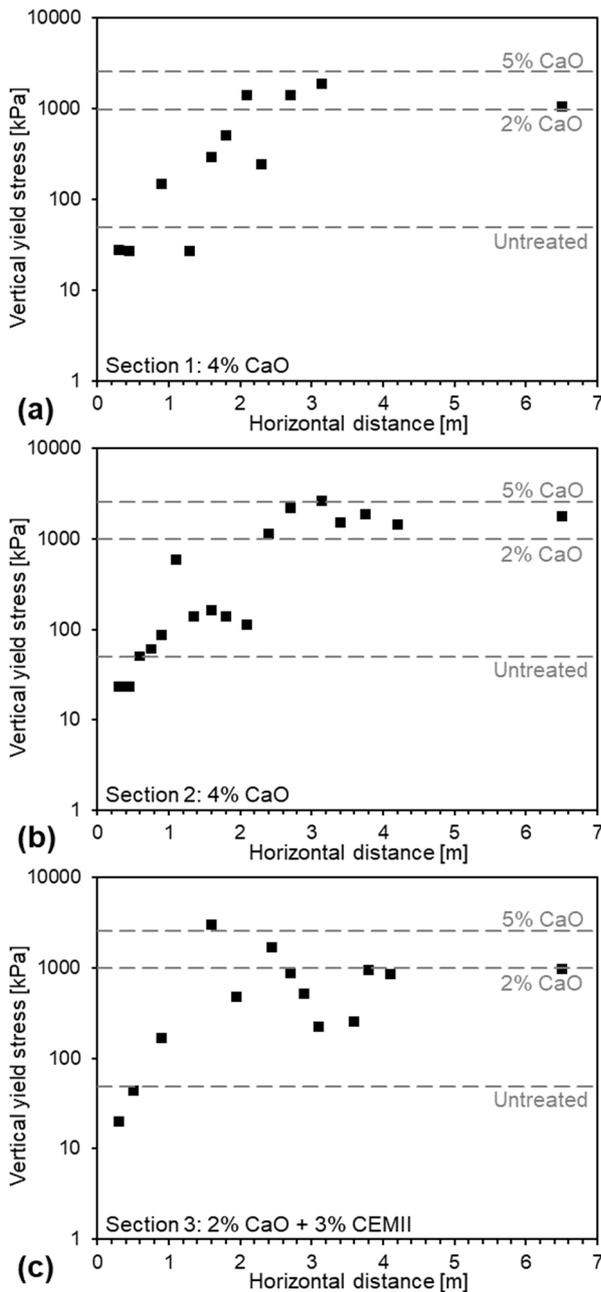
Figure 4. Yield stress of specimens taken from various horizontal distances of the three different sections and compared to the yield stress of the untreated clayey soil, and to the yield stress of specimens treated in laboratory at 2% and 5% lime.

In all sections, the three series of oedometer tests showed a progressive increase of the yield stress from the surface until about 2.50 m towards the inner part of the backfill. Beyond 2.50 m, the performance of the soil remained stable with values of yield stress higher than 1000 kPa. On the edge, the behaviour of the specimens is very close to the behaviour of the untreated soil. This indicates that the treatment is no longer impacting significantly the yield stress of the soil. Results obtained in section 1 and section 2, both treated with 4% lime, led to the same degradation of the edge of the embankment. This tends to confirm the repeatability of the tests performed. The yield stress of the soil treated with quicklime after 360 days of curing (at constant moisture content) was determined by Stoltz et al. (2014). It was equal to 3500 kPa with 5 % of quicklime and equal to 1200 kPa with 2 % of quicklime. These results demonstrate that both the yield stress of specimens from the inner part and the yield stress from treated specimens prepared and cured in laboratory have the same order of magnitude. It can be thus concluded that the treated soil was altered on the first two meters of the backfill, while the inner part performance is comparable to what has been observed after curing at constant moisture content in the laboratory.

The degradation that is observed on the outer part of the backfill can be partly explained by moisture content variations that are known to alter the behaviour of stabilised soils (Guney et al., 2007; Consoli et al., 2017; Liu et al., 2019). Indeed, the monitoring of the backfill showed that the moisture content variation was limited to the first tens of centimeters from the edge of the backfill (Bicalho et al., 2015). Freezing/thawing cycles over the years could have explained the degradation of the performances (Dempsey and Thompson, 1967; Consoli et al., 2017; Lu et al., 2020). However, *in situ* thermal sensors installed at 0.25 m from the surface did not evidence any temperature below 0°C (Bicalho et al., 2015). Other hydro-chemical processes like carbonation, temperature or water leaching could also have led to the degradations observed here, but complementary analyses are required to confirm their potential contribution.
