Real-time monitoring of snowmelt infiltration in steep permafrost-affected rock slopes using fluorescent dyes

Study site – Aiguille du Midi (3842 m a.s.l), Mont-Blanc massif, French Alps.

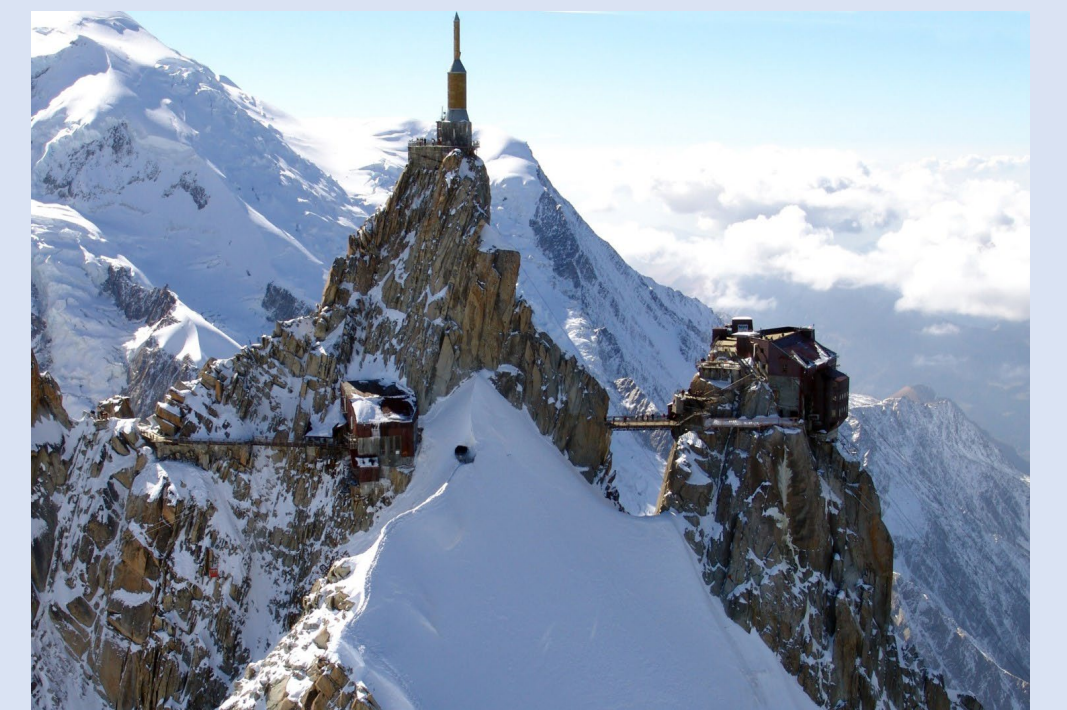
The Aiguille du Midi lies on the NW side of the Mont-Blanc Massif. Its summit consists of three granite peaks (North, Central. A tourist cable car runs from Chamonix to the north peak, where galleries and an elevator are carved in the rock mass, providing year-round access to the otherwise extreme and inaccessible environment.

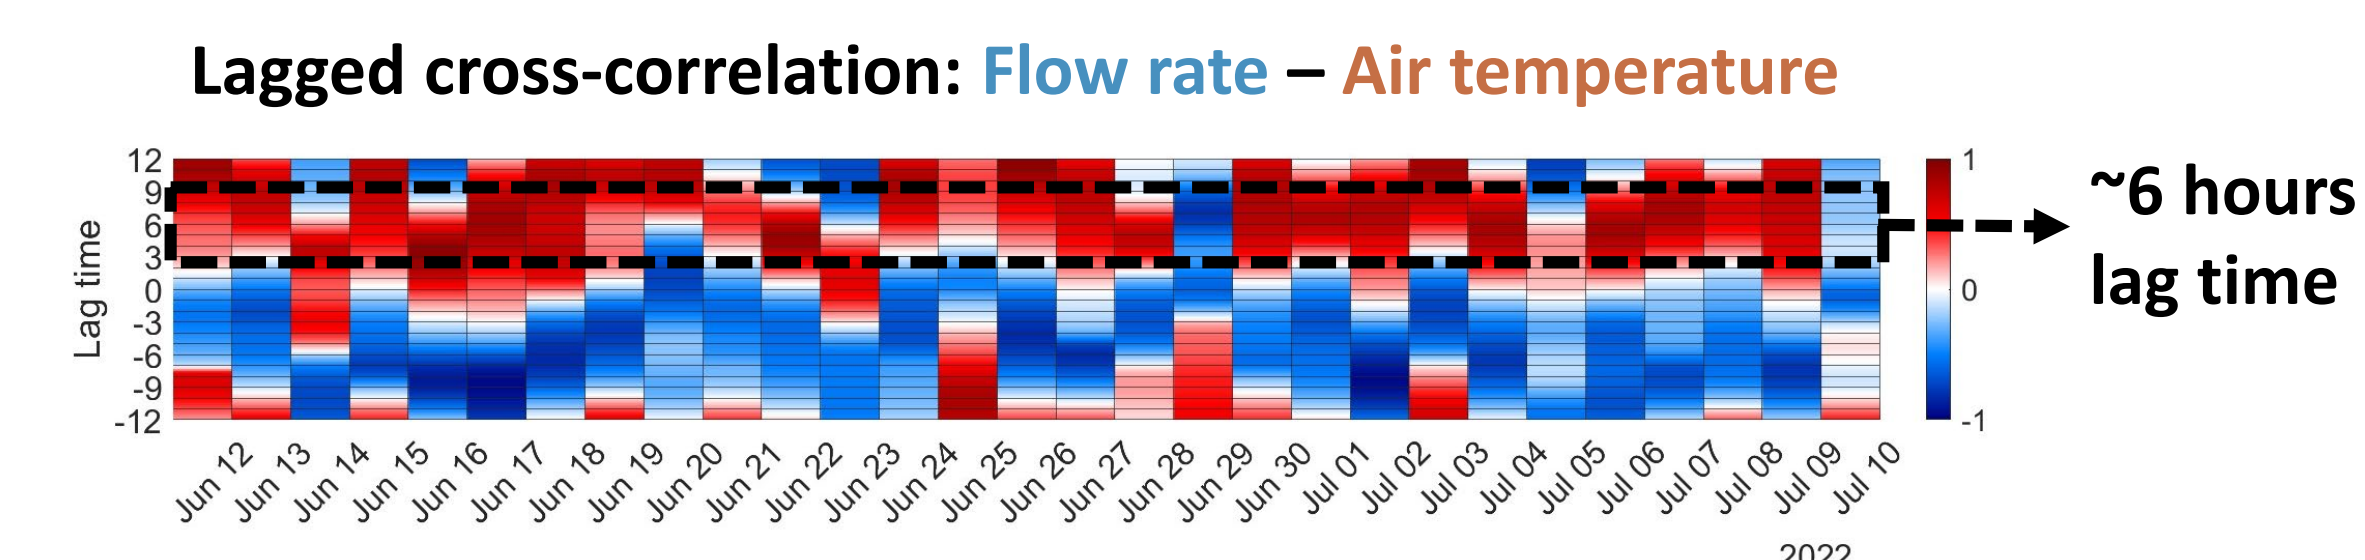
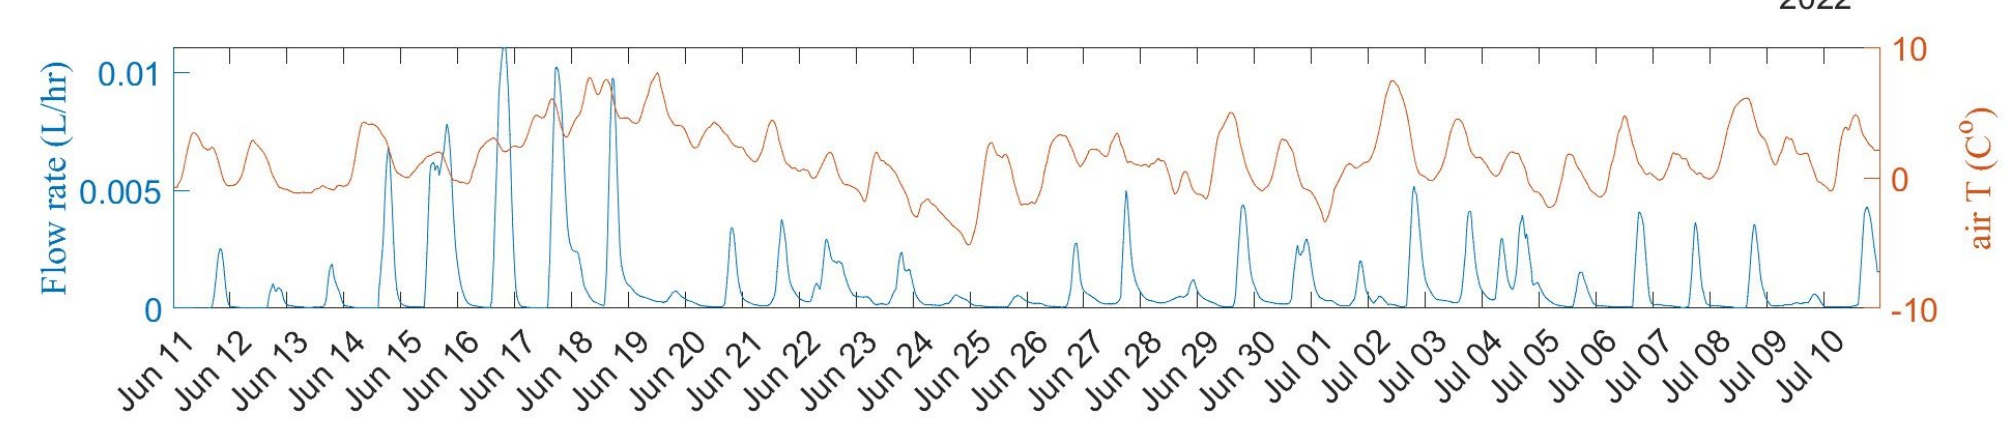
Lag time of peak water flow during the melt season

Lagged cross-correlations analysis show that peak water flow is lagged by ~6 hours after peak air temperature outside and by ~3 hours after peak rock surface temperatures

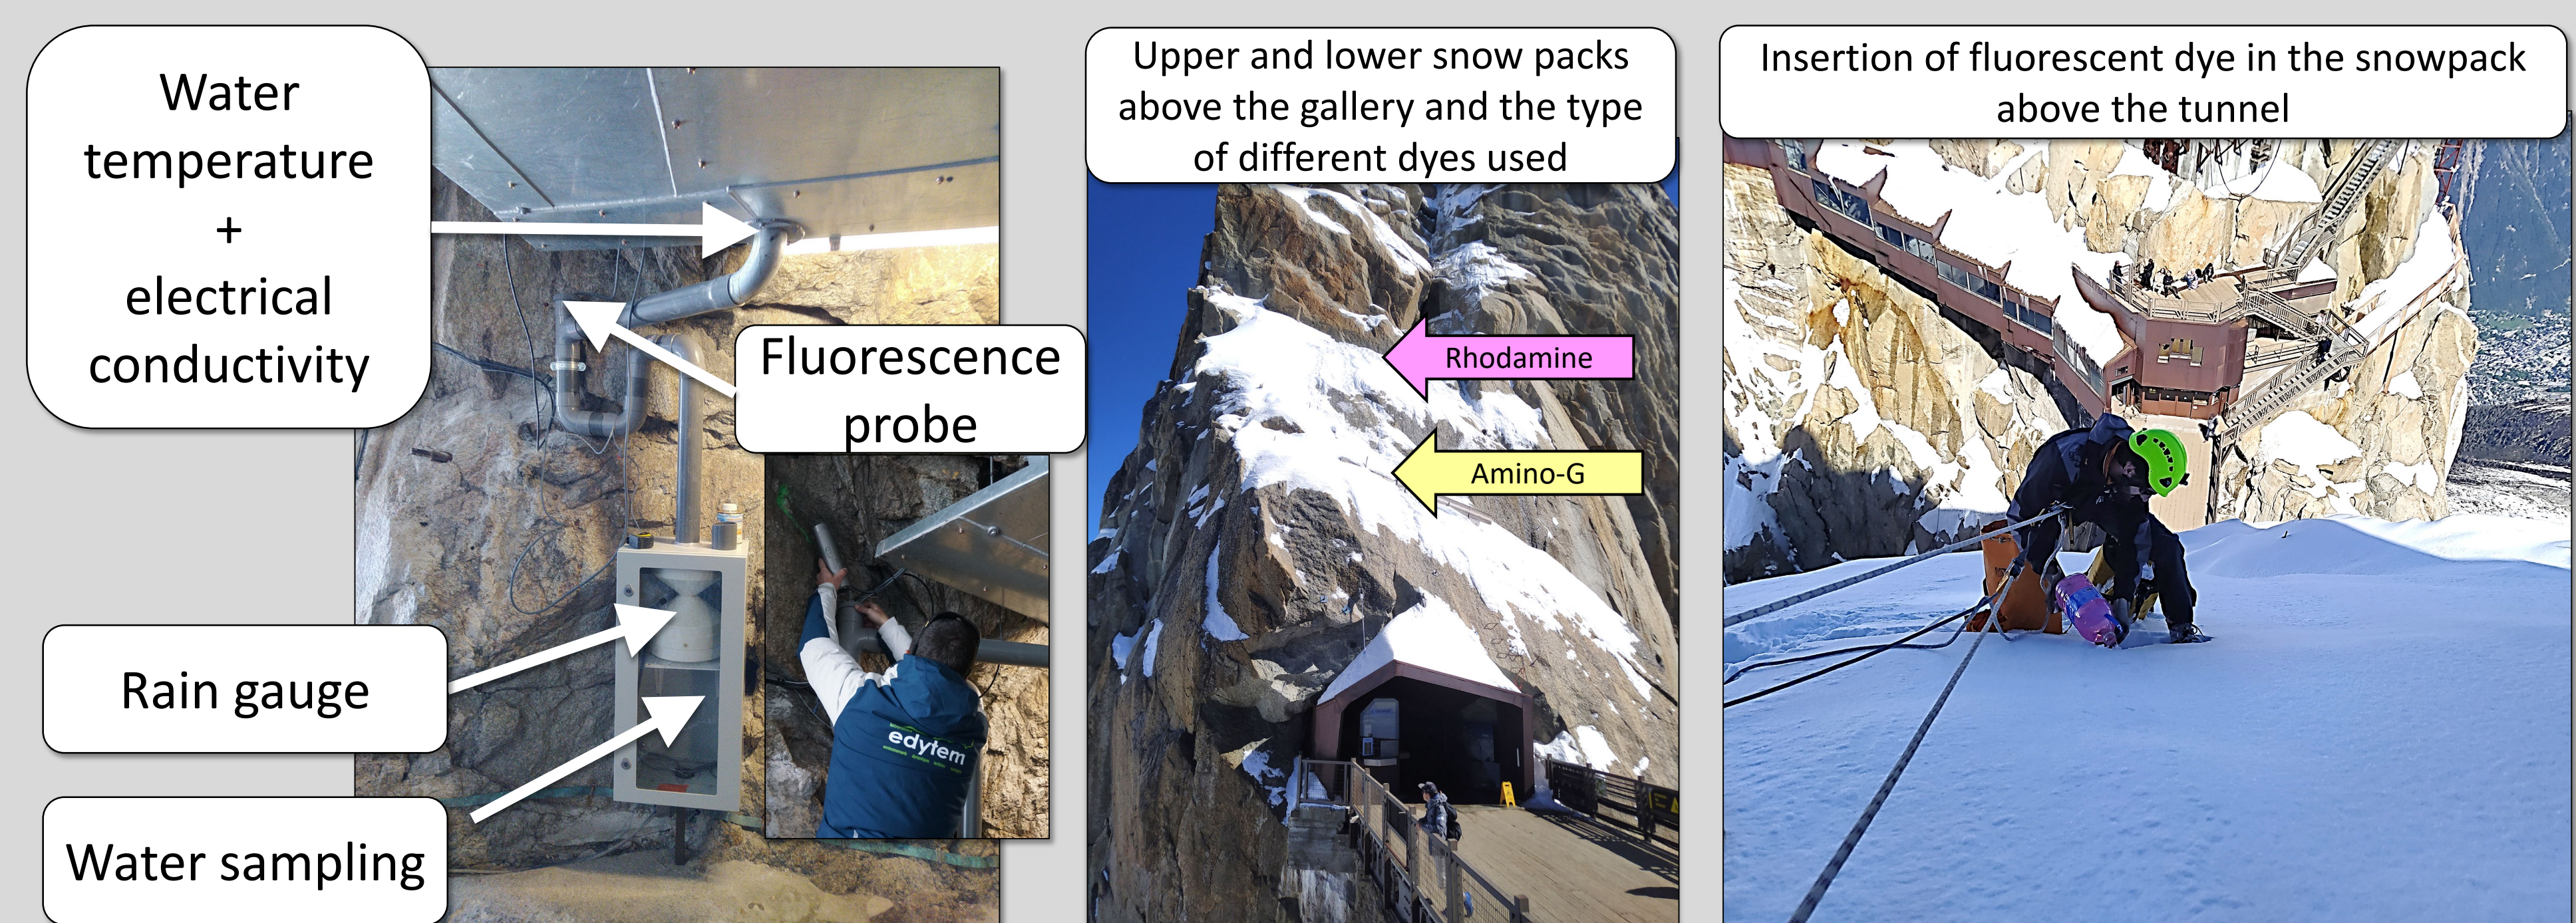
Experimental setup

- Real-time measurements of:
 - Flow rate in two locations
 - Water fluorescence
 - Water temperature
 - Water conductivity
- Rock surface temperature
- Water sampling for
 - Stable isotopes (¹⁸O/D)
 - Major elements
 - Fluorescence

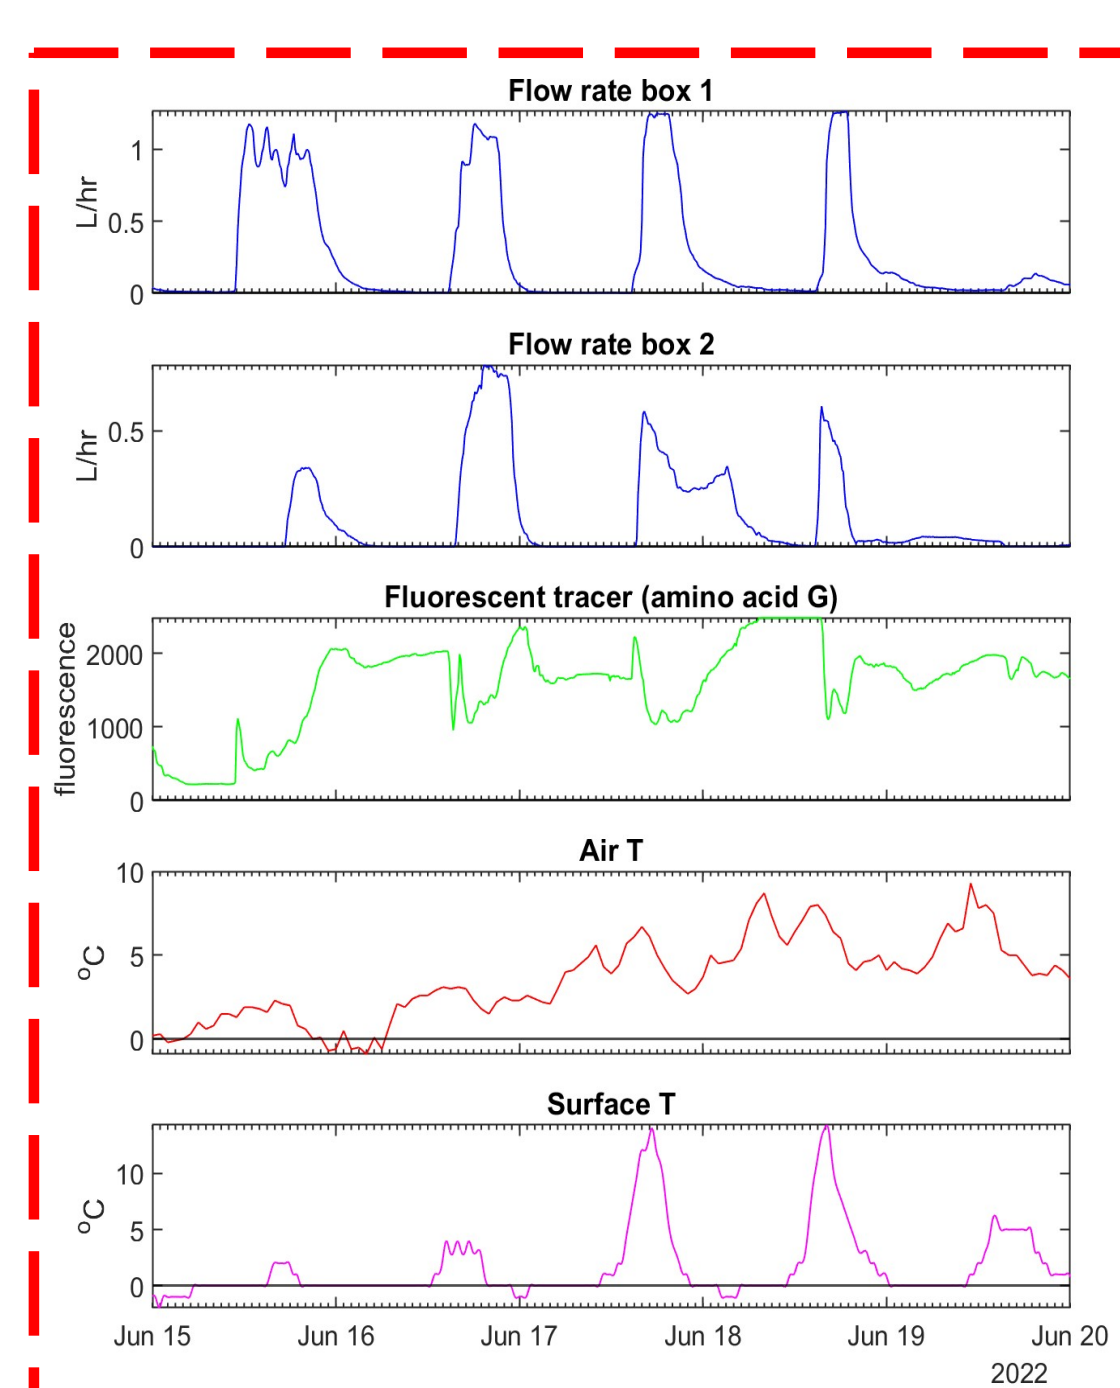
Diurnal changes

Diurnal fluctuations in flow rate range between <1 L/hour in the morning to >10 L/hour in the late afternoon, and correlate with oscillations in air and surface temperatures, with a 3-6 hours lag time, respectively

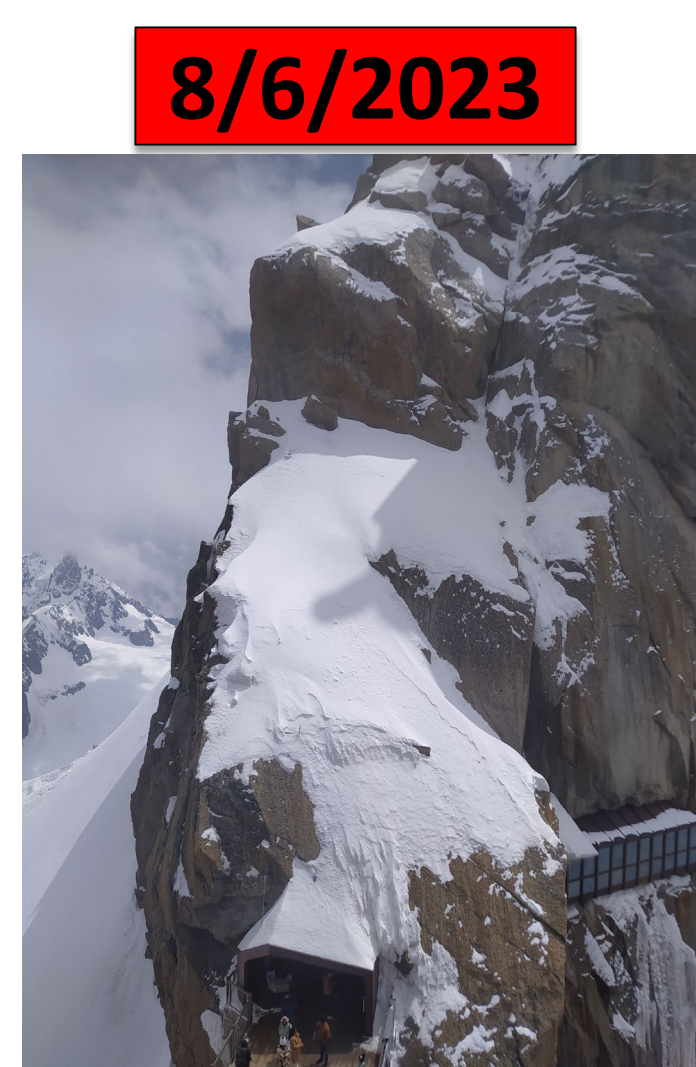
Comparison of June 2022 with 2023

June 2023 was significantly colder in comparison with June 2022 and with late snowfall – As of mid-June 2023 no flow documented
