Real-time monitoring of snowmelt infiltration in steep permafrost-affected rock slopes using fluorescent dyes

Real-time monitoring of snowmelt infiltration in steep permafrostaffected rock slopes using fluorescent dyes

Study site – Aiguille du Midi (3842 m a.s.l), Mont-Blanc massif, French Alps.

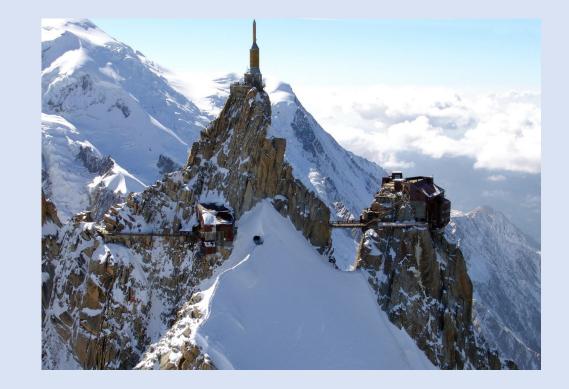
The Aiguille du Midi lies on the NW side of the Mont-Blanc Massif. Its summit consists of three granite peaks (North, Central. A tourist cable car

runs from Chamonix to the north peak, where galleries and an elevator are carved in the rock mass, providing year-round excess to the otherwise extreme and inaccessible environment.

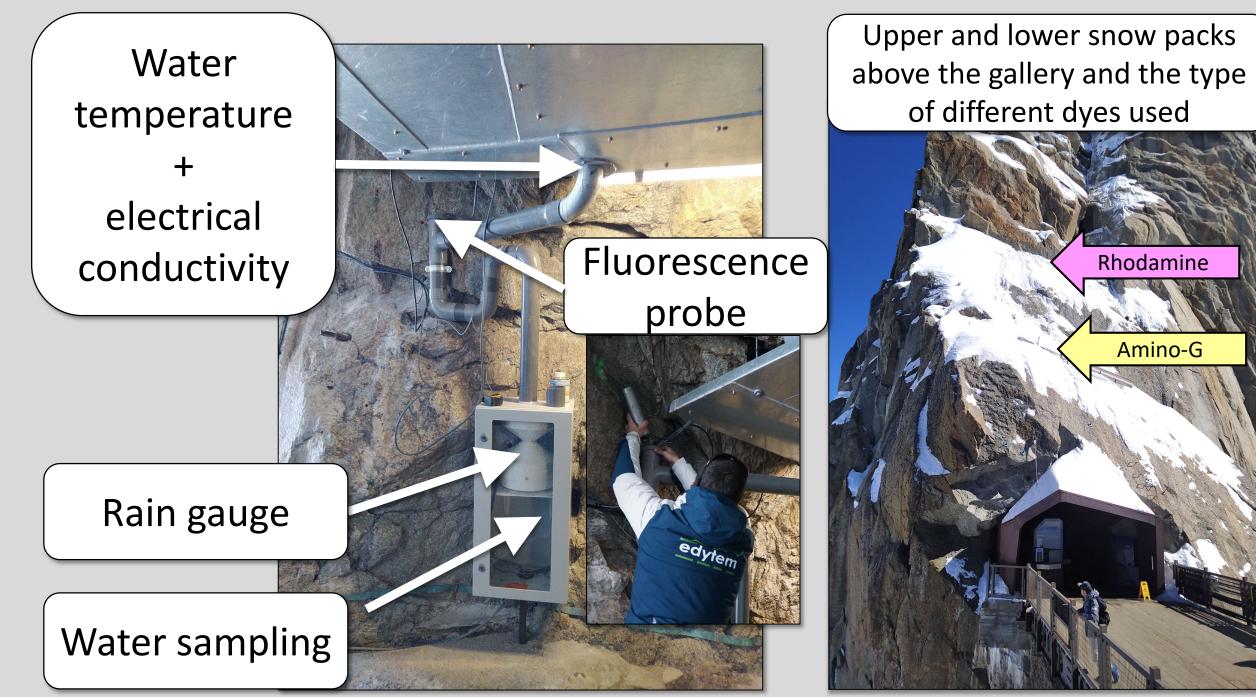
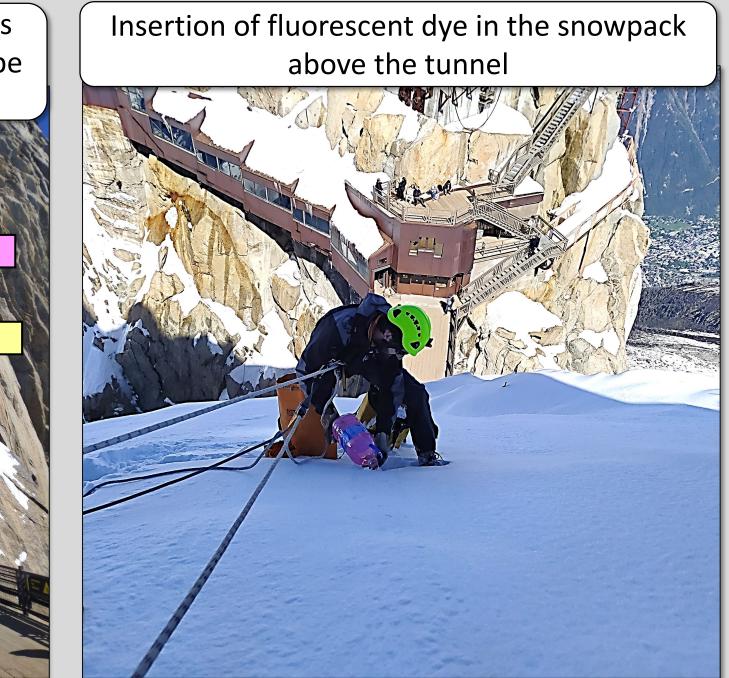
Experimental setup

- Real-time measurements of:
 - Flow rate in two locations
- Water fluorescence
- Water temperature
- Water conductivity
- Rock surface temperature
- Water sampling for
- \circ Stable isotopes (¹⁸O/D)
- Major elements
- Fluorescence

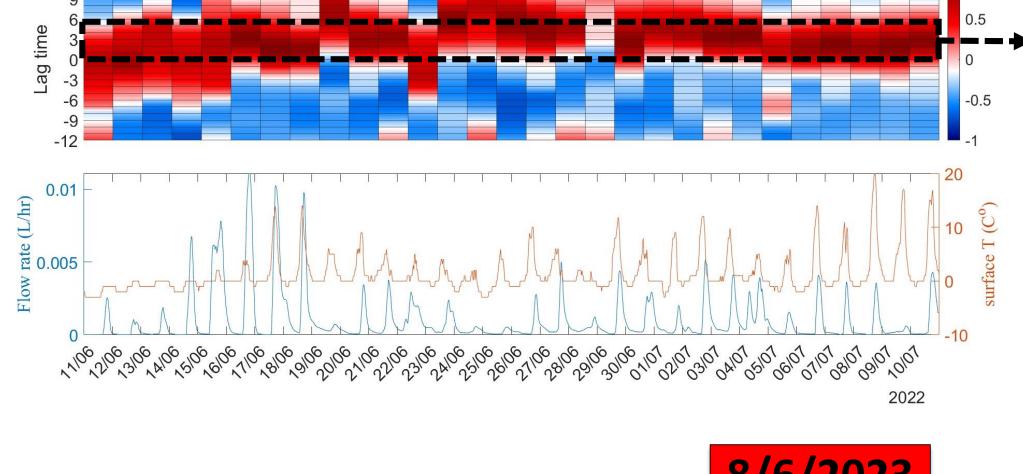
Real-time flow monitoring system

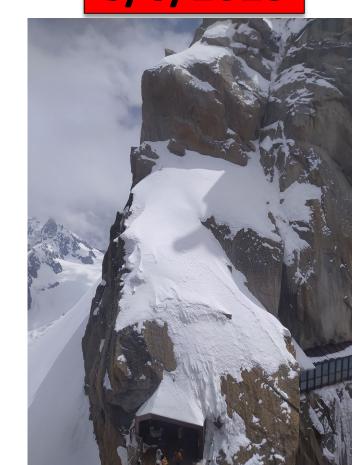
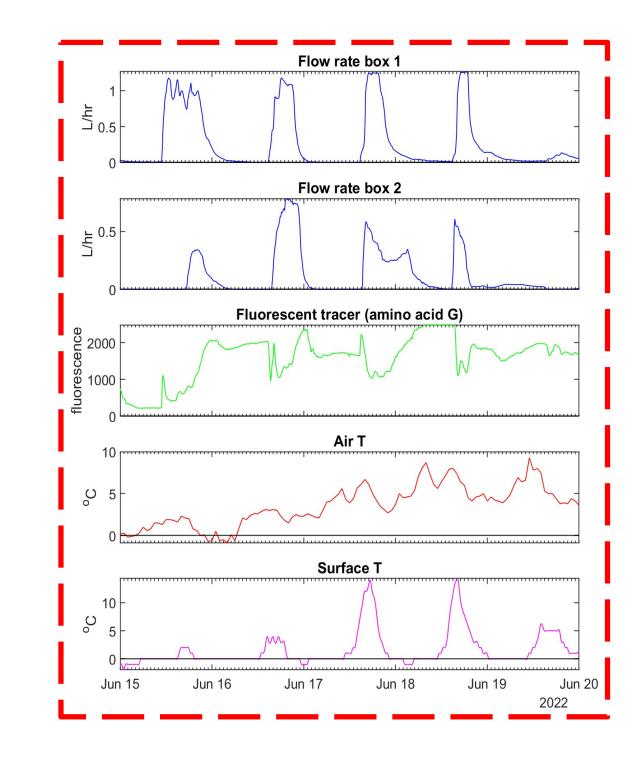
Comparison of June 2022 with 2023

2023 was significantly June colder comparison with in and with late snowfall – As of mid-June 2023 no flow documented

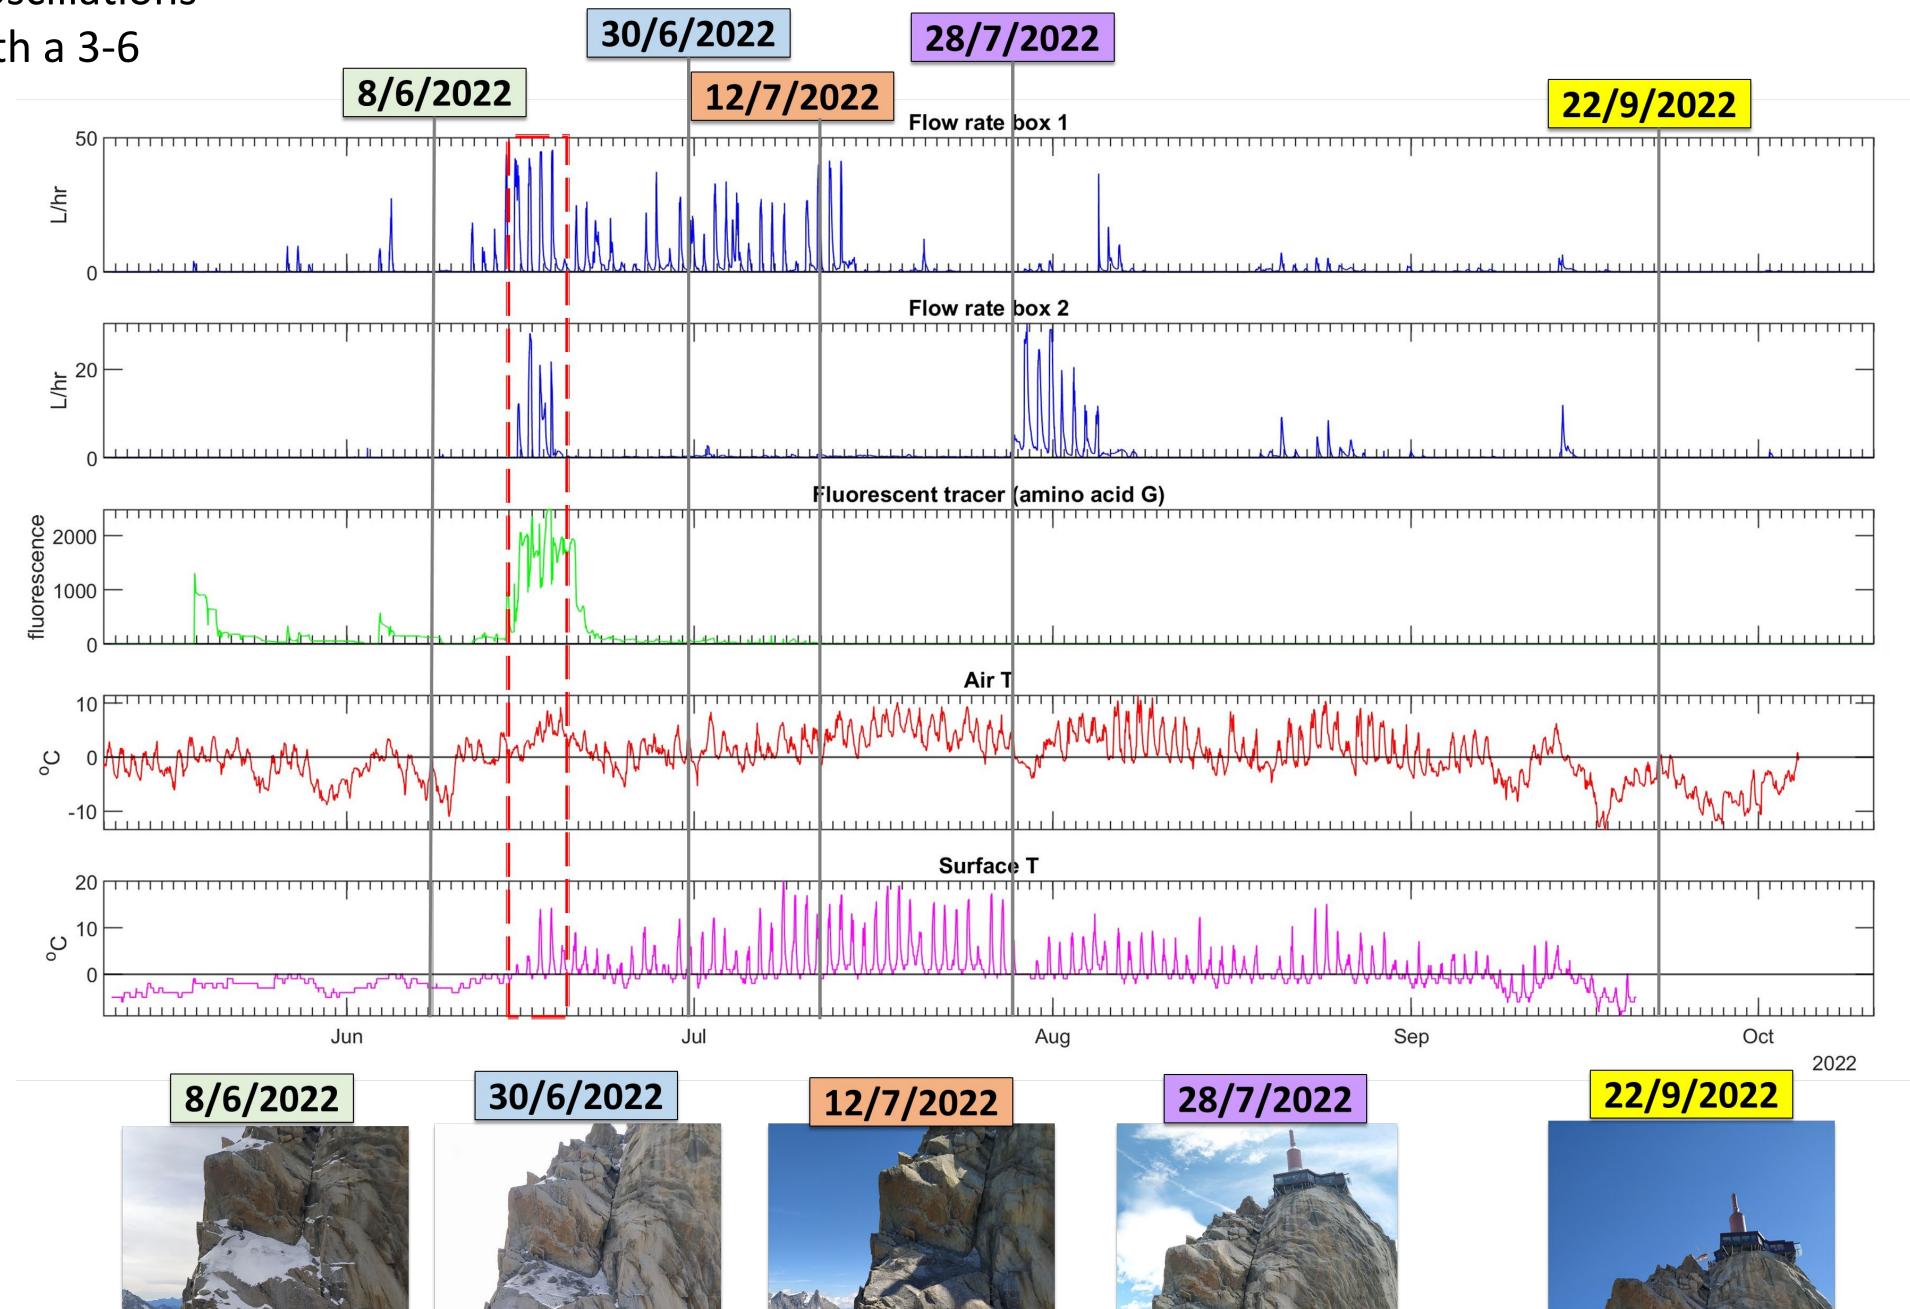
- The fluorescent tracer from the lower terrace was found in the water from the first flow events until mid-May and remained in the water until mid-June.
- The tracer from the upper terrace was never observed.
- Significant water continued for 3 weeks after the fluorescent tracer disappeared from the water.

- Flow continued after all snow cover was gone
- The two adjacent fractures show different flow regimes (box 1 and box 2).
- Initiation of continuous flow follows the heating of the rock surface and air temperatures above 0°C.
