## Real-time monitoring of snowmelt infiltration in steep permafrost-affected rock slopes using fluorescent dyes

Matan Ben-Asher, Florence Magnin, Jean-Yves Josnin, Josué Bock,  
Emmanuel Malet, Antoine Chabas, Marine Quiers, Amaël Poulain, Yves  
Perette

Matan Ben-Asher, Florence Magnin, Jean-Yves Josnin, Josué Bock, Emmanuel Malet, et al.. Real-time monitoring of snowmelt infiltration in steep permafrost-affected rock slopes using fluorescent dyes. 6th European Conference on Permafrost (EUCOP6), Jun 2023, Puigcerda, France. hal-04195991

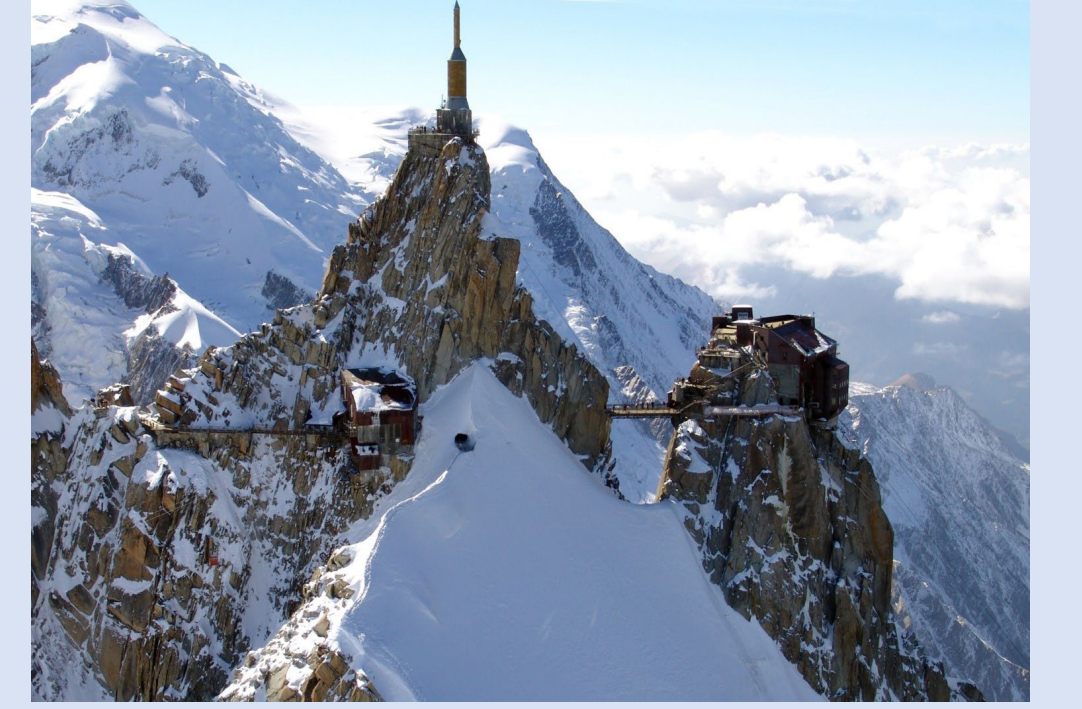
## Study site – Aiguille du Midi (3842 m a.s.l), Mont-Blanc massif, French Alps.

The Aiguille du Midi lies on the NW side of the Mont-Blanc Massif. Its summit consists of three granite peaks (North, Central. A tourist cable car runs from Chamonix to the north peak, where galleries and an elevator are carved in the rock mass, providing year-round access to the otherwise extreme and inaccessible environment.

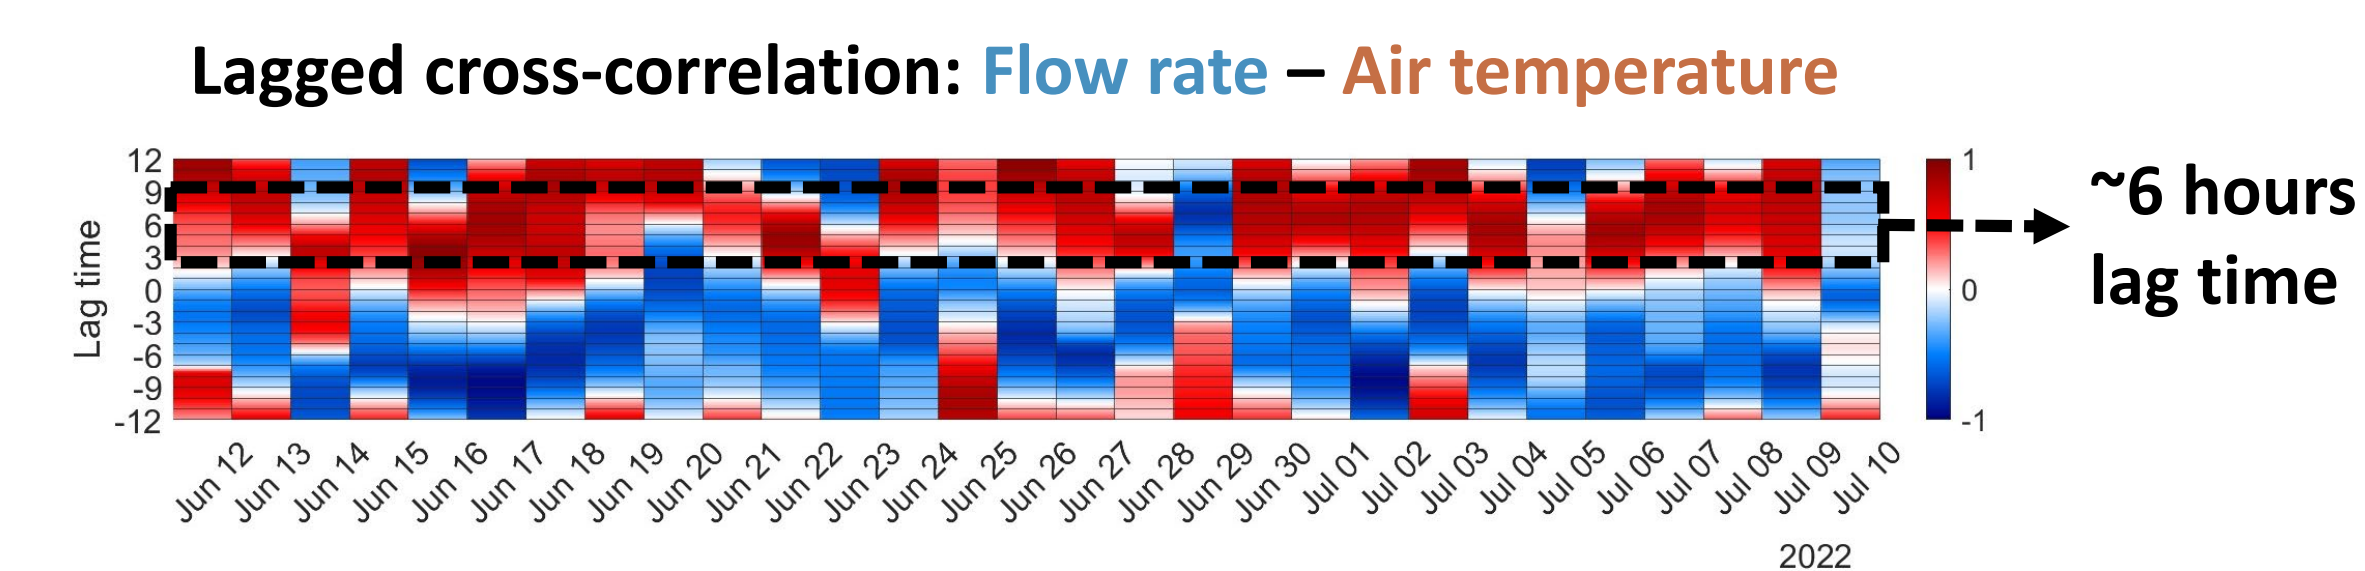
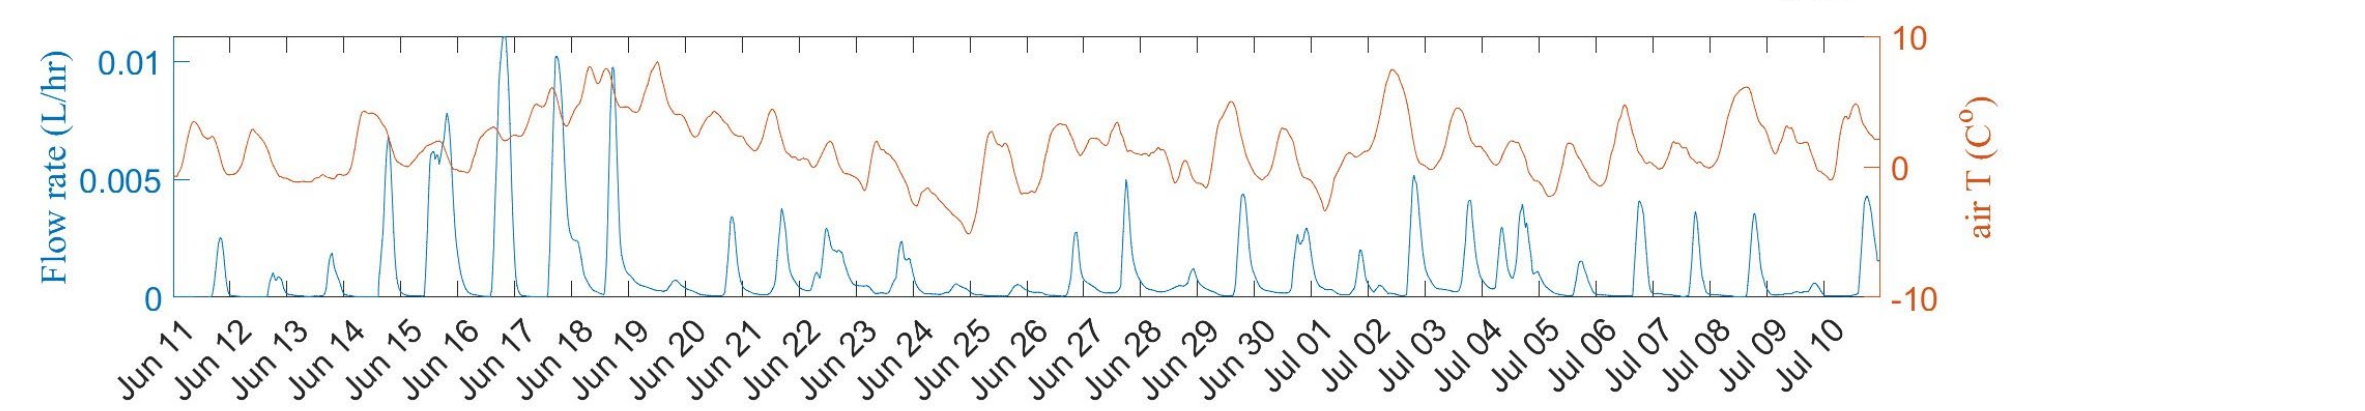
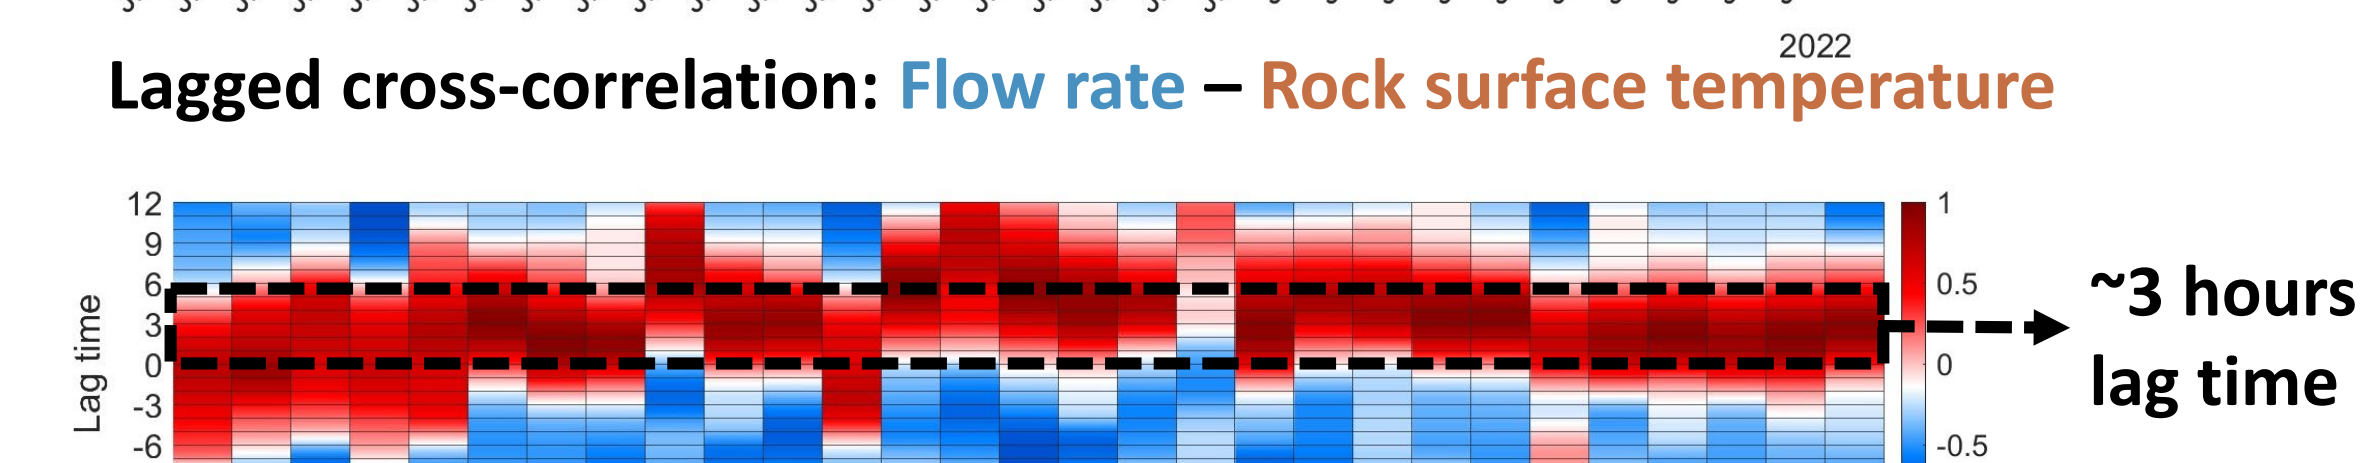
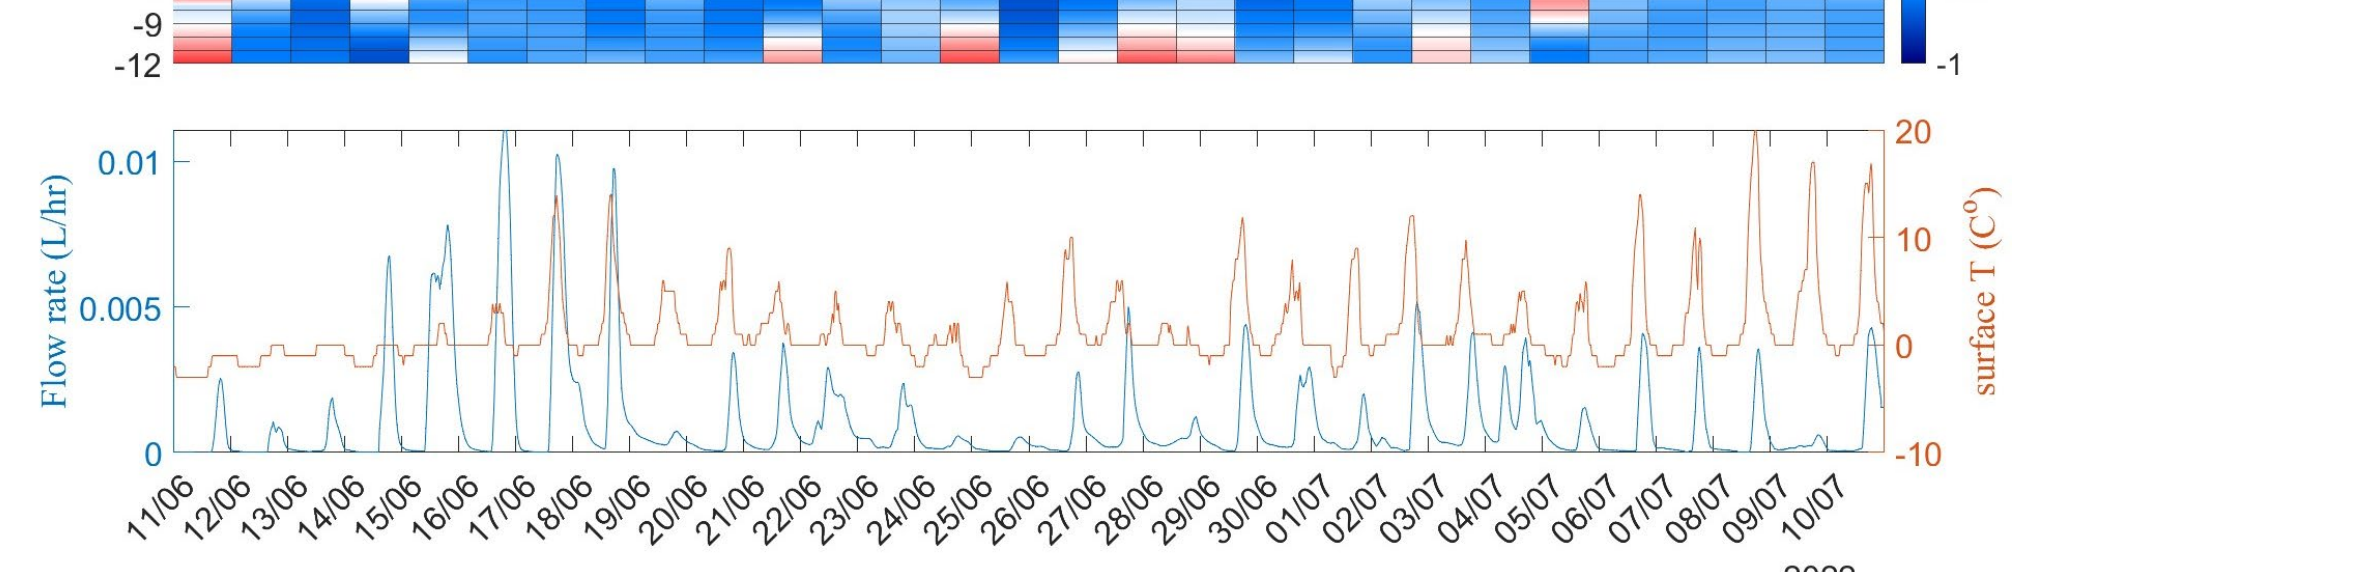
### Lag time of peak water flow during the melt season

Lagged cross-correlations analysis show that peak water flow is lagged by ~6 hours after peak air temperature outside and by ~3 hours after peak rock surface temperatures

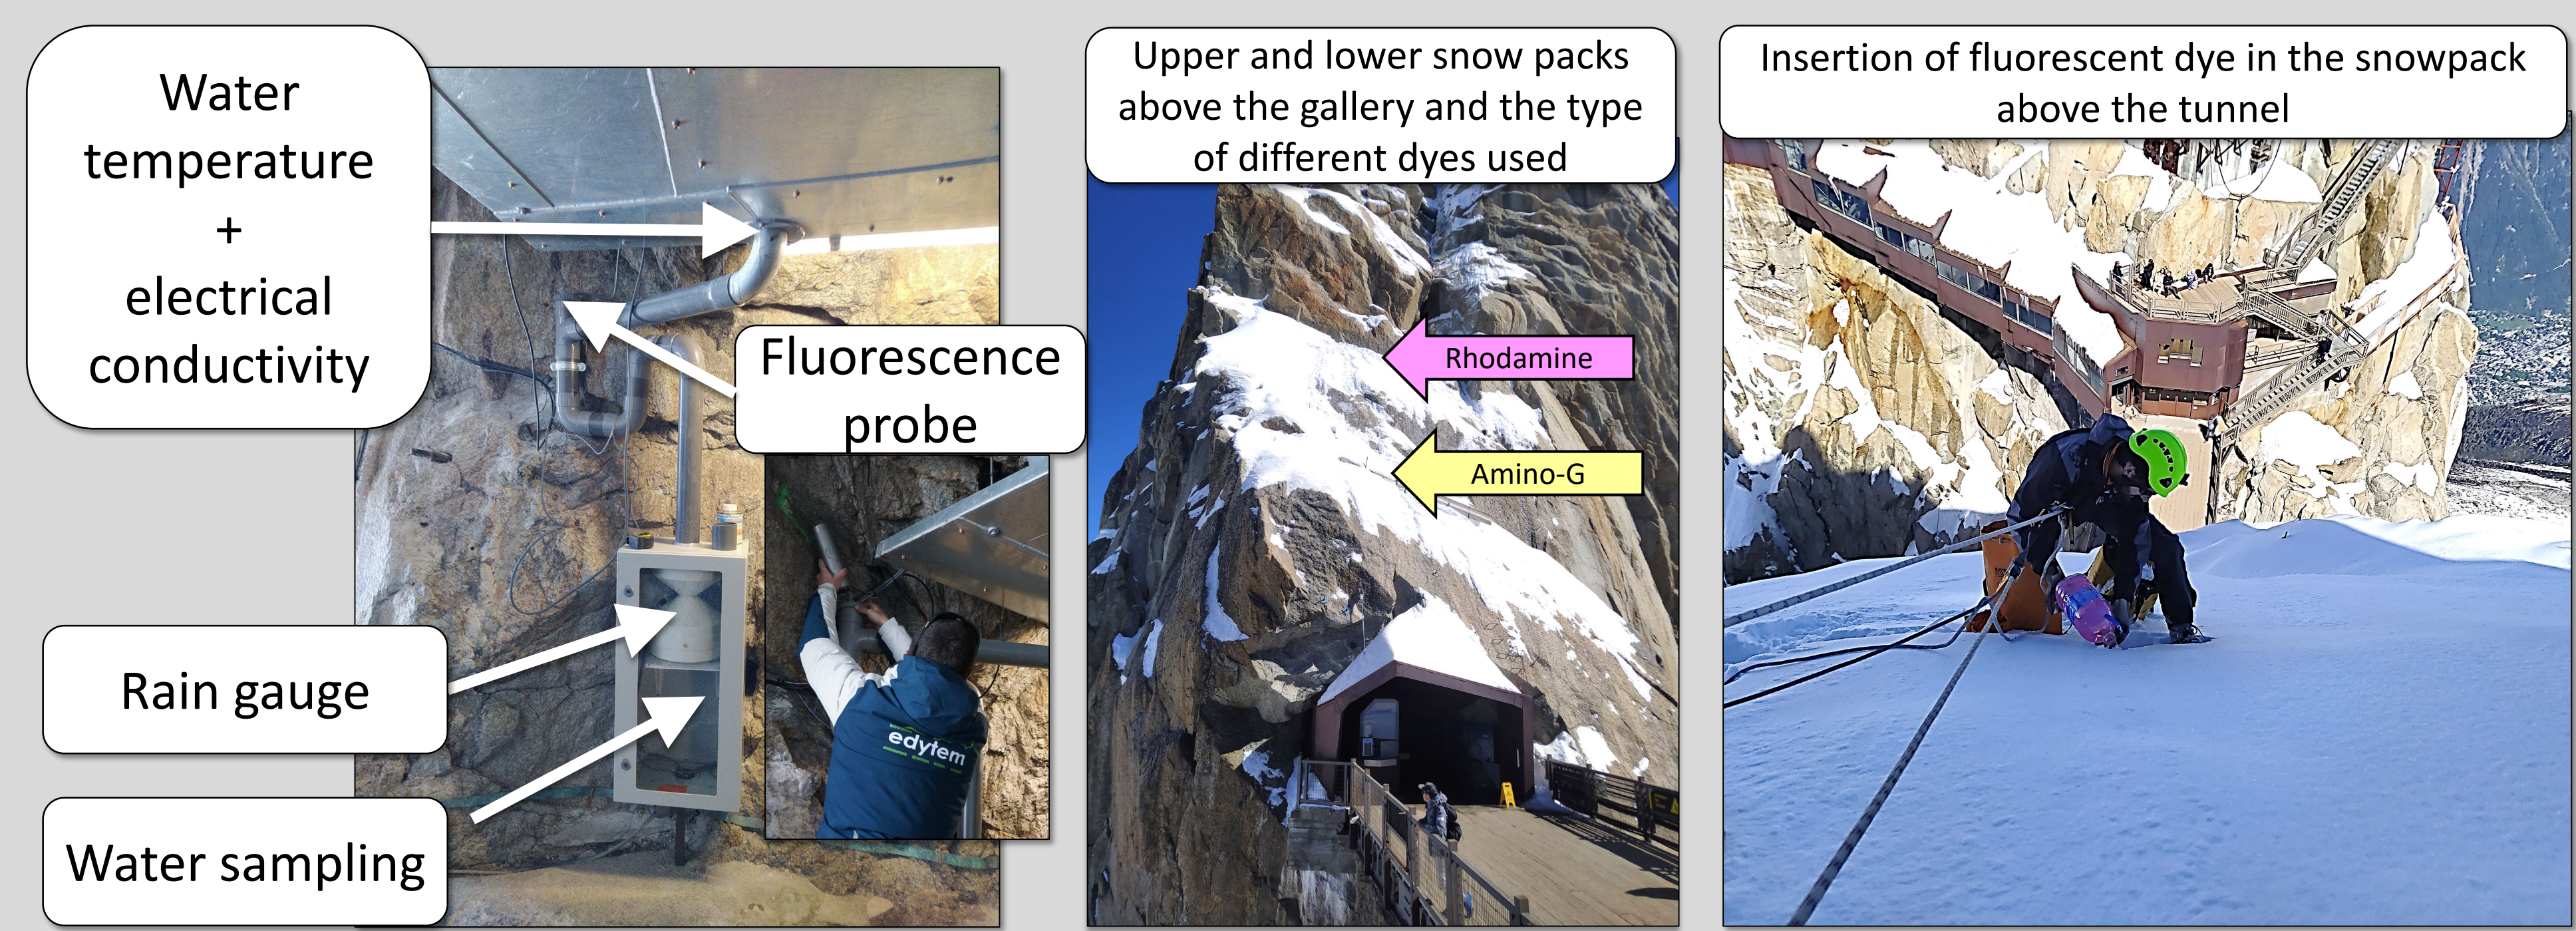
## Experimental setup

- Real-time measurements of:
  - Flow rate in two locations
  - Water fluorescence
  - Water temperature
  - Water conductivity
- Rock surface temperature
- Water sampling for
  - Stable isotopes (<sup>18</sup>O/D)
  - Major elements
  - Fluorescence
