Recommendation of RILEM TC 271-ASC: New accelerated test procedure for the assessment of resistance of natural stone and fired-clay brick units against salt crystallization

Keywords Recommendation · Salt crystallization test · RILEM TC 271-ASC · Sodium sulfate · Sodium chloride

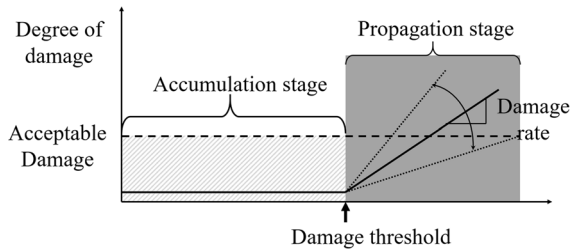
Fig. 1 Schematic representation of the durability of a stone or brick subjected to salt damage [3], adapted from the concept proposed by Tuutti [4] to describe the durability of reinforced concrete

The procedure involves a novel approach [3], that draws from literature on reinforced concrete durability [4]. It operates under the assumption that sufficient salt needs to accumulate in the pores (pore filling) to initiate damage. As a consequence, salt damage is regarded as a two-stage process: (i) in the accumulation stage, salts accumulate in the pores of the material (but the degree of pore filling is not yet sufficient to initiate damage); (ii) in the propagation stage, repeated salt dissolution/crystallization cycles cause damage to initiate and propagate (Fig. 1).

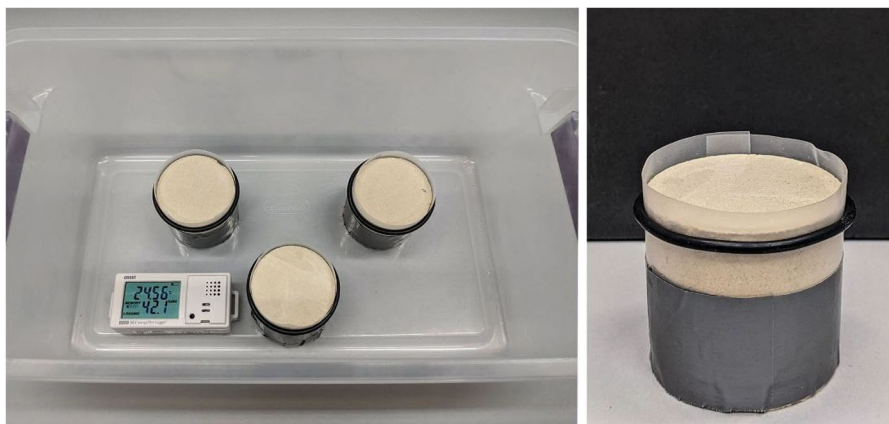
Fig. 2 Picture showing the specimens enclosed in a box with a T and RH sensor (left). Detail of a specimen (50 mm diameter and 50 mm height) sealed at the side with paraffin film, secured with tape and rubber O-ring (right)

The lateral surface of the specimens should be sealed with paraffin film, after pre-heating them in an oven at 50 °C for 10 min, to achieve better adherence. The paraffin film should extend 0.5 cm above the top surface of the specimens. A rubber O-ring should be used to secure good adhesion between the paraffin film and the uppermost area of the lateral surface of the specimen. Textile tape (water resistant and water vapour tight) can be used to secure the ends of the paraffin film and ensure sealing tightness during the entire test (Fig. 2).

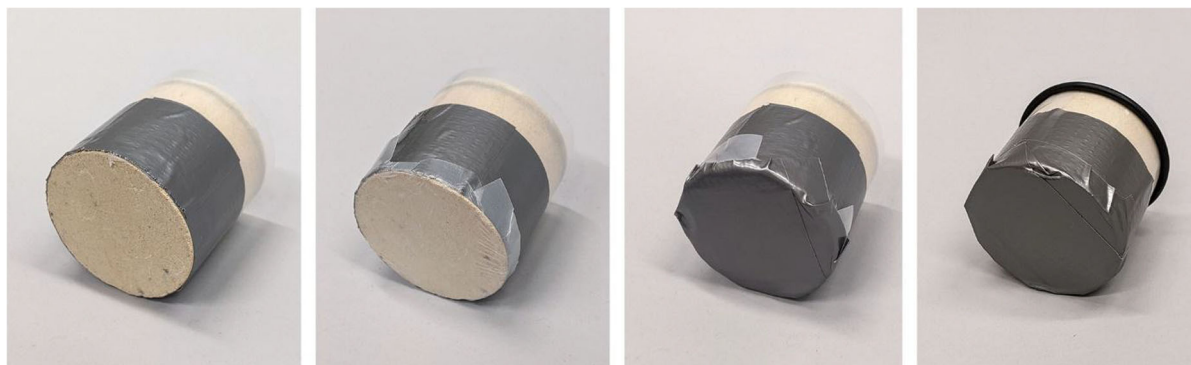
Fig. 3 Bottom of the specimen (left) is first sealed with paraffin film (middle) and then with textile tape to ensure perfect sealing (right)

Immediately after the full absorption of the salt solution, the bottom surface of the specimens is sealed by covering it with a first layer of paraffin film and a second layer of tape, as shown in Fig. 3. Afterwards, the specimens are weighed again, and their mass is recorded (m_s).

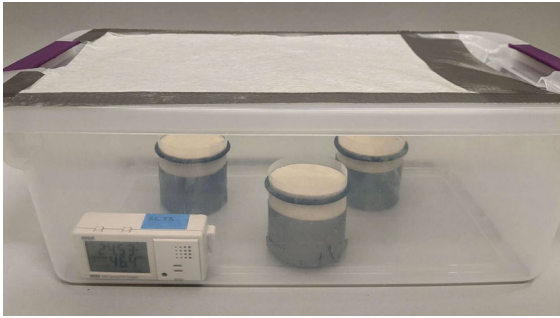
Fig. 4 Example of a box for storing the specimen during the test. The top of the box is closed with Japanese paper to allow for air exchange while limiting air velocity

test (Fig. 4). The distance between specimens and between these and the box walls should be at least 2 cm. The temperature and relative humidity in the box should be monitored with a sensor. The weight of each specimen should be recorded over time.

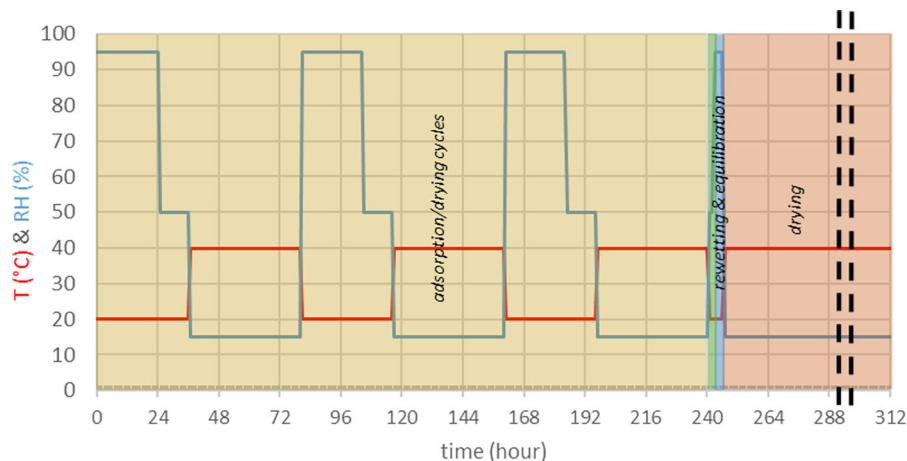
Fig. 5 Representation of a 3-week T and RH cycle of the propagation stage—NaCl test

The propagation stage consists of four 3-week cycles. Each of these cycles consists of 3 sub-cycles of temperature and relative humidity, plus one rewetting of the specimens with demineralized water through their bottom surface. More specifically, each 3-week cycle consists of (Fig. 5):

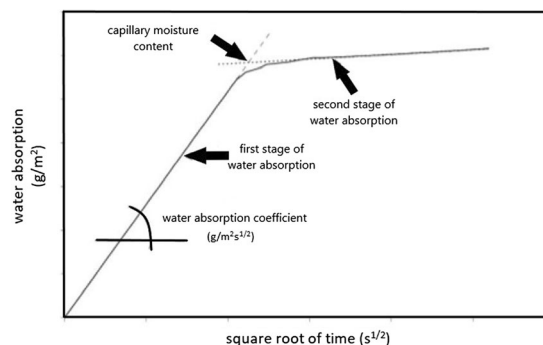
Fig. 7 Schematic of a typical water absorption by capillarity test result showing the point where the capillary moisture content of the material is determined

The capillary moisture content of the material must be determined first by performing the water absorption test according to EN 1925:1999 ("Determination of water absorption coefficient by capillarity" [7]). The capillary moisture content of the material is the mean water content at the end of the first stage of water absorption. It is determined as the point of intersection of straight lines drawn through the first and second stages of water absorption on a $t^{1/2}$ plot (Fig. 7).
