THE NEW RILEM TC 271-ASC RECOMMENDATION FOR THE DURABILITY ASSESSMENT OF POROUS BUILDING MATERIALS AGAINST SALT CRYSTALLIZATION

D. Gulotta¹ and RILEM TC 271-ASC members²

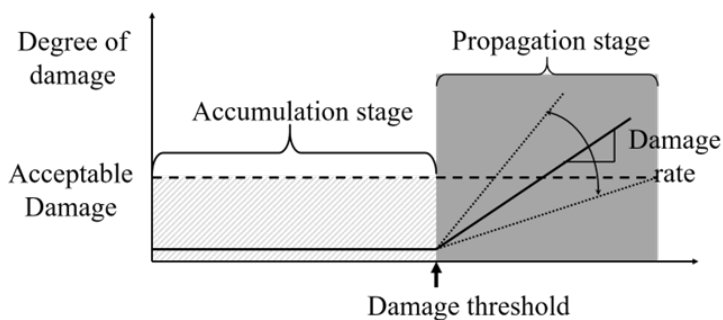
Figure 1: Two-step damage development of stone/brick substrates due to salt crystallization (from [1])

Building on the experience of reinforced concrete durability research, the TC has explored the feasibility of a two-stage approach (Fig. 1) to trigger damage development and progression, only after a certain degree of pore filling – as a result of salt accumulation – is reached.

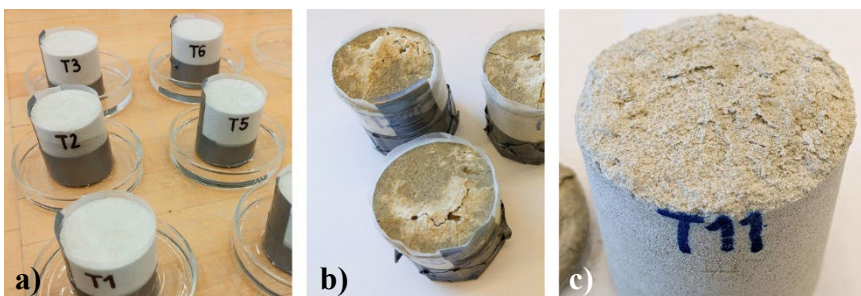
Figure 2: Photographic documentation of stone specimens (Tuffeau limestone) during the accumulation phase (a), after two propagation cycles (b), and at the end of the accelerated aging procedure (c).

The new procedure translates this theoretical assumption into two distinct testing phases: a preliminary salt accumulation phase, during which the porous substrate is contaminated with a salt solution with fixed concentration and capillary transport promotes its accumulation close to the evaporation surface without causing visible damage, followed by a propagation phase (Fig. 2).

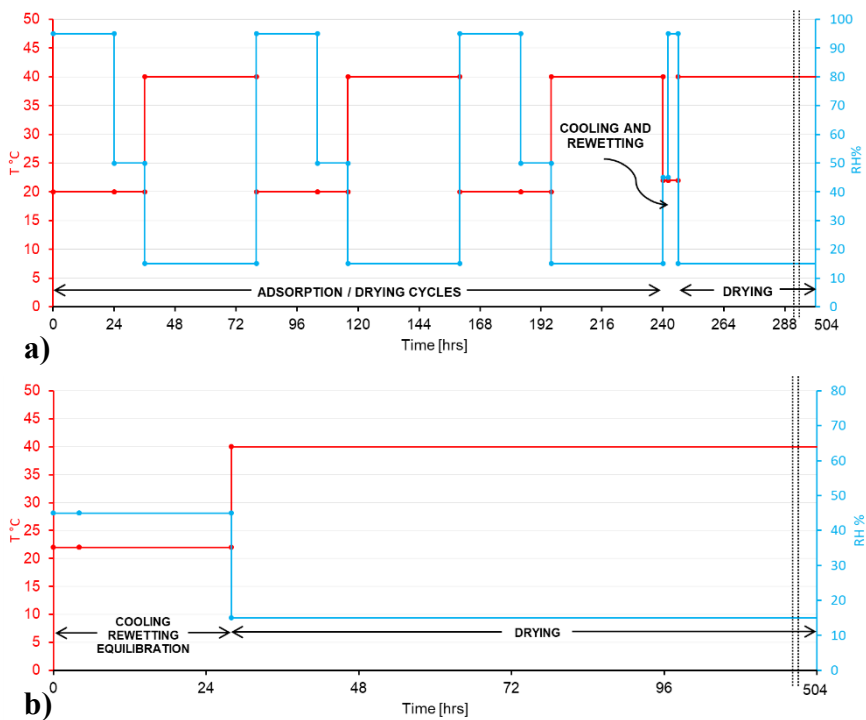
Figure 3: Testing conditions (propagation phase) characterizing each 3-week cycle of the NaCl (a) and Na₂SO₄ (b) testing procedure.

The propagation phase follows, based on four 3-week cycles. Differently from the accumulation phase, the set conditions of such cycles differ (i.e., T and RH values, duration, and use of rewetting stages) depending on the type of salt employed. In brief, each single 3-week cycle of the propagation phase of NaCl employs a series of high relative humidity adsorption sub-cycles alternated with drying stages, followed by a rewetting step and a final drying (Fig. 3a). Each Na₂SO₄ propagation phase starts with a cooling and rewetting sub-cycle at room conditions, followed by drying (Fig. 3b). The rewetting steps for both salts are carried out with deionized water only.
