# **KHUFU'S PYRAMID**

The “Inside-Out” construction theory

## **34 CLUES IN SUPPORT OF THE THEORY**

Study carried out by Jean-Pierre Houdin

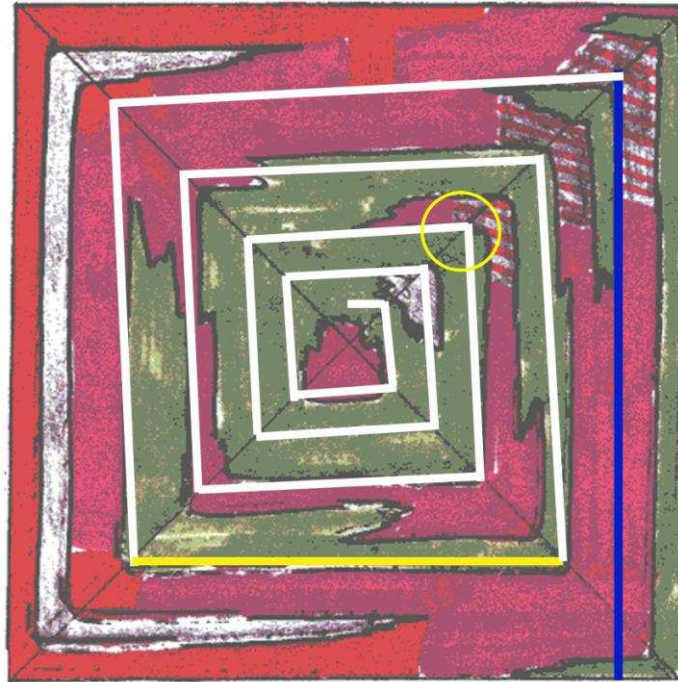
## The anomaly detected by microgravimetry

In blue, the first section of the internal ramp, beginning at the Southern face near the Southeast corner, and running North/South along the Eastern face of the pyramid. In yellow, the fourth section of the internal ramp running East/West along the Southern face of the pyramid. In the yellow circle, the location of Bob's room.

Right : a 3D application of the results with a vertical projection of the sections of the internal ramp.  
 Left : a drawing from the author of the above image—the ascending spiral clearly shows a low-density anomaly winding its way up the pyramid just beneath the surface.

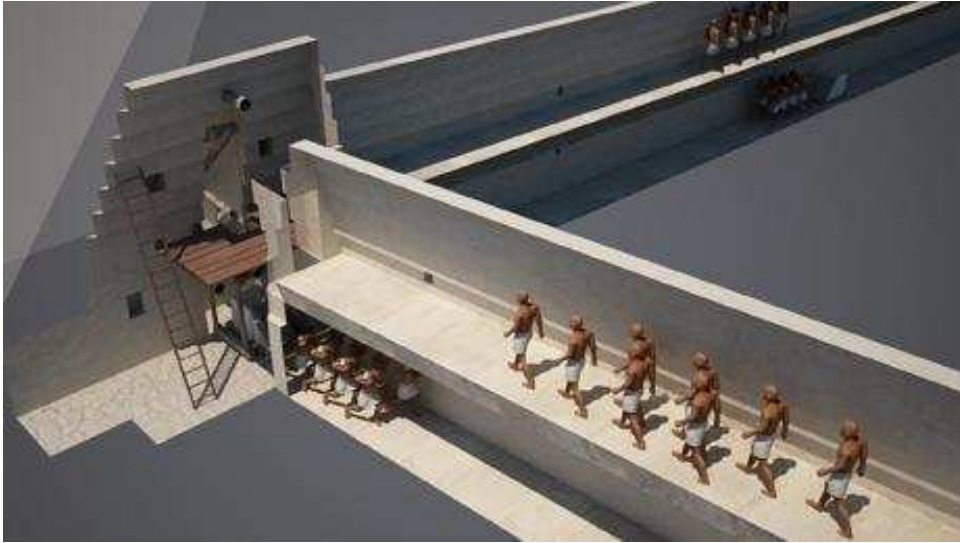
## The bi-level internal ramp

A corridor with a corbelled vault is a well-known technique for the builders of this era

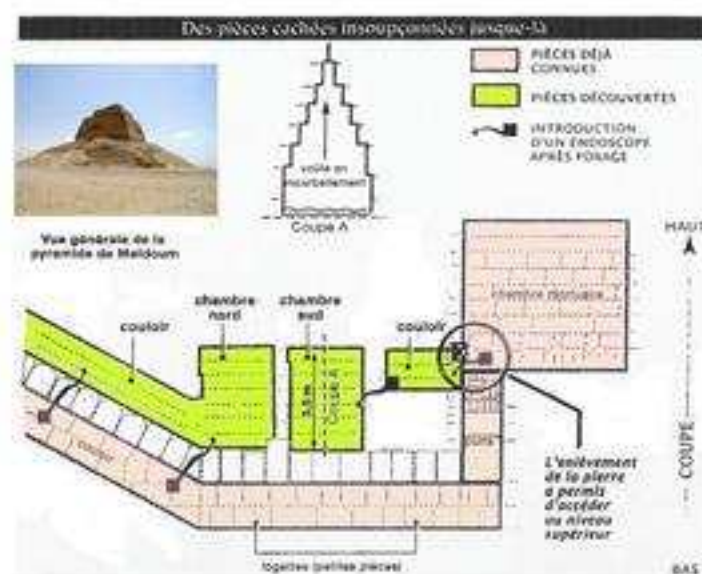
In 2000, a French team conducted a survey of Pharaoh Snefru's pyramid at Meïdum (built around 60 years before Khufu's pyramid). The team discovered several corbelled rooms above the descending corridor and the two small proto-antechambers

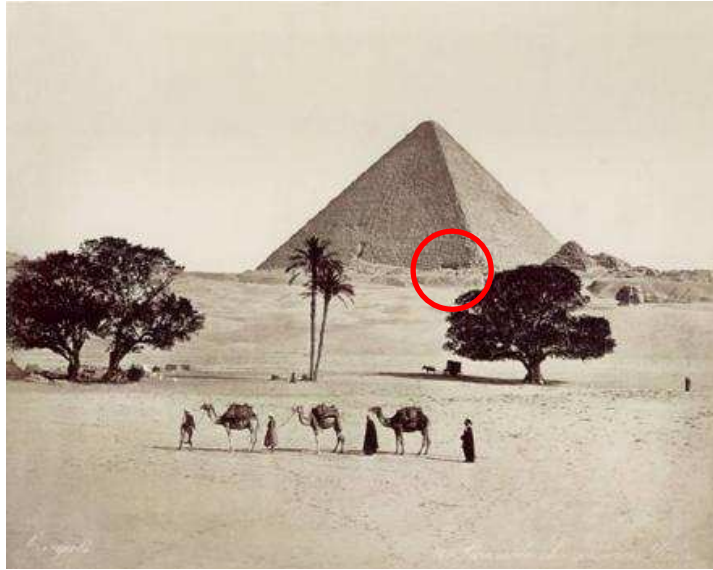
**Situation of the proposed entrance of the internal ramp**

This anomaly at the base of the south face is exactly at the perpendicular of the first “Bob’s room” under the northeastern edge. The first section of the ramp is parallel to the East face. This means that the inset of the anomaly from the Southeast corner places it where we would expect to see the entrance to the first section of the internal ramp and would align the trajectory of the ramp to end where a “Bob’s room” would be at the Northeast corner.

The anomaly is also in alignment with the path coming from the base of the Plateau and port, which also situates it where we would expect to find the entrance to the internal ramp.

The anomaly appears to have been filled in with blocks that look different from the surrounding masonry. This is what we would expect to see if an opening had been later walled-off.

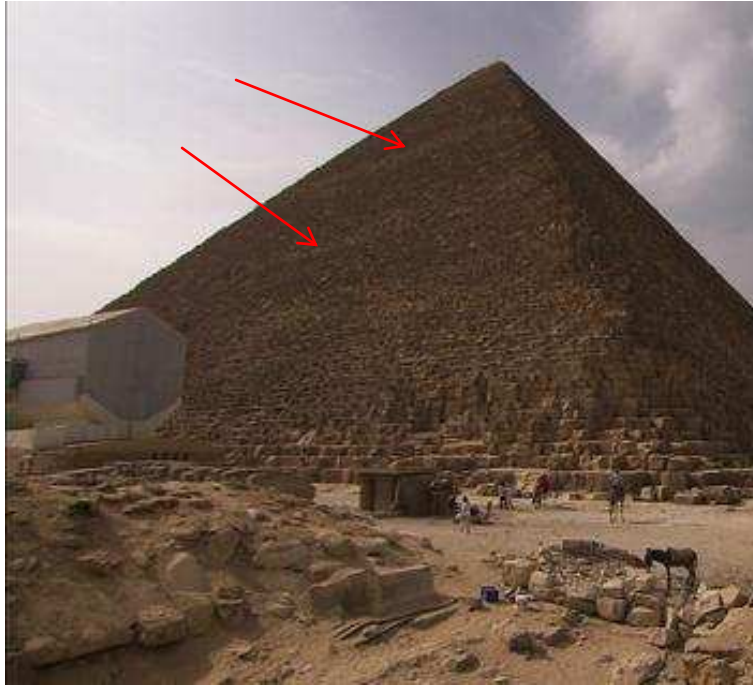
### Phantom lines on the South face

Two horizontal phantom traces are visible on the Southern face of the pyramid. The lower line runs along the +43 m level, the upper line runs at a slant corresponding to the eighth section of the internal ramp, passing just below the mouth of the Southern shaft that extends from the King's Chamber.

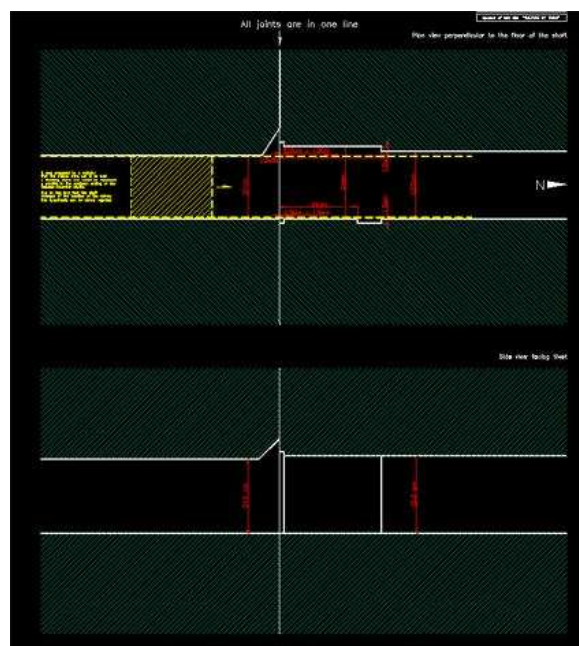
## The King's Chamber South shaft

The King's Chamber Southern shaft runs within a few meters of the internal ramp.

Because of how the shaft was built, its construction was halted when it reached an area where the internal ramp was under construction. The stopping point is visible in the shaft at the location of an anomaly dubbed the “Khufu Niche”. This is a place in the shaft where the joint between the upper and lower blocks that comprise the shaft runs perpendicularly on the same alignment on the four faces. Everywhere else the joints are out of line with each other. This suggests a change in the construction at this point, right where a section of the internal ramp would have been constructed. Once the construction of the ramp was completed, work on the shaft resumed.

There are four shafts in the pyramid and this anomaly is only found in this shaft.

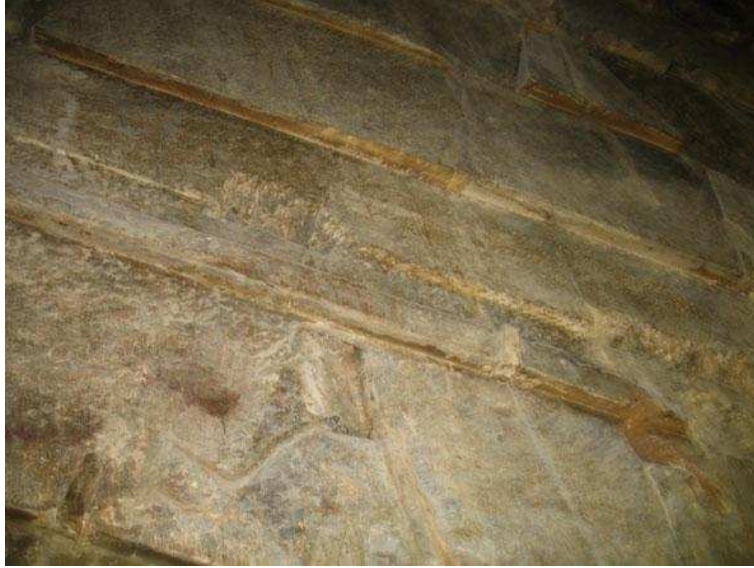
A groove on both sides of the Grand Gallery all along the third corbelling.

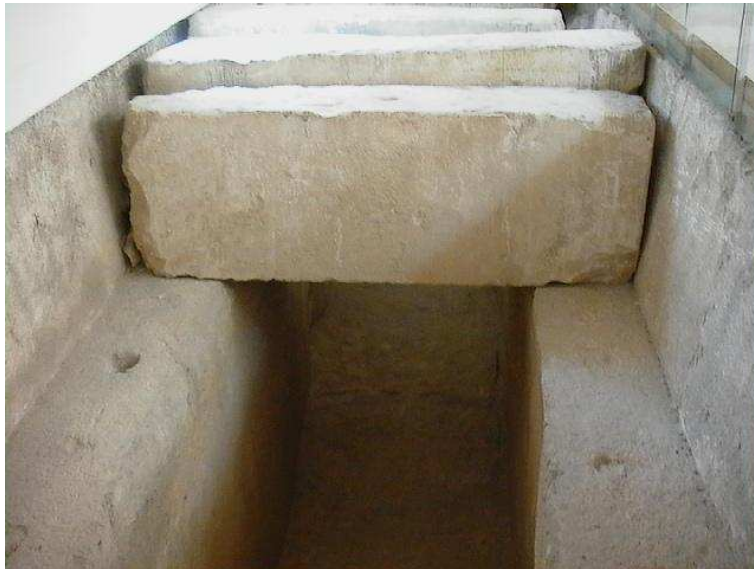
The roofing technique of the Grand Gallery is slightly different from usual corbelling. Some of the slabs were set in place at a later date (pictured here, the roof of the pit of the Khufu's Solar Boat).

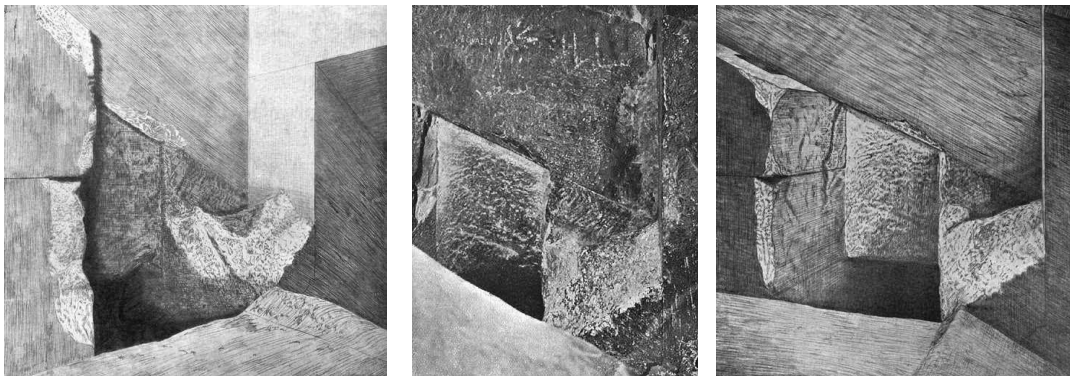
In order to set the green block in place and properly seal the well, one must set in place a supporting block as shown in the red circle (left).

If the red block is set in place first, it becomes impossible to position the green block from the well.

The evidence left by the robbers as they broke in indicates that the well-shaft was perfectly sealed from the Grand Gallery before being re-opened by the intruders. Only one vertical block was used to build this part of the bench in the Grand Gallery, as evidenced by the two vertical joints. In the image on the left, one can see a small vertical block, 13cm wide, in the first row. This detail is a result of the construction technique of the well-shaft.

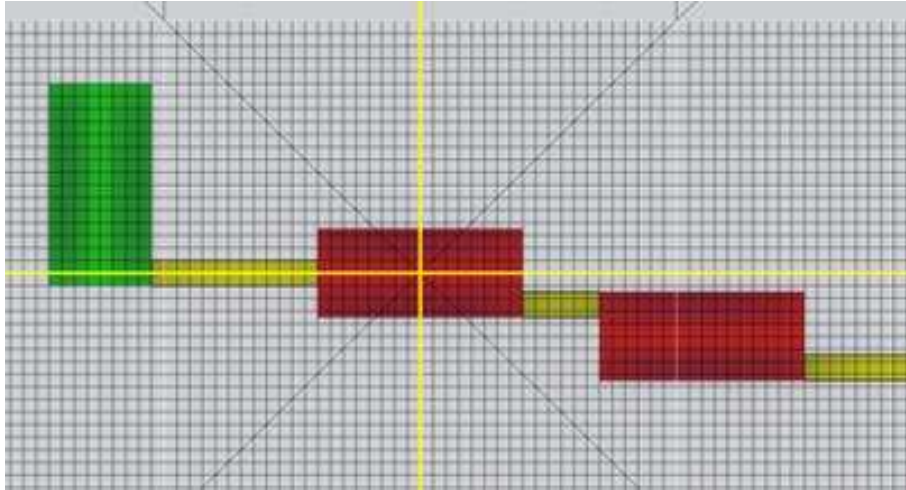
The two antechambers (red) and the funerary chamber (green) in the Red Pyramid

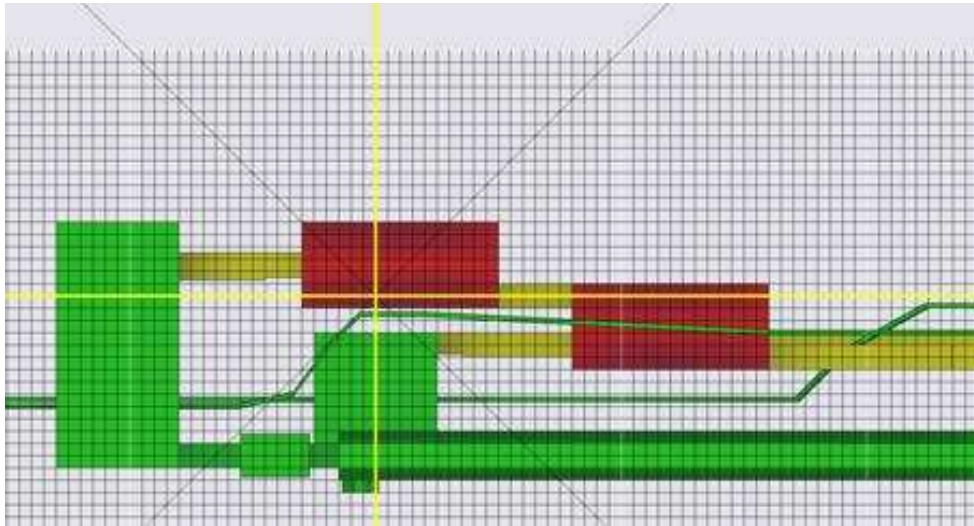
The two antechambers and the funerary chamber in Khufu's pyramid: a perfect "copy and paste".

All of the internal architecture of Khufu's pyramid was planned around this central configuration of two antechambers and a burial chamber. All other passages, chambers, and shafts were designed and built to accommodate the precise location of these three chambers.

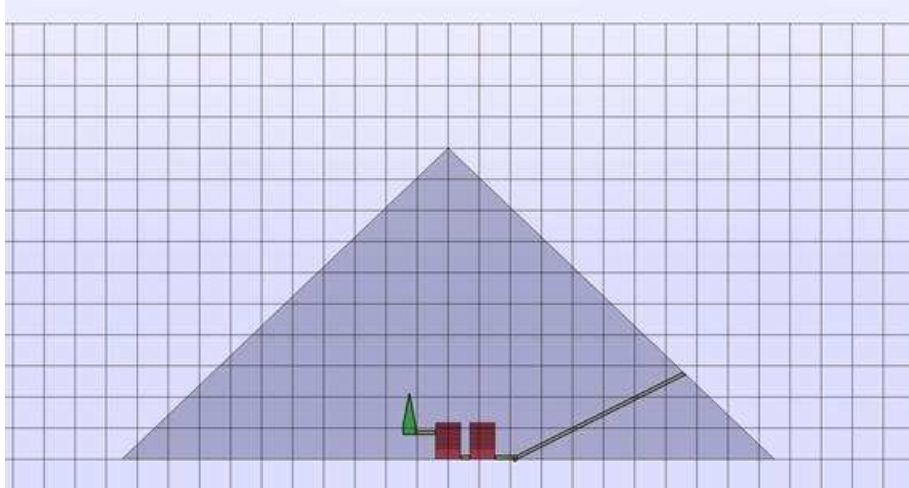
The funerary apartments in the Red pyramid

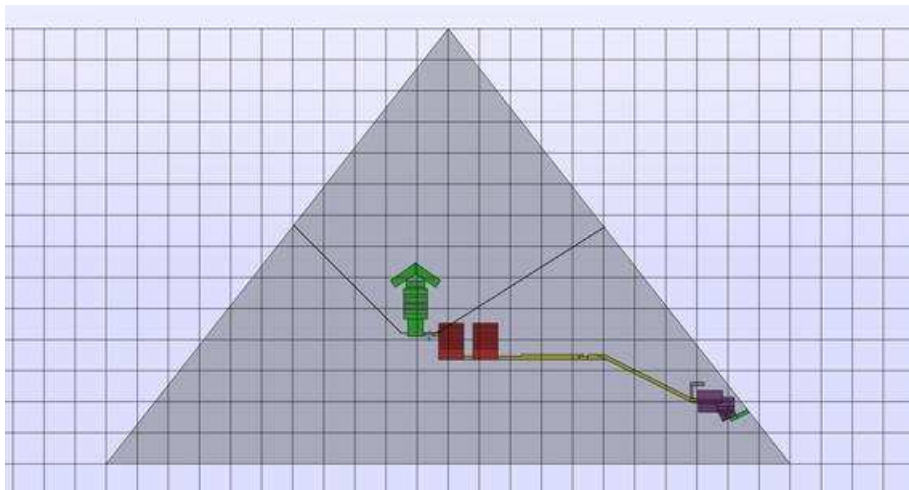
The funerary apartments in Khufu's pyramid

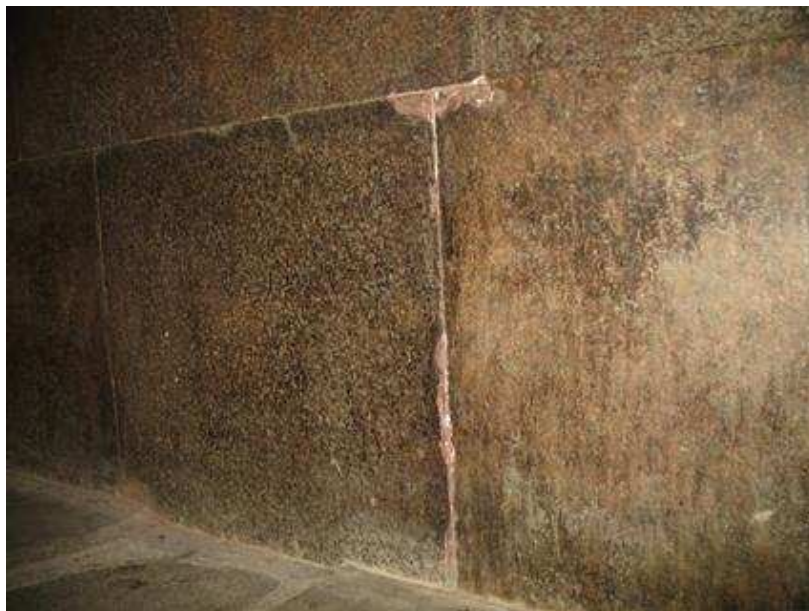
Hidden portico (in pink left) and the entrance block (red arrow right); the blocks in yellow (left) fill the space above the entrance, but do not rest on the entrance block. They are supported by the surrounding blocks instead. This entrance will hereafter be referred to as the “second entrance”, with the first entrance being the one we are all familiar with—the one that enters from porticulis chamber.

A wide joint is seen on the right of the block sealing the second entrance. A closer look shows that this block is not in the same alignment as the other blocks of the North wall.

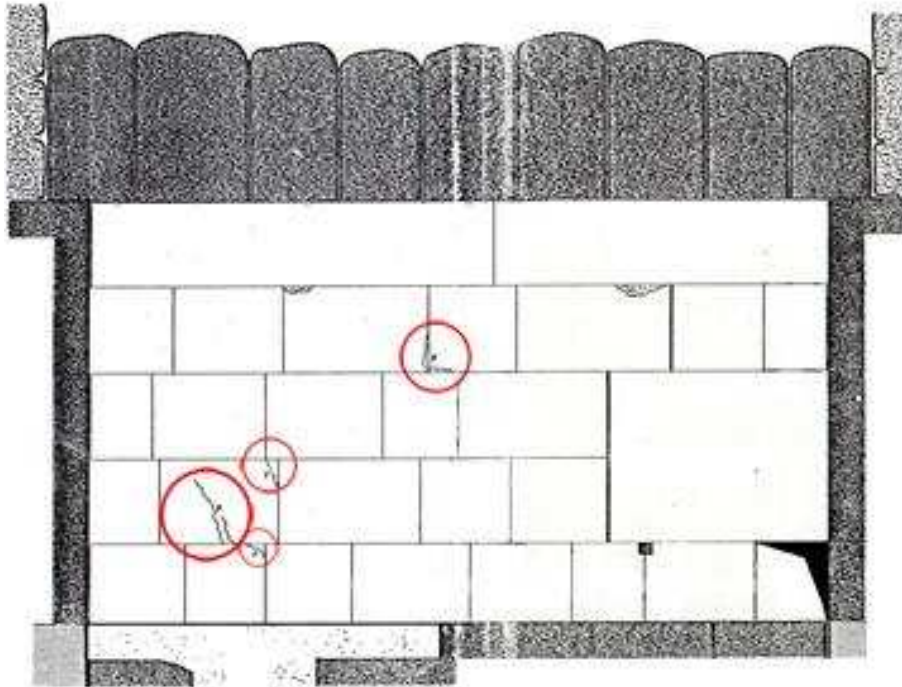
### The cracks in the blocks of the North wall of the King's Chamber

The North wall is perfectly resting on its foundations and hasn't moved in 45 centuries; only a few very thin cracks appear on four of the blocks: the block sealing the second entrance, the block immediately above it, and two blocks in the upper part of the portico. The width and positioning of the block above the second entrance allowed it to serve as a lintel, indicating that the block that currently rests under it does not serve a supportive function—its sole purpose was to seal the second entrance. It was not intended to support the weight above it. The builders left some clearance for the positioning of the sealing block. When Al-Mamoun's men dug a deep hole at the base of the sealing block while looking for treasure, it slightly weakened the foundation beneath the second entrance, causing the cracks as the structure resettled.

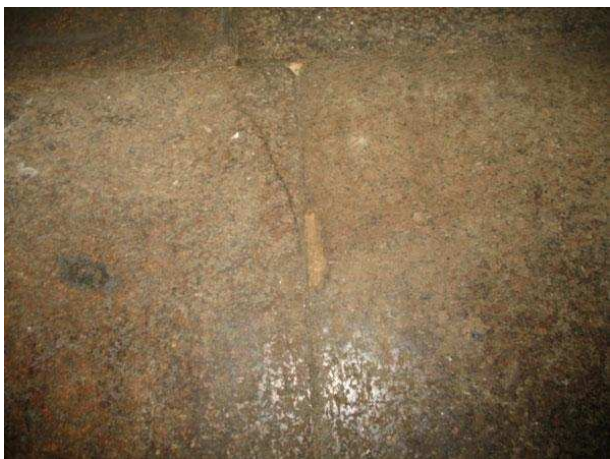
Cracks on the upper part of the lintel

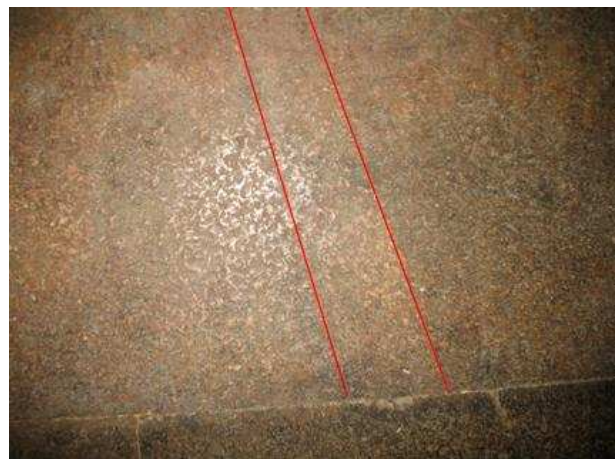
Cracks on the lower part of the lintel

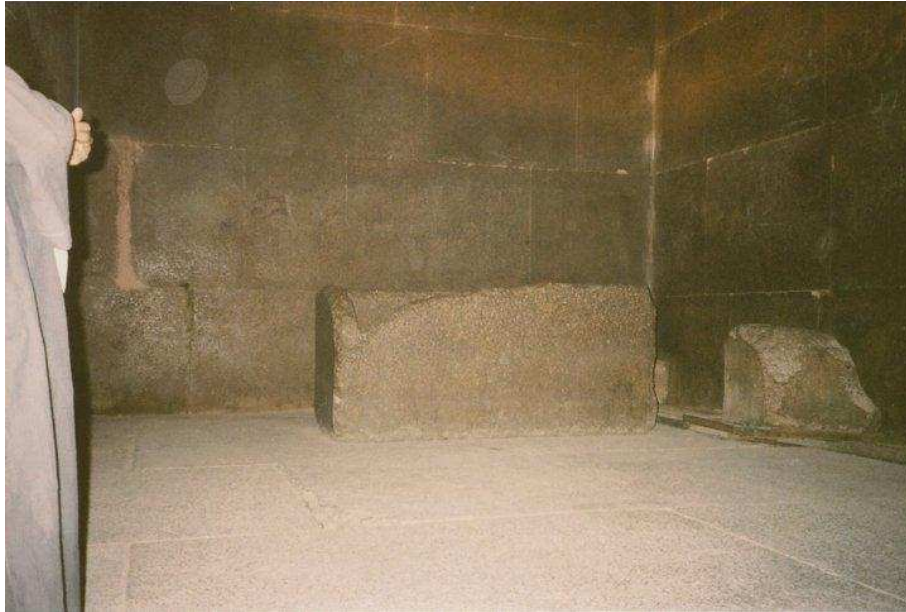
### The forgotten block in the King's Chamber

The granite block on the right was still in the King's Chamber in 1998, before some restoration work was conducted. This block has since disappeared.

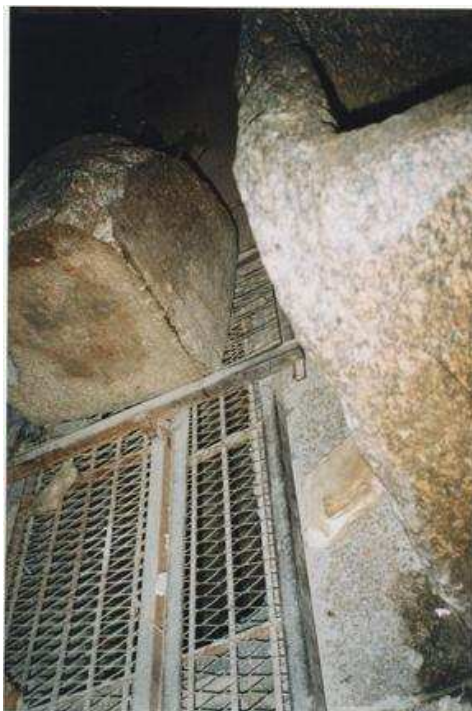
This block was perfectly cut: it was part of the North wall of the King's Chamber and sealed the entrance from the portcullis chamber. It was partially broken and pushed inside the King's chamber by Al-Mamoun's men when they broke into the pyramid around year 820, seeking treasure. The block stood in the chamber for nearly twelve centuries, although no one ever asked about its presence.

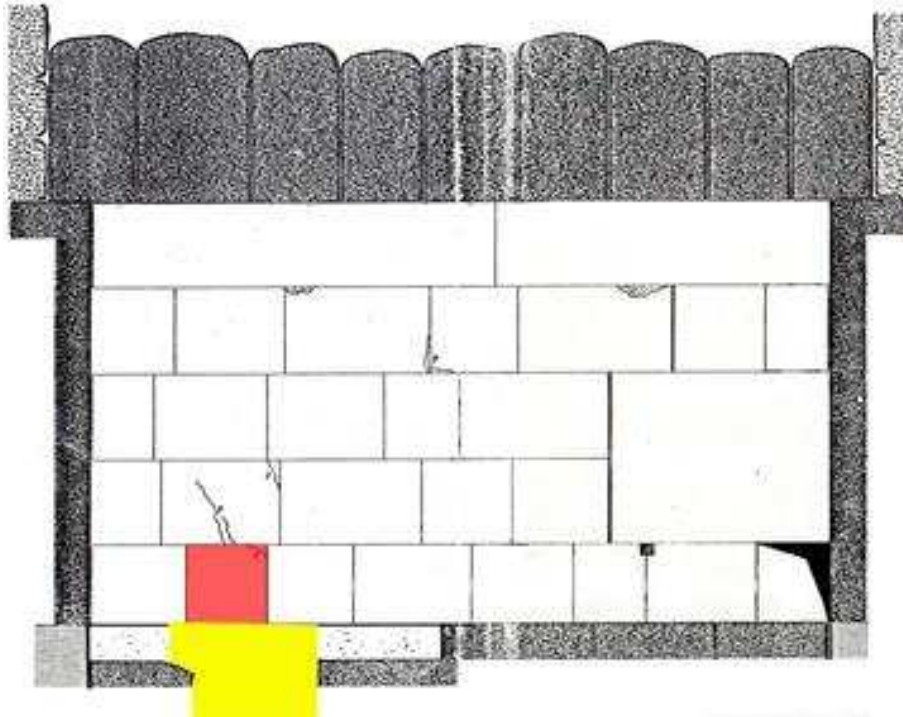
### The hole dug in the King's Chamber floor

Al-Mamoun's men dug a deep hole in the floor of the King's Chamber (in yellow at the base of the wall) exactly vertical to the second entrance block (in red). What drew the treasure hunters to this particular spot? They must have perceived some anomaly that suggested that there was something there to be found.

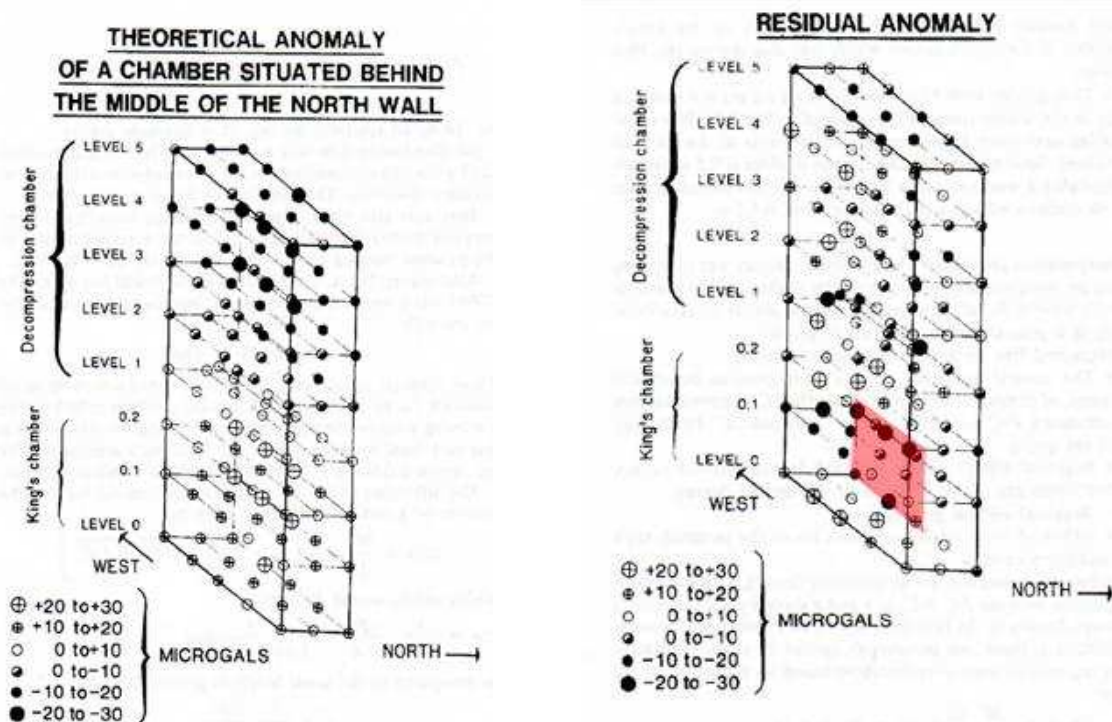
Figure 5.

In 1986, a microgravimetry survey was carried out by a team sponsored by the EDF Foundation. The team made a detailed analysis of the King's Chamber and the relieving chambers above it, searching for low-density anomalies that suggested a hidden chamber. The team had expected to find evidence of such a chamber in the North area behind the upper part of the relieving chamber, and had even gone so far as to simulate how such an anomaly would appear.

But the survey failed to produce the expected results. Instead of indicators of a hollow space north of the upper part of the relieving chamber, the team isolated a low-density area in the lower Northwestern corner of the North wall—precisely in the area of the proposed second entrance.

Simulation before the survey

Results of the survey

Separated by nearly twelve centuries, and using very different methods of observation, the microgravimetry team had been led to the same spot as Al-Mamoun's men. As the above images from the study show, the low-density anomaly (in pink) corresponds exactly with the location of the theoretical second entrance and the room that would house the closure mechanism that would maneuver its sealing block into place.

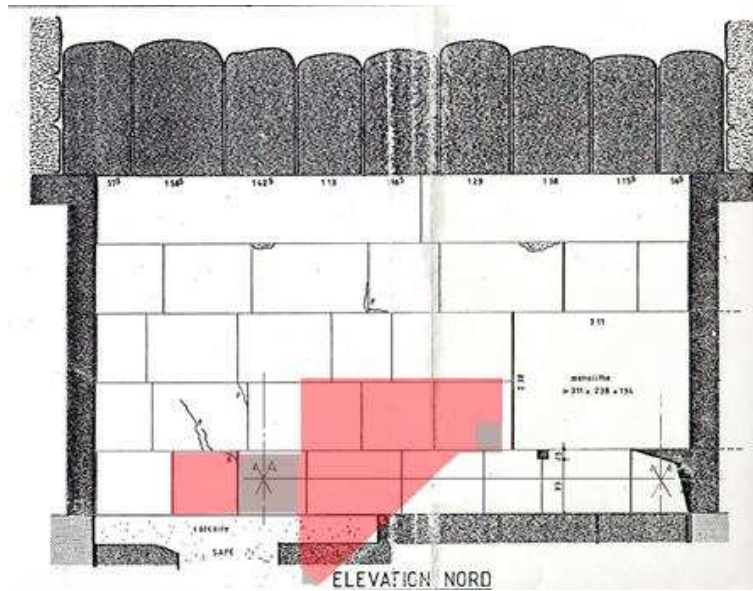
The room housing the closure system, which would have been used to position the sealing block in the corridor linking the second antechamber to the King's Chamber, should stand directly on the other side of the North wall where the anomaly was detected.

This closure system is a direct evolution from a portcullis system used in the Bent pyramid.

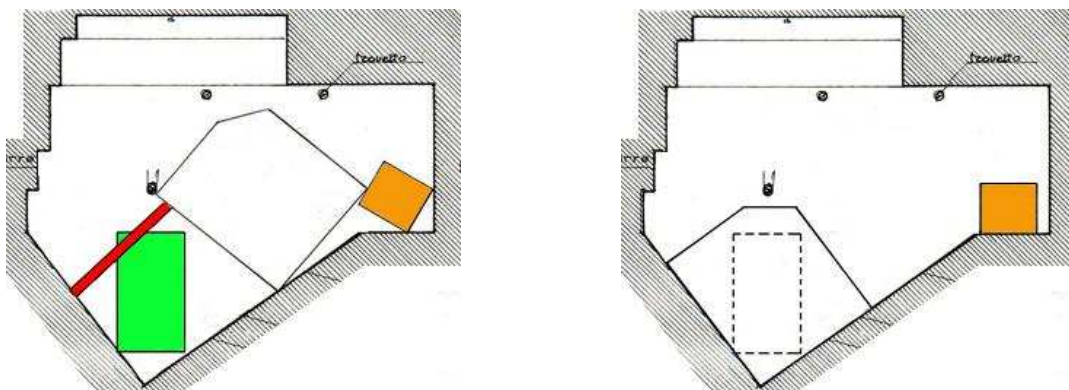
This closure system was already used in the Red pyramid between the Second antechamber and the funeral chamber.

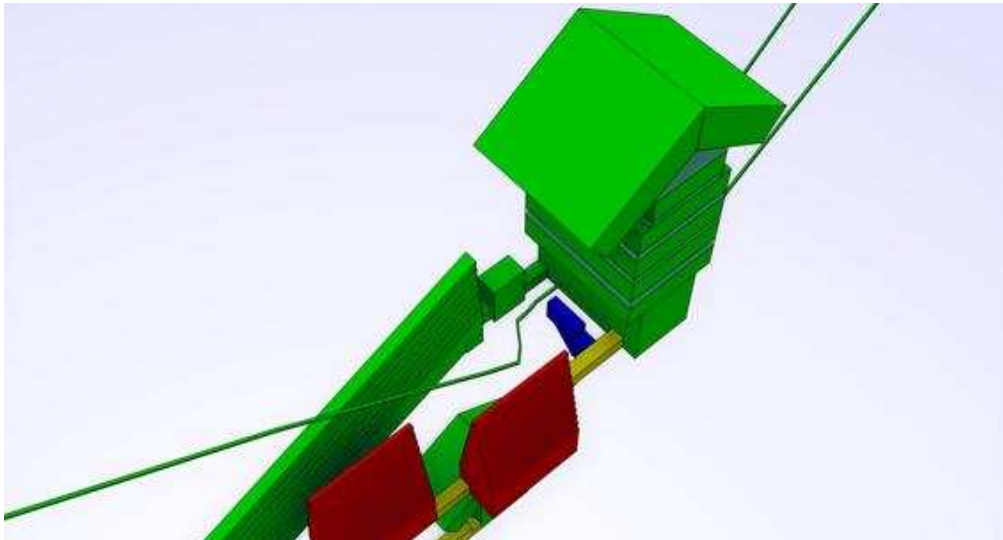
### The King's Chamber North shaft

The starting point of the Northern shaft in the King's Chamber was determined by the location of two elements of the pyramid's internal architecture that were already designed: the portcullis chamber to its right and the room housing the second entrance closure system to its left.

The shaft could have started straight from the center of the North wall and could have avoided a very tortuous path. But in that case, it would have crossed the room with the closing system.

Since we know that the shaft twists to avoid a known structure—the Grand Gallery—we may infer that other changes of trajectory were incorporated to avoid other internal structures, and one of these unaccounted-for twists occurs where the accumulation of evidence suggests the housing compartment for the second entrance sealing mechanism would be. Another change of course occurs where the corbelling of the second antechamber should be.

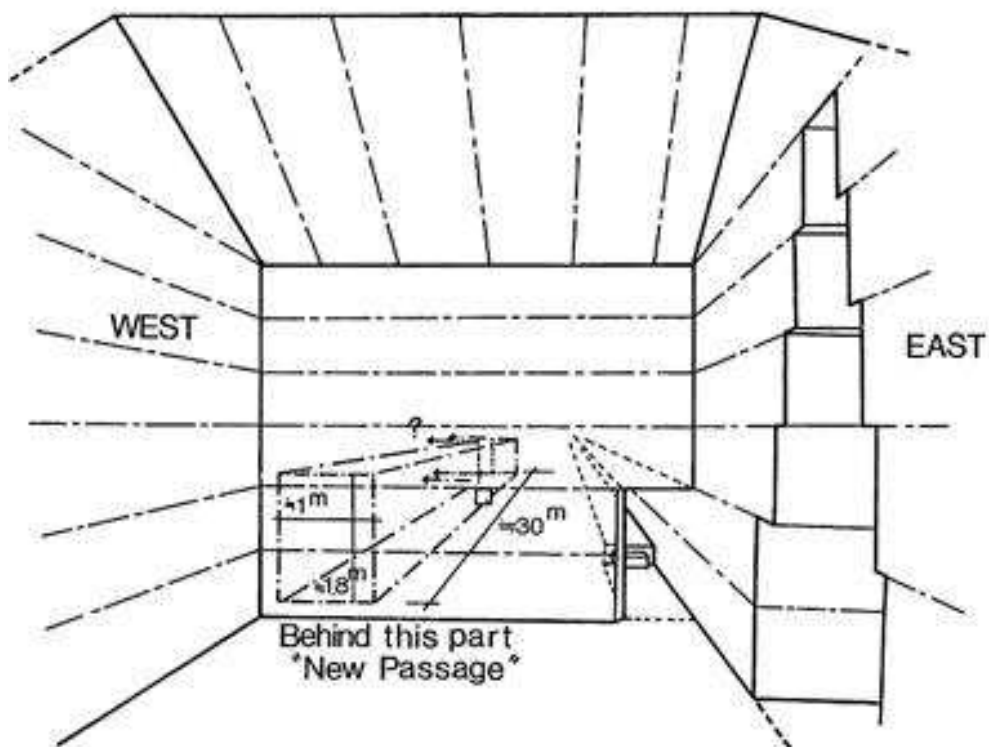
Fig.38 North wall of Queen's Chamber

A second corridor leading to the Queen's Chamber was detected by a team from Waseda University (Japan). Two radar surveys were carried out in 1987 and both results were identical: There should be a corridor (1m x 1.80m x 30m) starting in the Northwestern corner of the North wall (in the same corner as the second entrance to the King's Chamber)

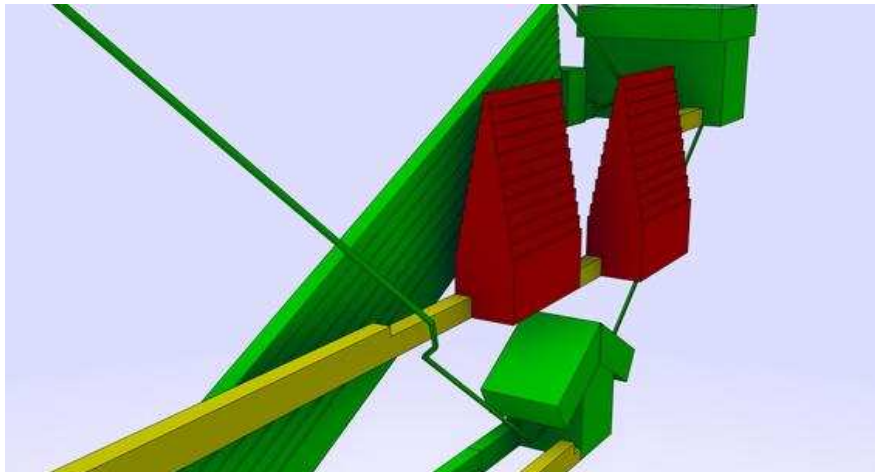
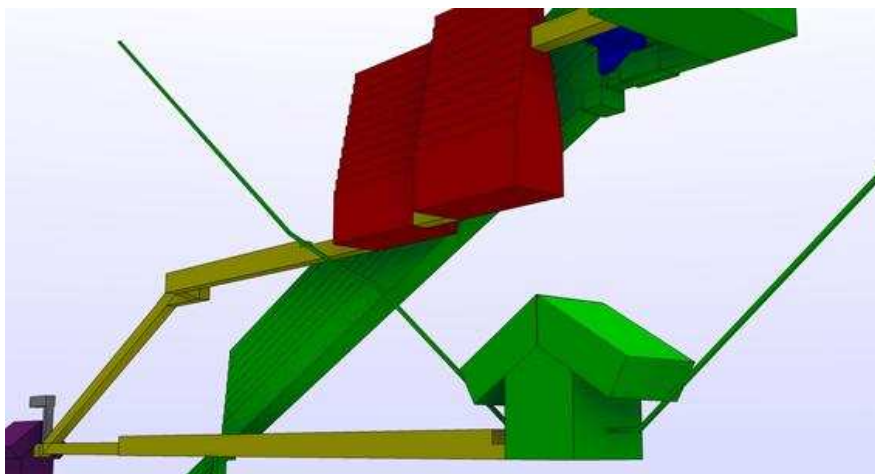
The size of the Queen's Chamber, the position of the North shaft and its path through the masonry were greatly influenced by the presence of this second corridor:

1. The designers had to navigate the North shaft between the two corridors.
2. Due to the thickness of the walls of these two corridors, the designers added one cubit to the length of the Queen's Chamber. Both the King's and Queen's Chambers are 10 cubits wide, but the Queen's Chamber is just over half (eleven cubits) the length of the King's Chamber (twenty cubits). Why the odd number? Why not an even 10 x 10 cubits, exactly half the length of the King's Chamber, if not for structural purposes? The extra cubit allows for the setting of the shaft between both corridors walls.

3. A little further up the shaft makes another unusual change of course, shifting about nine cubits to the West to avoid the second corridor leading to the King's Chamber, just north of the two antechambers. A shift of just one or two cubits would have been sufficient to avoid the Grand Gallery; so again, a radical change in the course of a shaft implies the existence of something the designers were trying to dodge, in this case the corridor leading into the antechambers.

A view from above

A view from below

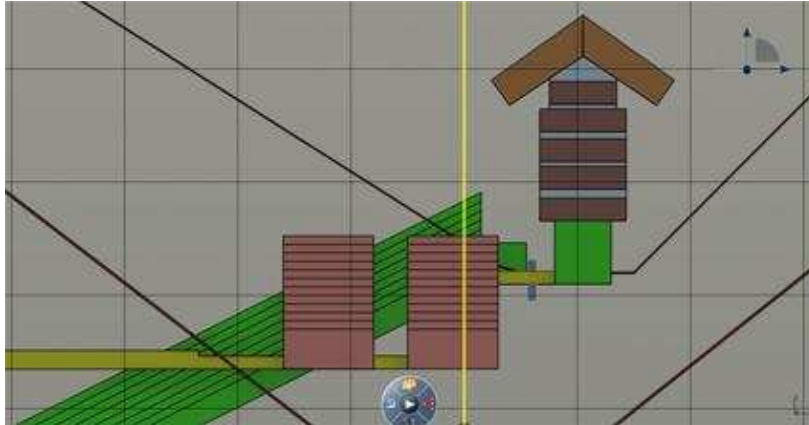
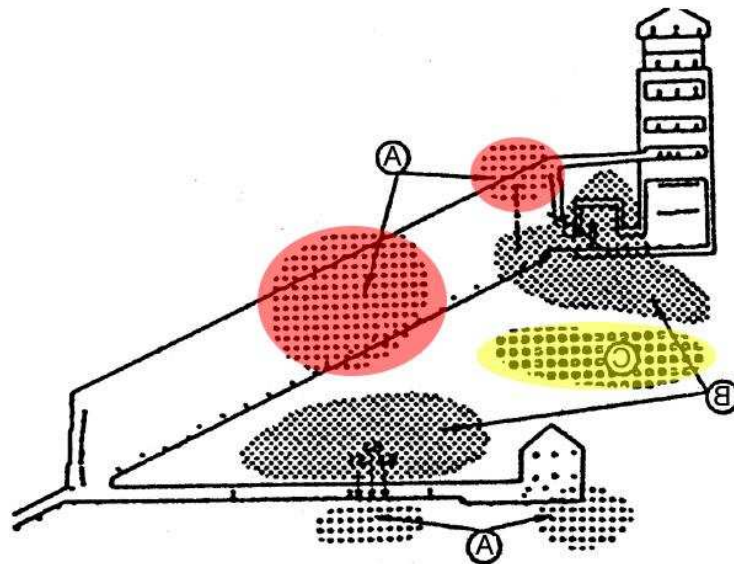
Microgravimetry survey - EDF Foundation - 1986

Areas marked A are areas of low-density:

Two small anomalies, one below the horizontal corridor leading to the Queen's Chamber, one below the same chamber

One small anomaly on top of the Grand Gallery (in red) which could correspond to the opening through which the ropes for the counterweight system ran

One large anomaly very close to the Grand Gallery (in red)

Areas marked B are areas of high-density:

Reinforced masonry beneath the Grand Gallery, beneath the King's Chamber, and on its North side

The area marked in C (in yellow) is an area of possible low-density:

Observations in this area could be linked to the nearby area B and by the lack of microgravimetry measurements on one part of the Northwestern edge.

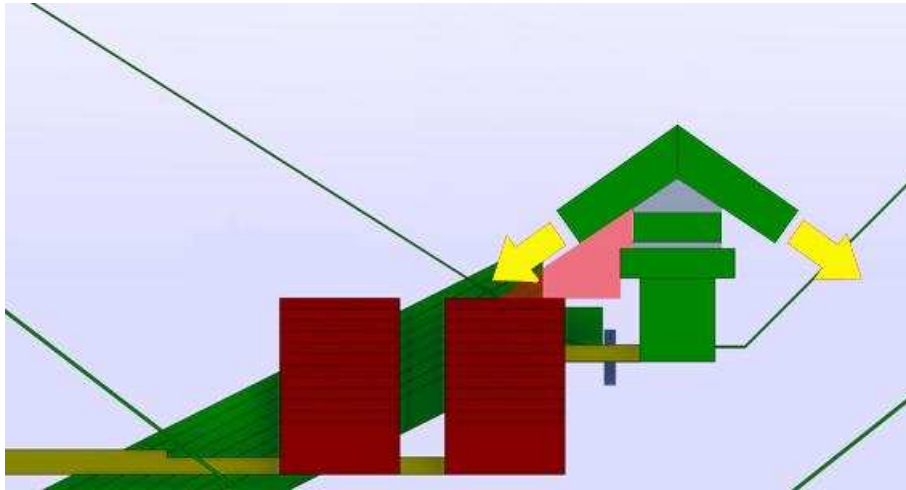
If the limestone gable roof bearing the load above the King's Chamber would have been built on top of the first ceiling, the oblique load transferred by the North side would have crushed the antechambers. The corbelled vaults of these rooms were only designed to bear vertical loads.

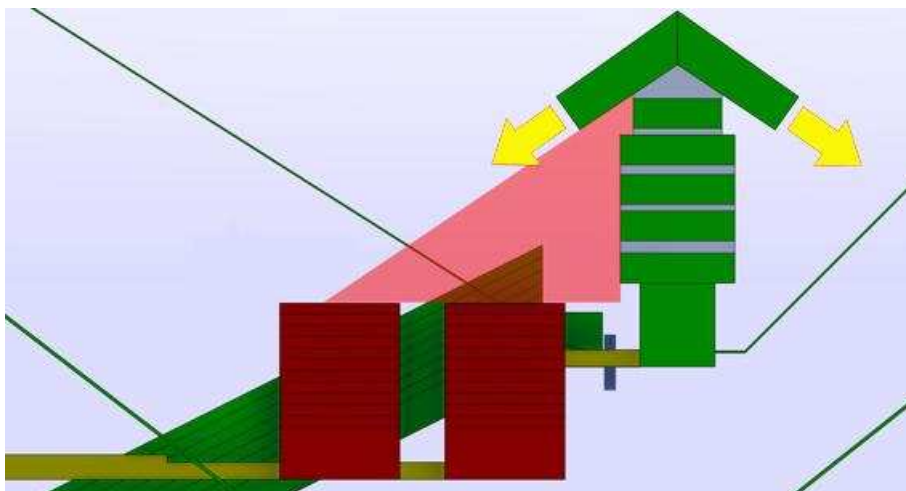
To avoid this problem, the Egyptians built this strange structure, made of five successive ceilings and a limestone gable roof. Doing so, the roof was pushed very high above the first ceiling. The oblique load of the North side of the roof is transferred in the masonry well above the antechambers.

The counterweight system running in the Grand Gallery was needed for the construction of the first ceiling. The Egyptians didn't hesitate to build this structure in order to assure the success of this grandiose project: a King's Chamber with a flat ceiling in the core of the pyramid.

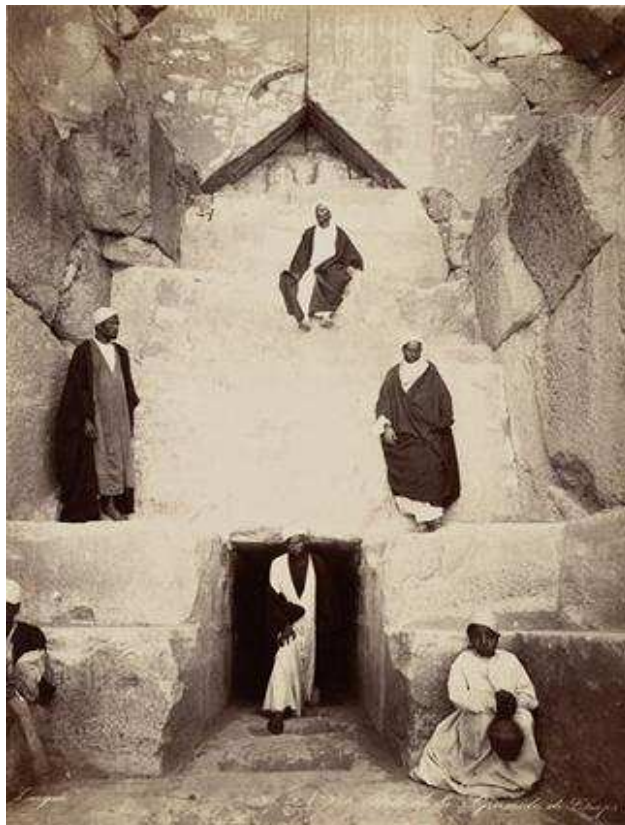
The limestone rafters above the original entrance (at the center of the photo above) are disproportionately large for a simple roof for the descending corridor. Moreover, they are set much too high above the descending corridor.

The men standing in the photo give a good idea about the distance between the descending corridor and the rafters.

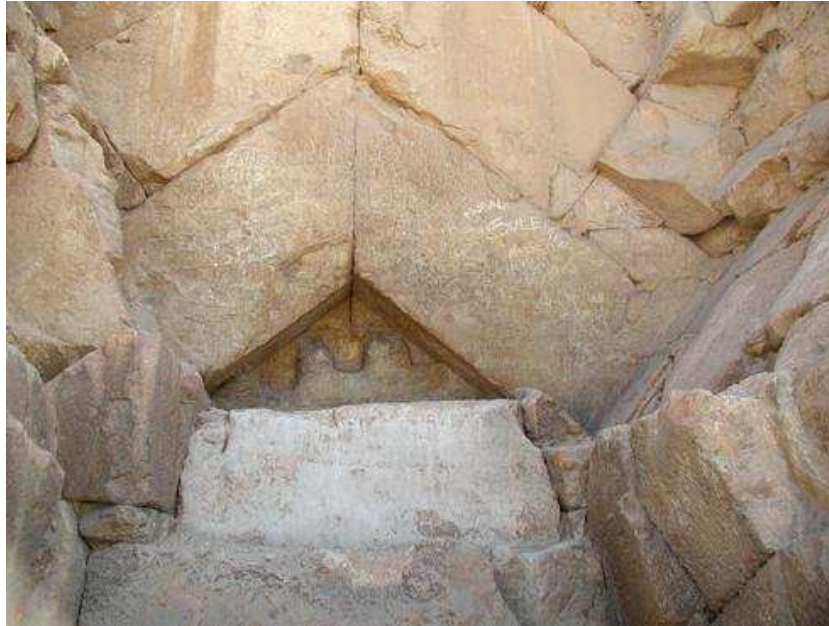
By measuring on site the oblique existing abutments, one can notice that 6 pairs of rafters are missing for the lower row and 3 are missing for the upper row. The lower series covered a void, while the upper series partly overlapped the lower roof.

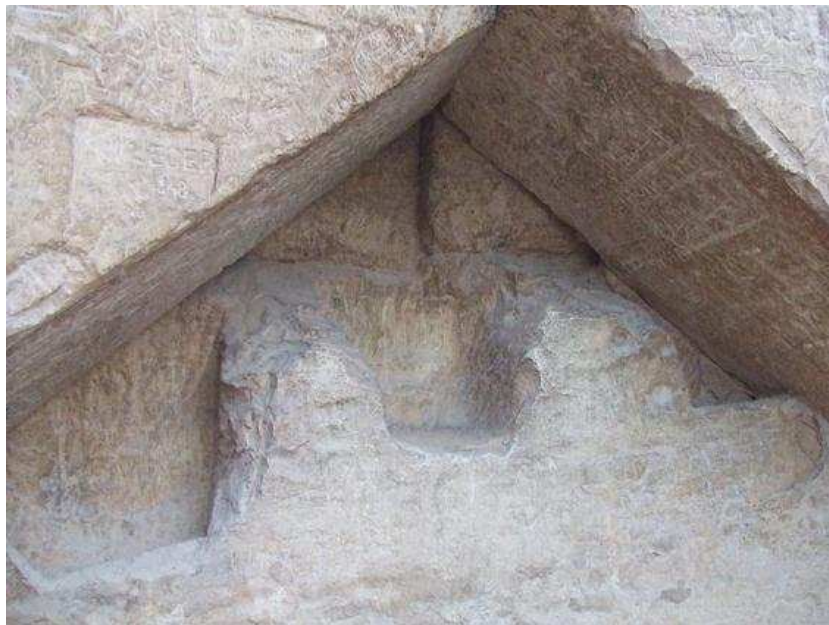
Obviously, the fluted block inserted below the first row of rafters was pushed from the inside, as indicated by traces of mortar jutting out below the rafter on the right. Ahead of this block, the limestone floor was carefully repointed with plaster and polished. Additionally, this block doesn't fill the whole opening, a 40cm high triangular void was filled with a masonry perfectly centered with the axis of the gable roof.

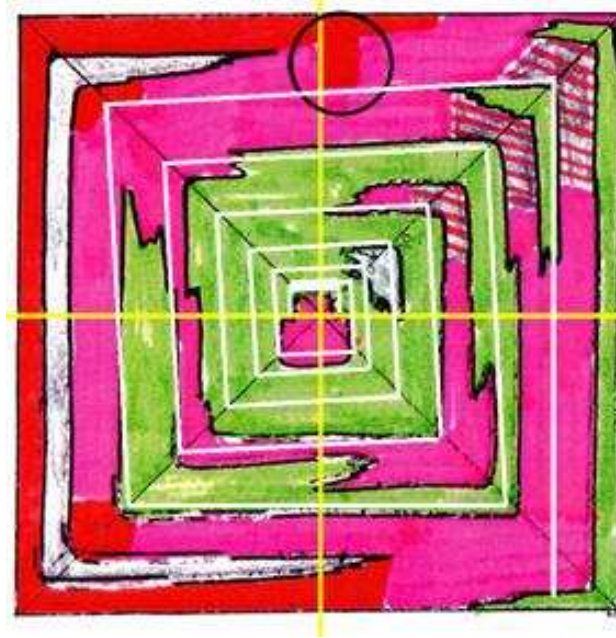
**The upper gable roof above the entrance was detected by microgravimetry**

A detail went unnoticed in the image of the spiral anomaly detected by microgravimetry: there is an area of very high density under the north face exactly corresponding with the prolongation of the rafters above the entrance. This area is shifted to the East of the North/South axis, placing it in precise alignment with the already known corridors of the pyramid. Moreover, this over-density stops just at the vertical of the second section of the proposed internal ramp.

Around ten pairs of rafters should be embedded in the masonry behind the upper series above the entrance. These pairs of rafters should cover a second void.

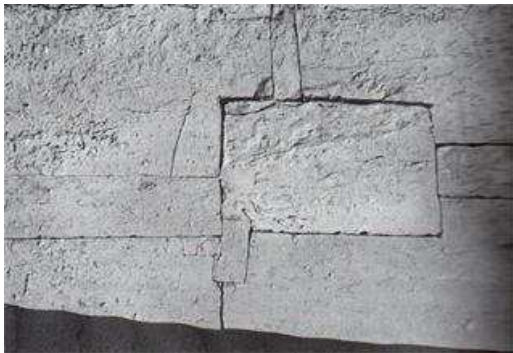
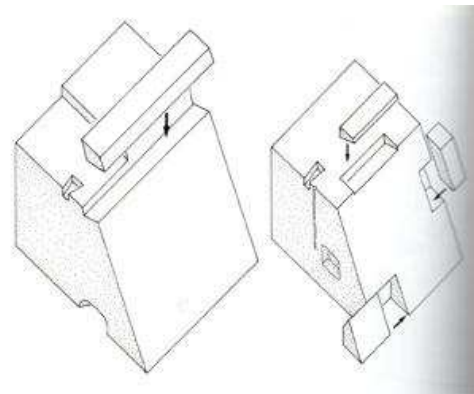
Many patches on the facing blocks, some of these could not have been inserted after the setting in place of the blocks in the row above them.

Examples of "repair patches" described by Egyptologist Dieter Arnold in his book "Building in Egypt"

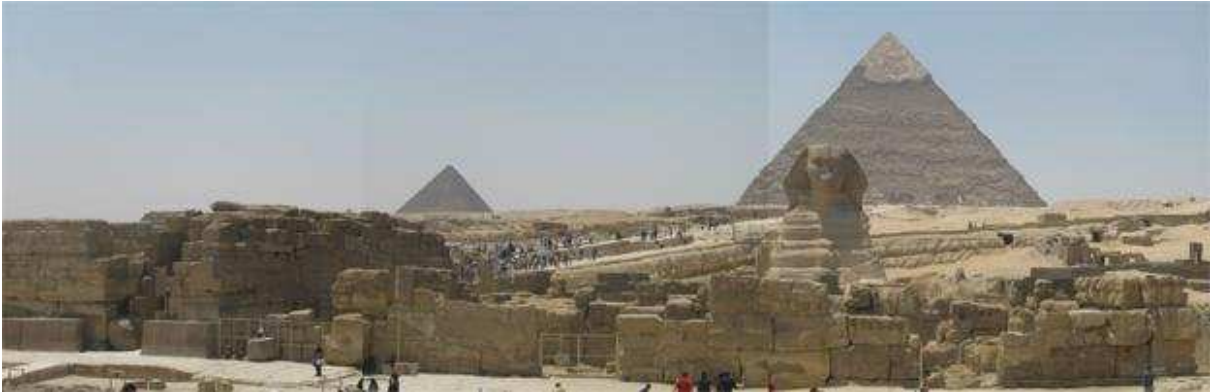
**The ramp from the port for the construction site of Khufu's pyramid**

General view with the ramp linking the Lower Temple of Khafre and his pyramid ; in the foreground, the Sphinx's Temple, and behind, the Sphinx. The length between the entrance of the Lower Temple and the pyramid is about 650m for a difference of level of 55m. The average slope is around 8,5%.

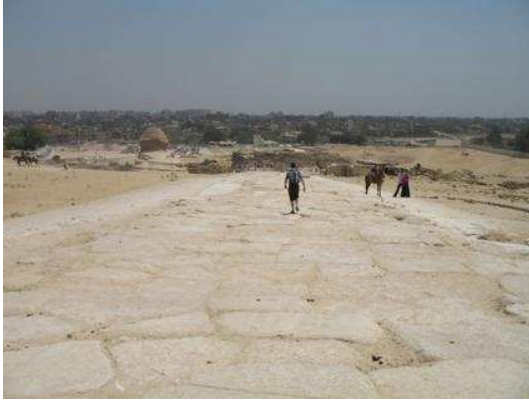
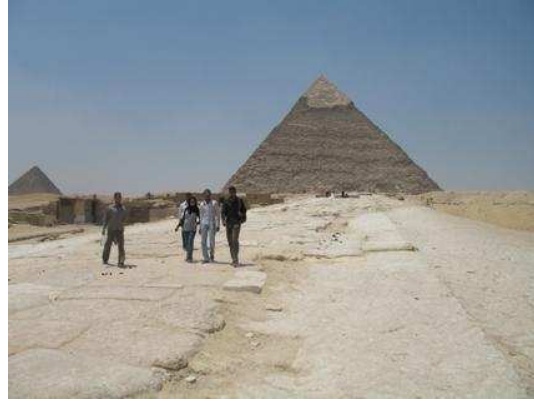
Centered at half-way of the ramp and for about 250m, there is a slight depression beneath the south part of the causeway. This section had to be filled with huge limestone blocks. The causeway had to be "built" for this precise area.

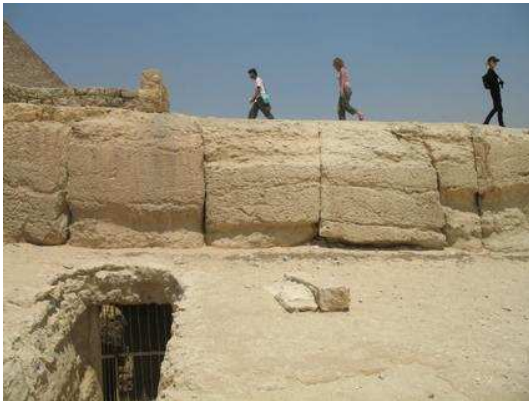
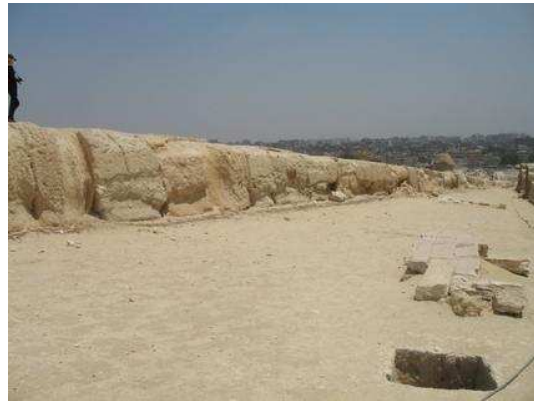
Left, a view towards the Lower Temple. Right, a view towards Khafre's pyramid. The width of the causeway can clearly be determined for the whole area: the main central lane, slightly thicker, is 19 to 20 cubits wide, and both side lanes, North and South, are 13 cubits wide each. The total width comes for 45 to 46 cubits (23.50m to 24m), which is twice the width of Khufu's causeway.
