# **KHUFU'S PYRAMID**

The “Inside-Out” construction theory

## **34 CLUES IN SUPPORT OF THE THEORY**

Study carried out by Jean-Pierre Houdin

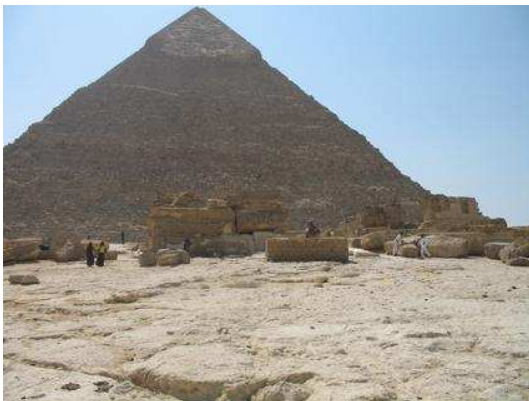
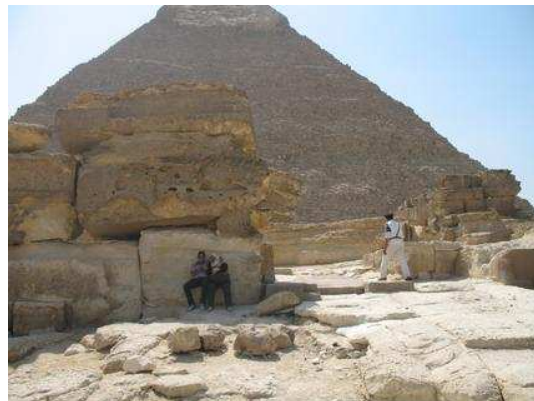
Only one layer of blocks was required to fill this slight depression. Passers-by give the scale of the blocks. At a later date, the bedrock was even dug beneath the causeway.

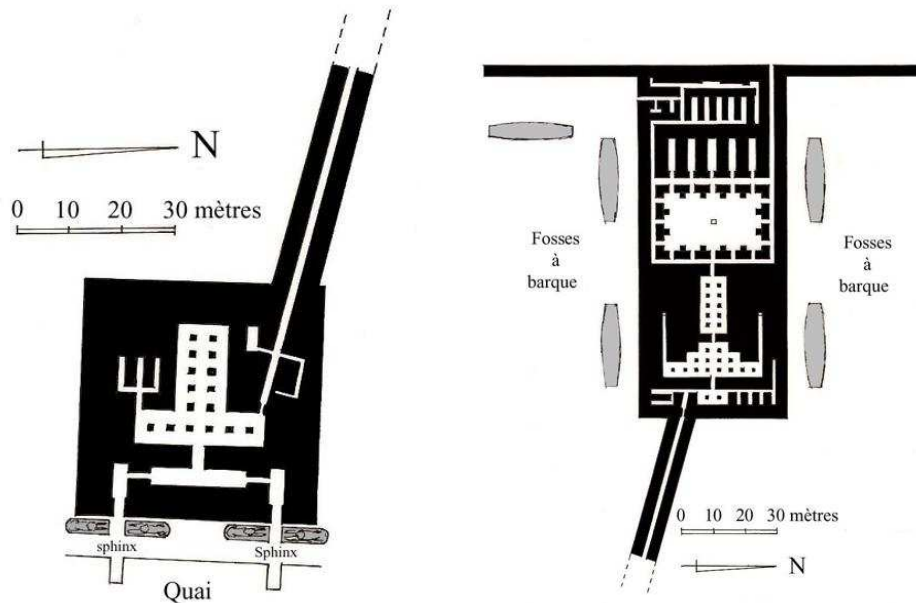
The Royal Causeway does not enter the temples in a logical manner but had to be adapted to an existing situation linked to the presence of the first ramp for Khufu's construction site, the ramp linking the port to the bottom of the exterior ramp. It does not enter along the centre-lines of the temples but to the sides of the faces. Moreover, the Causeway starts from the middle of the Lower Temple, pointing out that the Temple was built astride on an existing ramp. In addition, the architecture is solid and heavy, the void/solid ratio distinctly favouring solid. We could qualify it as "solid" architecture.

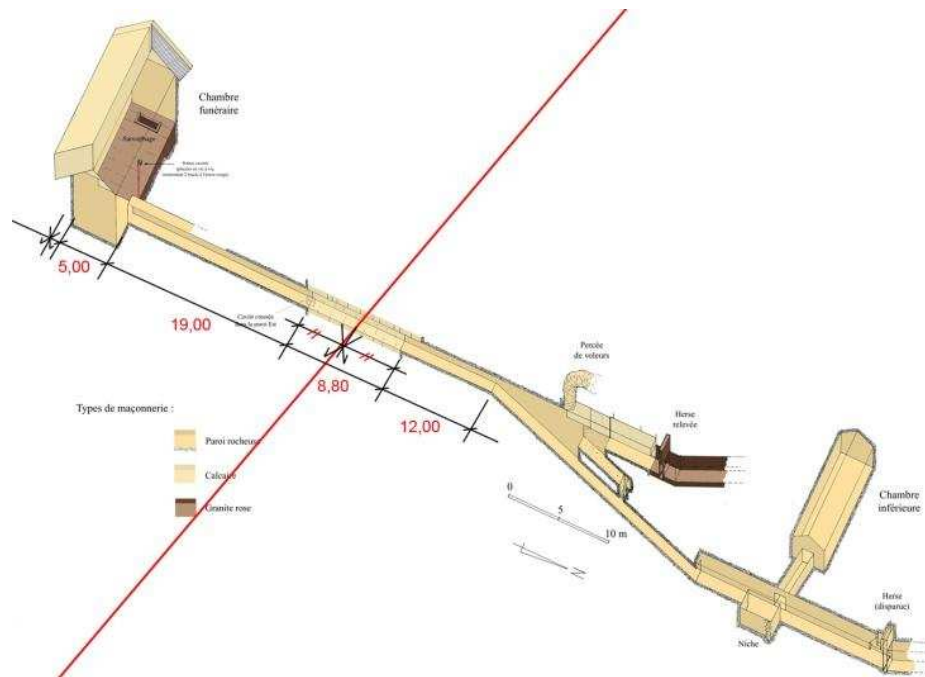
The red axis of the ramp from the port crosses the corridor leading to the King's Chamber in Khafre's pyramid. The designers had to "build" this part of the corridor with masonry while the rest of the corridor was simply dug through the bedrock. In other words, as the corridor was being dug through the bedrock, when the builders came to the point where the corridor intersected the counterweight trench they had to patch the intersection with masonry. This patched section does exist in the corridor, exactly where the counterweight trench would be.
