## **A new adhesively bonded composite repair for offshore steel structures: strength assessment and fatigue**

Quentin Sourisseau, Emilie Lepretre, Sylvain Chataigner, Xavier Chapeleau, Maxime Deydier, et al.. A new adhesively bonded composite repair for offshore steel structures: strength assessment and fatigue. CICE 2023 - 11th International Conference on Fiber-Reinforced Polymer (FRP) Composites in Civil Engineering, Jul 2023, Rio de Janeiro, Brazil. pp.1-11, <10.5281/zenodo.8136454>. <hal-04350830>

## A NEW ADHESIVELY BONDED COMPOSITE REPAIR FOR OFFSHORE STEEL STRUCTURES: STRENGTH ASSESSMENT AND FATIGUE

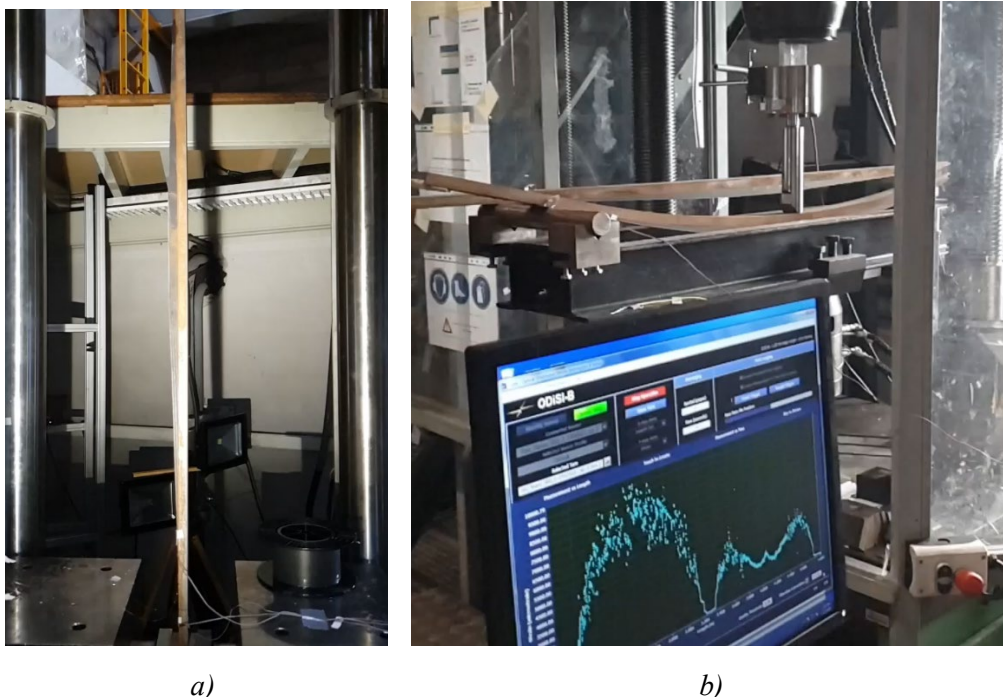
Figure 5: Traction (a) and three points bending (b) tests of composite to steel bonded assembly patch.

Figure 5 presents the two types of static tests carried out during our investigations. On the left, a tensile test is carried out on an Instron tensile machine with an ultimate capacity of 2500 kN while on the right, 3 points bending test is carried out on a Losen press with a capacity of 300 kN. The distances between supports for the bending test are 1450 mm. These two tests were chosen because they were identified as similar two the two types of solicitation that the patches would encounter in real case application.

These tests are made to measure the ultimate states at failure (strain) in the bonded patches as well as the ultimate capacities (force) for the two types of scarfs (short and long) and for the two types of tests

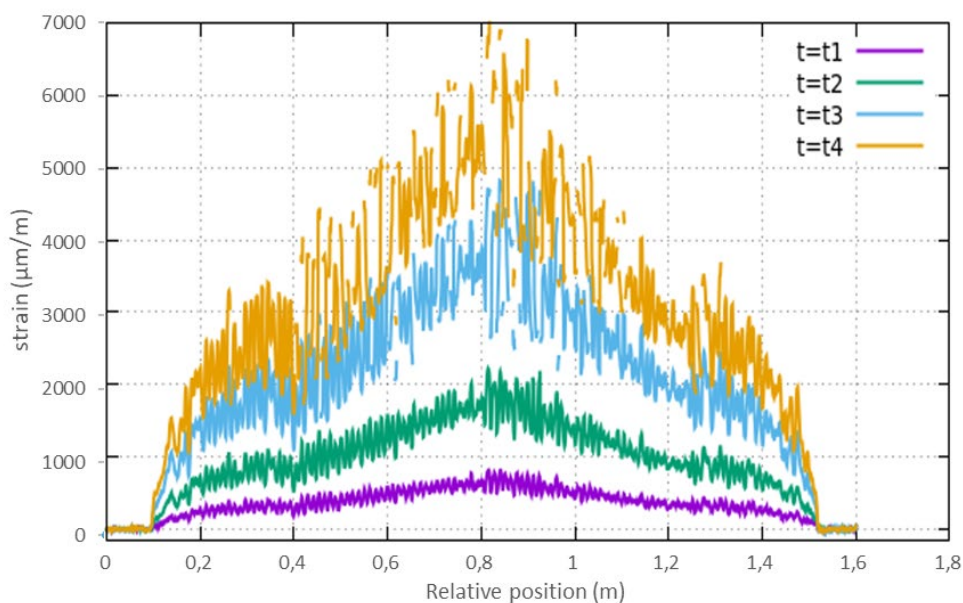
Figure 7: Bending test of small scarf samples optical fiber surface strains measurement.

The Figure 7 presents the obtained strains measurement along the optical fiber for one of the bending test with a specimen with small scarfs.

For the bending test (figures 7 and 8), the observation of strains profile on the surface of the patches shows that no strains concentrations are visible at the border of the patch (whether it be for the small scarfs or the long scarfs samples). In the case of the long scarf sample with embedded fiber, the direct effect of the patch on the steel surface strains is visible. It can be seen that they remain really low, especially in the center section of the patch. It indicates that the patch help to reduce stress in the steel surface where it is supposed to be corroded

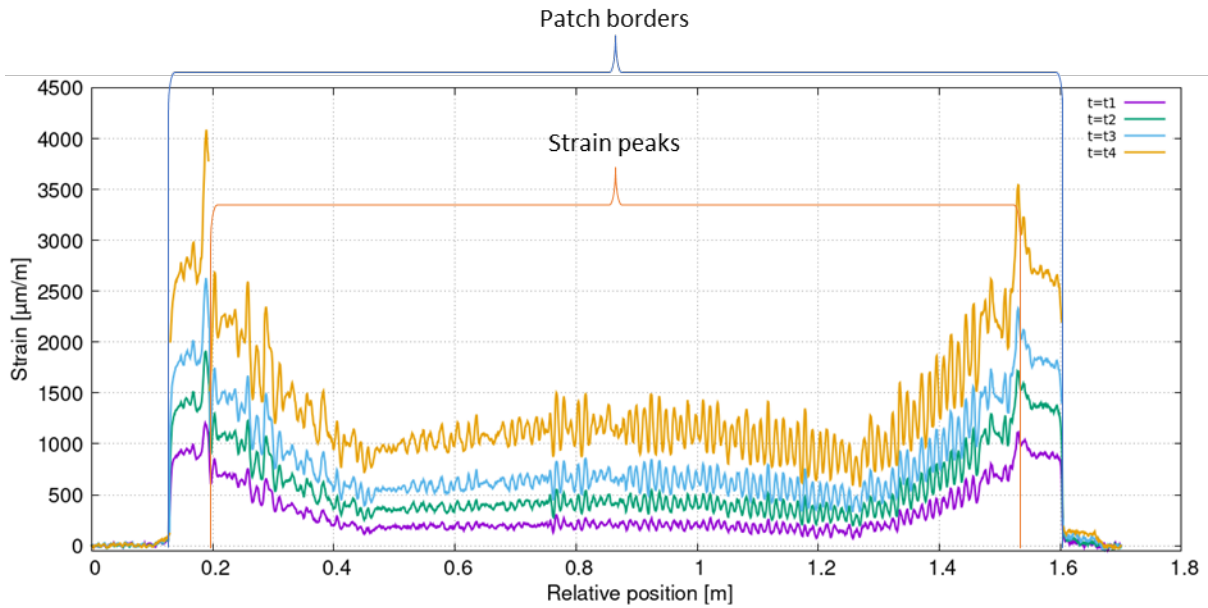
Figure 9: Tension test of small scarf sample optical fiber surface strain measurement.

The figure 9 presents the strains measurement obtained along the patch for one of the small scarfs specimens tested in tension. While, figure 10 presents the measured distributed strains during the tension test for a long scarfs sample. The left part of the curves shows the surface measurement and right part of the curves, the embedded one.

For the tension test, two high strain peaks are clearly visible between 5 and 7 cm from the border of the patch (figure 9 and figure 10). These locations correspond to the position of the border of the first carbon plies. When comparing the small scarf surface results (figure 9) and long scarf surface (figure 10), the strain transition length (distance of the effect of scarf from the border of the patch) is much longer for the long scarf. It allows to obtain locally, higher strain at failure. From the results of the embedded optical fiber, it can be seen that, compare to the short scarf results, the strain gradient is much lower at failure. It indicates that the longer scarf allows to have a much smoother strain transition from the steel plate to the patch. Also, these results indicates that despite the capacity of the patch to sustain equivalent strain in the steel plate of around 787MPa for the long scarf, ultimate properties could be increased by further modification of the design (example: change in the layup to reduce the strain peak at the patch border). These results also prove that the patch performances (much higher than the standard requirement) are directly linked to the patch design. The tension test seems to be more critical because

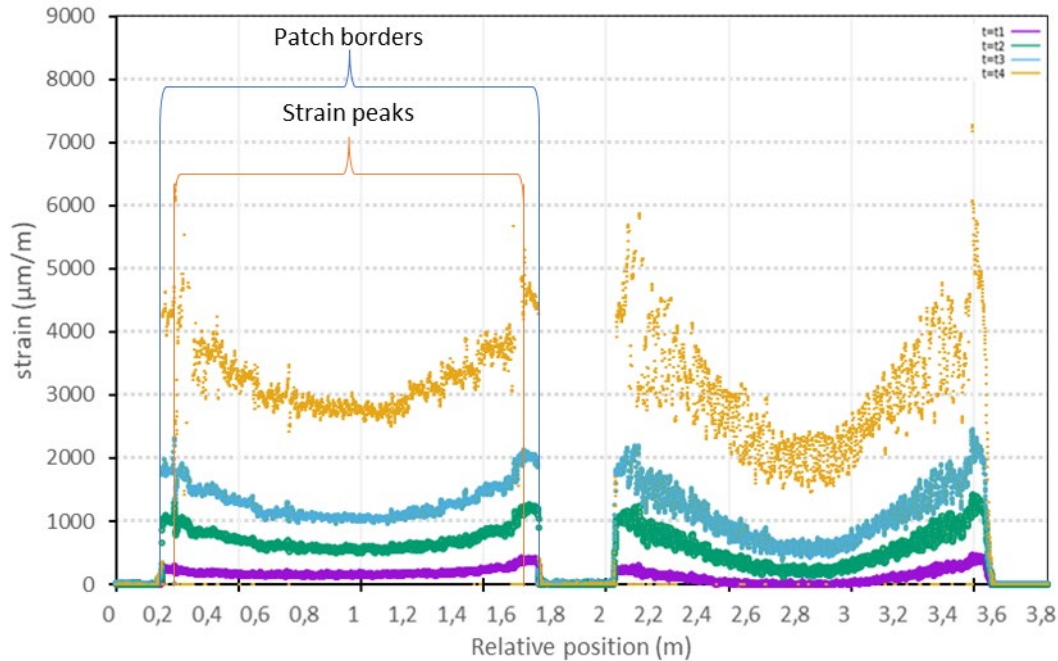
Figure 10: Tension test of long scarf sample, optical fiber inside (left) and outside (right) strains measurement.

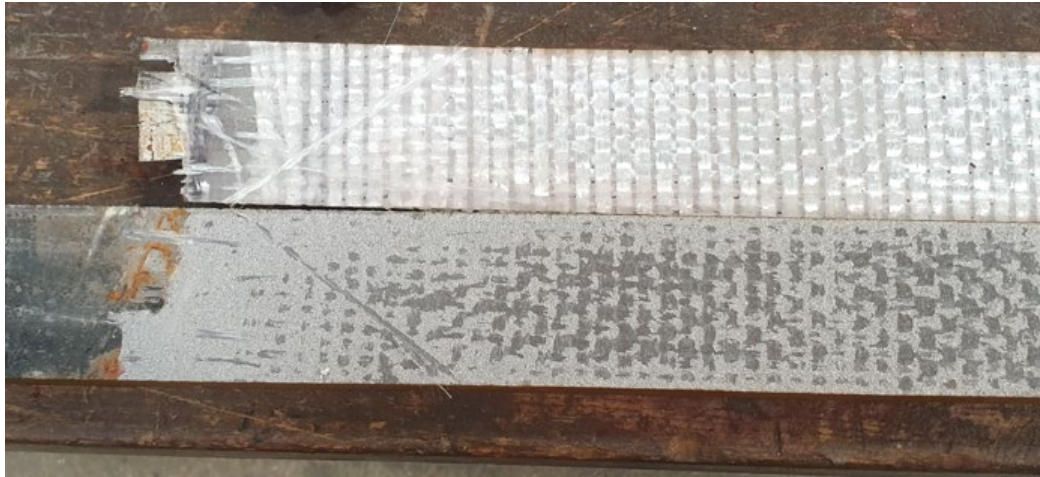
Figure 12. Fracture surfaces of the fatigue test samples in tension.

The Figure 12 shows the obtained fracture surfaces after the fatigue tensile tests. A multi-interfacial failure similar to the ones obtained for the monotonic test has been observed. Similar fracture surfaces were obtained for all the load levels tested. It is concluded that when a fatigue crack is initiated in the patch, the failure of the patch occurs in the same way as in the monotonic test and therefore, no real fatigue crack propagation happened. This assumption has been validated by the witnessing of the violent debonding of the patch during fatigue tests.
