Rapid and Continuous Imaging for Crack Monitoring during APT Experiments

Mai Lan Nguyen, Juliette Blanc, Stephane Trichet, Thierry Gouy, Gilles Coirier, et al.. Rapid and Continuous Imaging for Crack Monitoring during APT Experiments. 6th International Conference on Accelerated Pavement Testing, Université Gustave Eiffel, Apr 2022, Nantes, France. pp.649-657, <10.1007/978-3-030-55236-7_67>. <hal-04376775>

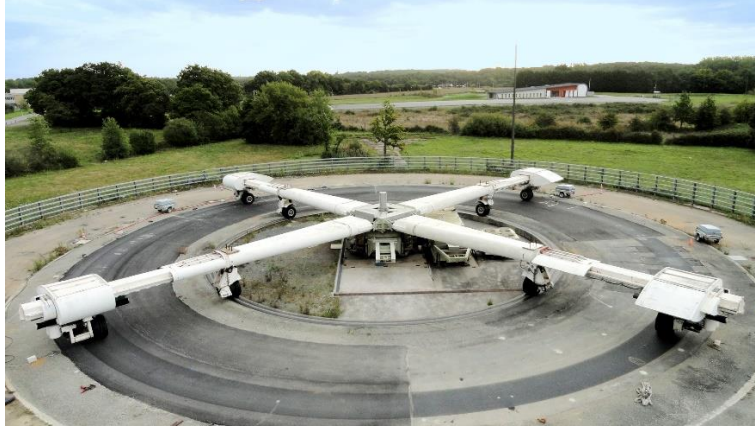
Fig. 2 The Accelerated Pavement Testing (APT) facility at IFSTTAR

The center of Nantes of IFSTTAR has a large scale circular accelerated pavement testing (APT) facility, also called the pavement fatigue carousel (Figure 2). By its characteristics (40 m in diameter, maximum loading speed of 15 rounds/min corresponding to a linear speed of 100 km/h at the radius of 19 m), it is one of the largest accelerated pavement testing facilities in the world. The APT facility can simulate in a few months the heavy traffic supported by a pavement during its whole service life. Its maximum loading rate is approximately 500 000 heavy loads per month. With this facility, it is possible to reproduce, in a few months, the deterioration mechanisms of real pavements, and to overcome the long durations necessary to observe significant deteriorations on real roads.

The carousel consists of a central tower and four arms (each 20 m long) equipped with wheels, running on a circular test track. The positions of the loading modules can be adjusted for different radii on each arm, for instance to test simultaneously the effect of different load configurations. During loading, a lateral wandering of the loads (up to 1.6 m wide) can be applied to simulate the lateral distribution of loads of real traffic. The moving speed of the loading module and its lateral position are controlled while the loading level is maintained, whatever the degree of deterioration of the experimental pavements.

The circular test track has a mean radius of 17.5 m and a width of up to 6 m, and thus a total length of approximately 110 m. Experimental pavements are built at full-scale by standard construction equipment.

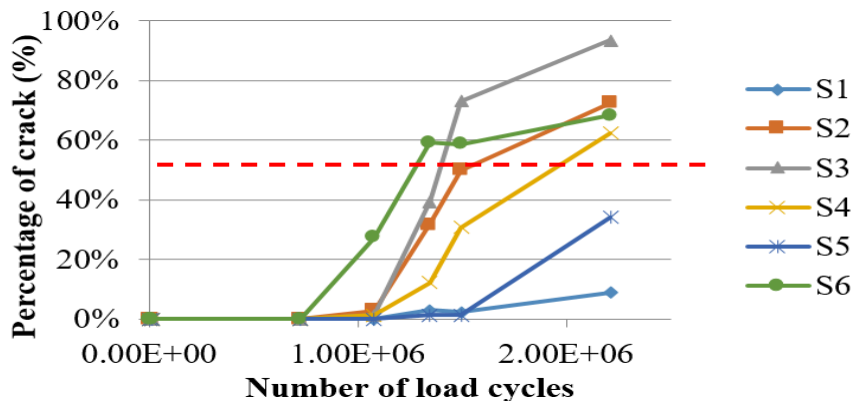
Fig. 7 Crack evolution on the 6 sections tested in the APT experiment, determined from the crack mapping process

Figure 7 presents the evolution of the percentage of cracking of the six different experimental pavement sections with applied traffic, calculated with the approach

described previously. On the IFSTTAR APT facility, it is generally considered that the failure of the pavement is attained when the level of cracking is equal to 50 %. (This limit is represented by the dotted line on figure 7). The results indicate that :

Sections 1 and 5 present the best fatigue behaviour, with levels of cracking of 10 % and 35 % respectively, at the end of the experiment.

Section 4 presents an intermediate behaviour, reaching a level of cracking of 50 % (corresponding to failure) after approximately 2 million loads.

Sections 2, 3 and 6 present the worst behaviour, reaching failure (50 % of cracking) after between 1.2 and 1.4 million load cycles.
