Rapid and Continuous Imaging for Crack Monitoring during APT Experiments

Mai Lan Nguyen, Juliette Blanc, Stephane Trichet, Thierry Gouy, Gilles Coirier, et al.. Rapid and Continuous Imaging for Crack Monitoring during APT Experiments. 6th International Conference on Accelerated Pavement Testing, Université Gustave Eiffel, Apr 2022, Nantes, France. pp.649-657, 10.1007/978-3-030-55236-7_67 . hal-04376775

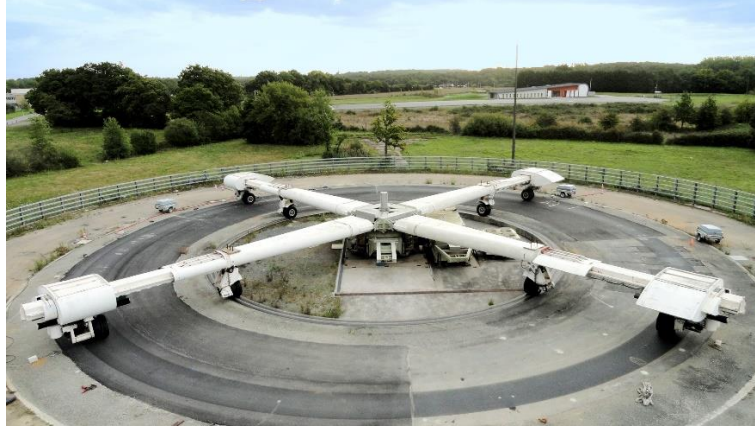
Fig. 2 The Accelerated Pavement Testing (APT) facility at IFSTTAR

The center of Nantes of IFSTTAR has a large scale circular accelerated pavement testing (APT) facility, also called the pavement fatigue carousel (Figure 2). By its characteristics (40 m in diameter, maximum loading speed of 15 rounds/min corresponding to a linear speed of 100 km/h at the radius of 19 m), it is one of the largest accelerated pavement testing facilities in the world. The APT facility can simulate in a few months the heavy traffic supported by a pavement during its whole service life. Its maximum loading rate is approximately 500 000 heavy loads per month. With this facility, it is possible to reproduce, in a few months, the deterioration mechanisms of real pavements, and to overcome the long durations necessary to observe significant deteriorations on real roads.

The carousel consists of a central tower and four arms (each 20 m long) equipped with wheels, running on a circular test track. The positions of the loading modules can be adjusted for different radii on each arm, for instance to test simultaneously the effect of different load configurations. During loading, a lateral wandering of the loads (up to 1.6 m wide) can be applied to simulate the lateral distribution of loads of real traffic. The moving speed of the loading module and its lateral position are controlled while the loading level is maintained, whatever the degree of deterioration of the experimental pavements.

The circular test track has a mean radius of 17.5 m and a width of up to 6 m, and thus a total length of approximately 110 m. Experimental pavements are built at full-scale by standard construction equipment.
