## Preventive fatigue strengthening of steel structures with bonded CFRP Efficiency demonstration on a real bridge

8<sup>th</sup> International Conference on Advanced Composite Materials in Bridges and Structures  
8<sup>ème</sup> Conférence Internationale sur les matériaux composites d'avant-garde pour ponts et charpentes  
Sherbrooke, Quebec, Canada, 18 – 20 August 2020 / 18 au 20 août 2020

## PREVENTIVE FATIGUE STRENGTHENING OF STEEL STRUCTURES WITH BONDED CFRP – EFFICIENCY DEMONSTRATION ON A REAL BRIDGE

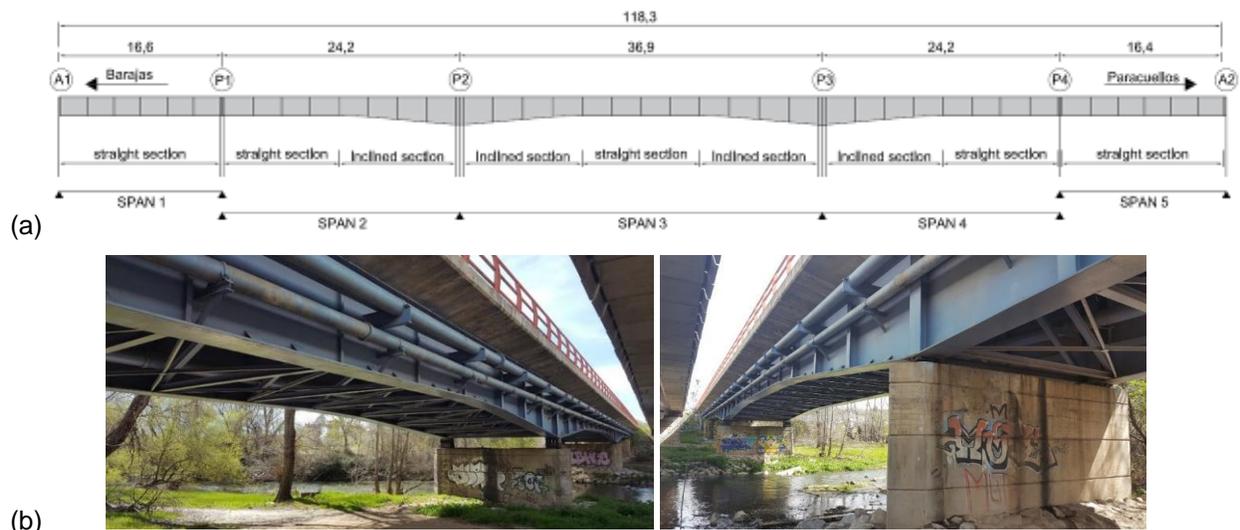
Fig. 1 – Span distribution (a) and general views (b) of Jarama bridge

Jarama Bridge is located in Madrid (Spain) over Jarama river on road M-111. It was designed in 1962 (Design Code 1956) and erected around 1965. It is a 3 span continuous beam with two lateral simply supported spans, with the following distribution: 16.6 m – 24.2 m – 36.9 m – 24.2 m – 16.95 m (Figure 1.a). The total length is 118.85 m. The main structure is made of structural steel whereas the top slab is in reinforced concrete with a width of 9,20 m. The whole structure is welded. The cross-section consists of two I-beams connected by transversal cross-bracings to stiffen the bridge in transversal direction (Fig. 1.b). The design code of 1956 did not take into account any fatigue limit state. Adequacy of the structure for the project needed to be checked by carrying-out a fatigue limit state analysis.

Span number 2 was selected for the demonstration (Barajas side, see Fig. 1.a). Single beams of span 2 are named "beam 1" and "beam 2". On each beam, four butt welds were worth investigating. Two were discarded because they are too close to the kink of the bottom flange. Therefore, only welds n° 29, 26, 25, 20, 17 and 16 were investigated (Fig 2.a) and effect of strengthening action was evaluated. In order to get as much information as possible from the demonstration, it was decided to apply different CFRP plate layer arrangements at these selected weld locations: one single layer of 5 plates, 2 layers of 4 plates, and 3 layer of 3 plates.

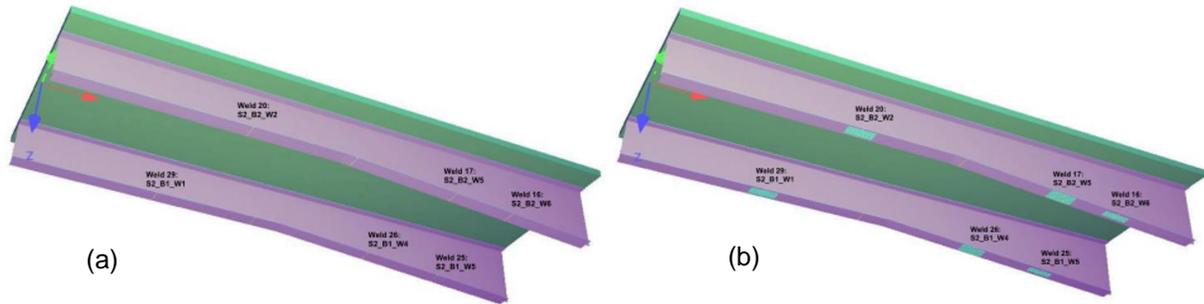
**Fig. 2 – Models of the studied span of Jarama bridge (Span 2) before (a) and after (b) reinforcement at the 6 selected weld locations.**

To evaluate the strengthening action of CFRP laminates on the butt welds of span 2, a 3D-shell-model was created in FEM-Program (Fig. 2). The two main girders are modelled with shell elements. The deck slab carries out the connection between both girders. For the modelling, the slab induces no loadings into the system and the stiffness in longitudinal direction was set to zero. This allows ensuring a realistic load distribution on both of the girders. The stiffness in transversal direction is achieved in reality by cross-bracings. To simplify the model, these latter are idealised by bearings fixed in y-direction.

Beforehand several scenarios were investigated to estimate an interaction between the welds (possible influence on the neighbouring weld if only one of the welds of the beam is strengthened). From the results of this preliminary investigation, it was decided to strengthen all 6 welds as shown in Fig. 2.b.

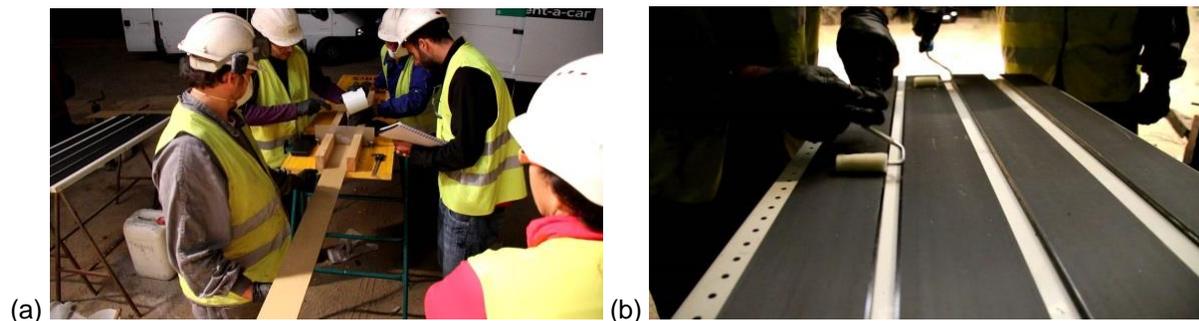
**Fig. 3 – CFRP preparation: (a) Application of the adhesive layer and (b) pressure application**

The adhesive mix was applied directly to the surface of the CFRP plate. In general, the target thickness for metal and FRP joints should be 0,5-2,0 mm. To spread the adhesive uniformly, a trowel with a v-notch was used (Fig. 3.a). The application was carried out on CFRP surface, and the impregnated plate was then applied to the steel surface; a roller was used to apply pressure along the reinforcement and remove voids from the adhesive layer (Fig. 3.b).

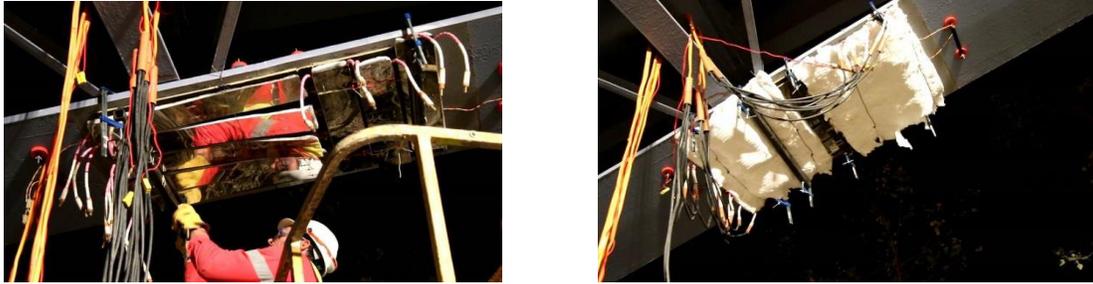
Fig. 4 – Installation of the heating system used for post-curing operation

Post-curing (1h at 80°C) of the bonded CFRP system attached to the structure was achieved onsite using ceramic pad units, isolating blankets and a clamping device (Fig. 4). Temperature at the surface of the CFRP plate was monitored continuously during the whole process, in order to control the heating rate and the target post-cure temperature. After removal of the heating system, paint was applied on the whole reinforcement and surrounding steel to protect the area where the coatings had been removed.

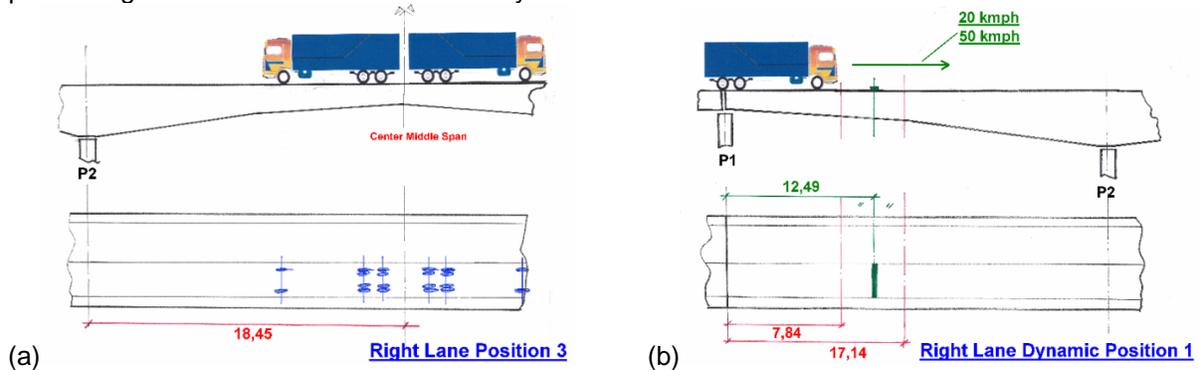
Fig. 5 – Examples of positioning of the trucks during static (a) and dynamic (b) load tests

Static tests were first performed by placing two 27 tons trucks (Renault Kerax) at three predefined positions of the bridge. Dynamic load tests were also performed by placing a wooden plank, 4 cm in height, at two selected positions, over which a single truck passed at a speed of 20 km/h and 50 km/h. The passage of the truck when hitting with plank, induced a dynamic impact load in the structure. Fig 5. shows examples of positioning of the truck for both static and dynamic load tests.

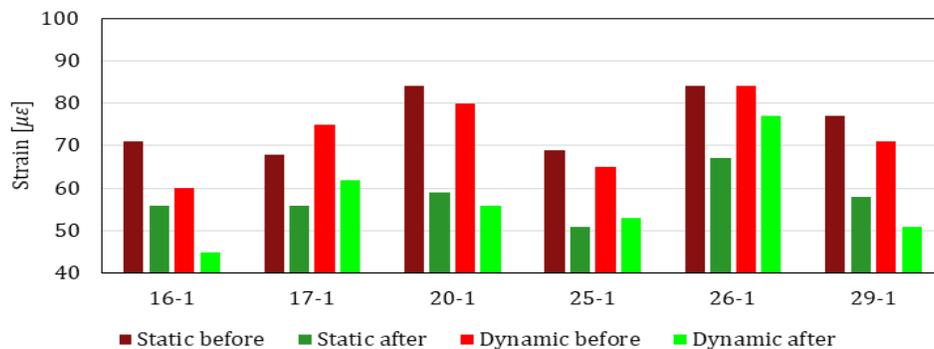
**Fig. 6. Strain measurements during static and dynamic load tests before and after retrofitting**

Main results collected by strain gages at the six weld locations are given in Table 1 and in Fig. 6 before and after reinforcement and for both static and dynamic tests. In all cases, a strain decrease between 8 and 30 % was observed after retrofitting, in agreement with theoretical expectations. The highest strain reductions (20 to 30 %) were obtained for locations reinforced with the highest numbers of CFRP plates, showing that the proposed solution works well in the case of the 3 layer configuration (welds 16 and 25). In addition, there was no discrepancy (in terms of strain reduction) for the locations that were reinforced without total traffic disruption (weld n° 16, 26 and 29) compared to those reinforced with total disruption. This suggests that the solution could be applied under low traffic, which would be a major advantage.
