Durability of FRP reinforcing bars exposed to an alkaline environment with/without additional sustained load

DURABILITY OF FRP REINFORCING BARS EXPOSED TO AN ALKALINE ENVIRONMENT WITH/WITHOUT ADDITIONAL SUSTAINED LOAD

Durability; FRP rebars; Alkaline solution; Concrete; Sustained load.

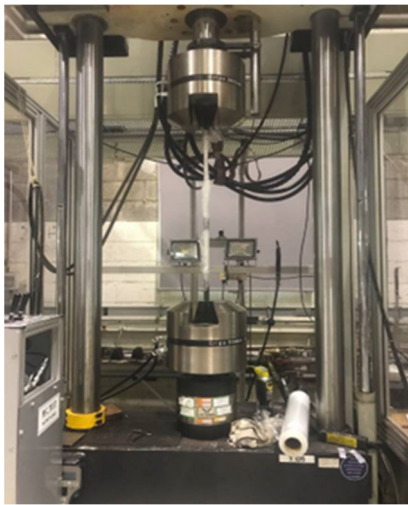
a) Tensile test

Figure 2 : Experimental setups used for the mechanical tests

The tensile strength and the longitudinal modulus of elasticity of the rebars were determined through tensile tests conducted in accordance with the American standard ASTM D7205 (ASTM, 2006), the ISO standard 10406-1 (ISO, 2008) and the French AFGC recommendations (AFGC, 2021). To prevent excessive damage to the ends of the FRP rebars during testing and to avoid premature rupture, a specific anchoring system was employed at each end. This system consisted of a steel tube filled with expansive mortar, which enabled more uniform distribution of radial tightening stresses. The tensile tests were performed on a hydraulic universal testing machine (UTM) of capacity 250 kN equipped with a force

measurement cell, at a displacement rate of 1 mm/min (see Figure 2.a). To measure the strain of the rebar during loading, a non-contact video extensometer was employed. This setup ensured accurate and reliable data collection during the experiments.

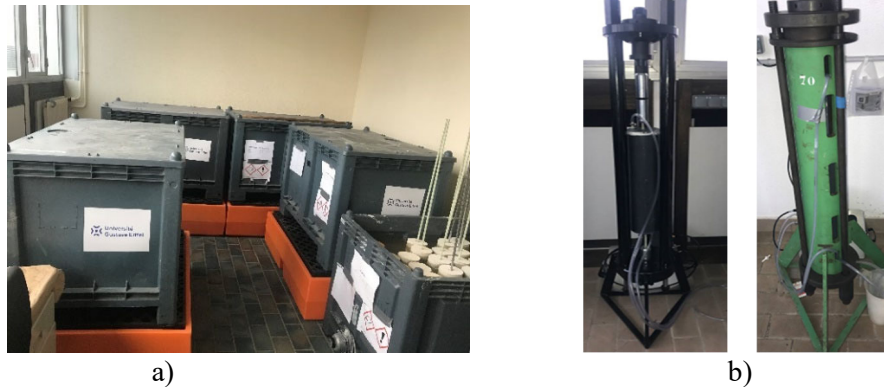
Figure 3 : a) Conditioning of ANL specimens in thermoregulated tanks filled with the alkaline solution; b) Metallic devices used for exposing the FRP specimens to an alkaline environment combined with sustained load (ASL conditions)

As mentioned earlier, a series of FRP rebars were subjected to accelerated aging in alkaline environments without the application of additional mechanical stress. This specific aging condition is denoted as ANL (Aging with No Load applied) in the following sections. The FRP rebars were first embedded in a concrete cylinder with a 50mm external diameter. These specimens were then immersed in an alkaline solution, which consisted of sodium hydroxide (NaOH) at a concentration of 0.1 mol/L and potassium hydroxide (KOH) at a concentration of 0.5 mol/L, resulting in a pH level of around 13.5. This solution is commonly employed in durability studies (Rolland, 2021) due to its ability to simulate the concrete medium at early age. GFRP rebars were immersed in large tanks filled with this alkaline solution and regulated at three different temperatures: 20°C (room temperature), 40°C, and 60°C

(Figure 3a). Differently, CFRP specimens were only exposed to the solution at 60°C (i.e., the most severe condition).

For this purpose, two models of metallic devices were utilized, as depicted in Figure 3b, with a total of six devices allowing for the simultaneous exposure of six specimens. These devices enabled the specimens to be loaded using a hydraulic jack, and the resulting longitudinal deformation was then maintained by securing the anchors. To ensure a constant force during aging, a reloading procedure was implemented due to relaxation phenomena. This procedure was calibrated using preliminary specimens that were monitored using a load cell. Maintaining constant force is a crucial aspect of these investigations, particularly considering the significant relaxation that can occur, especially at elevated temperatures. Using this device, two levels of load were examined, corresponding to 20% and 40% of the average tensile strength of the unaged FRP rebars (as determined at 20°C).

Besides, each device was equipped with a double cell: one cell containing the alkaline solution and the other for circulating water at a fixed temperature. Here again, three different temperatures were used, namely 20°C, 40°C, and 60°C. The specimens were aged for periods of up to 90 days under these ASL conditions.

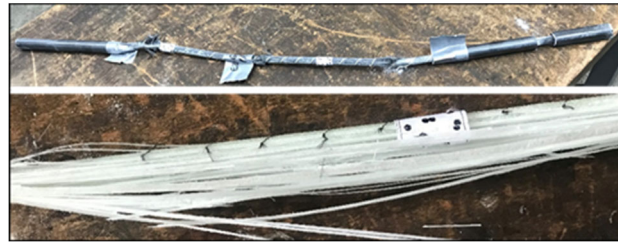
Figure 5: Typical tensile failure modes of GFRP (bottom) and CFRP (top) rebars, after exposure to ANL conditions.

Tensile tests were conducted on FRP specimens aged for the various durations under ANL conditions, in order to evaluate their residual properties. The failure modes commonly observed for GFRP and CFRP rebars are depicted in Figure 5. GFRPs typically undergo a brittle failure, whereas CFRPs exhibit more localized failure occurring at various points along the test device. These localized ruptures were observed to initiate primarily in the center of the rebar and subsequently near the anchorages, probably due to the release (after the first failure) of the elastic energy stored during loading.

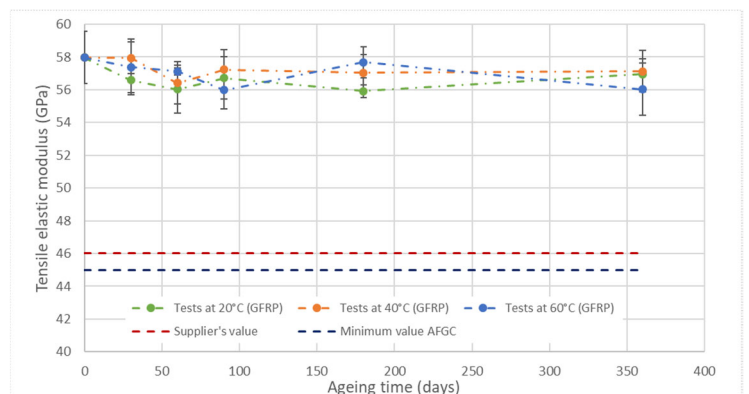
Figure 6: Evolution of the tensile properties of GFRP rebars during the aging process without load at different temperature (ANL conditions)

The average tensile strength and longitudinal modulus of elasticity of the aged rebars are presented in Table 2, while their variations over time (at different temperatures for GFRPs and at 60°C only for CFRPs) are illustrated in Figures 6 and 7, respectively. The modulus of elasticity was determined using the following equation:

In the case of GFRP rebars, no significant evolution of tensile properties was observed after one year of exposure to ANL conditions at 20°C and 40°C. However, a notable decrease in strength was observed at 60°C for exposures exceeding 180 days (reduction by about 16% after a 1-year exposure). For CFRP rebars, a significant decrease in strength was observed during the first two months of exposure at 60°C. However, after this initial period, a recovery in strength was observed, and the strength values tended to stabilize around the initial values of the unaged specimens.

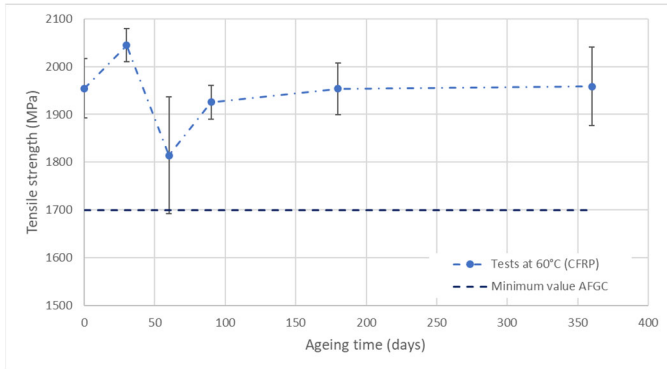
Figure 7 : Evolution of the tensile properties of CFRP rebars during the aging process without load (ANL) at 60°C.

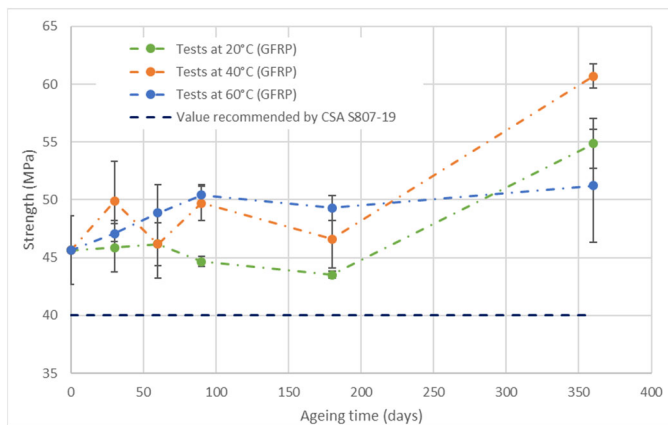
Figure 9: Evolution of the interlaminar shear strength (ILSS) of GFRP (a) and CFRP (b) rebars during the aging process without load (ANL).

The average Interlaminar Shear Strengths (ILSS) of the aged rebars are presented in Table 3, while their variations over time (at different temperatures for GFRPs and at 60°C only for CFRPs) are illustrated in Figure 9. The average values and standard deviations (Pearson) are calculated from the results of three repeated tests.

The results indicate an increase in interlaminar shear strength for GFRP rebars after 200 days of aging. Differently, for CFRP rebars, a significant decrease in ILSS is observed over aging at 60°C. Overall, the sensitivity to ANL aging appears to be higher for the matrix/carbon fiber interface compared to the matrix/glass fiber interface. This difference is likely attributed to the effectiveness of the sizing used (surface treatment of the fibers), which is generally better in the case of glass fibers.

According to the Canadian guide (CSA S807-19, 2010), a minimum ILSS value of 40 MPa is recommended for FRP rebars. It can be observed that initial values obtained for GFRPs are close to the guide's recommendations but still remain relatively low. On the other hand, the ILSS of CFRP rebars is significantly lower than the recommended values.

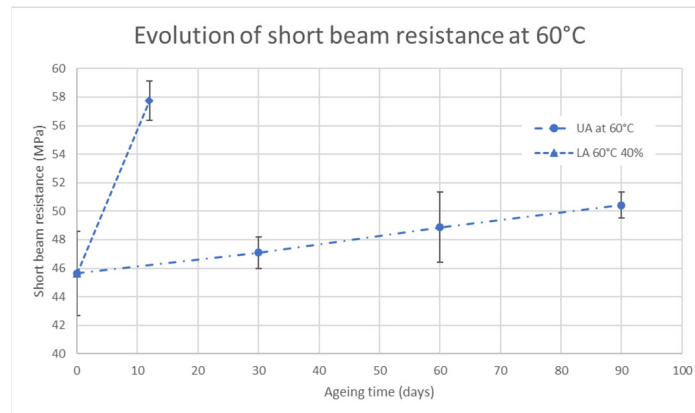
Figure 13: Evolution of the ILSS of GFRPs during ASL aging process at 60°C/40% of tensile strength and comparison with ANL results.

The average ILSS value for this series of specimens is presented in Table 5. In Figure 13, a comparison is made between this ILSS value and the values obtained for specimens aged under ANL condition at the same temperature (60°C). Interestingly, the ILSS of the ASL-aged specimen is significantly higher, indicating that the combined environmental/mechanical aging process contributes to a substantial improvement in the fiber/matrix properties. However, the underlying mechanism responsible for this enhancement has not been identified at this stage.
