# Influence of microstructure on mass loss caused by acoustic and hydrodynamic cavitation

**Abstract.** The proposed study investigates the damage mechanisms of martensitic stainless steel X3CrNiMo13-4 exposed to cavitation using two complementary experimental apparatus: ultrasonic horn (MUCEF) and hydrodynamic tunnel (PREVERO). Cavitation testing has been carried out on two different metallurgical states: QT780 and QT900 corresponding to coarse and fine microstructure respectively. Acoustic cavitation erosion tests have been performed on the MUCEF equipment inspired from the ASTM G32 standards but specially designed to be installed inside X-Ray tomographs. The ultrasonic horn operates at 20 kHz and the tested specimen is located at 500  $\mu\text{m}$  from the horn tip. Hydrodynamic cavitation erosion tests were conducted with classic experimental conditions of PREVERO device: a cavitation number of 0.87 corresponding to a flow velocity of 90  $\text{m}\cdot\text{s}^{-1}$  and an upstream pressure of 40 bars. For acoustic cavitation, mass loss has been identified as dependent of the microstructure while for hydrodynamic cavitation the mass loss is identical whatever the microstru

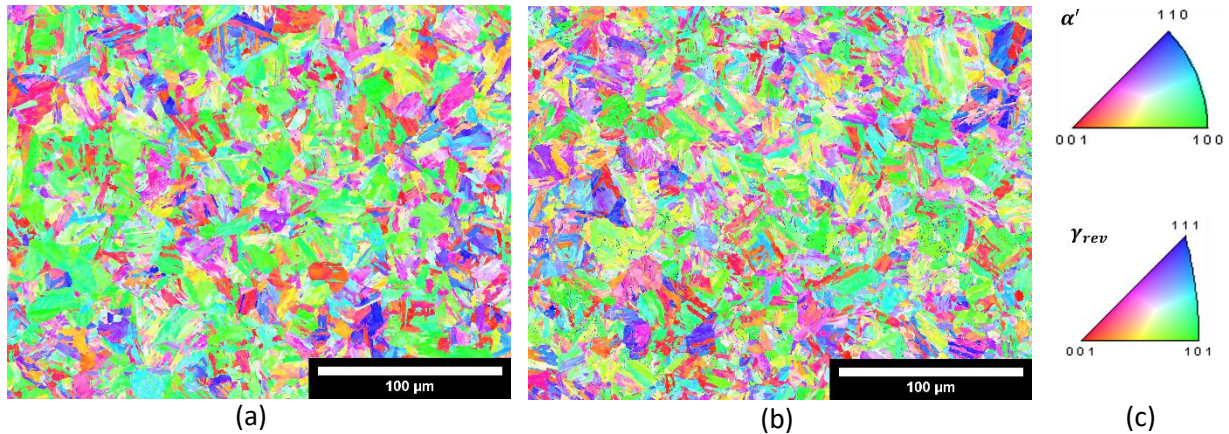
Figure 1: Electron backscatter diffraction (EBSD) orientation maps for grade (a) QT780 and (b) QT900 of X3CrNiMo13-4 martensitic stainless steel. (c) Inverse pole figures.

In the present study, the low-carbon martensitic stainless steel X3CrNiMo13-4 was used as the tested material. The two metallurgical states QT780 and QT900, corresponding respectively to coarse and fine microstructure, have been studied. Both grades were austenitised at 1100 °C and quenched. The differences in the two grades QT780 and QT900 lays in the tempered sequence, 600 °C for 2\*4 h and 540 °C for 4 h respectively. The resulting materials are composed of a  $\alpha'$  martensitic matrix with lamellar reversed austenite,  $\gamma_{rev}$  and residual delta ferrite,  $\delta Fe$ . Presence and proportion of these phases were confirmed using XRD analysis. Due to the different tempering conditions, the percentage of reversed austenite in each grade is different: respectively 11.9 vol.% and 2.7 vol.% for QT780 and QT900 grades. The reversed austenite can transform to martensite when submitted to plastic deformation: this is known as the transformation-induced plasticity (TRIP) effect. This transformation is associated to a volumetric expansion, which produces compressive forces that delay crack initiation and propagation. The low-carbon X3CrNiMo13-4 is hence widely used for water turbine manufacturing due to its high mechanical strength and high corrosion resistance. Figure 1(a) and Figure 1(b) show the orientations maps for the grades QT780 and QT900 respectively at the initial state with the martensitic matrix  $\alpha'$  and reversed austenite lamellas  $\gamma_{rev}$ . These observations using EBSD technique reveal that the QT780 grade is coarser than the QT900 grade.

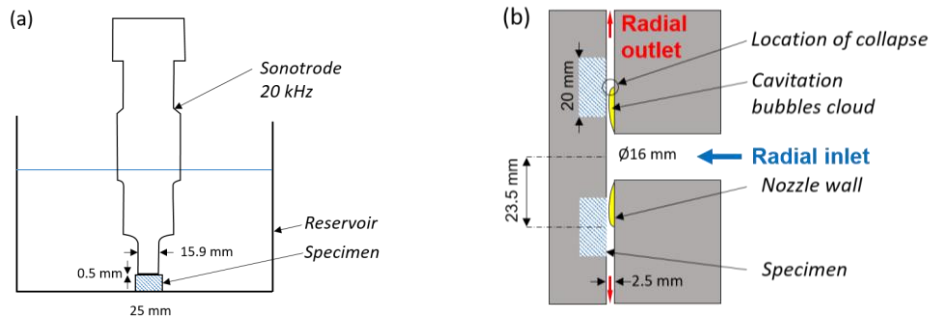
Figure 2: (a) MUCEF device used for generating acoustic cavitation. Specimen is located at 0.5 mm from the sonotrode (indirect method). (b) Cross section view of PREVERO device used for generating hydrodynamic cavitation. A constant cavitation number  $\sigma$  of 0.789 has been used for experiments.

For testing material, two experimental devices were used for generating acoustic and hydrodynamic cavitation. For MUCEF device, a sonotrode vibrating at 20 kHz with a peak-to-peak amplitude of 50  $\mu\text{m}$  was used for generating acoustic cavitation. The distance of 500  $\mu\text{m}$  between the specimen and tip was measured using x100 optical camera (Dino-Lite AM4815ZTL, Taiwan) and adjusted using a micrometric motorized stage (OWIS LTM120, Germany). This in-house setup, using indirect method and inspired from the ASTM G32 standard, is depicted in Figure 2(a).

Hydrodynamic cavitation testing was performed using the famous 40 bars flow tunnel called PREVERO located at LEGI laboratory. Water was accelerated using a centrifugal pump rotated by an 80 kW electric engine. Tap water was pressurized using nitrogen gas on the free surface of a water tank. As shown in Figure 2(b) on a cross section view, specimen were located at 2.5 mm from the nozzle wall where the velocity is approximately equal to 90  $\text{m}\cdot\text{s}^{-1}$  leading to the formation of cavitation bubble clouds. Hydrodynamic cavitation erosion tests were conducted at a constant cavitation number  $\sigma = 0.870 \pm 0.001$ .

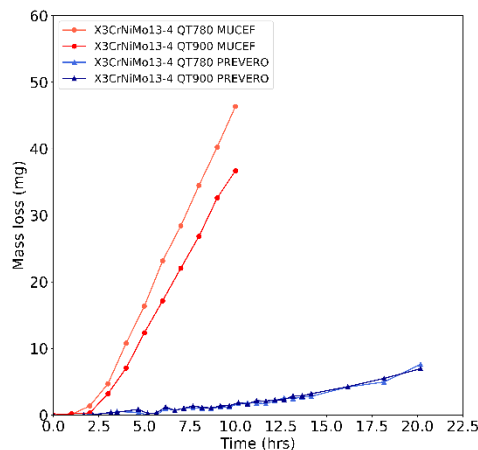
Figure 3: Mass loss as a function of exposure time in acoustic (MUCEF) and hydrodynamic cavitation (PREVERO) for the QT780 and QT900 grades.

Figure 3 shows the mass loss as a function of the exposure time to cavitation for both grades QT780 (coarse microstructure) and QT900 (fine microstructure) for acoustic and hydrodynamic cavitation. For each measurement point, the specimen were dried carefully and then weighted using an analytical balance. Incubation time, defined as the exposure time required to observe first mass loss, is greater for hydrodynamic cavitation than acoustic cavitation. The incubation times are respectively 1 h and 2 h for the grades QT780 and QT900 for acoustic cavitation while it is approximately 5 h for both grades for hydrodynamic cavitation. For hydrodynamic cavitation, the type of microstructure has no effect on the incubation time and both mass loss curves are identical. According to MUCEF experiments, the mass loss measured for the coarser microstructure (QT780) is more important than for the finer (QT900). This is consistent with the ranking of the ultimate strengths of these two grades. It is concluded that the mass loss curves depend on the microstructure only for acoustic cavitation whereas hydrodynamic cavitation could not distinguish the behaviour of the two grades. This difference of material response according to the type of cavitation could be attributed to the size of the bubble. It has been previously shown that hydrodynamic cavitation erosion creates large pits (20-250  $\mu\text{m}$ ) at a small pitting rate and, conversely, acoustic cavitation erosion creates small pits (5-30  $\mu\text{m}$ ) at a high pitting rate (5). Bubbles size generated by acoustic cavitation is thus closer to the characteristics size of the microstructure while the collapse of hydrodynamic cavitation bubbles does not differentiate the grains.
