Permittivity Analysis of Weathered Concrete in a Bridge Based on Open-ended Probe and Impedance Measurements

Benhui Fan¹*, Frédéric Bosc¹, Yu Liu², Mathieu Le Feuvre¹, Cyrille Fauchard³*

¹Cerema, Research Team ENDSUM, 23 avenue Amiral Chauvin, 49136, Les Ponts de Cé, France

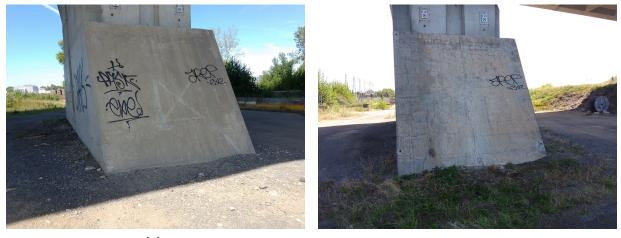
The test was performed on August 8th, 2023, a fine day at 16-22°C. We chose two faces of Pillar #12, the east and the west faces as presented in Figures 1 (a) and (b), because the two faces have the same reinforcement structure (19 vertical rebars with an interval of 0.224 m; 11 horizontal rebars with an interval of 0.3 m), but do not have a similar crack density on the surface. To reduce the potential increase caused by the rebar's conductivity on the complex permittivity, before the measurement, a ground penetrating radar (GPR, a GSSI StructureScan MiniXT at 2.7 GHz frequency) was used to find the position of the rebars. Then based on the positions of the hyperboles in the radargram (also known as B-scan, as presented in the lower left parts of Figures 1 (c) and (d)), we traced the rebar's positions in red solid lines on the wall and marked them in dashed black lines in the diagram. The points for the permittivity test were in the center of the grid, as indicated by the yellow crosses in the diagram.

Figure 1 Pillar #12 for the test: (a) for the east face and (b) for the west face; Photo of the tested area in each face (above); radargram (B-scan) by GPR along a light blue line on the photo (lower left); diagram of the tested points (in yellow): (c) for the east face and (d) for the west face

Additionally, if we check the photos in Figure 1, we can see cracks on both faces. The influence of the cracks cannot simply be explained as a reduction of the dielectric constant because the bridge is never dry. The development of the cracks makes the concrete absorb the wet air more easily, which can sometimes increase the complex permittivity. This is also the reason why we find more obvious cracks on the west face than on the east face as shown in the photos, but the complex permittivity of the west face is much higher. Hence, we will use loss tangent as an indicator to compare the health of the concrete in
