Damage evaluation under thermal fatigue of a vertical target full scale component for the ITER divertor

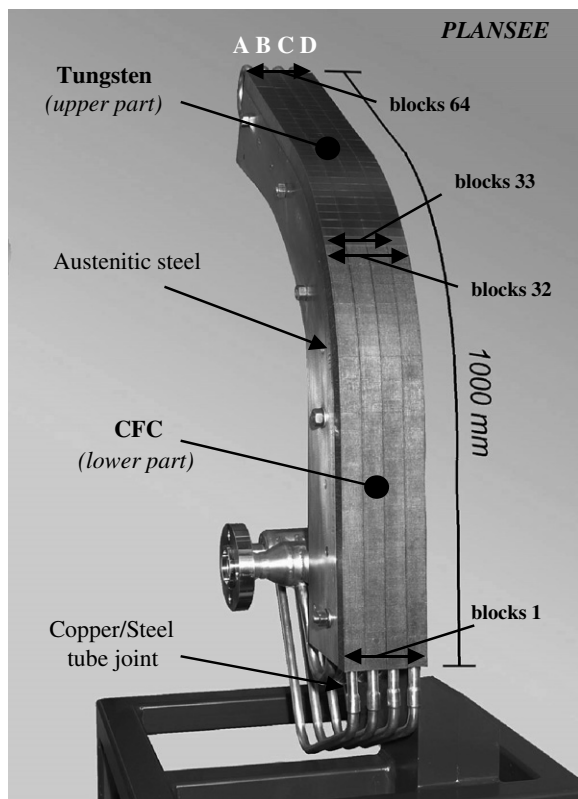
Fig. 1. Vertical target full-scale prototype manufactured by Plansee (high heat flux units) and Ansaldo Ricerche (support structure and integration).

The VTFS prototype is 1000 mm long and represents the main features of the vertical target ITER divertor design (Fig. 1). Four units (A–D) having a full monoblock geometry, obtained by drilling a hole into each armour block, were assembled in parallel and actively cooled. The lower part of the prototype (blocks 1–32) has a carbon fibre reinforced carbon (CFC) armour, grade NB31, supplied by the French company *Snecma Propulsion Solide*. The upper part of the prototype (blocks 33–64) is armoured with tungsten. A commercial grade was used (WL10) which contains 1% La_2O_3 . Active Metal Casting (AMC[®] registered by Plansee company [2]) process is used to join the OFHC Cu to the CFC armour. This assembling process is

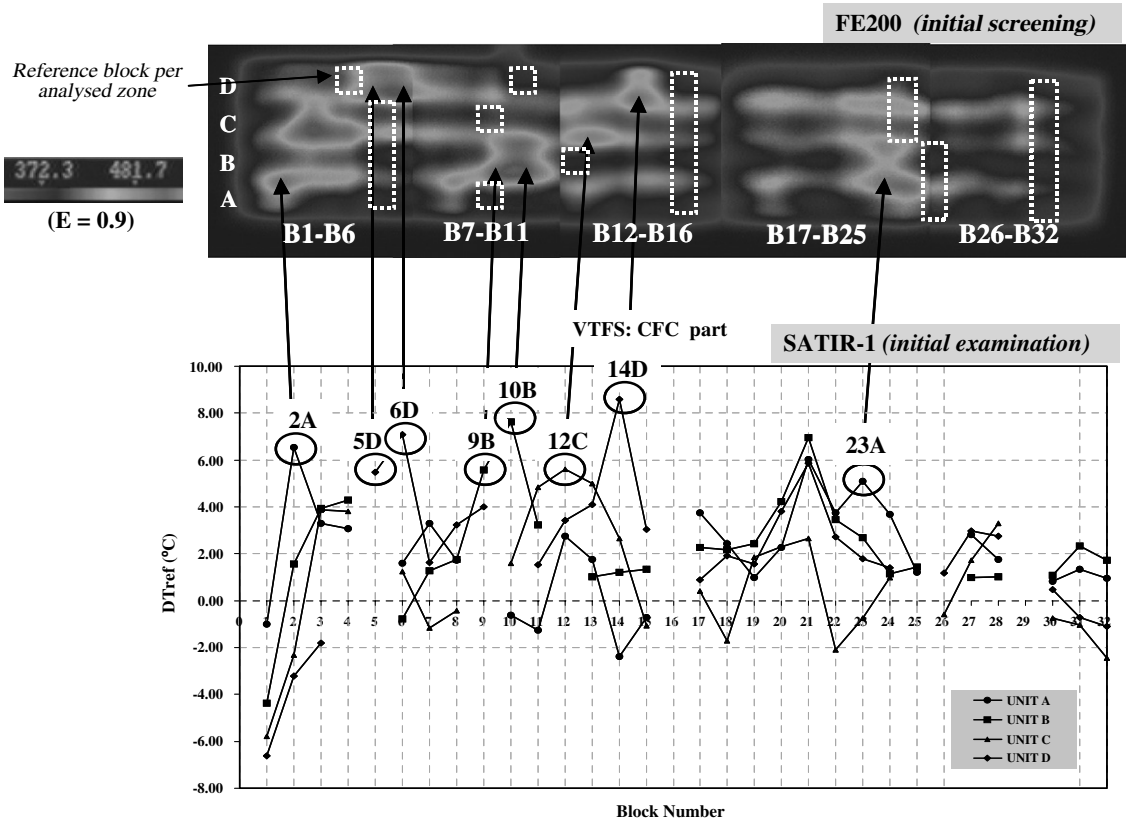
Fig. 2. CFC component infrared examination before the fatigue testing campaign.

On the other hand, the SATIR thermographic examination of the CFC straight part showed a

quite good correlation with the FE200 screening. These comparisons are shown in Fig. 2, before fatigue testing of all units, and Fig. 3, after fatigue testing of units A and D.

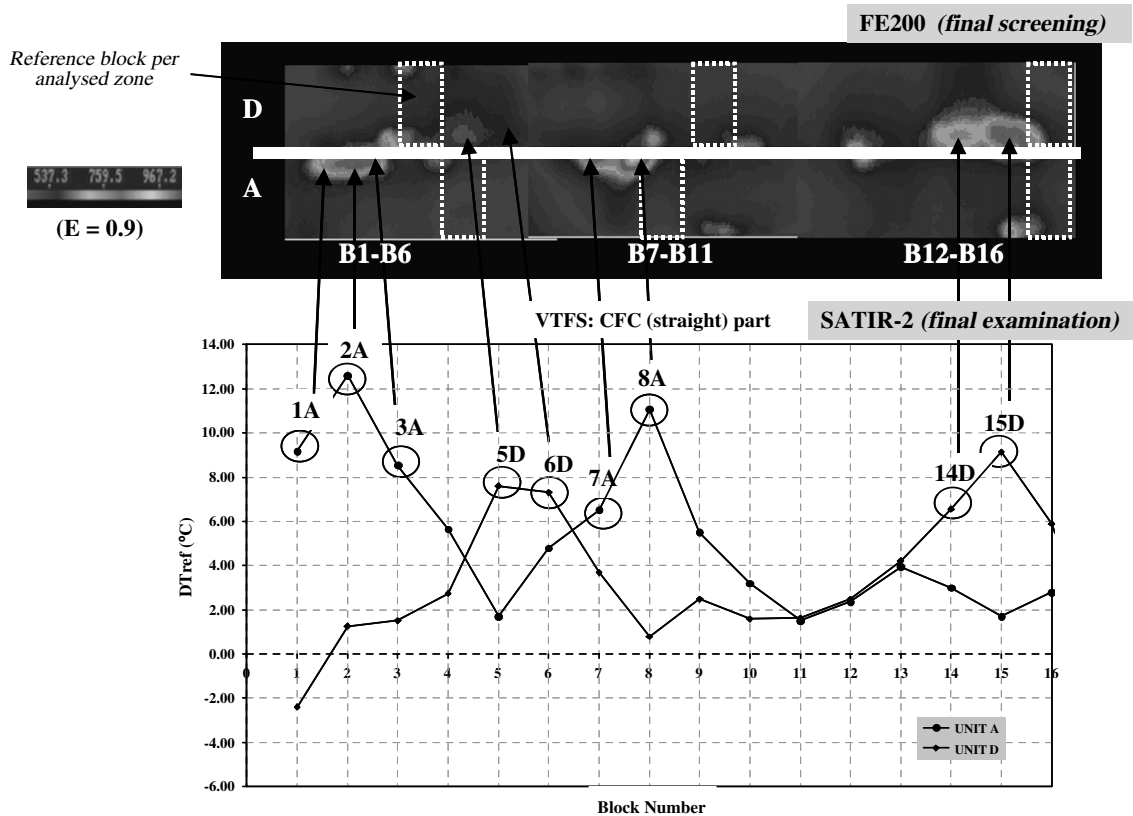
Fig. 3. CFC component infrared examination after the fatigue testing campaign.

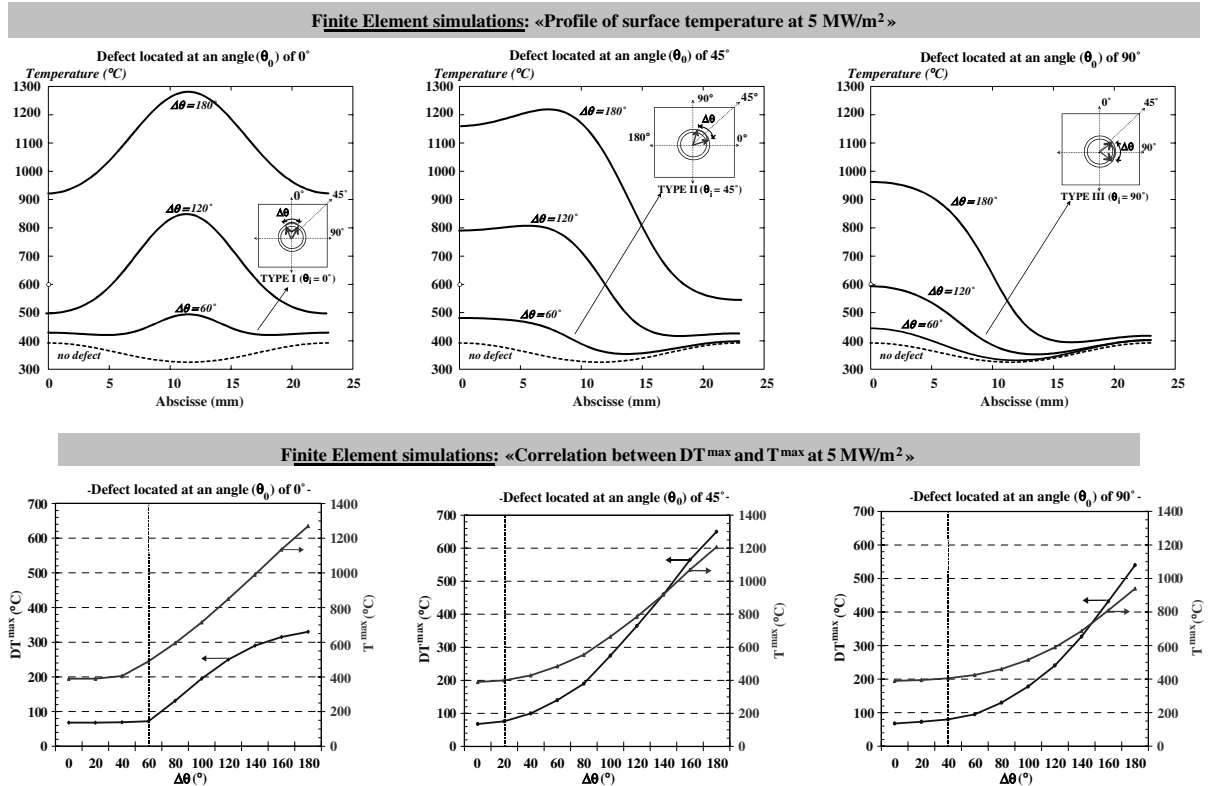
Fig. 4. Calculated profiles obtained from finite element simulations (CAST-3M) – T^{\max} profiles and correlation DT^{\max}/T^{\max} versus the location/size of defects.

First, the quality of the CuCrZr/Cu joint was inspected by ultrasounds and revealed an overall quite good quality of bonding. Second, FE calculations were done using the CAST-3M code to evaluate the location and size of defects observed for both SATIR and FE200 screening. The analysis of experimental data¹, compared to a set of calculated transverse profiles (Fig. 4) obtained from 2D simulations (hypothesis of traverse defects, corresponding to the experimental evidence) allowed the determination of possible defect location (θ_0) from the T^{\max} profile, and size ($\Delta\theta$), considering the T^{\max} and DT^{\max} amplitudes (cross check between these two parameters).

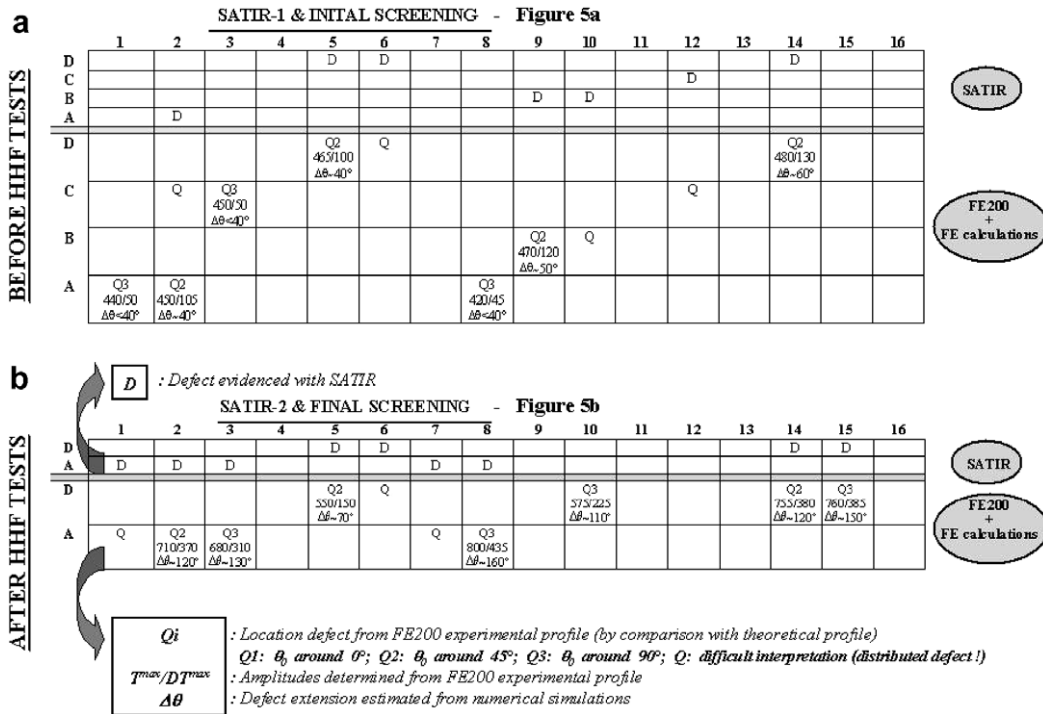
Fig. 5. Global sketch based on IR examination (SATIR/FE200-screening) before and after HHF loading.

The main observations obtained by IR examination before fatigue cycling and after the HHF load-

ing are given in Fig. 5. The analysis of blocks characterized by poor thermal contact showed that a few manufacturing defects at the Cu/CFC joint (11 blocks among 64) preferably appeared at an angle of 45° or 90° along the tube (with 0° corresponding to the top of the monoblock, i.e., parallel to the plasma facing surface) and are minor with an extension ranging not exceeding 60° (i.e., ~ 5 mm size) (Fig. 5a). The SATIR testing showed that the detected defects are preferentially located at an angle of 45° along the tube. The detection of minor defects located at an angle of 90° would have required an examination of lateral surfaces (not possible with this parallel assembly).

After the fatigue testing campaign (three series of 1000 cycles at 10, 20, 23 MW/m²), a generally increasing DT^{\max} and T^{\max} is observed during the FE200 final screening, mainly on the blocks already identified with a poor thermal contact during the initial screening. This does not show any critical defect propagation. The systematic analysis of experimental profiles correlated with calculated

profiles, allowed an estimation of flaws location and propagation during HHF testing (Fig. 5b), leading to these main findings:

- The AMC bond defects identified at an angle of 90° are more sensitive to damage propagation under high heat flux cycling than those located at an angle of 45° .
- The transient infrared thermographic (SATIR) control², including the uncertainties due to background noise, is especially sensitive to the detection of defects located near the examination surface. The detectable minimum defect was identified close to $\sim 40^\circ$ circumferential (i.e., ~ 4 mm size) in the CFC–Cu joint for the VTFS geometry (5 mm thickness of CFC). To obtain comprehensive information on internal bond quality of the monoblock component, this type of inspection requires control of all outside surfaces (top and lateral sides).

- AMC bond defects, identified initially by thermographic examination with an extension not exceeding $\sim 60^\circ$ (i.e., ~ 5 mm size), remain relatively stable up to 10 MW/m^2 . At higher heat flux, some defects slowly propagate during fatigue testing, reducing the thermal lifetime of the component. However, the results obtained during this experimental campaign with heat fluxes higher than required for normal operation, demonstrates the impressive high defect tolerance of the monoblock technology, confirming results obtained elsewhere [6].
