INFLUENCE OF BOUNDARY CONDITIONS ON THE FAILURE BEHAVIOR OF T-JOINT-SHAPED OVERMOLDED COMPOSITE STRUCTURE

Xiaofei Song, Federica Daghia, Christophe Cluzel, Yannick Elie

Xiaofei Song, Federica Daghia, Christophe Cluzel, Yannick Elie. INFLUENCE OF BOUNDARY CONDITIONS ON THE FAILURE BEHAVIOR OF T-JOINT-SHAPED OVERMOLDED COMPOSITE STRUCTURE. 21st European Conference on Composite Materials, Jul 2024, Nantes, France. 10.60691/yj56-np80 . hal-04670208

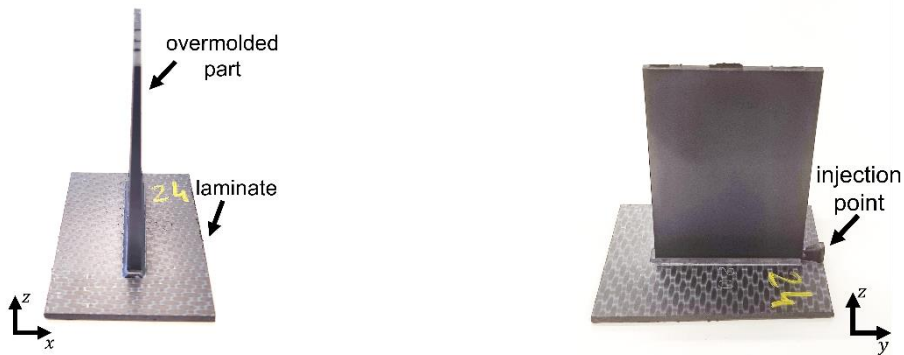
Figure 3. Original T joint structure as produced, before recut

In terms of specimens, two types of joints are studied: a straight T joint (Table 1 left (a)) and a T joint with added chamfer (Table 1 left (b)). The original T joint structure is shown in Figure 3. The length along the injection is approximately 42 mm. Two specimens, each with 20 mm width (Figure 4), were extracted from every T joint. To better guarantee the uniformity of the stress distribution of the interface, the leftover length of the laminate in the y direction (without the overmolded part) was removed.

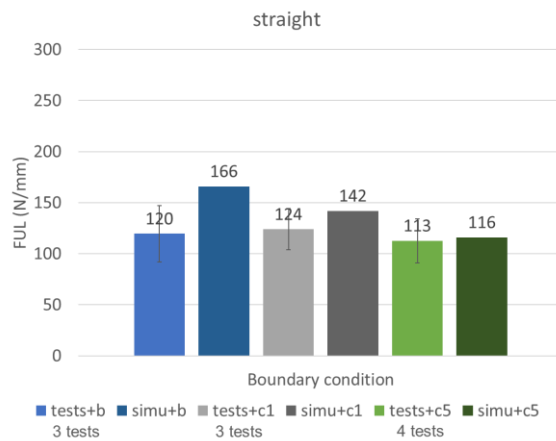
Figure 9. FUL of the straight joint

In the numerical simulations, the interface between the laminate and the overmolding was represented by means of a cohesive zone model, but no crack in the laminate or bulging laminate geometry was simulated in the area under the overmolding. Since previous simulations were carried out with a 2D model, the maximum force (at ultimate failure) measured by the tensile test machine was converted to FUL by dividing it by the width of the T joint (in the y direction) to facilitate the comparison (Figures 9 and 10).

First of all, a significant difference can be observed between the simulations and the tests under condition (b). As was explained in Section 3.1, this is associated with the cracking in the laminate, which lead to a change of boundary condition. This phenomenon is also identifiable during the testing: a noise could be heard and a load drop appeared systematically at the same time. Moreover, the interface presents voids that were created during the injection process. The condition (b) forces the load transfer to go through the lower part of laminate that is potentially a weak zone, as was mentioned in Section 3.1, which could justify the low FUL compared to other configurations with bending. Secondly, the STD of the tests can be interpreted by the scatter of the specimens mentioned in Section 3.2. Longer cracks that did not result in failure are visible among the specimens with higher failure force. From the point of view of joint shape design, adding a chamfer does contribute to achieving a better performance. Nevertheless, it seems to be less efficient when more bending occurs.
