The Wreck of the Mid-17th-Century Erquy-Les-Hôpitaux (Côtes D' Armor, France)

Éric Rieth, Olivia Hulot, Marine Jaouen, Frédéric Osada, Pierre Poveda. The Wreck of the Mid-17th-Century Erquy-Les-Hôpitaux (Côtes D' Armor, France). Shipbuilding, knowledge and Heritage, 2018, Vila do Conde, Portugal. pp.21-51. <hal-04670817>

THE WRECK OF THE MID-17TH-CENTURY *ERQUY-LES-HÔPITAUX* (CÔTES D'ARMOR, FRANCE)

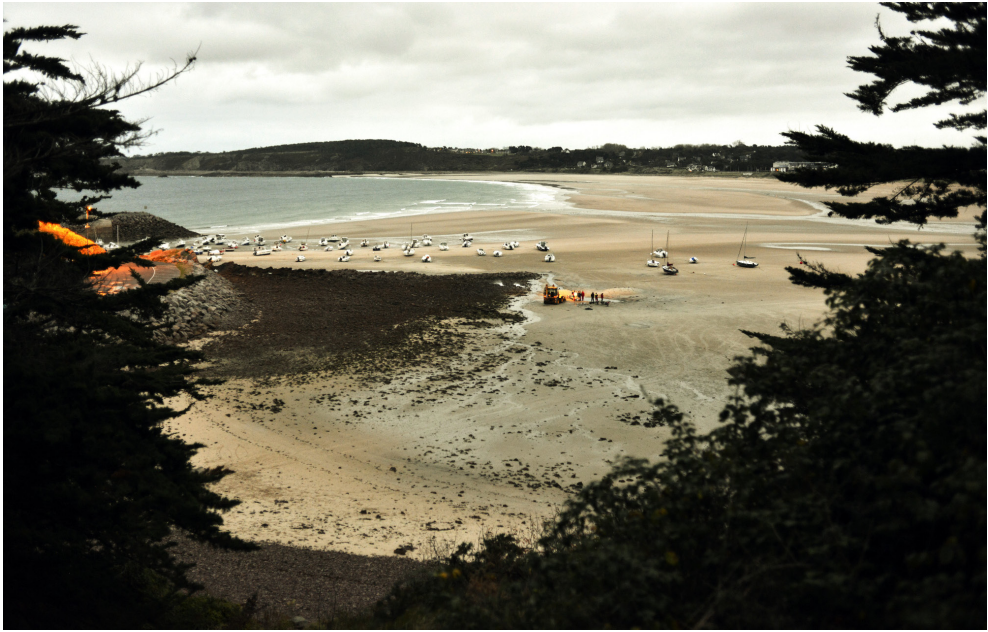
Fig. 1.2. General view of the site; the wreck is situated near the yellow tractor and the group of people
Source: Images Explorations — F. Osada

Besides, beyond the excavation, that operation is attached to a programme of multi-year studies directed by O. Hulot on the problems of excavation in the context of the foreshore which implies the definition of a strategy of terrain and the putting into effect of methods and techniques of excavation, as well as the recording of data (architectural statements in particular), adapted to such an «amphibious» environment (Fig. 1.2).

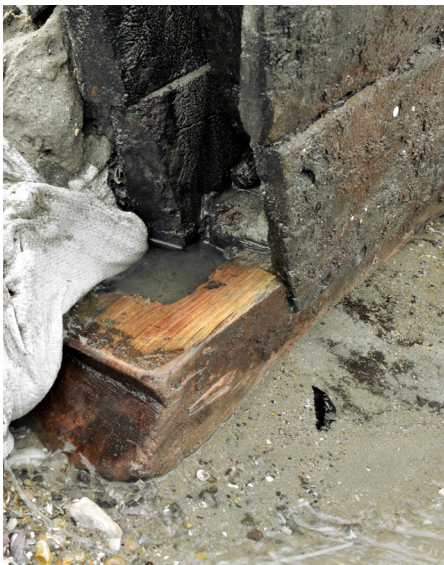
Fig. 1.6. The open mortise in the aft extremity of the keel
 Source: Images Explorations — F. Osada; E. Rieth/S. Bertoliatti

The aft extremity of the keel is given a mortise open on its port side into which the foot of the sternpost is assembled (Fig. 1.6). This building of the tenon of the sternpost into an open mortise appears to be uncommon with regard to the usage of a closed mortise which is itself attested in Western and Northern Europe from the end of the Middle Ages. The mortise has a breadth of 9cm, a length of 12cm, and a depth of 9.5cm corresponding to the height of the keel at that point. These dimensions evidently correspond as well to those of the tenon of the foot of the sternpost. The aft face of the mortise is fashioned obliquely. The inclination in relation to the upper horizontal face of the keel is of the order of 70 degrees, a value which, as we will examine later, corresponds to that of the aft face of the sternpost knee and therefore of the sternpost. That of the forward face has not been observed. Besides the open mortise, the aft extremity of the keel possesses two other characteristics. The first is a discontinuity of 0.5cm between the height of the keel (9cm) at the level of the notch and that of the keel forward of the notch (9.5cm). The second is a skeg of angular profile, of 7.5cm length.

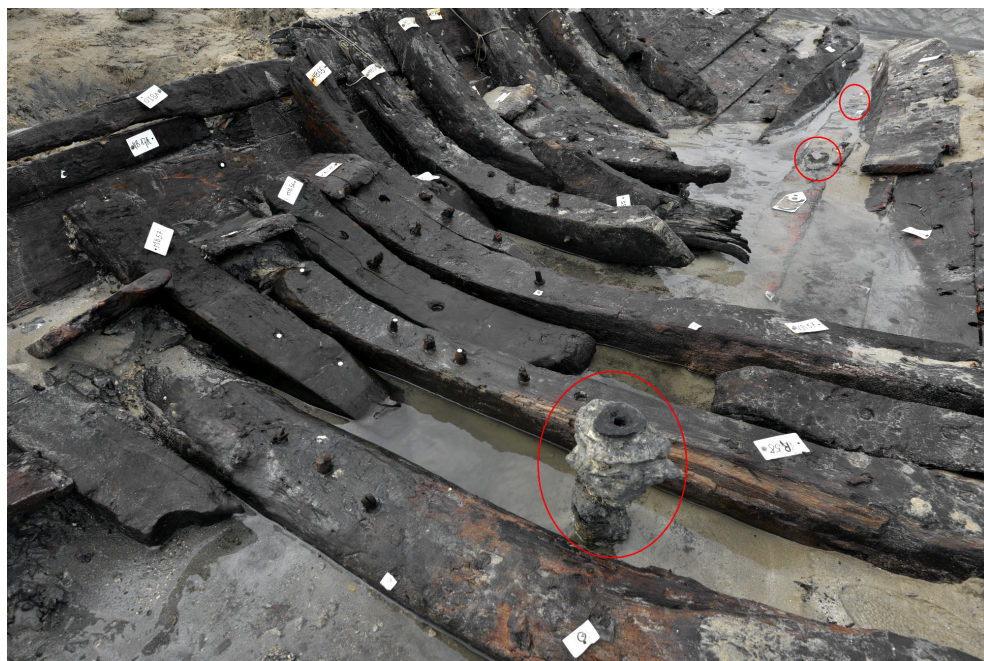
Fig. 1.7. Three traces of assembly by iron pins/bolts in the keel
Source: Images Explorations — F. Osada

One last characteristic of the keel, very important from the point of view of the general knowledge of the interior carpentry of the hull, has been registered. Along the whole length of the upper face of the keel, just three traces of assembly by an iron pin have been observed (Fig. 1.7). The first, corresponding to a pin of 3cm diameter, is situated at 70cm from the forward extremity of the keel, some 1/10 of the length of the keel. The second, corresponding to a pin of 4cm section, is placed at 1.66m from the forward extremity of the keel, or around 1/4.3 aft. Finally, the third is placed at 3.8m from the forward extremity of the keel, or around 1/1.9 aft. Unlike the other two this pin of 3cm section is preserved intact in height under the form of an iron concretion. Its height is 37.5cm. This pin is located in the space separating the floor timbers VR48 and VR59. An important characteristic to recall: these three pins are the only traces of the assembly observed, and carefully checked on various occasions, on the upper face of the keel. They are essentially intended to fix a keelson — not preserved — to the keel. That signifies that the floor timbers, with the exception of the rising floor timber VR61 fixed to the keel by two carvel nails, are «floating», that is to say without any assemblage, in relation to the keel. We will return during the study of the framing to the floating character of the floor timbers.

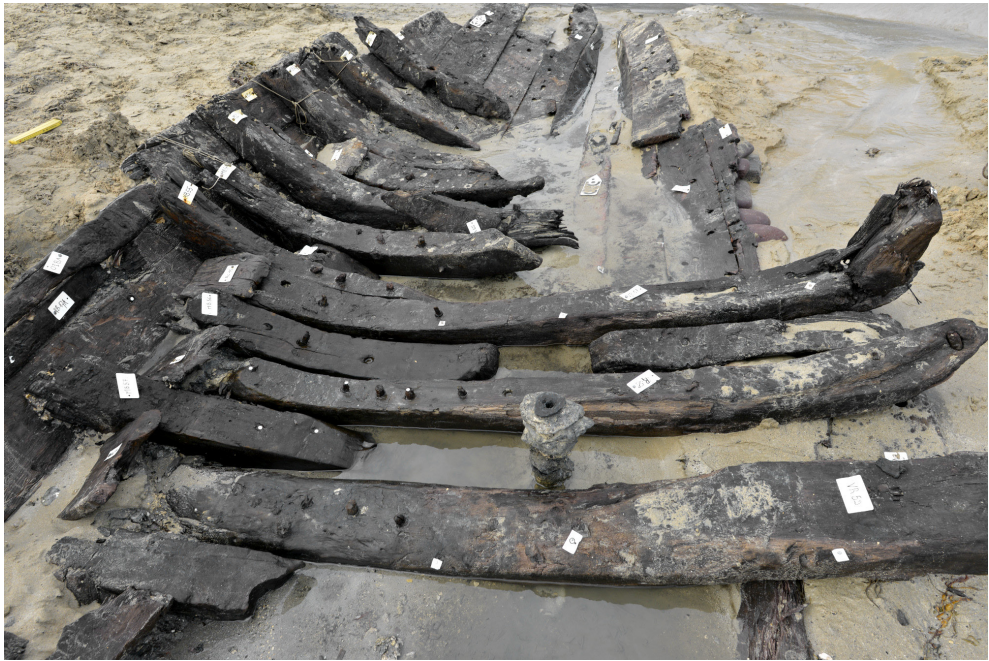
Fig. 1.9. The best preserved iron pin/bolt between the floor timbers VR58 and VR59
Source: Images Explorations — F. Osada

A second «phantom piece»: the keelson¹⁰. A bolt, that situated between the floor timbers VR58 and VR59, is preserved intact to its head (Fig. 1.9.). Its height is 37.5cm. Taking account of the height of the two floor timbers (17 and 19cm), the height of the keelson can be reconstructed in all likelihood as around 18cm/18.5cm above the floor timbers. No data allows its breadth to be reconstructed. As a hypothesis, a breadth close to that of its height seems reasonable. The length of the keelson is more difficult to determine. Its minimum length in terms of the three points of attachment could comprise between 3.8 and 4m. As to its maximum length it seems hardly possible to evaluate it, from the too great number of unknowns. Two characteristics however are certain. On the one hand, the reconstructed section of the keelson appears clearly to be stronger than that of the keel and consequently makes the keelson into a major piece of reinforcement of the primary longitudinal carpentry of the hull, even if the number of bolts in the assembly and their intervals appear a little too reduced in relation to the reconstructed length of the keelson. It is besides possible that that presumed keelson, in a principal or secondary role, served as a mast step. If the relationship of proportions between the sections of the keelson and that of the keel corresponds to traditional practices¹¹, the weakness of their assembly seems unusual, and in any case reduces the structural function of the keelson. On the other hand, the three bolts are located, for one amongst them for sure and for the others in all probability¹², in the space separating two floor timbers. Although it hardly conforms to the theoretical usages that wish the bolts to pass systematically through a full thickness over their whole length at the risk of weakening their solidity, the *Erquy* wreck shows, after other wrecks, that important deviations can exist between the theoretical precepts of the treatises and the practical reality of the shipyards.

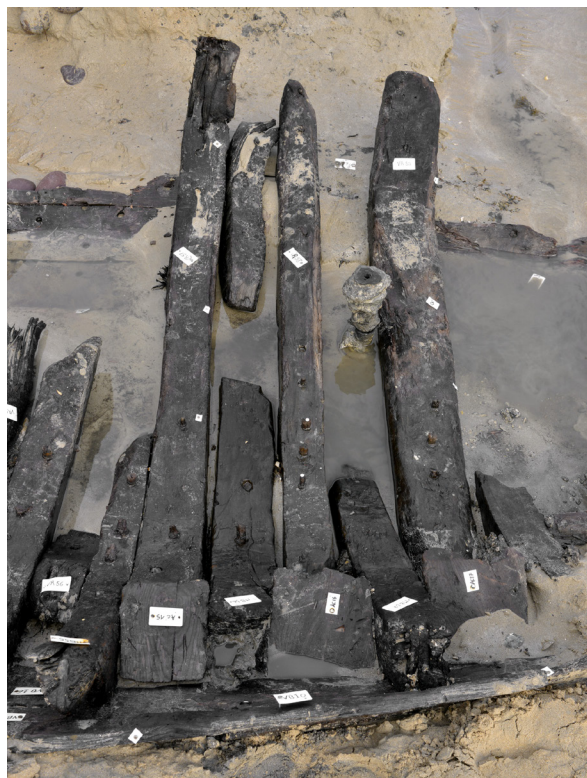
Fig. 1.11. Obliquely worked lower extremities of the futtocks; the direction of the bevel is reversed
Source: Images Explorations — F. Osada

Conversely, the obliquely worked lower extremities of the port futtocks MB56, MB57, MB59 and MB60 and those of the starboard futtocks MT51 and MB52 have their tapered extremities oriented towards the sternpost (Fig. 1.11). If one takes into account that orientation of the lower extremities of the futtocks as a criterion for the organisation of the frames, the master section could be situated at the frames VR57/MB55, confirming the transition with the frames of the after part of the hull, for which the direction of the bevel of the lower extremity of the futtocks is reversed. We add that that frame VR57/MB55 is situated at around 35 cm forward of the middle of the length of the keel, a position completely compatible with that of the master section. Lastly it will be seen that this frame, presumed to be the master section, possesses besides another very important characteristic.

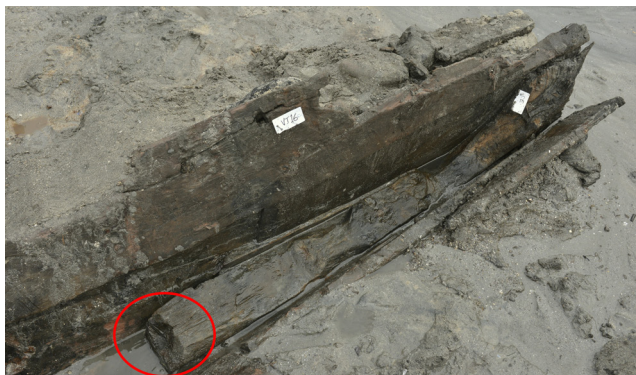
Fig. 1.13. The tetrahedral pilot hole in the front end of the sternpost knee
Source: Images Explorations — F. Osada

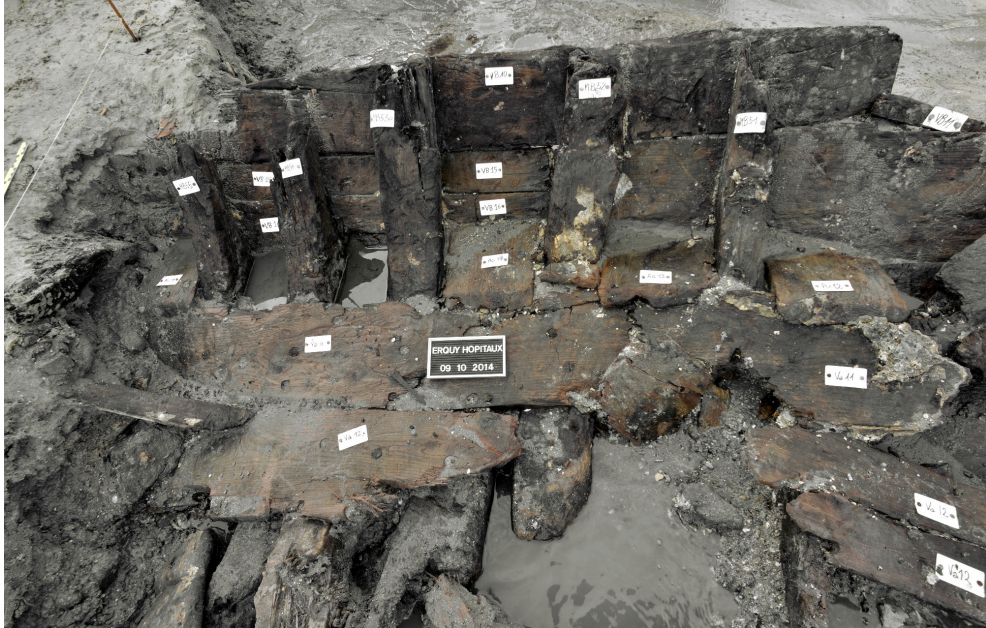
Fig. 1.15. The filling boards (left to right) AC15, C14, AC13, AC12
Source: Images Explorations — F. Osada

2.3.2. The Filling Boards (Fig. 1.15)

In total, nine filling boards (AC10-AC18) of which six are in elm (AC12-AC17)¹⁵ are preserved on the port side. These pieces are simply built in forcibly in the space between futtocks at the upper edge of the floor timbers Va11, Va22 and Va59 which form the ceiling pieces called filling boards. Their length comprises between 24 and 30cm for a breadth of 26cm and a thickness varying between 3.5 and 5cm. Generous as the frames are, these filling boards contribute to the cohesion and reinforcement of the transverse carpentry of the boat¹⁶, assuring a function of protection of the bottom by preventing objects from falling into the space and slipping into the bottom of the hull, risking obstruction of the flow of water to the pump. We add that the full ceiling of the bottom of the hull and the closure of the frame spaces by the filling boards facilitate the loading of loose cargo.

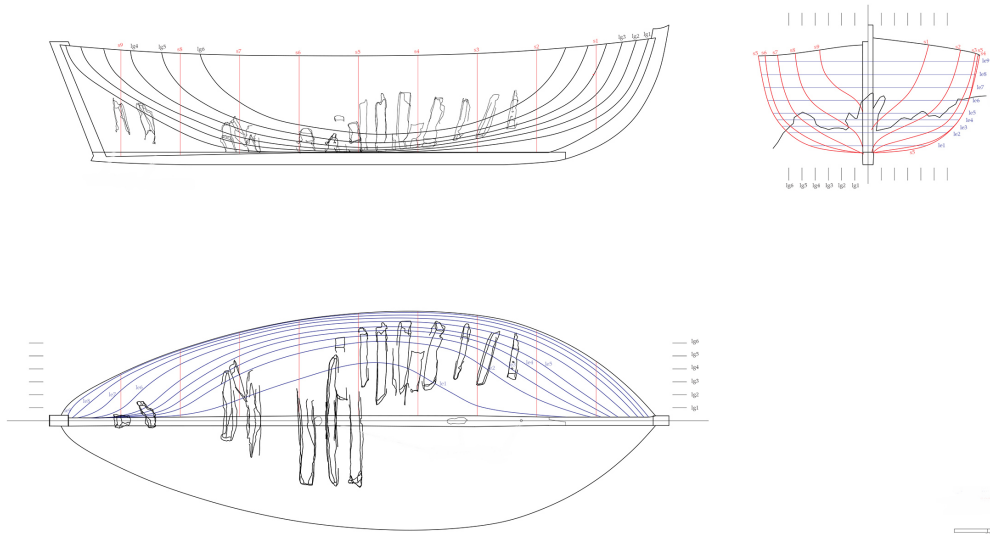
Fig. 1.16. Reconstruction of the lines
Source: S. Bertoliatti

The forms of the hull: the study of the reconstruction of the lines of the forms (Fig. 1.16), the definition of the hydrostatic characteristics of the boat (Fig. 1.17), and that of the rigging (Fig. 1.18), will begin in close collaboration with Sammy Bertoliatti (a professional ship carpenter) and Pierre Poveda (CNRS).

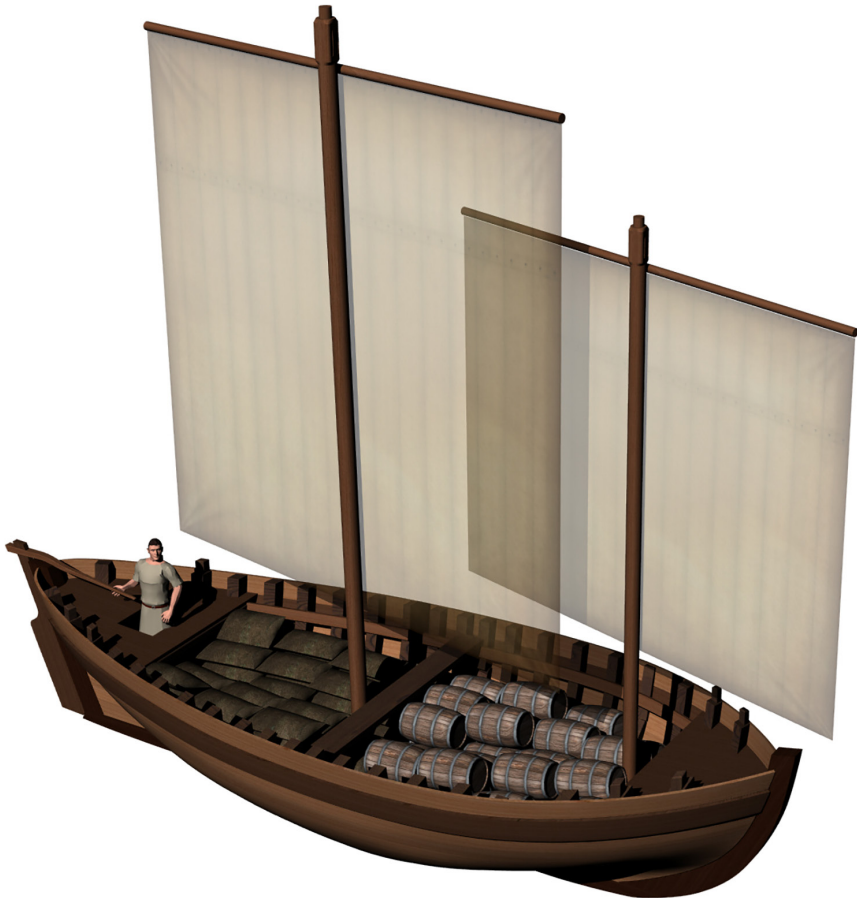
Fig. 1.18. 3D reconstruction of the coaster *Erquy-les-Hôpitaux*
Source: P. Poveda, AMU, CCJ, CNRS
